**INFRARED THERMOGRAPHY ENHANCEMENTS FOR  
CONCRETE BRIDGE EVALUATION**

Khatereh Vaghefi

A DISSERTATION

In Civil Engineering

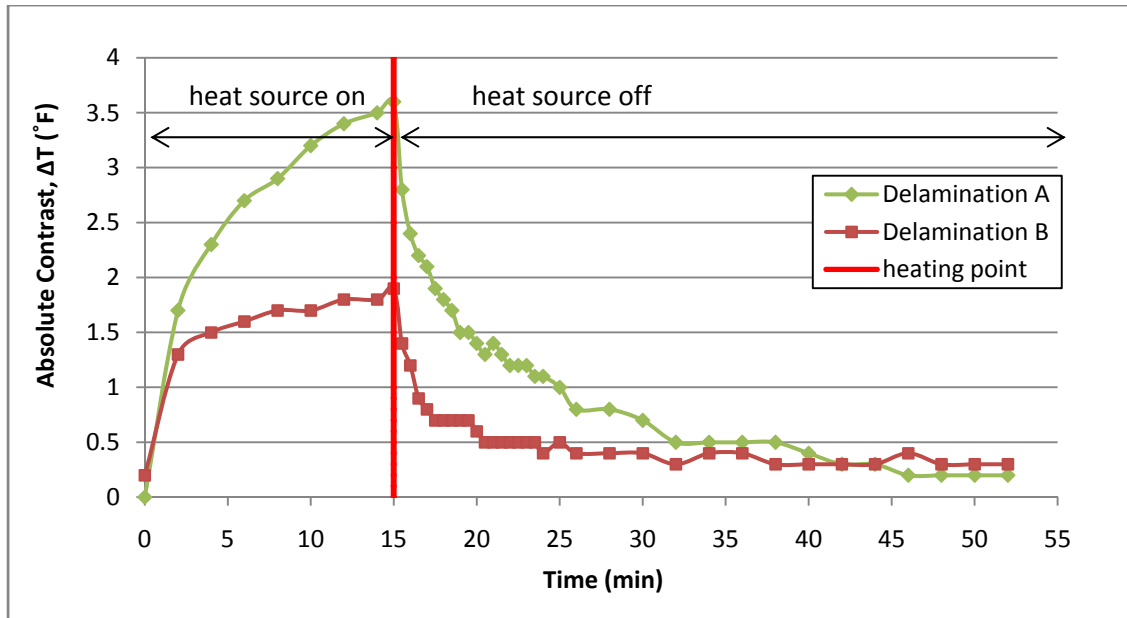
Figure 6.17 shows the absolute contrast variation of delaminations A and B on this location of the beam (location W2). It can be seen that delamination A had a higher absolute contrast than delamination B when the heater was turned off (15 minutes after data collection began). Because the trend of the absolute contrast variation does not show any maximum absolute contrast, it is not possible to estimate the exact depth of the delamination at this location. However, one can still estimate that delamination B is deeper from the concrete surface due to the lower absolute contrast value at this area. Absolute contrast for delamination B, remained constant at 0.7°F between 17.5 and 19.5 minutes after data collection began.

**Figure 6.17 Absolute contrast variations above delaminations at location W2.**

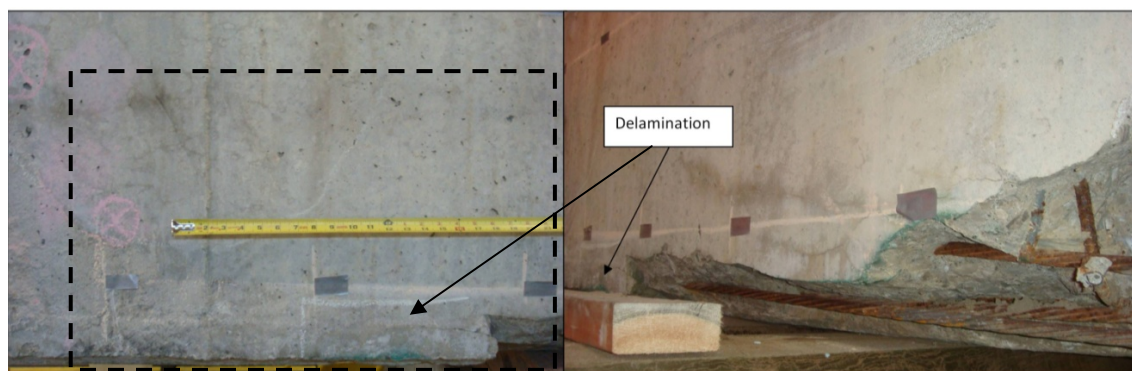
Location W3 is close to the bottom of the beam on the south side where the corroded strands and stirrups are visible. Figure 6.18 shows the visible condition of the box beam specimen at the location W3. Active infrared thermography was conducted at this location and the temperature was monitored over the 15 minute heating period and for about 40 minutes after the heat source was turned off. The ambient temperature was 75.7 °F and the ambient humidity was 55.2% during the data collection.

**Figure 6.18 Visible condition of the concrete surface at the W3 location.**

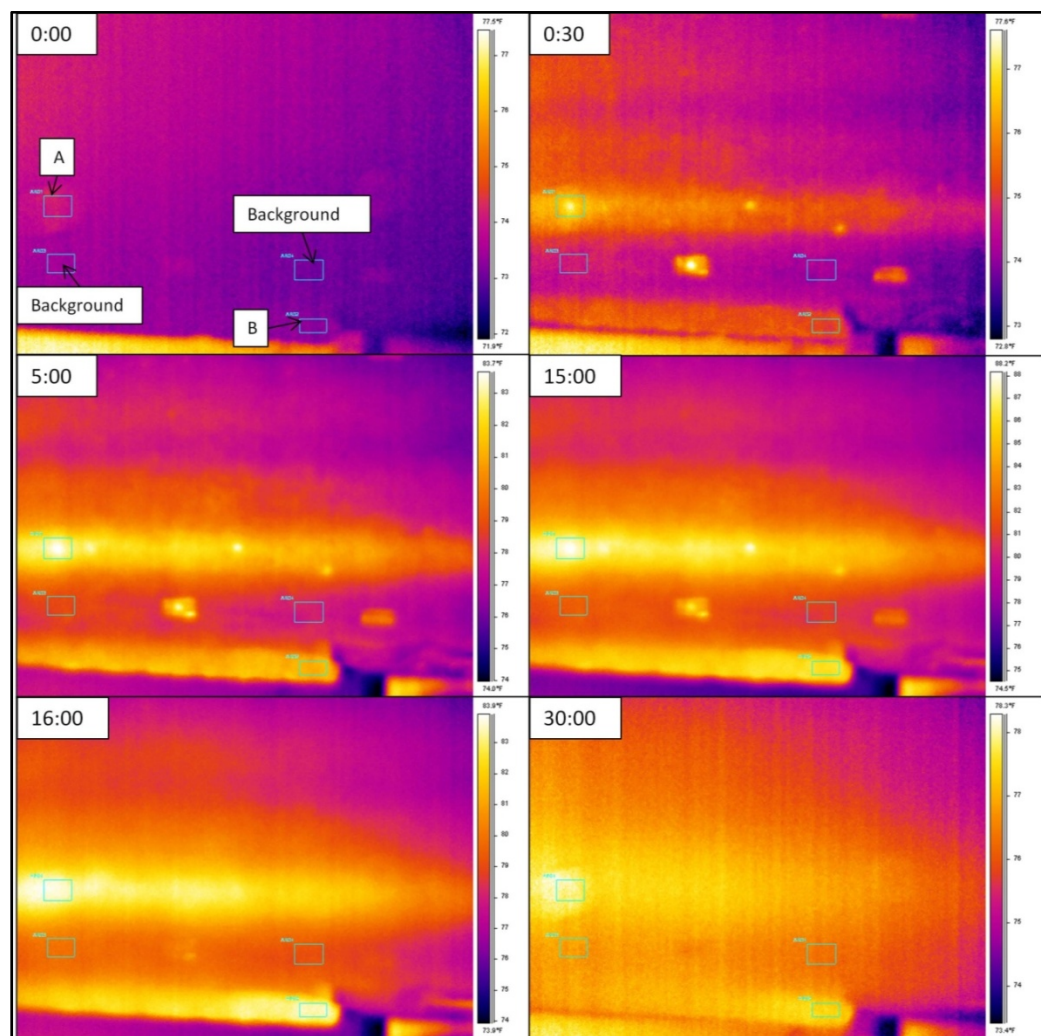
Figure 6.19 shows the thermal infrared images taken from the location W3 at different times. Timestamps on thermal infrared images indicate the time at which the image was taken relative to the beginning of the data collection. Two suspected areas of delamination can be observed at this location; delamination A, which does not have any visible indicator of delamination on the surface, and delamination B, which is close to the area of section loss and exposed stirrups and strands on the south end of the west side of the beam. These two areas were selected based on the subjective interpretation of the thermal infrared images taken from this location.

**Figure 6.19 Thermal infrared images taken from the location W3 during an active infrared thermography test (timestamps on each image represents the relative times to the beginning of the data collection).**

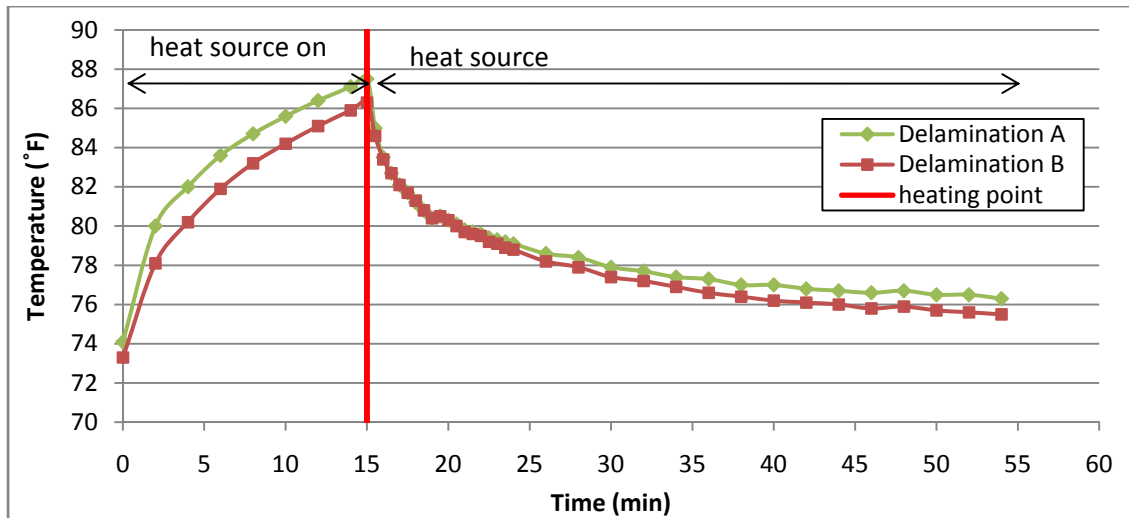
Figure 6.20 shows the plot of the surface temperature variation for delaminations A and B at the location W3. It can be seen that the average surface temperature above the delamination A increased to a slightly higher temperature compared to the average surface temperature above the delamination B, which means that delamination A is located at a shallower depth compared to the delamination B.

**Figure 6.20 Temperature variation above the delaminations at location W3.**

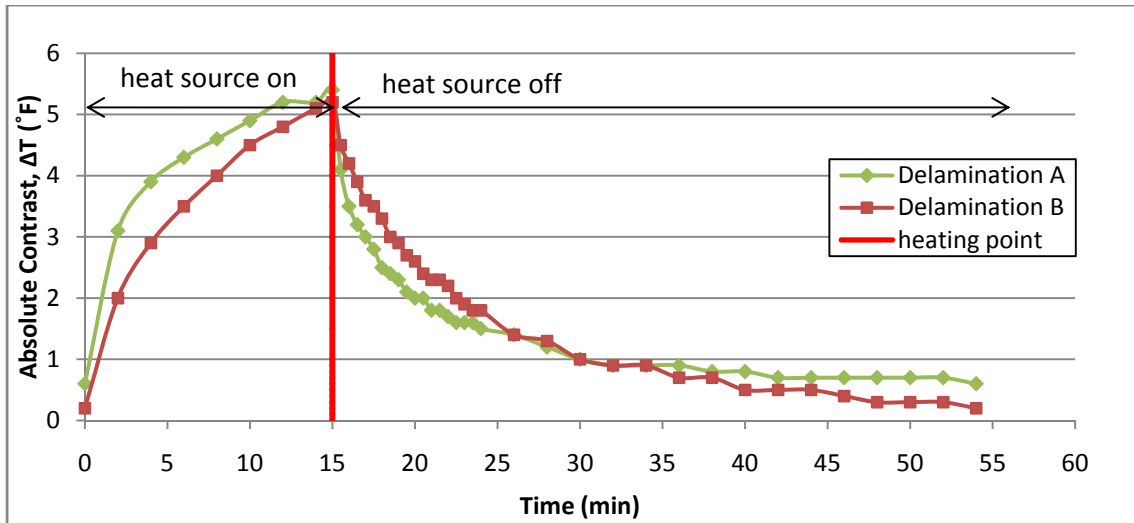
Figure 6.21 shows the absolute contrast variation of delaminations A and B at location W3. It can be seen that a few minutes after heating was stopped on the beam the absolute contrast for delamination B is higher than absolute contrast for delamination A. This higher absolute contrast right after the heating was stopped indicates a deeper delamination at area A compared to area B. Also, the change in absolute contrast is faster in delamination B compared to delamination A and 40 minutes after the data collection began, the absolute contrast of delamination A is higher than delamination B. This indicates that delamination A is deeper than delamination B.

There was no obvious maximum absolute contrast observed at this location to help in estimating the depth of the delaminations. Because delamination B is close to the exposed stirrups and strands, the depth of delamination could be measured. The depth of delamination for delamination B was approximately 1 in.

**Figure 6.21 Absolute contrast variations above the delamination at location W3.**

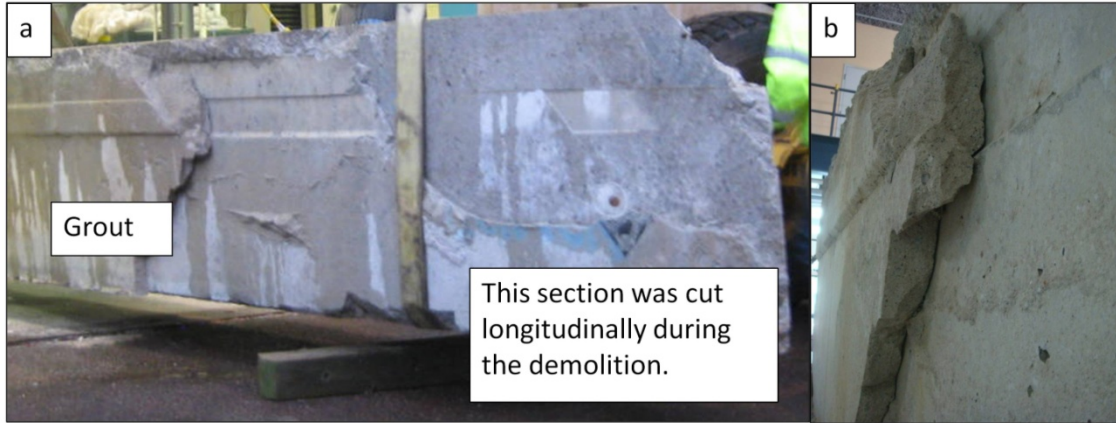
In the Silverbell Bridge, the shear keys between the adjacent box beams were grouted full depth. The thickness of the grout between the box beams was about 2 in. A segment of this grout was still attached to the box beam segment under study in this dissertation. Also, a section of the precast beam was cut during the demolition. Figure 6.22 shows the location of the grout segment and the precast section that was cut. Four locations on the east side of this beam were identified as possible delaminations. These four locations (E1, E2, E3 and E4) were shown in Figure 6.9.

**Figure 6.22 (a) Side of the Silverbell Bridge beam showing the grouted segment and the section that was cut during the demolition (b) grout that is delaminated from the precast section.**

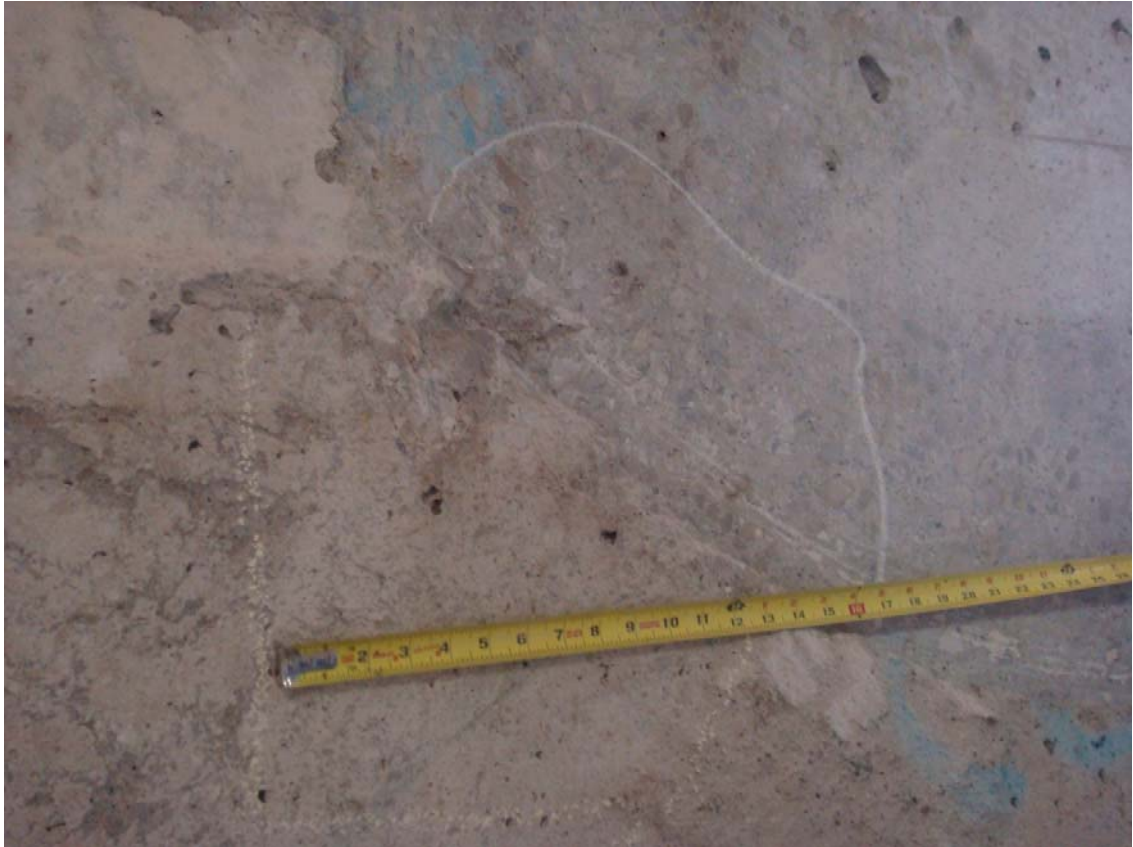
The delaminated area at location E1 was very close to the section that was cut during the demolition and it is situated on the precast section and not the grout. Figure 6.23 shows the visible condition of the beam at this location. There were no visible indicators of delamination on the concrete surface at location E1. The ambient temperature was 78.4°F and the ambient humidity was 37% during the data collection at this location.

**Figure 6.23 Visible condition of the concrete surface at location E1.**

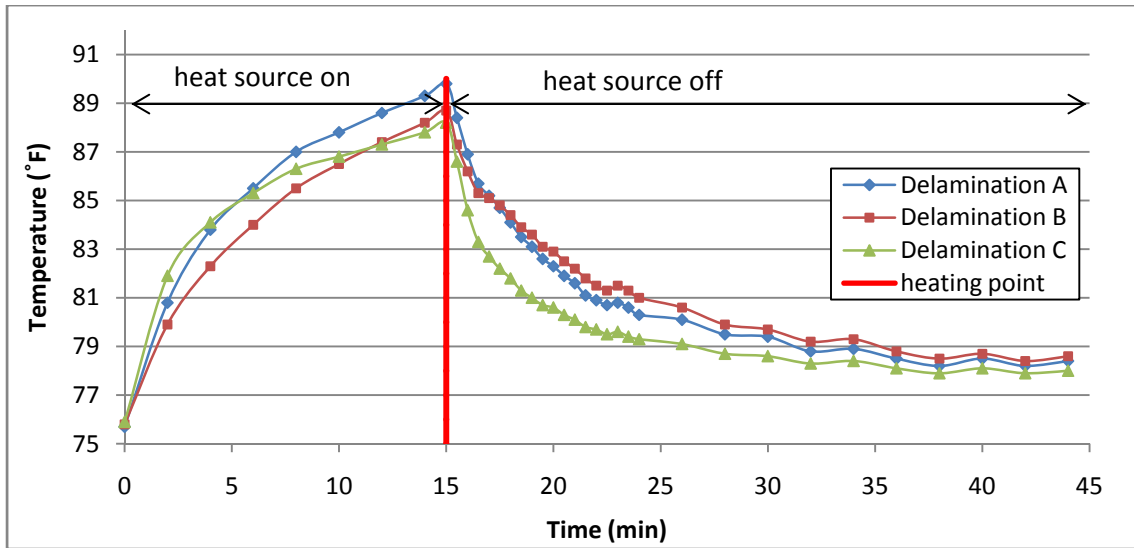
Figure 6.25 shows the plot of the surface temperature variation of concrete above each subarea of delamination A, B and C. Temperature digits showing on this graph indicate the average temperature within each subarea. It can be seen from the plot that the temperature reached a higher value within the subarea A after 15 minutes. This can be an indicator that delamination in subarea A is closer to the surface compared to the other two subareas.

**Figure 6.25 Temperature variation above the delamination at location E1.**

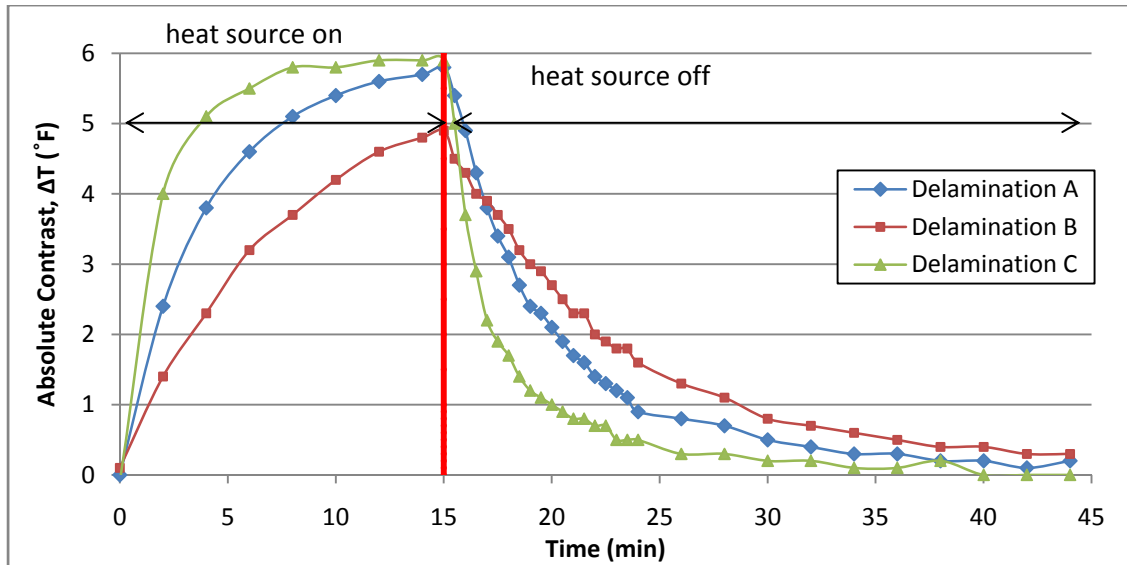
Figure 6.26 shows the absolute contrast variations for the three subareas of delamination located at E1. It can be seen that at the time when heating was stopped (15 minutes after data collection began), the absolute contrast for subareas A and C are higher than the subarea B. However, 5 minutes after the heater was turned off (20 minutes after data collection began), subarea B appeared with higher absolute contrast than subareas A and C. This change in absolute contrast can be an indicator of deeper delamination within the subarea B compared to the subarea A and C. This confirms the results obtained from the temperature variation plot. However, the depth of delamination cannot be estimated at this location because there was not any obvious maximum contrast value that can be observed.

**Figure 6.26 Absolute contrast variations above the delamination at location E1.**

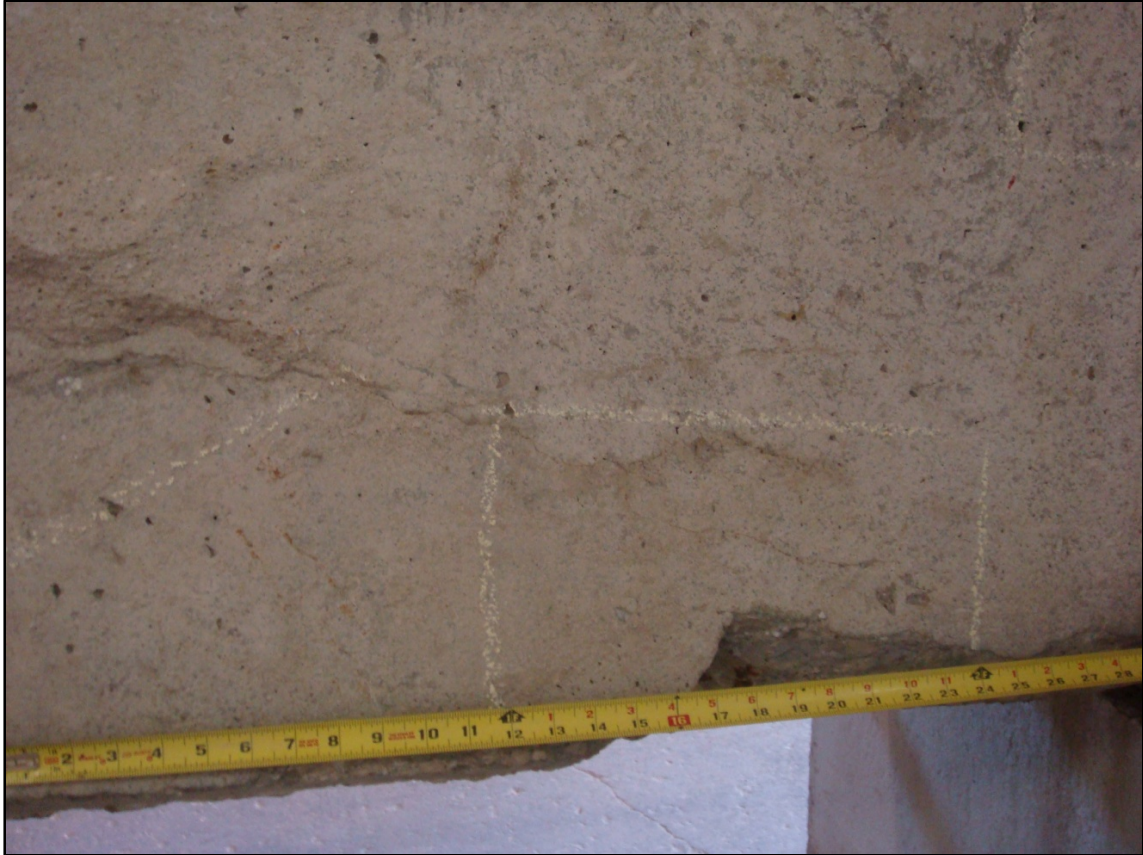
Location E2 is situated close to the bottom surface of the beam near the north support (beam is placed on two supports in the laboratory; north and south). Figure 6.27 shows the visible condition of the concrete surface at the location E2. At this location, a delamination is located around the spalled area close to the bottom of the beam. This delamination was detected by the hammer sounding technique. Also, there is another suspected delaminated area 6 in. away from the spall on the east side of the box beam. The ambient temperature was 77.7°F and the ambient humidity was 45% during the data collection at this location.

**Figure 6.27 Visible condition of the concrete surface at the location E2.**

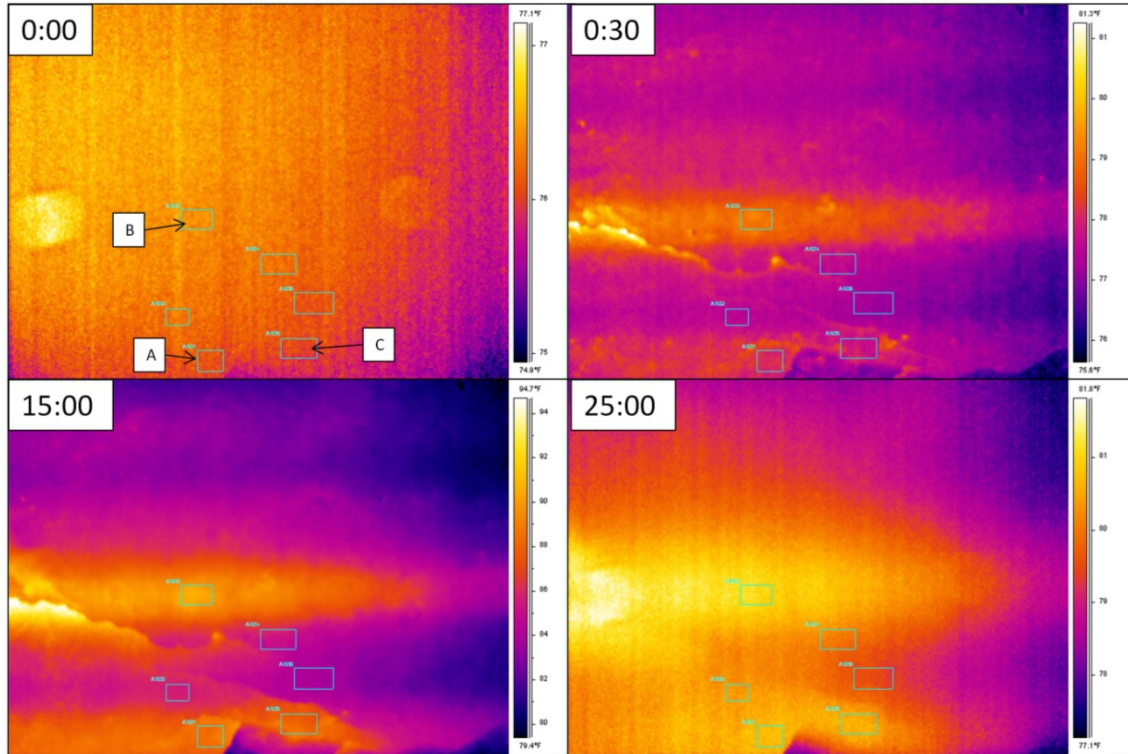
Figure 6.28 shows the thermal infrared images taken from the location E2 at different times. It can be seen from these images that the highest contrast was observed at the time when the heat source was turned off (at 15:00). Suspected delaminations at this location (A, B, and C) are shown in Figure 6.28. Areas A and C are located close to the spalled area.

**Figure 6.28 Thermal infrared images taken from the location E2 during an active infrared thermography test (timestamps on each image represents the relative times to the beginning of the data collection).**

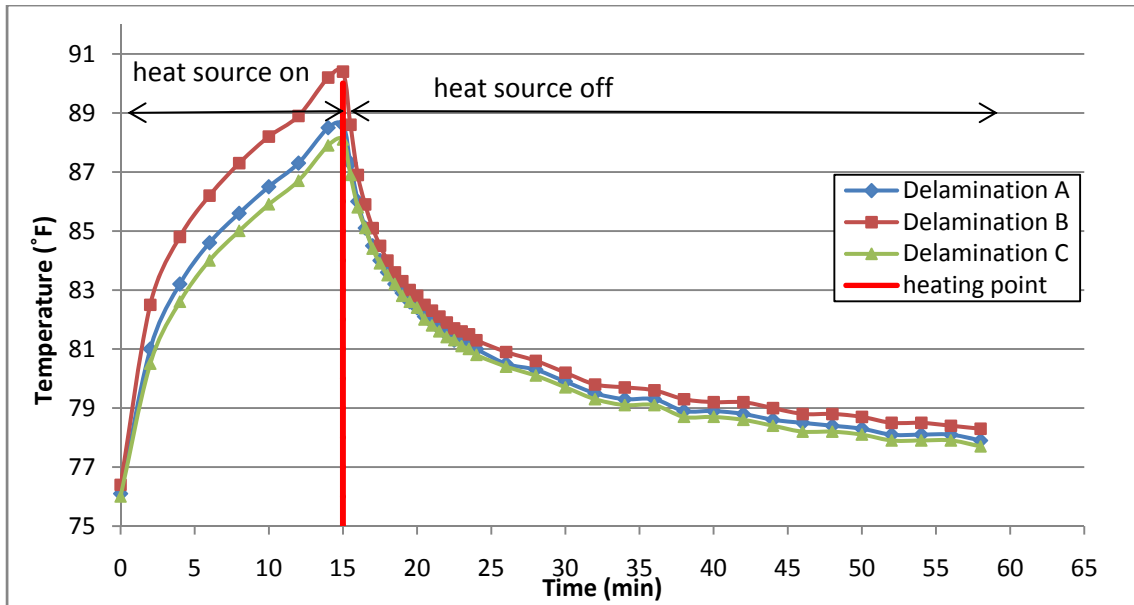
Figure 6.29 shows the plot of surface temperature variation of concrete above each area (A, B and C). It can be seen that at 15 minutes after data collection began (when the heater was turned off), delamination B had a higher temperature compared to the other two delaminations. However, all three delaminations appeared with the same temperature shortly after the heating was stopped. This higher temperature of delamination B before the heat source was turned off can be due to the closer distance of delamination B to the heat radiations and non uniform heating of the surface.

**Figure 6.29 Temperature variation above the delamination at location E2.**

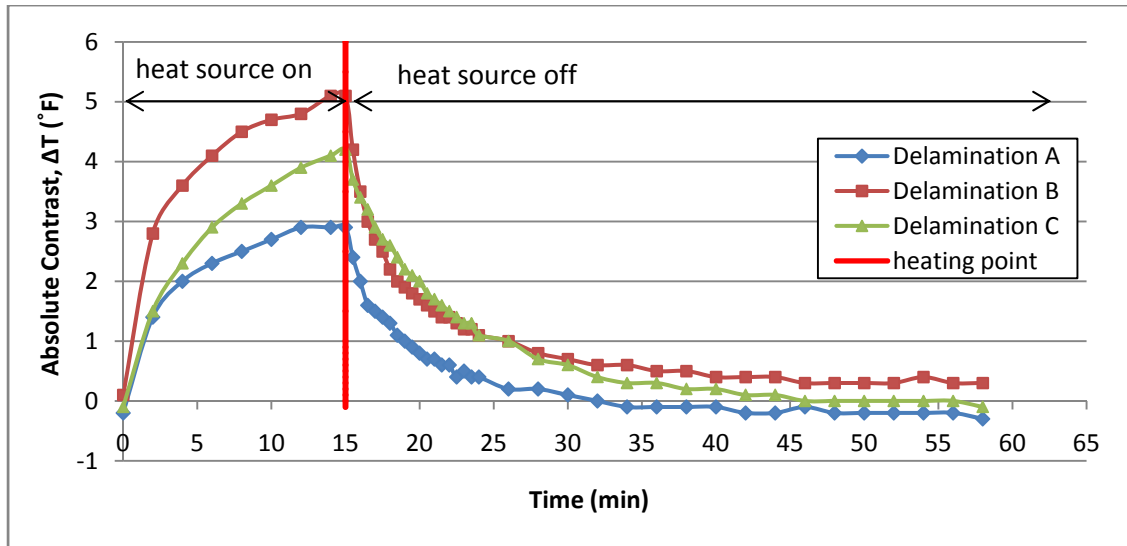
Figure 6.30 shows the absolute contrast variation for the delaminations A, B and C situated at location E2. It can be seen from these graphs that 15 minutes after data collection began, delamination B had a higher absolute contrast compared to the other two delaminations. However, about 5 minute after heat source was turned off; the absolute contrast for delaminations B and C are the same and absolute contrast for delamination A was lower than the other two delaminations. About 10 minutes after the heat source was turned off the absolute contrast for delamination C is lower than delamination B and this indicates that delamination B must be deeper than delamination C. Decision on the depth of the delamination A is not possible because the absolute contrast values for this delamination is much lower than the other two areas.

**Figure 6.30 Absolute contrast variations above delaminated areas at location E2.**

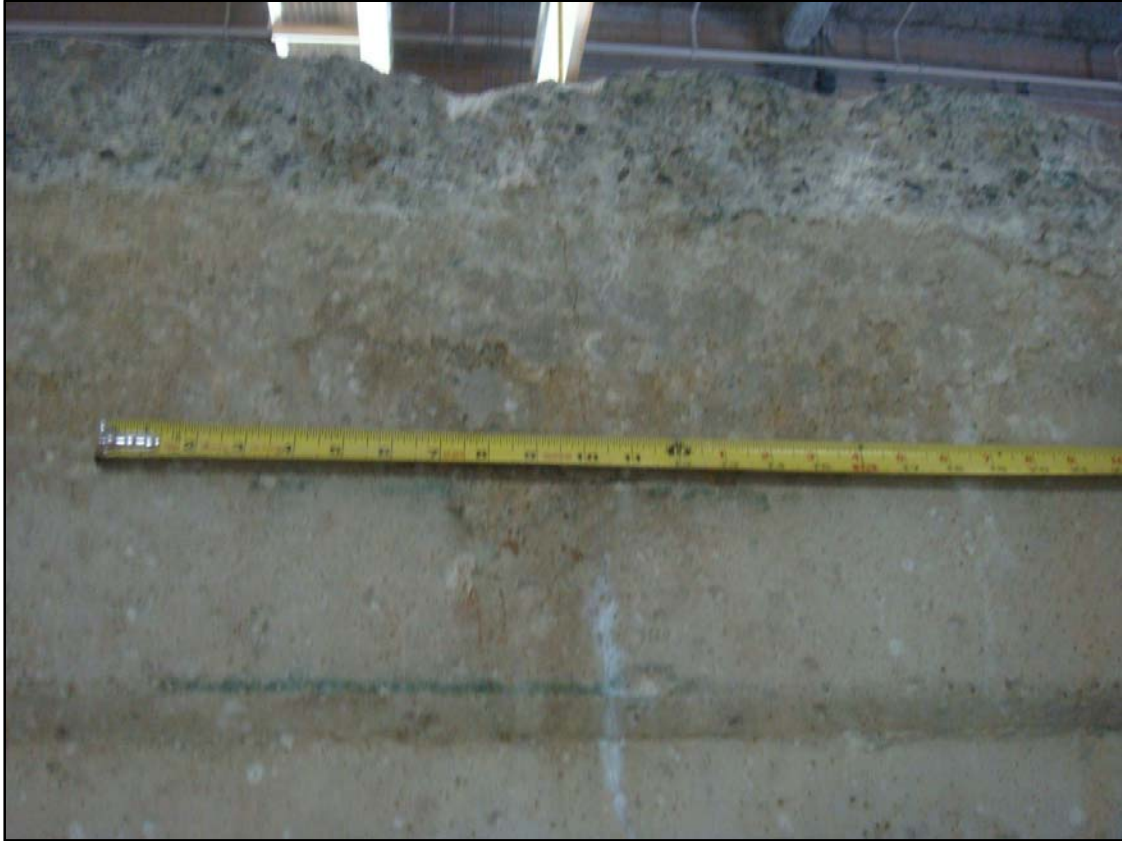
Location E3 is situated within the precast beam section above the shear key and below the 3 in. concrete overlay on the top of the beam which was the riding surface of the bridge. Grout scaling is visible at this location which indicates the deteriorating condition of the grout segment that remains attached to the box beam. Figure 6.31 shows the visible surface condition of the concrete beam at location E3. The ambient temperature was 74.4°F and the ambient humidity was 27% during the data collection at this location.

**Figure 6.31 Visible surface crusting on the concrete surface at location E3.**

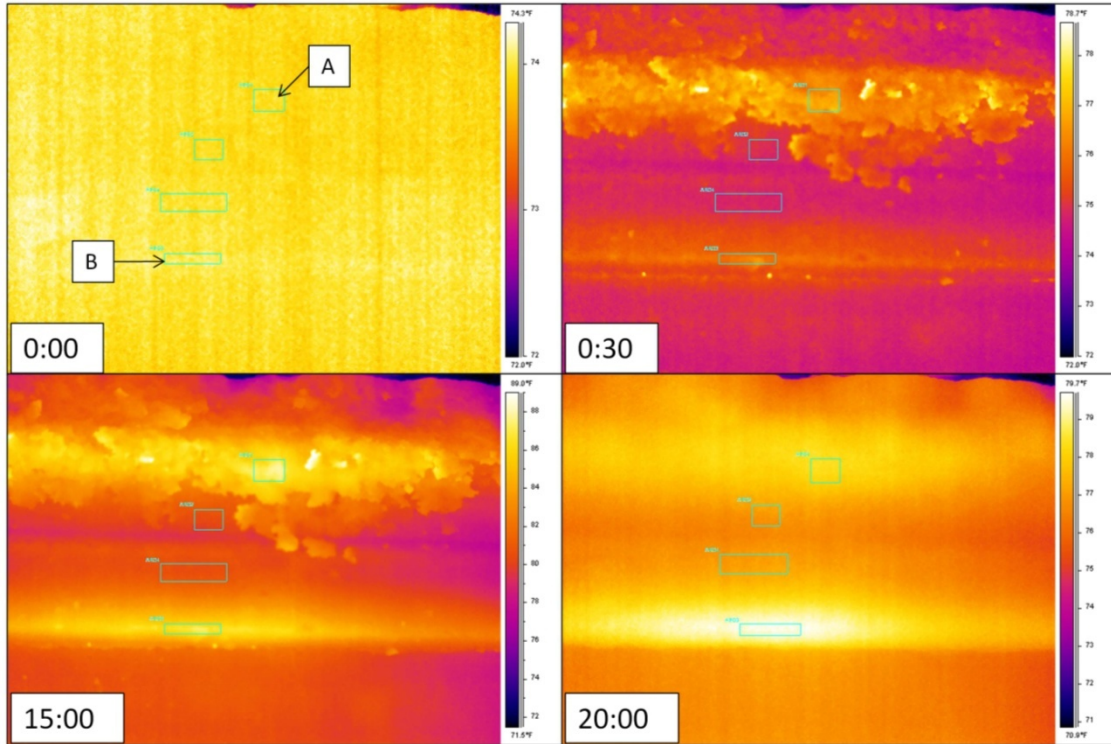
Figure 6.32 shows the thermal infrared images taken from the location E3 at different times. It is very interesting to see the difference between the thermal infrared images when the heat source was on (0:30 and 15:00) and when the heat source was off (0:00 and 20:00) at this location.

**Figure 6.32 Thermal infrared images taken from the location E3 during an active infrared thermography test (timestamps on each image represents the relative times to the beginning of the data collection).**

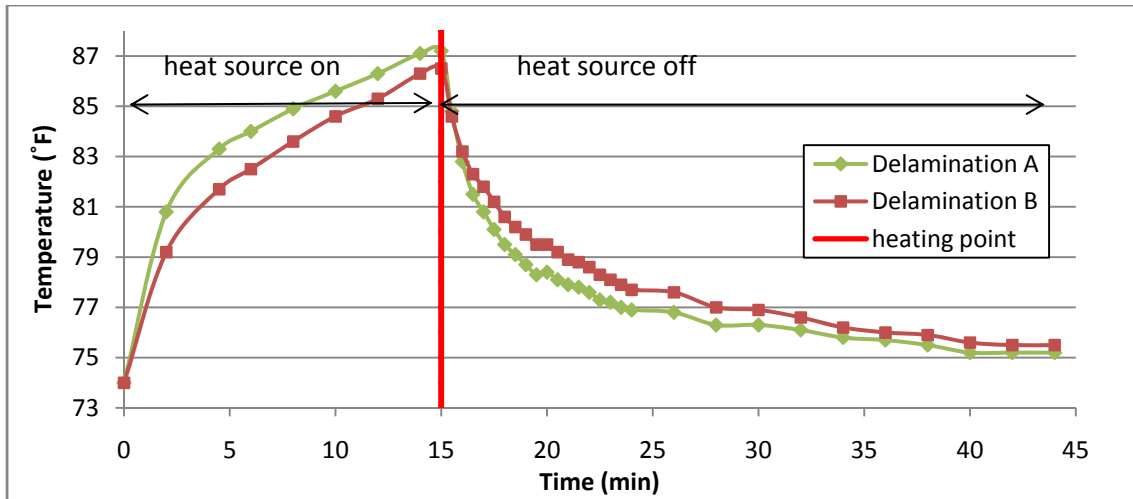
**Figure 6.33 Plot of the temperature variation above the delamination at location E3.**

Figure 6.33 shows the plot of the surface temperature variation of concrete above delaminations at this location. Delamination A is considered to be an area above the section with scaling and delamination B is on the shear key segment of the grout. Note that the temperature change and contrast on the shear key segment can be due to the unlevel surface of the concrete and is not necessarily an indicator of a delamination underneath the surface.

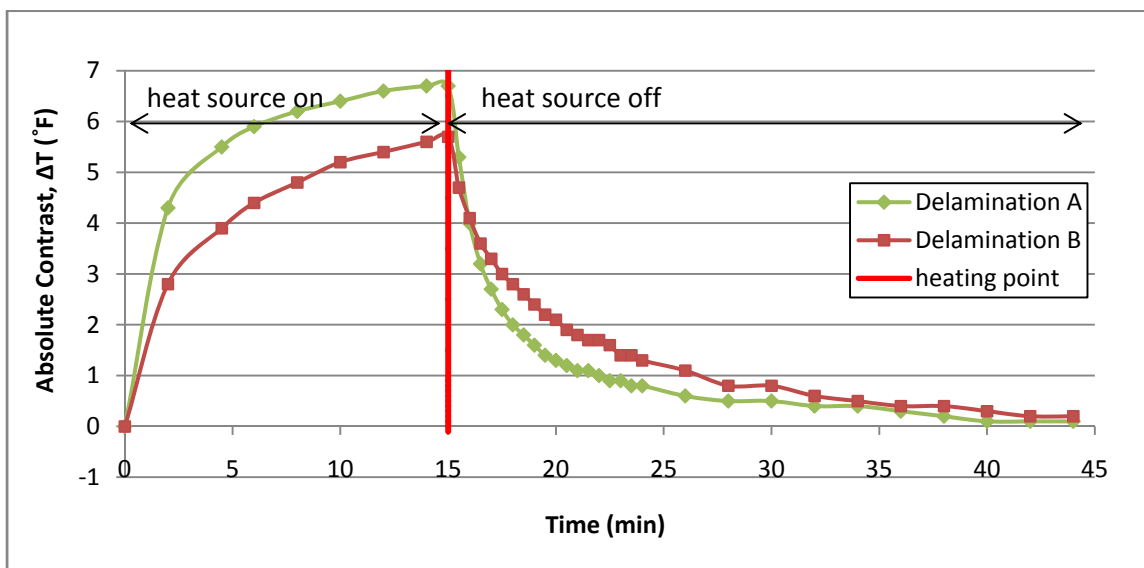
**Figure 6.34 Absolute contrast variations above delaminated areas at location E3.**

Figure 6.34 shows the absolute contrast variation on the concrete surface above delaminated areas A and B. As it can be seen from the graph when heating was stopped (15 minutes after data collection began), delaminated area A had a higher contrast compared to delaminated area B. However, 5 minutes after heating was stopped (20 minutes after data collection began), delamination B appeared to have a higher contrast compared to delamination A. This higher absolute contrast indicates that delamination B is deeper than delamination A.

It is not possible to estimate the depth of delaminations at location E3 because there was not any maximum absolute contrast that could be observed after the heat was stopped on the beam or grouted section.

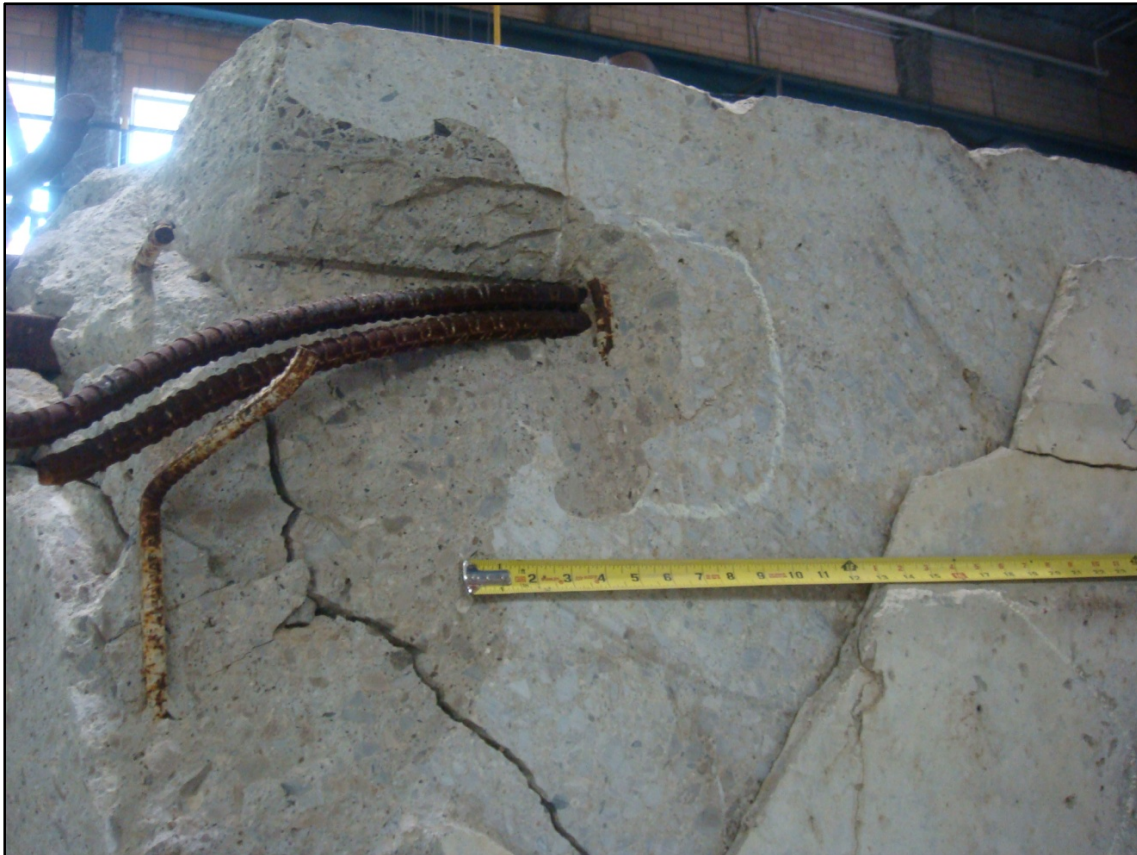
**Figure 6.35 Visible condition of the concrete surface and mild steel at the location E4.**

Location E4 is situated close to the south side of the beam. The delaminated area at this location is close to the exposed reinforcement and spalled area on the precast section. Figure 6.35 shows the visible condition of the concrete surface at the location E4. Delaminations, located closer to the exposed reinforcement, were detected by the hammer sounding technique. The ambient temperature was 70.1°F and the ambient humidity was 38.4% during the data collection at this location.

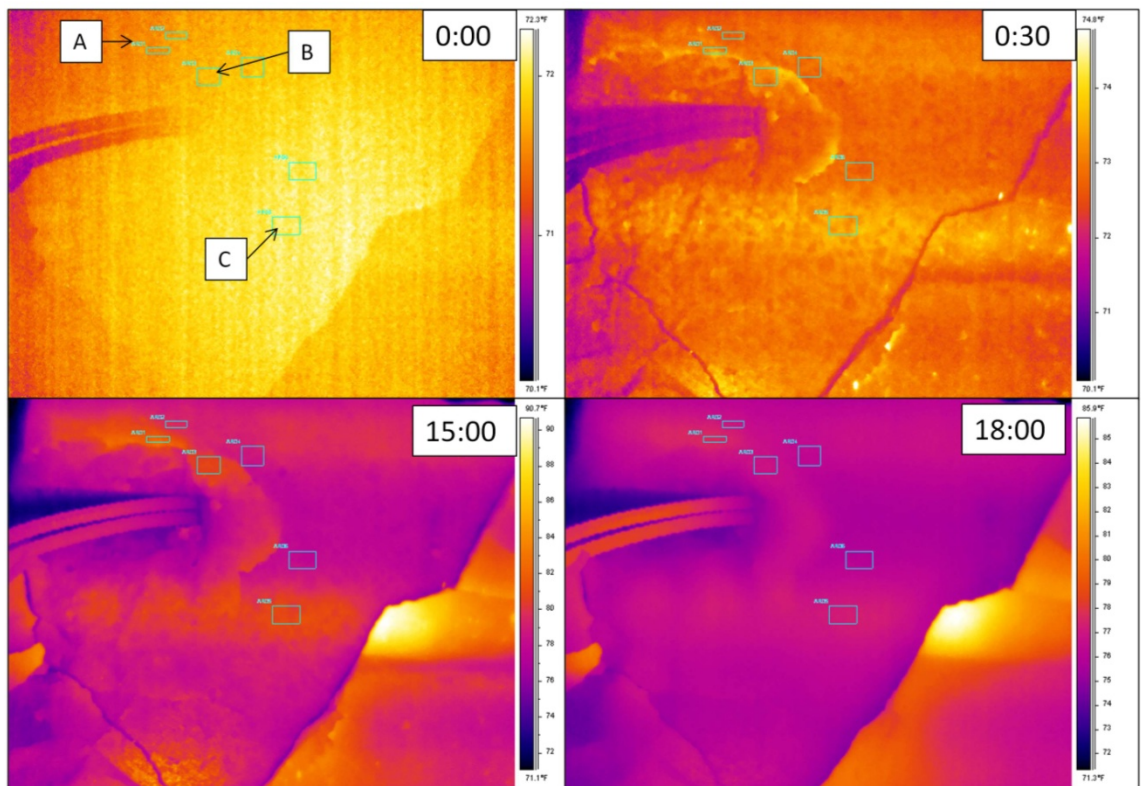
**Figure 6.36 Thermal infrared images taken from the location E4 during an active infrared thermography test (timestamps on each image represents the relative times to the beginning of the data collection).**

Figure 6.36 shows the thermal infrared images taken from the location E4 at different times. It can be seen from these images that the highest contrast was observed at the time when the heat source was turned off (at 15:00). Contrast was disappeared on the delamination areas after about 18 minutes from the beginning of the data collection. This loss can be due to the bright area on the image as a result of the precast section that was at the cut.

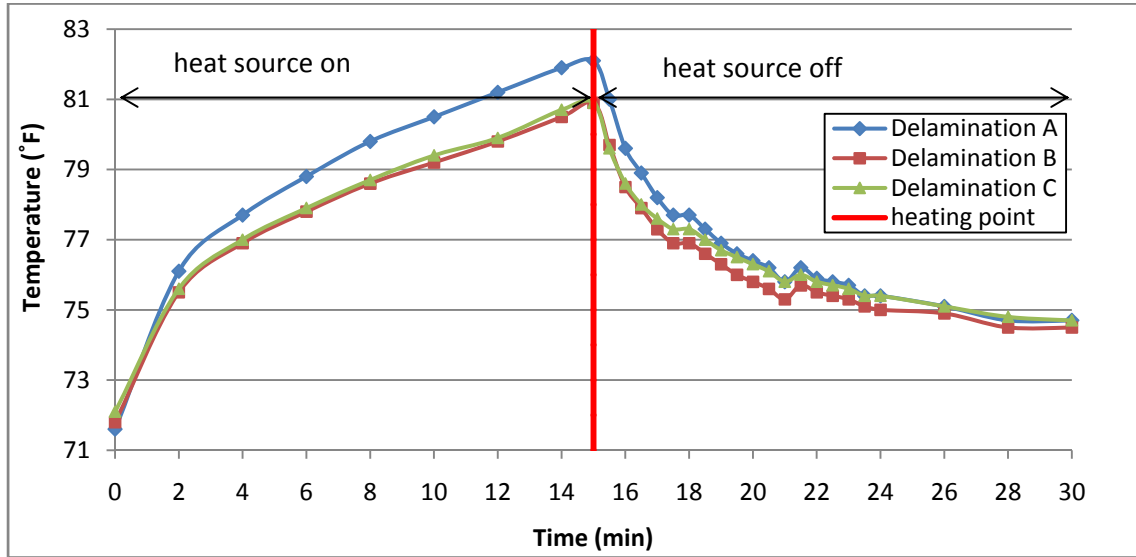
**Figure 6.37 Plot of the temperature variation above the delamination at location E4.**

Figure 6.37 plots the surface temperature variation of concrete above delaminations. This delamination is divided into three subareas A, B and C to investigate the different depths at each subarea. It can be seen from the graphs presented in Figure 6.37 that the maximum temperature for delamination A is higher than delamination B and C. This higher maximum temperature can indicate that delamination A is closer to the concrete

surface than the other two delaminations. Monitoring the absolute contrast variation can give a better estimate of the depth of the delaminations.

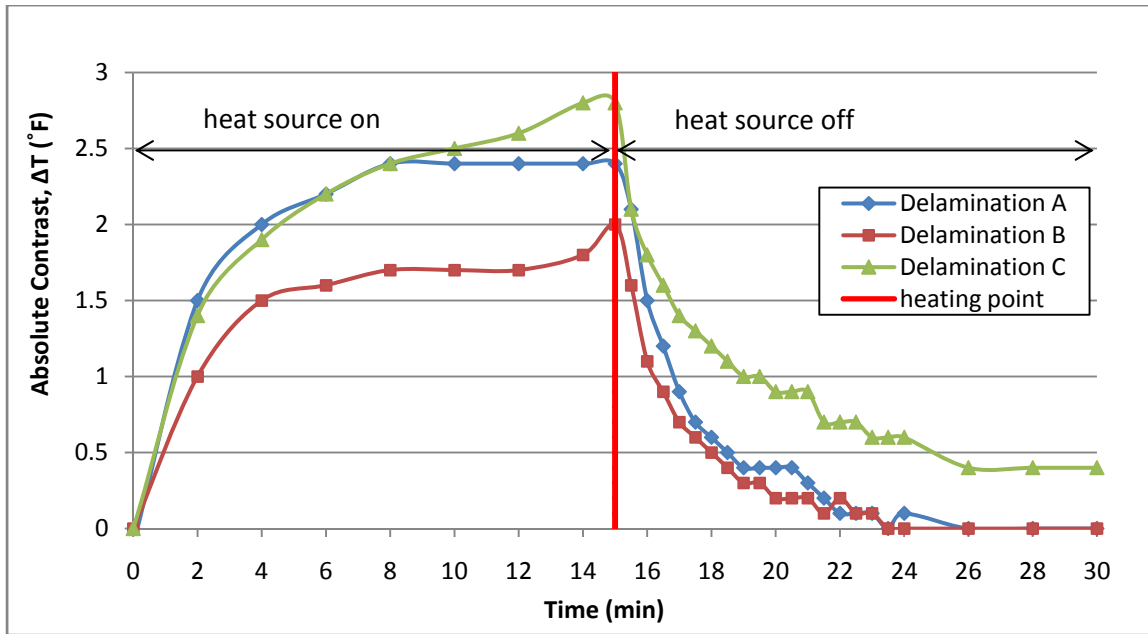
**Figure 6.38 Absolute contrast variations above delaminations at location E4.**

Figure 6.38 shows the absolute contrast variation above subareas of delaminations (delamination A, B, and C). It can be seen from this graph that the constant absolute contrast for delamination C appeared at 19 minutes after data collection began. This indicated that the delamination C is located at a deeper depth compared the other two delaminations.

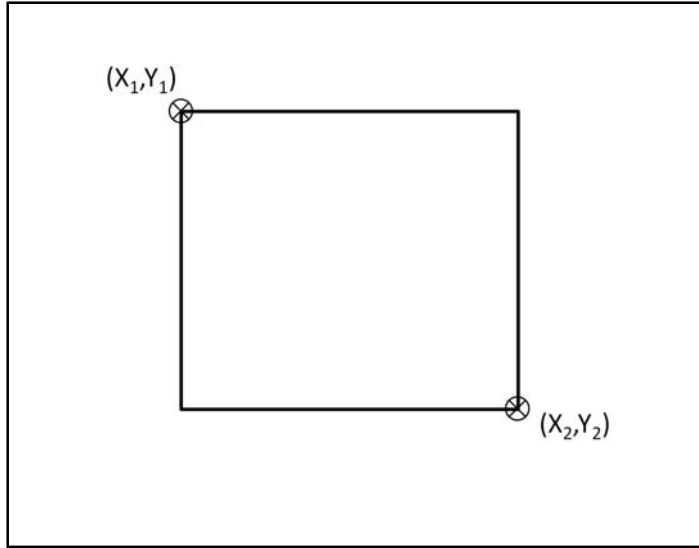
**Figure 6.39** Coordinates of the two corners of the rectangle around each delaminated areas that can be obtained from the software.

Total delaminated area at each location was determined by creating a rectangular shape area around each delamination and summing up the total number of pixels within each area. This calculation was performed by using the ThermoCAM Researcher Professional software and obtaining the coordinate information of each rectangle. Figure 6.40 shows the rectangular shape areas that considered in the total area calculation at each location on the beam. Positions of the pixels located at the top left corner and at the bottom right corner of the rectangle were obtained from this software and based on these coordinates the total number of pixels in each area was computed (see Figure 6.39).

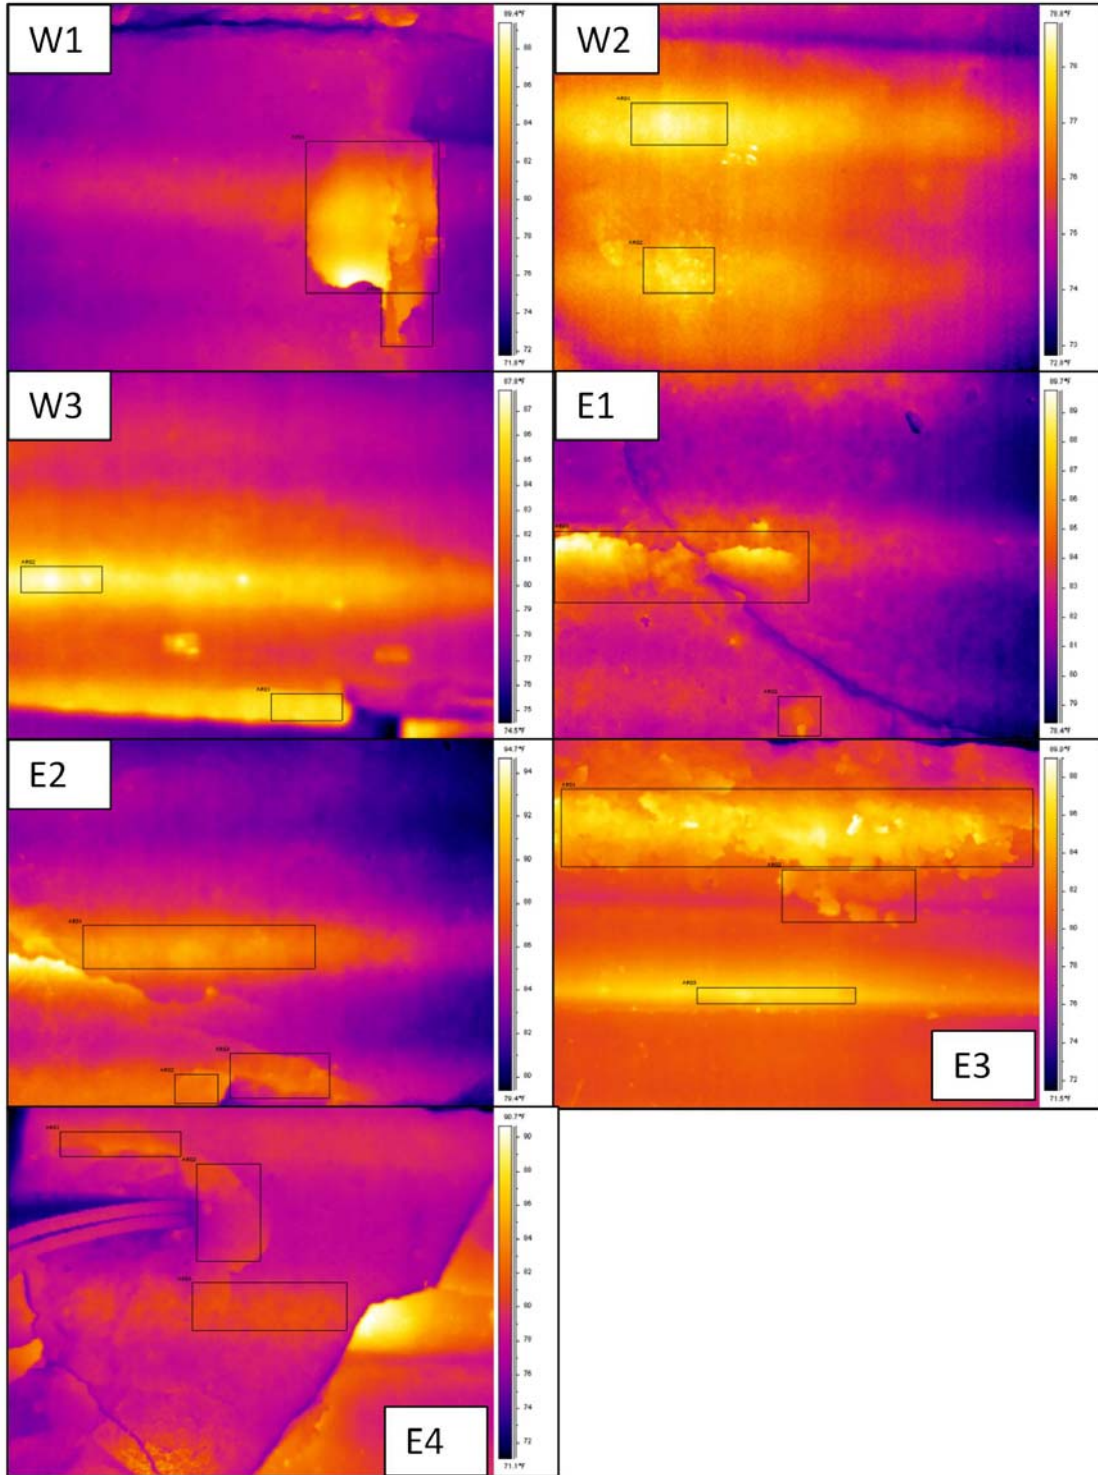
**Figure 6.40 Delaminated areas on the Silverbell Bridge beam considered in the total area calculation.**

A summary of the total number of pixels and delaminated areas at each location is presented in Table 6.1. The total delaminated area on the two sides (east and west) of this beam was determined to be 3.63 ft<sup>2</sup> using active infrared thermography which is about 2.25% of the total area of the sides of this beam. The total delaminated areas using hammer sounding technique was determined to be 5.94 ft<sup>2</sup>, which is about 3.69 % of the total area of the two side of this beam. It was noticed that in locations W1, W2, W3, E1, and E2 total delaminated areas determined by hammer sounding was larger than delaminated areas detected by infrared thermography and in locations E3 and E4, the total delaminated area detected by infrared thermography is larger than the total delaminated area detected by hammer sounding. This is due to the difficulty in estimating the exact location and boundaries of the delamination using the hammer sounding technique.
