**INFRARED THERMOGRAPHY ENHANCEMENTS FOR  
CONCRETE BRIDGE EVALUATION**

Khatereh Vaghefi

A DISSERTATION

In Civil Engineering

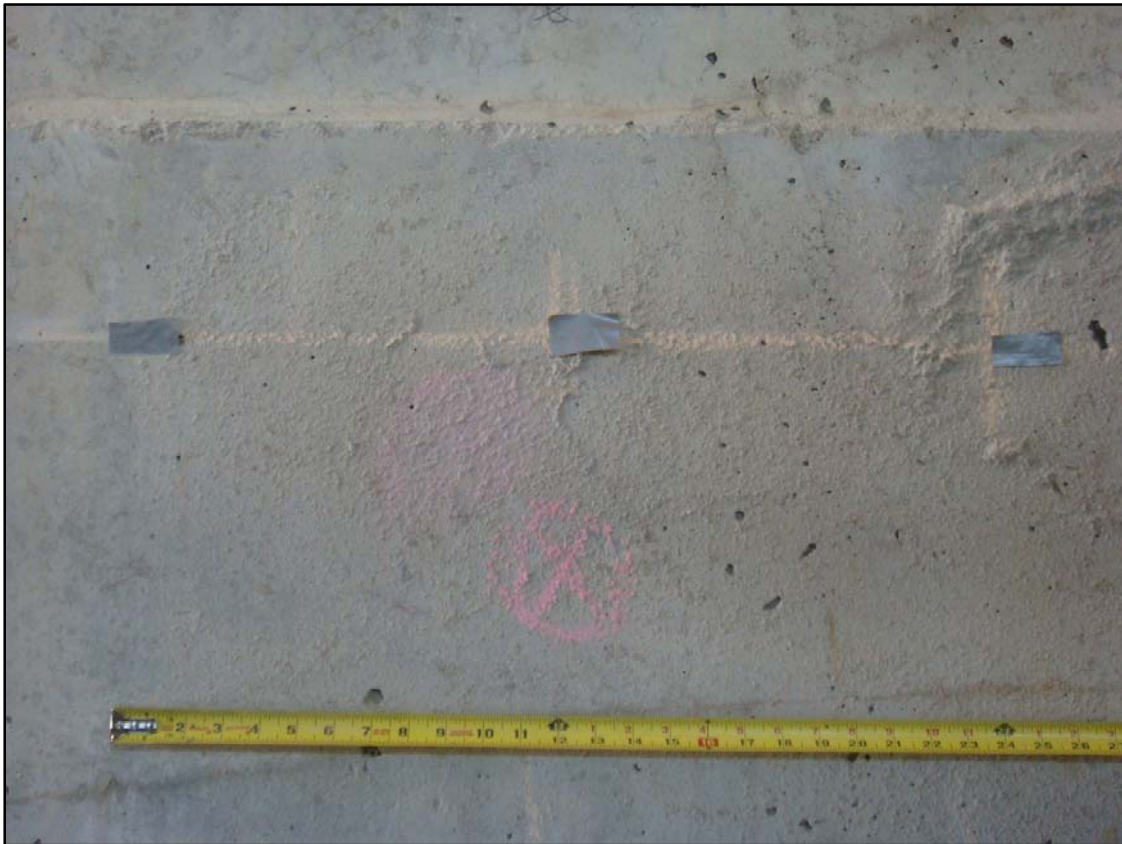
**Figure 6.41 Location W4 with no delaminations.**

to compare the results with locations with delaminations. The location was selected on the east side of the beam. Figure 6.41 shows the location on the Silverbell Bridge beam with no delaminations for active infrared thermography testing. The shear key section of the beam is in the field of view of the thermal infrared images taken from this location.

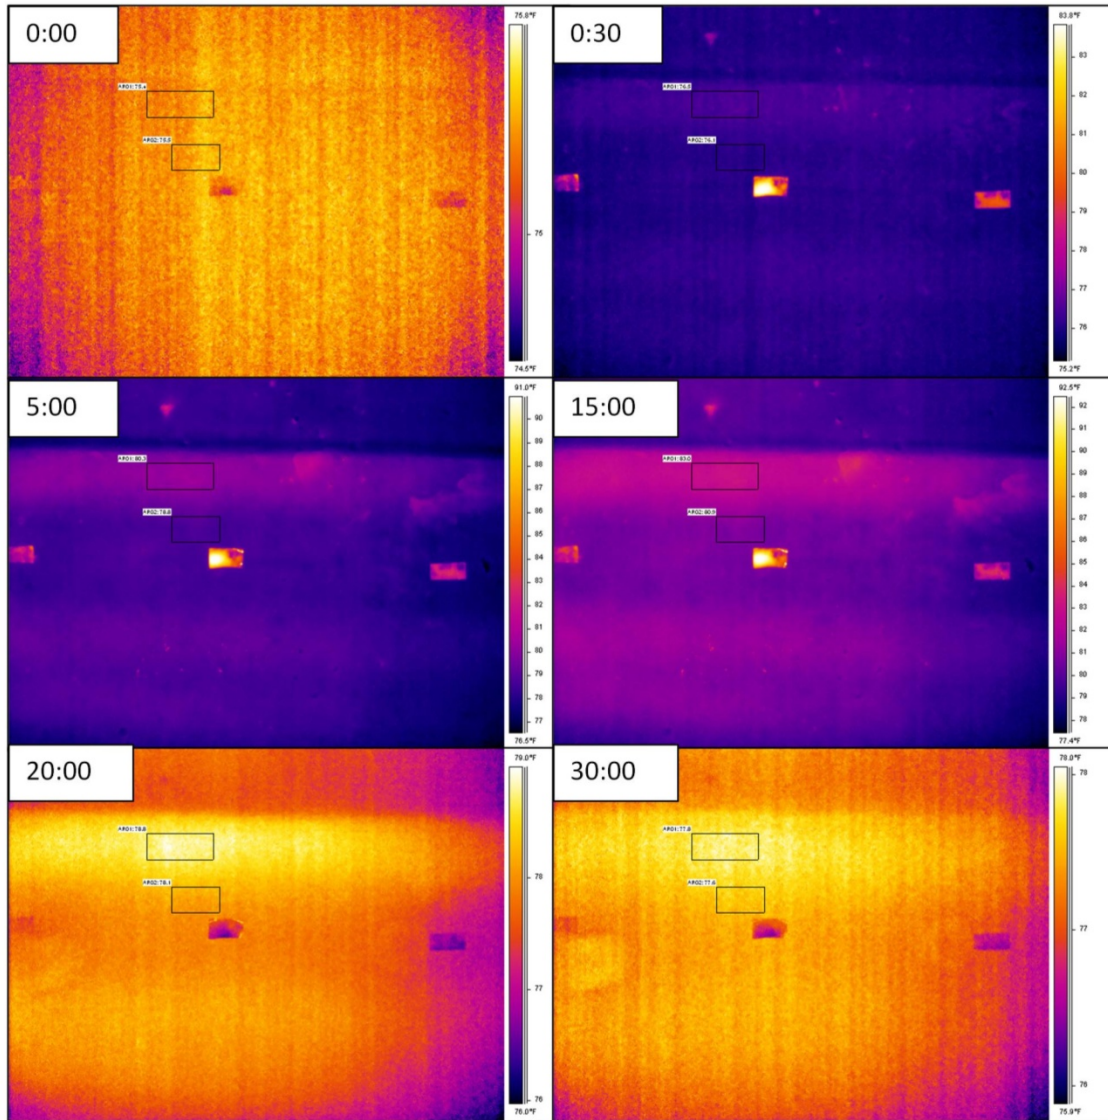
**Figure 6.42 Thermal infrared images taken from the intact location of the Silverbell Bridge beam, taken at 0, 0.5, 5, 15, 20, 30 min after data collection began.**

Images were collected from this location at 30 second intervals. Figure 6.42 shows the thermal infrared images taken from this intact location on the beam at 0, 0.5, 5, 15, 20 and 30 minutes after data collection began. It can be seen that duct tape on these images are shown as bright areas due to the reflective surface and lower emissivity than concrete. Heating was stopped on the beam after 15 minutes and images, taken at 20 and 30 minutes, were taken when no heat was present.

A bright area was observed on the shear key after the heating was terminated, however this bright area vanished from the thermal infrared image within a few minutes. No bright

areas were evident on the thermal infrared images about 10 minutes after the heat source was turned off, which means that no delaminations exist at this location.

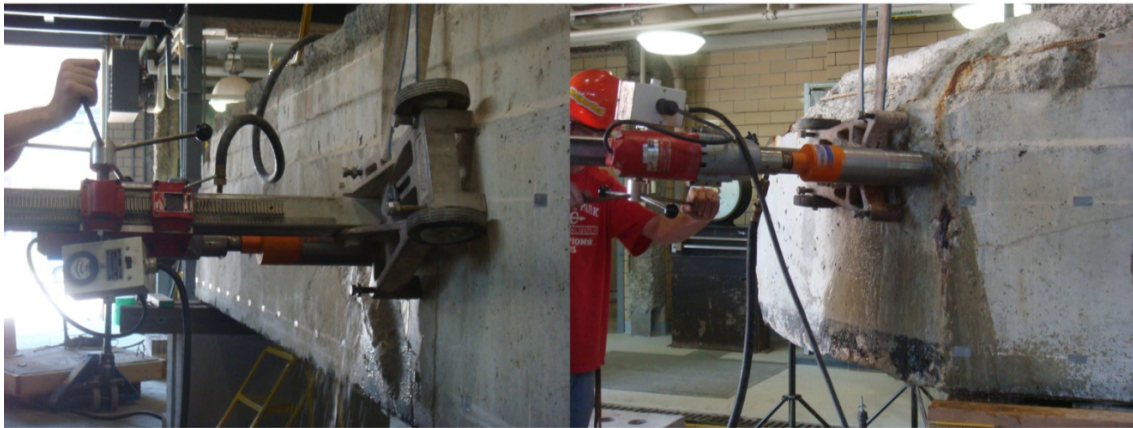
**Figure 6.43 Coring procedure on the Silverbell Bridge beam.**

4¼ in. for all cores extracted from W2-A, W2-B, W3-A, and W4 (Note that Figure 6.2 shows the web wall thickness was designed to be 4½ in. Location W1-B was drilled up to 13.5 in. inside concrete but proved to be a solid section and did not reach the Styrofoam filling inside the box beam. Figure 6.43 shows the coring procedure and the way the drilling was carried out on the beam.

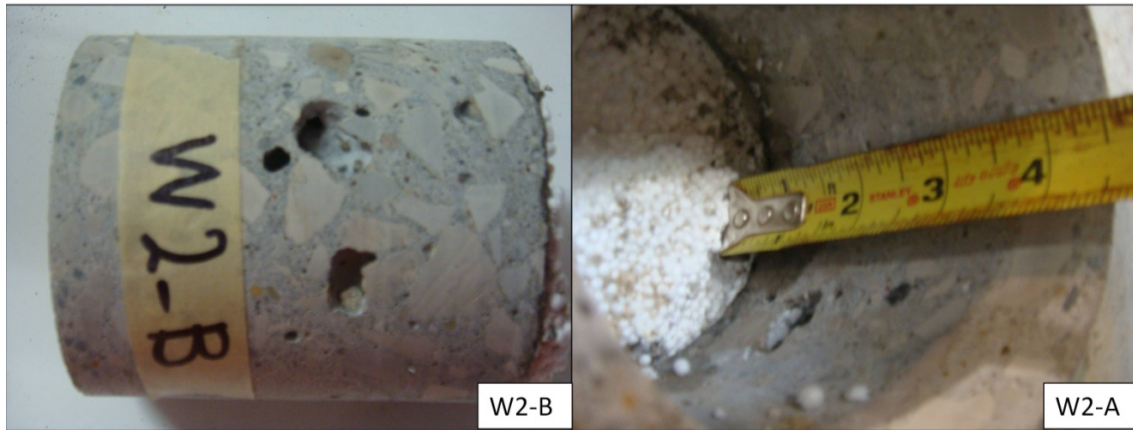
**Figure 6.44** Voids observed in the cores obtained from the Silverbell bridge box beam.

It can be seen from these results that delamination W1 and E2-C could be precisely predict as being located at less than 1 in. deep. Cores that were extracted from location W2 and W3 showed no delaminations although both these location were also shown some indicators of delaminations when tapped with a hammer. Note that some of the locations for extracting cores were selected on spots that did not have an obvious indicator of delaminations, such as W2-A that was placed below the shear key. Also, it has been noted that cores W2-A and W2-B contained some large voids (see Figure 6.44).

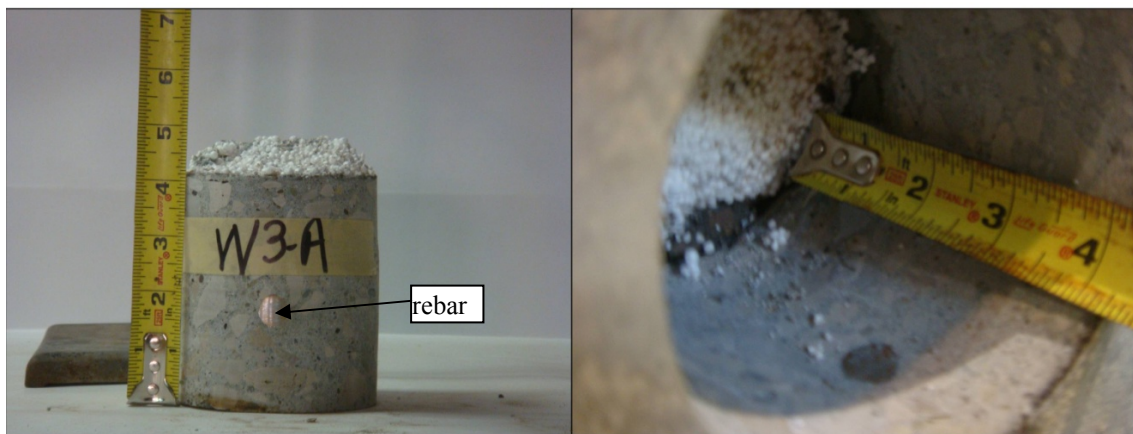
**Figure 6.45** Concrete core obtained from location W3-A, showing the 1¼ in. cover over the rebar.

Concrete cover to the stirrup was confirmed to be 1¼ in. from the core obtained at location W3-A (see Figure 6.45).
