**Water Resources Assessment of the Cimarron River
and
Evaluation of Water Quality Characteristics at the
Maxwell National Wildlife Refuge**

Final Report

**Water Resources Program
University of New Mexico
Albuquerque, NM 87131**

June 2010

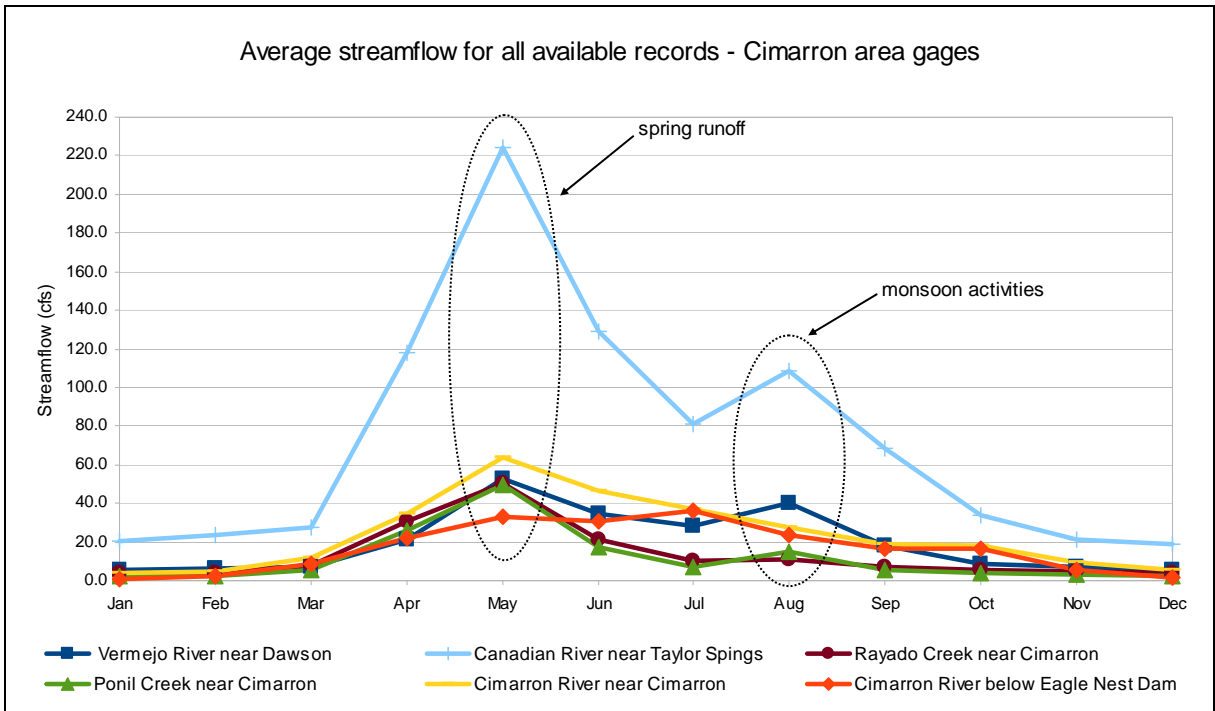
Figure 7. Average monthly streamflow for all available records (USGS, 2009)

Figure 7 illustrates the average monthly streamflow for these six USGS gages. The peaks in May and August indicate that the Cimarron subbasin streamflow is largely influenced by snowmelt and monsoon activities. Figure 9 shows that the streamflow in the region from 2000-2003 was sustained at a low level, and Figure 9 further substantiates this observation because there is a measurable drop in precipitation in the region from 2000 through 2003. This produced the lower streamflows observed during that period. Another possible factor that may have contributed to reduced streamflows may be increased water diversions for agricultural use.

Streamflow measurements collected during this study are similar to the USGS data. Historic seasonal and annual flows are plotted in Figure 7 and Figure 8 respectively. The historic average monthly flow at Cimarron (yellow line) is higher than the flow at Eagle Nest Dam (orange line). The actual streamflow measurements show similar difference between the Village of Cimarron and Tolby Day Use sites. However, the actual flow measured was lower than the USGS monthly June average. Actual flow measured at Tolby Day use was 16 cfs while the average monthly streamflow for June was 25 cfs below Eagle Nest Dam. On the other hand, actual flow measured at Cimarron Bridge was about 28 cfs while the average monthly streamflow for June was 31 cfs at Cimarron.

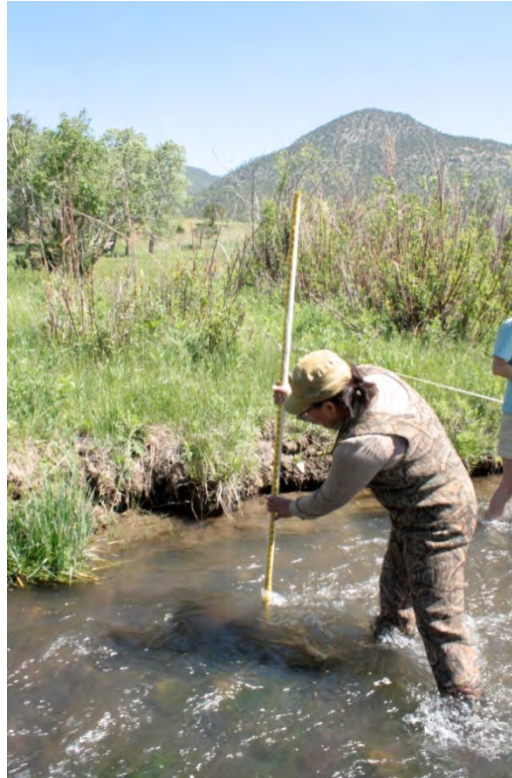
- The thalweg depth (the deepest point in the stream's cross section) was measured every ten feet for entire reach of stream assessed (400 ft at all sites except Rayado Creek at the Philmont Ranch which was 200 ft in length) centered on the baseline transect using a surveyor's rod (Figure 11).

Figure 11. Measurement of thalweg depth at EMAP site number 2, Cimarroncita Ranch

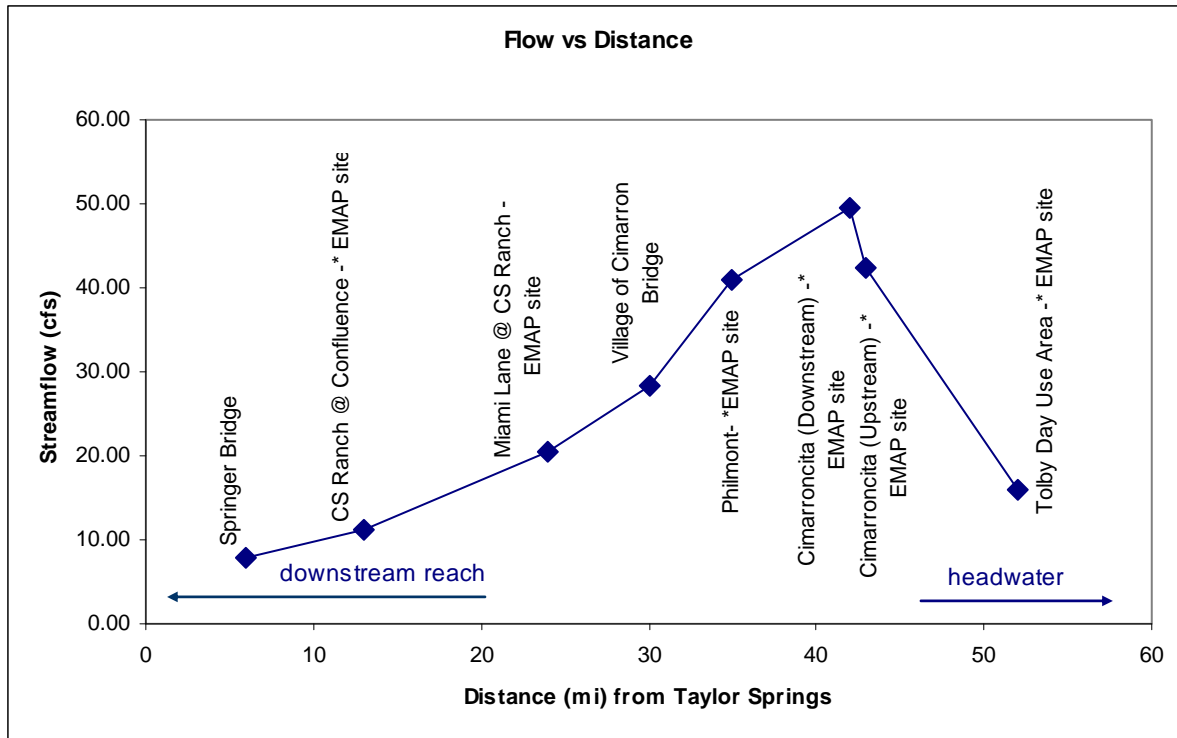
Figure 15. Flow data for the Cimarron River below Eagle Nest Dam.

The variation in Cimarron River flow for the EMAP sites and the river near its confluence with the Canadian River is shown in Figure 15. Beginning just downstream of Eagle Nest Dam, the measured flow in the Cimarron River was 16 cfs. Approximately ten miles downstream at the Cimarroncita sites near Ute Park, the flowrate was found to be between 42 and 50 cfs. EMAP assessments were completed at the upstream and downstream boundaries of the Cimarron River at Cimarroncita, and these provided flowrates that vary by 15%. The large increase in flow from the outflow of Eagle Nest Lake and Cimarroncito is believed to be due to the inflow of Ute Creek located upstream from the Cimarroncito site, along with a few smaller tributaries. No flow measurements were made on these tributaries.

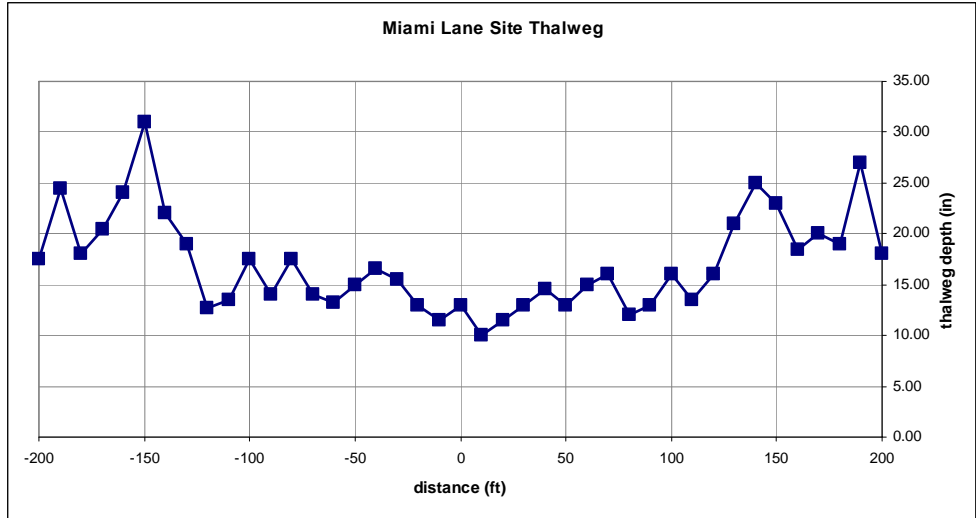
Cimarron River at Miami Lane at CS Ranch shows the least variation in depth and has the most homogenous bed materials, mainly silt and clay. With these fine sediments, transition of different channel features would be sparser. Overall, all three sites have a good variation of thalweg depth that provide potential habitat for different aquatic organisms.

Figure 18. Thalweg depth profile at the Miami Lane EMAP site on the Cimarron River located on the CS Ranch.

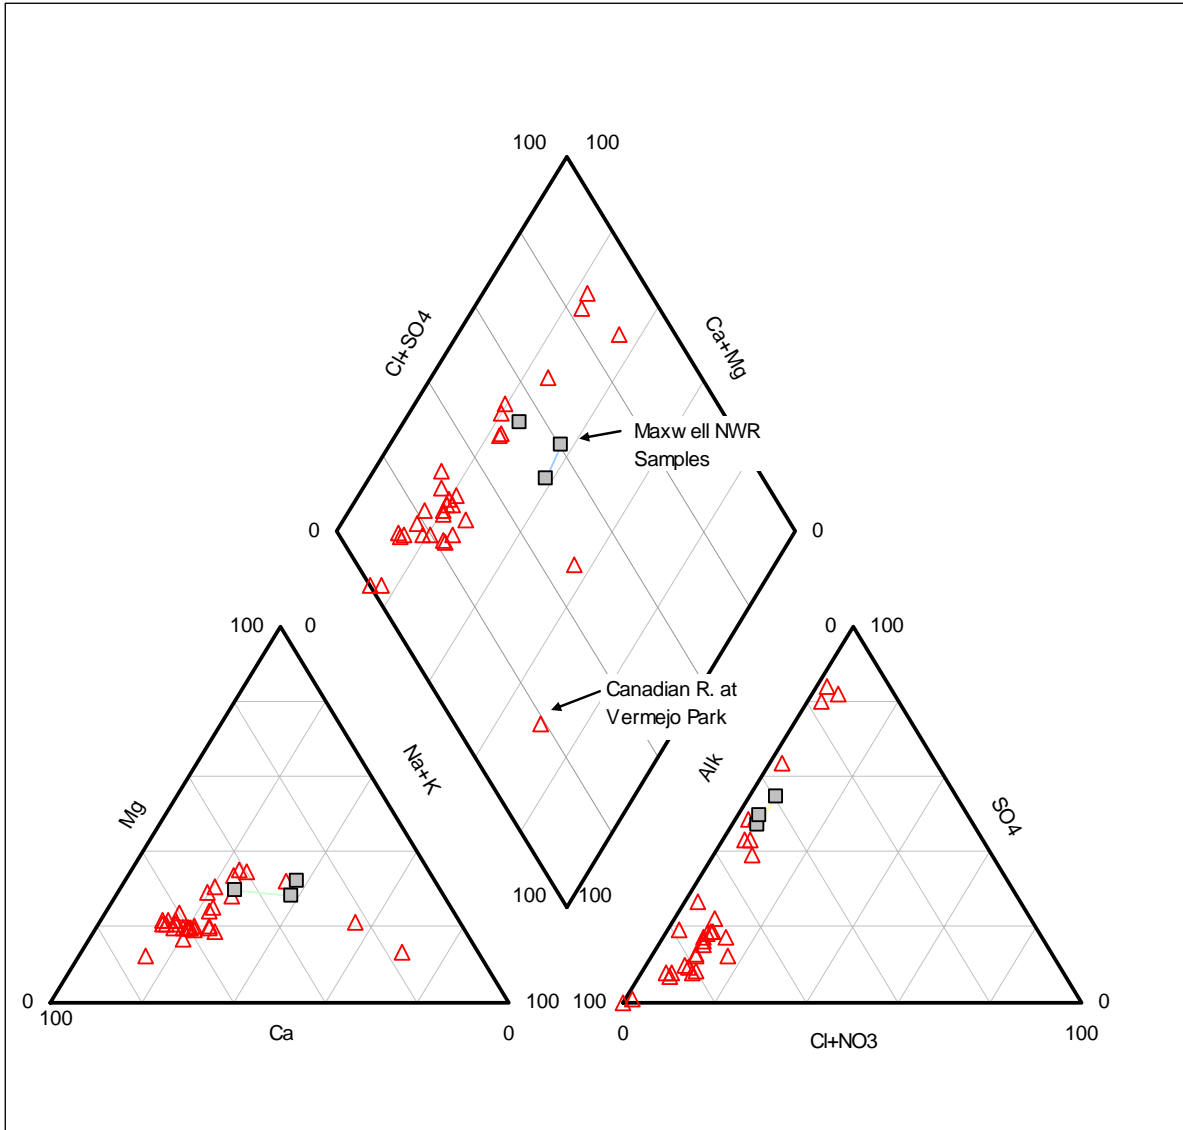
The major ion characteristics of natural waters is frequently summarized graphically through the use of trilinear diagrams (also known as Piper diagrams) (Hem, 1985). These diagrams are prepared by plotting the fraction of major ion concentration when expressed as meq/L. This permits visual comparison of the ratios of these ions for a large number of water samples (Figure 21). A couple of notable observations can be made. The first is that major cations are fairly tightly grouped in all water samples at roughly 80% Ca and Mg ions, and 20% Na and K ions. This is consistent with the previous observation that all of the waters sampled were relatively hard. The second point is that, in contrast to the cation data, there is a wide variation in the distribution of anions. All of the samples had Cl concentrations that were less than 20% of the total anion concentration when expressed as meq/L; the waters were dominated by bicarbonate-carbonate ions and sulfate ions. But the sulfate fraction ranged from near zero near the headwaters of Cieneguilla Creek to greater than 80% of the total anions on the Canadian River near Taylor Springs. The high sulfate concentrations at the Maxwell National Wildlife Refuge are consistent with the observed white Ca-SO₄ deposits collected at the Playa Lake.

Figure 21. Trilinear diagram representation of the major ion composition of all of the water samples collected during this investigation. Samples collected at the Maxwell National Wildlife Refuge are presented as gray boxes.

The major ion chemistry for water samples collected at the Maxwell NWR are presented in Table 12 and the complete analyses are presented in Appendix I. The water has high concentrations of Ca and Mg resulting in a total hardness of greater than 150 mg CaCO₃/L, as well as high alkalinity which is likely due to the prevalence of limestone deposits in the Canadian River watershed. A plot of the major ion chemistry of the water samples collected at the refuge is presented in Figure 21.

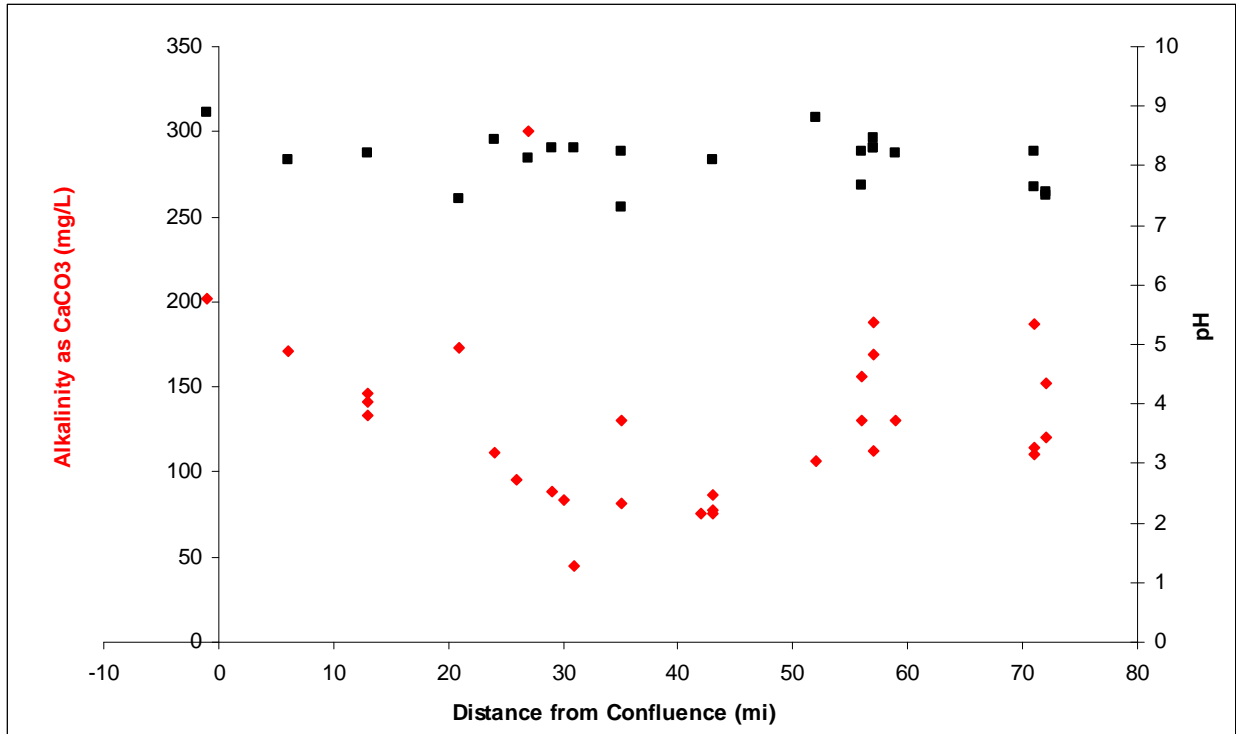
Figure 22. Variation of pH and alkalinity at sample sites along the Cimarron Watershed. Distances are approximate mileage from the confluence of the Canadian and Cimarron Rivers near Taylor Springs, NM.

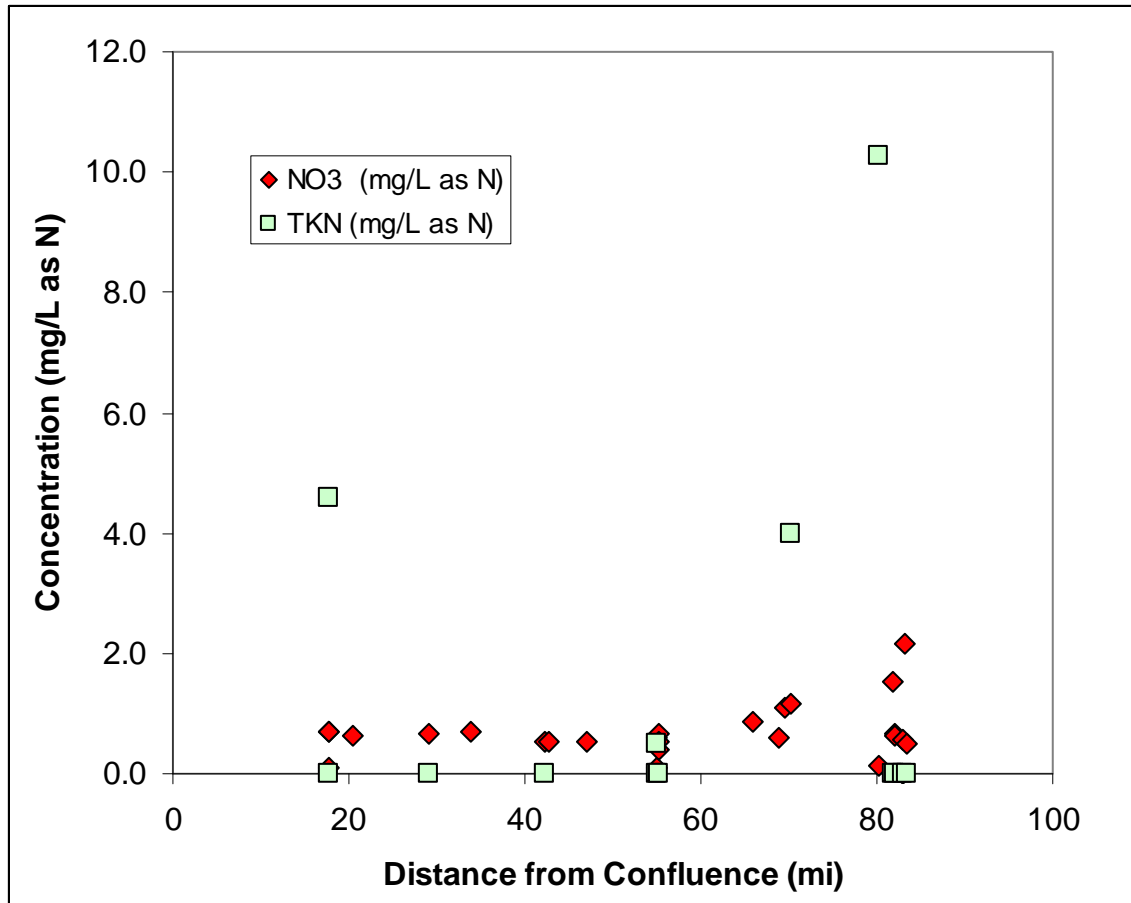
Figure 24. Variation of nitrate (NO₃) and Total Kjeldahl Nitrogen (TKN) concentrations along the Cimarron River upstream from its confluence with the Canadian River near Taylor Springs, NM.

Elevated concentrations of nitrogen compounds will stimulate growth of aquatic plants, especially algae, resulting in a process known as eutrophication. Plant growth can be observed more in low water flow sites where plants can more easily get established (Campbell & Wildberger 2001). Nitrate is the only nitrogen compound regulated for drinking water; its maximum contaminant level (MCL) is 10 mg/L measured as N. A plot of the nitrate and TKN concentrations along the Cimarron River is presented in Figure 24. The nitrate concentrations are greatest in water samples taken near the Angel Fire Country Club. The highest concentration of TKN was found in a sample taken immediately downstream from the town of Angel Fire. Possible sources include fertilizer from the golf course and high density of residences served by on-site wastewater disposal systems. It is worth noting that of 25 samples analyzed for nitrate in the Cimarron watershed, only 5 were less than 0.5 mg/L. Confirmation of elevated nitrate levels was suggested by the presence of noticeable algal growth on cobbles and boulders at most sampling locations.

A TKN concentration of 4.6 mg/L was measured in a water sample taken from Rayado Creek at its confluence with the Cimarron River. The cause of this high nitrogen concentration is not known. Re-sampling of this location is needed to provided confirmation of the elevated value.

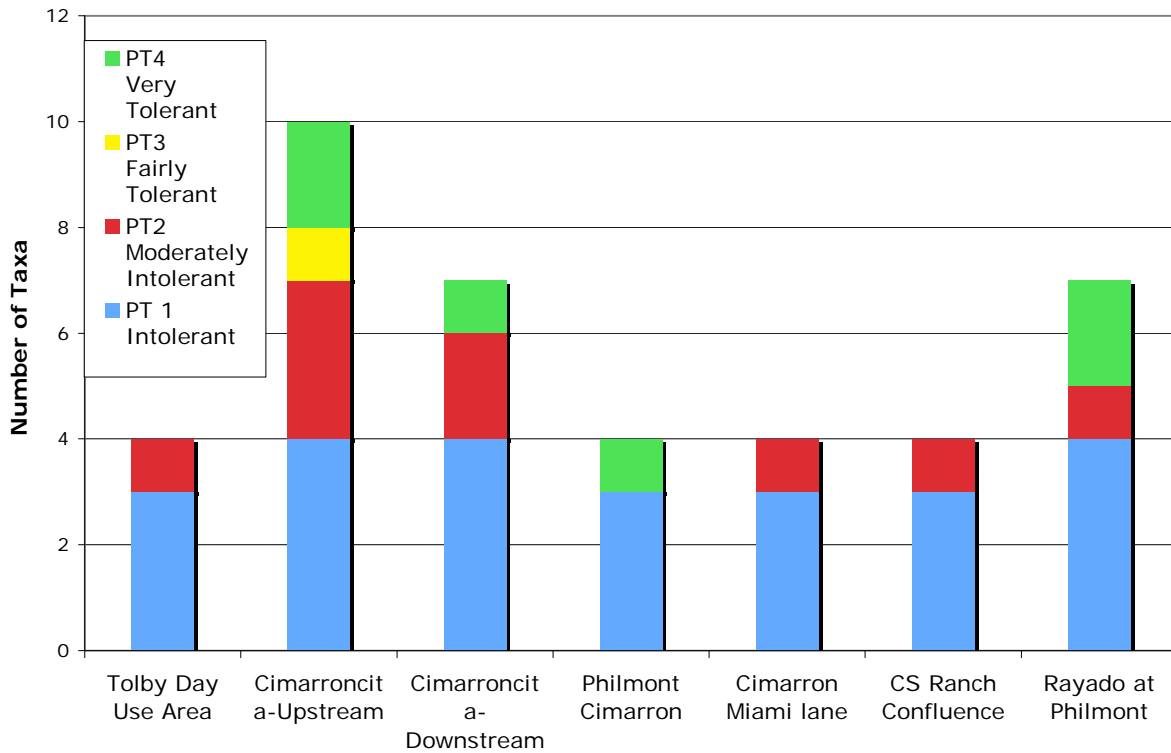
Figure 25. Number of taxa for benthic macroinvertebrate populations at each of the EMAP sites.

Figure 25 shows the total number of taxa per PTI Group and for each of the EMAP study sites. The variation of the overall Pollution Tolerance Index Rating (PTIR) with location along the river is plotted in Figure 26
