Investigation on the Possibility of Matching Vulnerability Assessment with Field Observations for Real Structures

This paper is focused on two real case study structures that were built in the highly influenced areas from the 1999 earthquake of Kocaeli. The characteristics of the structures, as well as the field measurements allowed the authors to work on the structures in detail and calibrate their model and findings of the analyses and assessment. The assessment approach given in the latest version of the Turkish Earthquake Code (TEC) of 2007 has been adopted to approximate the structural demand as well as the observed structural damage distribution.

In this article, two bare frame reinforced concrete structures are studied from the database of the research project of 108M303. The on-site measurements, damage states and distribution as well as the nonlinear analysis and assessment methods and their results are discussed in detail.

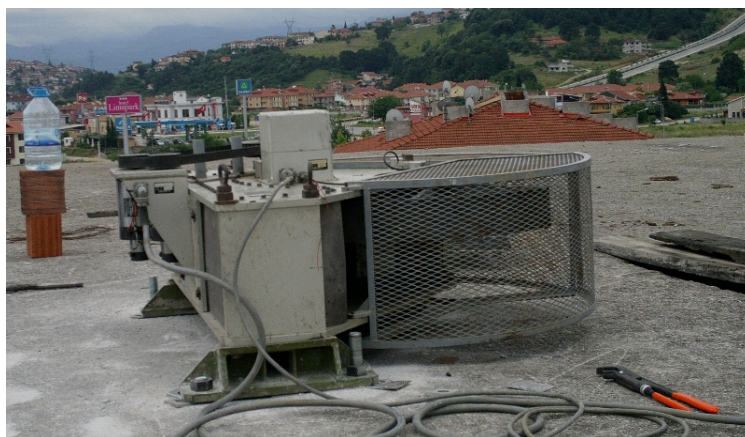
Sophisticated finite element structural models were established to perform modal analysis, nonlinear static procedures and dynamic time history analysis. The rigidity center and mass center of the test buildings were computed by running the structural models. In order to record the ambient responses and forced vibration responses (i.e., harmonic responses) of the structures, 10 structurally important observation points were instrumented with three component accelerometers as shown in Figure 1. Locations of the sensors are the key points, which are assumed to reflect the structural characteristics. The equipment used for the measurement and data acquisition are DAC series accelerometers manufactured by Arel Electronics [3]. In case of the force vibration tests, eccentric vibration generator manufactured by Kinematics was mounted at the mass center of the top floor as shown in Figure 2.

Figure 2 Vibration generator manufactured by Kinematics mounted at the top of the building

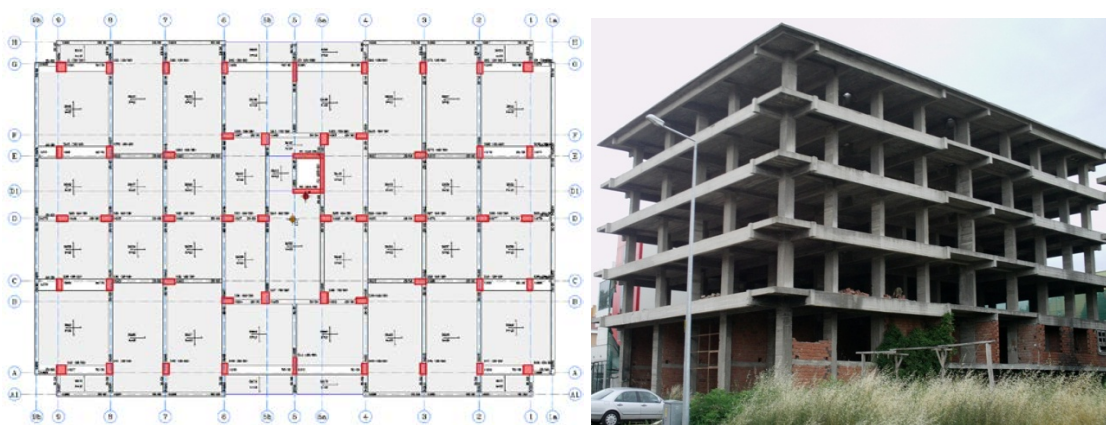
The first case study structure (Dayal) is located in Serdivan district in Sakarya of the Marmara region, where the recent Turkish earthquakes of 1999 hit the most. The case study structure is a 6-storey RC bare frame apartment building that was under construction during the 17 August 1999 Kocaeli earthquake. Minor damages on some columns are inspected. Plan of the structure can be seen in Figure 3. Infill walls were partially constructed in some bays in the ground floor. The regular storey height is 2.80m except at the sub-floor formed inside the ground floor.

As part of this research work, concrete and steel samples were taken from the structures and tested in the laboratory. The material properties have been used as the values that the concrete has 20MPa compressive strength and steel has 420MPa yield strength. In the field measurements, stirrup spacing has been measured as 10cm in the confinement zones.

Figure 3 Dayal building floor plan and 3D view

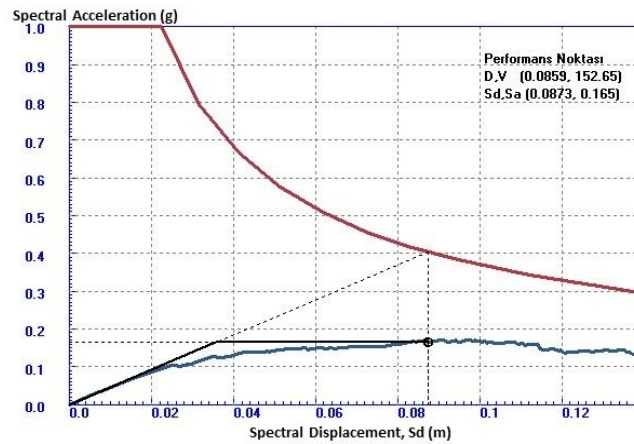
The displacement Demands are calculated by using the equivalent displacement rule given in the TEC'07 and found as 0.086m (for top displacement). The calculation of the displacement demand by using the TEC'07 methodology has been graphically shown in Figure 5.

Figure 5 A. Levent building performance point

As an overall result of the non-linear analyses and the assessment procedure applied, the demand level predicted by the TEC'07 does not cause significant damage in the structure. The overall damage of the both structures, according to the Global Limit States of TEC'07 are found as "Life Safety" performance level which corresponds to moderate damage. This is inline with the damage observed in A. Levent but it does not match with the damage level of Dayal Building.

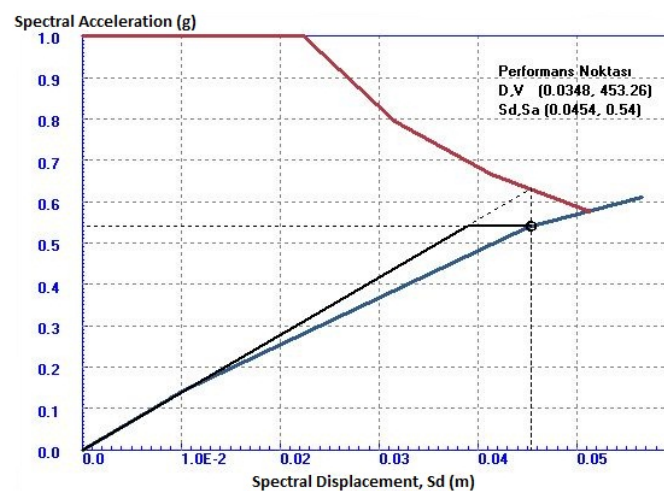
Figure 6 Dayal building performance point calculation according to TEC 2007

The displacement demand of Dayal building has been calculated by using the TEC'07 as 0.035m (for top displacement). The calculation of the displacement demand by using the TEC'07 methodology has been graphically shown in Figure 6.
