Verstrynge, E., Wevers, M., Ghiassi, B., Lourenço, P. (2016). Debonding damage analysis in composite-masonry strengthening systems with polymer- and mortar-based matrix by means of the acoustic emission technique.

Smart Materials and Structures, 25, art.nr. 015009: 2016

## Debonding damage analysis in composite-masonry strengthening systems with polymer- and mortar-based matrix by means of the acoustic emission technique

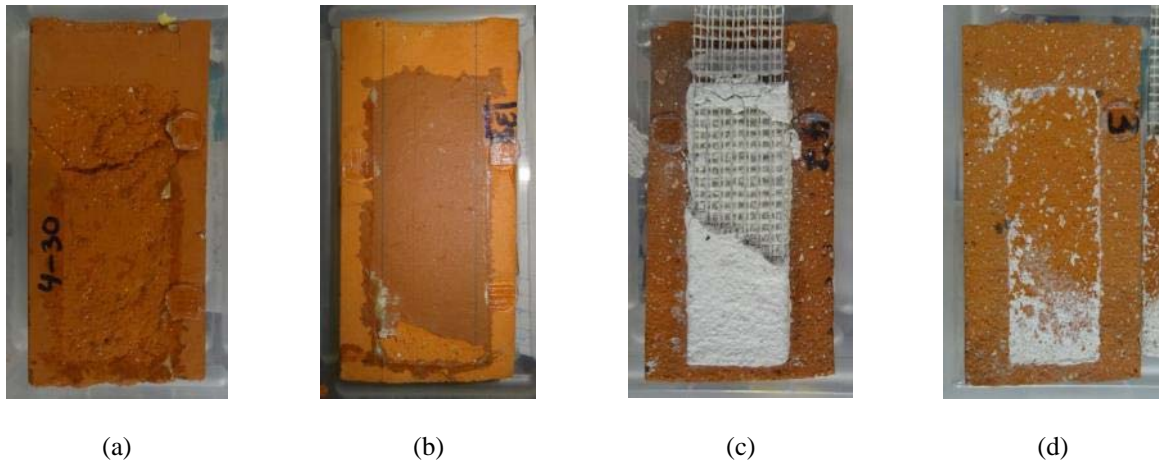
**Figure 1.** Observed failure modes in GFRP- and SRG-strengthened brick specimens: (a) cohesive failure; (b) adhesive failure; (c) steel fibers slipping and mortar cover separation; (d) mortar-brick interface debonding

In case of strengthening with steel reinforced grout (SRG), in addition to masonry cohesive failure and adhesive debonding at the mortar-brick inter-face, debonding at the fiber-mortar interface can occur. The latter, being the most observed failure mode in the tests described in this paper, is followed by slipping of the fibers in the matrix. Typical failure modes are presented in **Figure 1** for GFRP- and SRG-strengthened brick specimens.

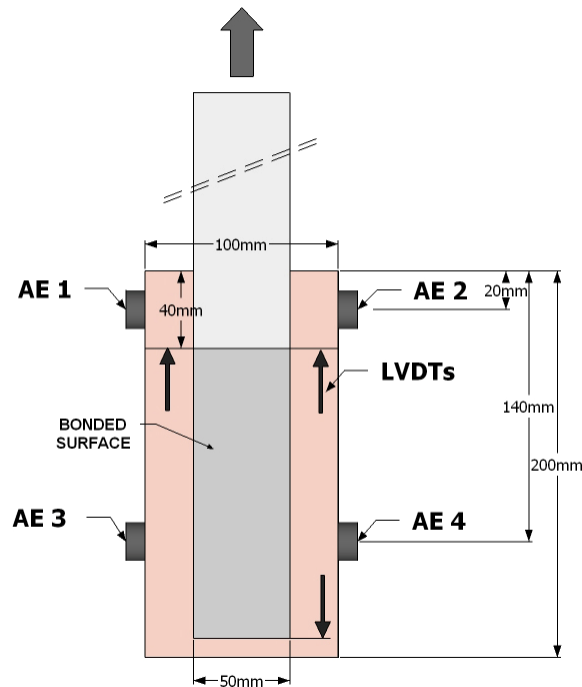
**Figure 2.** Single-lap shear bond test: test instrumentation and specimen dimensions.

The relative slip between the composite material and the brick was measured with two LVDTs glued at the loaded end and one LVDT glued at the free end. Four 150kHz resonance AE sensors were attached two by two on opposite sides of the bricks, see [Figure 2](#).

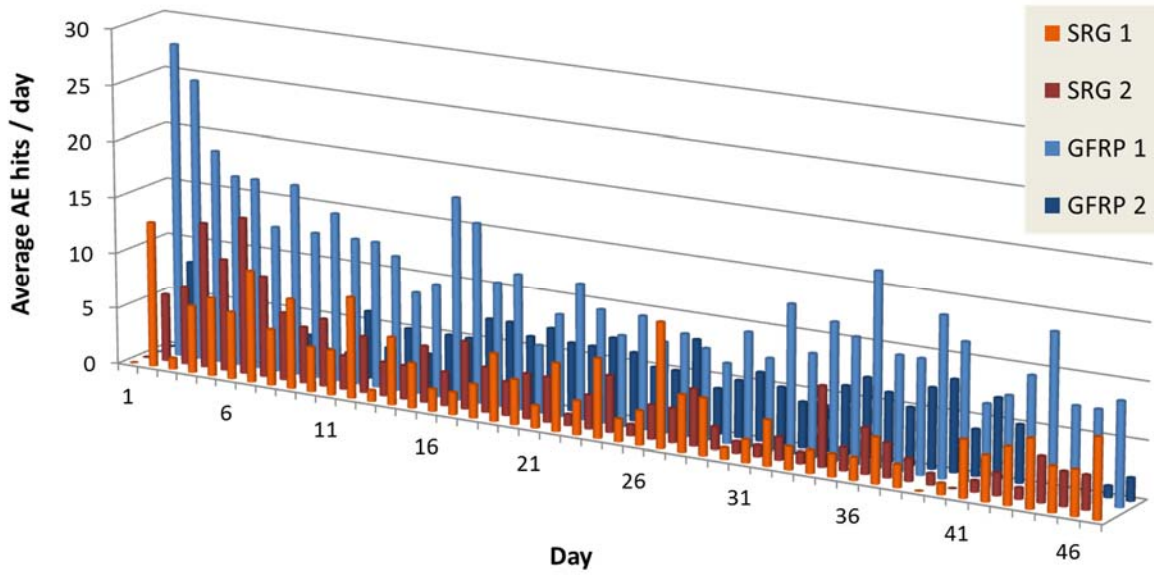
**Figure 3.** Average number of AE hits per day, recorded on 2 SRG-strengthened and 2 GFRP-strengthened specimens during environmental ageing test.

Damage progress was monitored by means of acoustic emission detection on two SRG- and two GFRP-strengthened bricks. The average number of AE hits per day recorded for each specimen within a period of 45 days is presented in [Figure 3](#). Limited AE activity is recorded for each type of specimen and, as a first observation, it can be mentioned that not much difference is observed between the SRG- and GFRP-strengthened specimens.

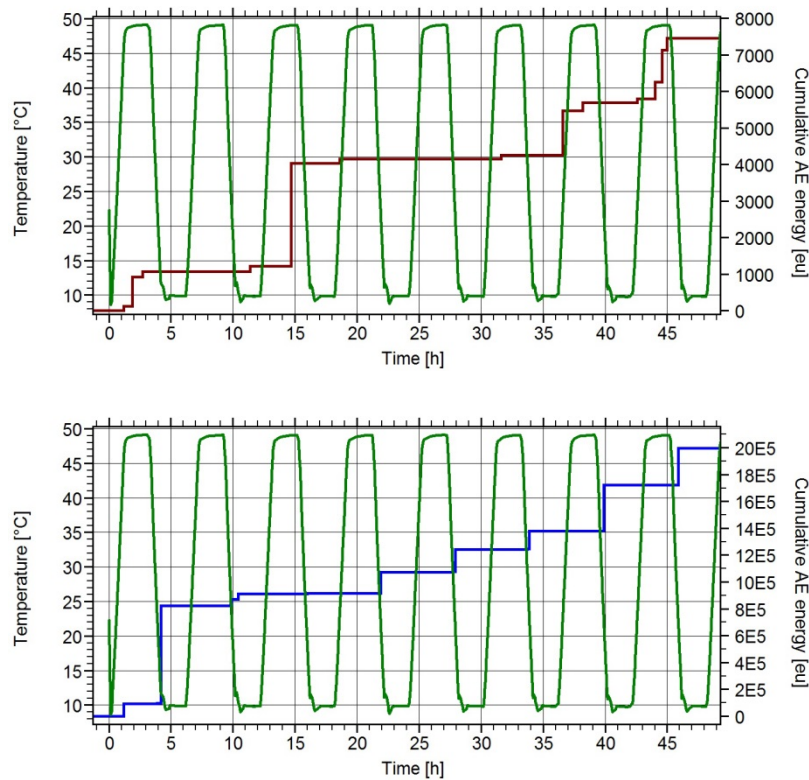
**Figure 4.** SRG-strengthened specimen: typical temperature fluctuation and random emission of AE energy (above); GFRP-strengthened specimen: typical temperature fluctuation and periodically emitted AE energy (below).

When the moments of AE energy emission are compared for both types of specimen, an important difference is observed. AE emissions in the SRG-strengthened specimens occur randomly, while for the GFRP-strengthened bricks, the majority of AE energy is emitted during temperature decrease ([Figure 4](#)). This is an indication of the different damage sources. The AE hits which are detected from SRG-strengthened specimens probably originate from the further hardening, shrinking or cracking of mortar. In the GFRP-strengthened bricks, the AE output during temperature decrease is a manifestation of the thermal incompatibility between the epoxy glue and the brick. Since the thermal expansion coefficient of epoxy can be up to 10 times larger compared to brick, the temperature cycling causes stress concentrations which might lead to damage propagation at the brick-GFRP interface.

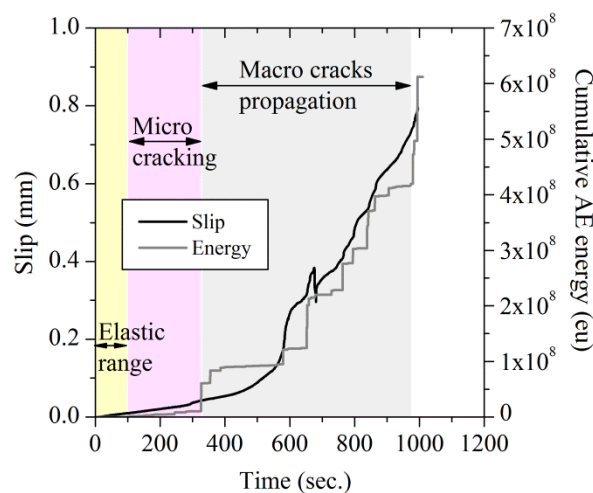
**Figure 5.** Typical AE results in a GFRP-strengthened brick specimen with cohesive/ adhesive failure mode: evolution of slip and cumulative AE energy

Typical AE results obtained from the debonding tests on GFRP-strengthened brick specimens are presented in Figures 5-6. The results in Figure 5 are presented for a specimen with mixed cohesive/adhesive failure mode, in terms of cumulative AE energy and slip development during the test. Generally, the debonding phenomenon can be divided into three main regions: elastic range, micro-cracking range, macro-cracking and progressive fracture. In the elastic range, the system deforms without any crack generation or AE activity. The small displacement measured at this stage is due to the elastic deformation of the FRP composite. As the applied force increases, micro-cracks appear in the interfacial region and they can be distinguished by initiation of AE activity with low emitted energies. As the debonding progresses, macro-cracks are formed and propagate along the interface with higher fracture energy being released. The cumulative AE energy increases with a stepwise pattern in which each sudden jump can be attributed to macro-fracture events. A sudden release of AE energy is also observed at the moment of full debonding at the end of the test. The cumulative AE energy could thus be applied to define the subsequent regions of fracture progress.

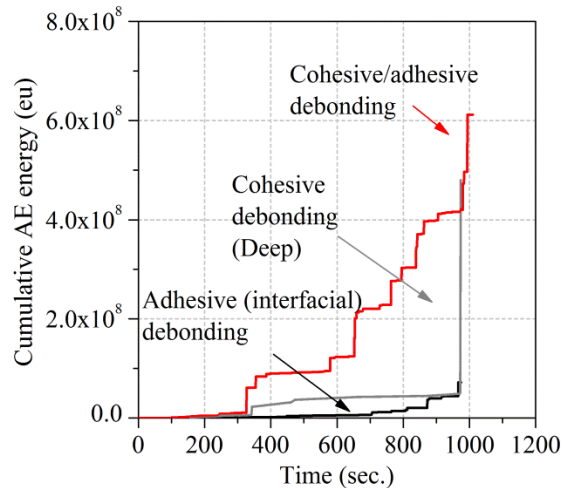
**Figure 6.** Comparison of AE output for different failure modes in GFRP-strengthened bricks

The effect of failure mode on the AE outputs is investigated in Figure 6. A clear distinction is found between AE outputs of specimens with different failure modes. In the specimen with cohesive debonding, the AE energy release remains relatively low throughout the test, accompanied by a sudden and large amount of AE energy release when debonding occurs at the end of the test. The observed behavior confirms the brittle and sudden nature of the cohesive debonding. In the specimen with cohesive/adhesive failure, a progressive release of energy is observed during the test. In the specimen with adhesive debonding mode, progressive detection of AE energies is observed until complete debonding. However, the magnitude of the detected energies is much lower than the ones detected in the specimens with cohesive failure mode, due to the different nature and fracture properties of brick and FRP/brick interface.

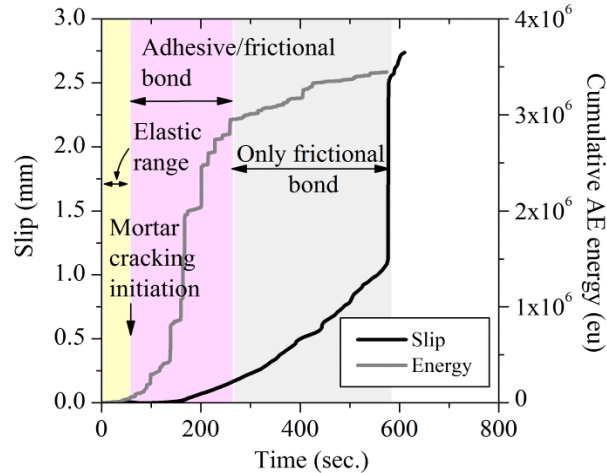
**Figure 7.** Typical AE results in an SRG-strengthened brick specimen: evolution of slip and cumulative AE energy

**Figure 7** presents a typical result obtained from an SRG-strengthened brick specimen, which failed with slipping of the steel fibers and mortar cover separation. Mainly, three regions representing different mechanisms can be observed during the debonding process. AE activities before the first cracking of the mortar are negligible. During the mortar cracking, the rate of AE activities increases and high AE energy is detected as the force increases. The resisting mechanisms in this region are adhesive bond and friction between the steel fiber and mortar. Detachment of the bond is accompanied by releasing relatively high fracture energies, observed as sudden jumps in the AE cumulative energy curve. As the debonding progresses, the bond diminishes and friction governs the failure mechanism resulting in a reduction of the detected AE energy rate. The debonding occurs with a sudden force reduction and slip increase. In contrary to the GFRP-strengthened specimens, no direct relation can be observed between the measured slip and AE cumulative energy.

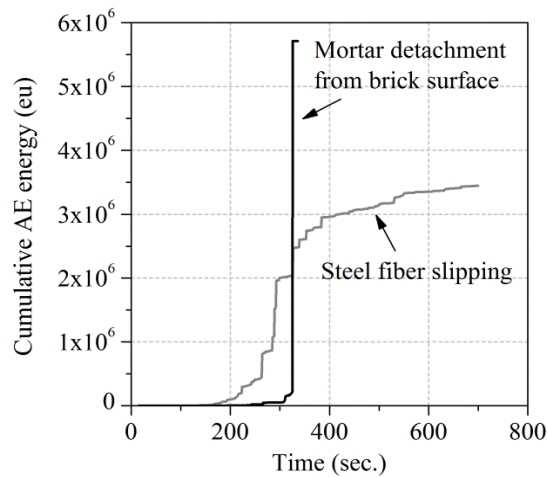
**Figure 8.** Comparison of AE output for different failure modes in SRG-strengthened bricks

In **Figure 8**, a comparison is made between two SRG-strengthened specimens with different failure modes, namely brick/mortar detachment and fibers slipping. A brittle behavior is observed in the specimen with brick/mortar detachment failure. The detected AE energy level in this specimen is very low during the test followed by a sudden release of energy at the moment of debonding. On the other hand, the fibers slipping failure mode produces a progressive release of energy during the test while the adhesive bond diminishes, followed by a reduction of the AE energy rate in the stage governed by frictional resistance.

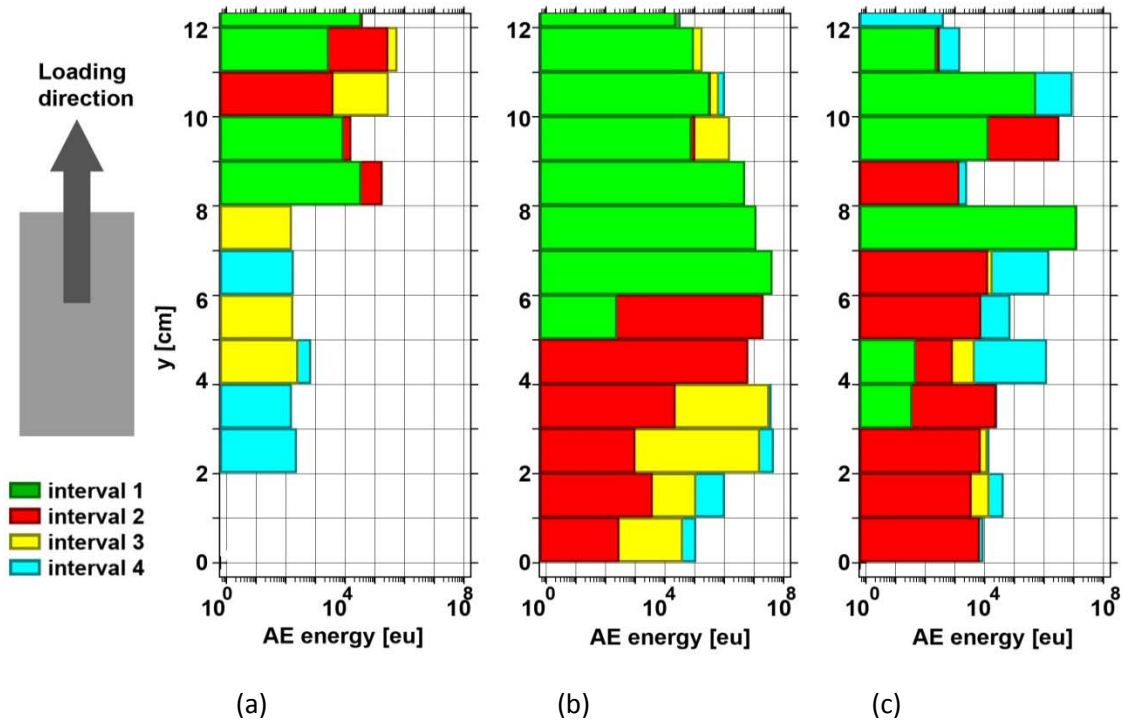
**Figure 10.** Cumulated energy of located AE events on SRG-strengthened specimen (a), GFRP-strengthened specimen with progressive cohesive/adhesive debonding (b) and with predominantly adhesive debonding (c).

This downshift of located AE events as a function of time is illustrated in [Figures 9 and 10](#). The moments at which the cumulated energy from the located AE events is calculated, are indicated on the force-slip curves in [Figure 9](#). The color bars in [Figure 10](#) present the total energy of all AE events located in zones of 1 cm perpendicular to the loading direction. Herein, interval 1 refers to the time duration between the start of the test and point A on the force-slip curve, interval 2 spans the time duration between point A and B, etc.. The Y-axis indicates the vertical distance between the AE sensors (12 cm).

Progressive debonding can more distinctively be observed for the specimen with predominantly cohesive debonding (=progressive cohesive/adhesive debonding) and the cohesive debonding phenomenon typically produces more and higher-energy AE sources.

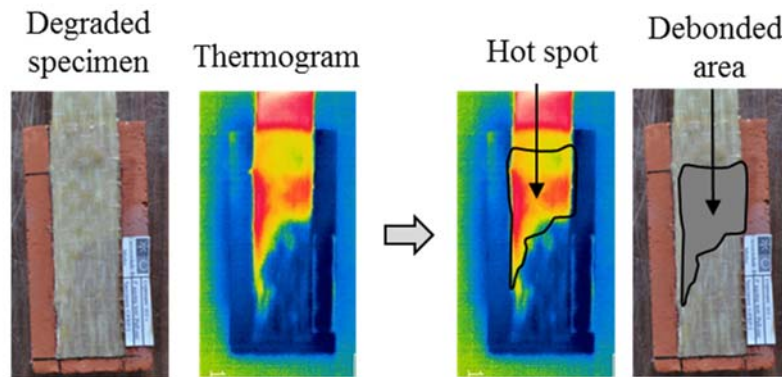
**Figure 12.** Application of IR thermography in detection of FRP delaminations.

delaminations larger than 5 mm can be detected and their size measured precisely. Moreover, the technique was successfully used for detection of FRP delamination induced by accelerated ageing, see **Figure 12**. The output of this technique is the full-field surface temperature in which the cold or hot spots, depending on the heat excitation method, represent interfacial defects or delamination. Similar to DIC, the failure mode cannot be recognized from the outputs. A drawback of IR thermography is that any changes in the material thermal properties, which may not be necessarily due to the FRP delamination or defects, are observed as hot/cold spots in the thermograms. For instance, the non-uniformity of the FRP surface in wet lay-up applications may result in misleading interpretation of the results. For on-site application, this technique is also limited to the cases in which the FRP surface is accessible and not protected with renderings. The accuracy of the results is also dependent on the uniformity of the surface heating which is a complex task when the observation is performed on a large structural element.
