## Effects of Different Fuel Specifications and Operation Conditions on the Performance of Coated and Uncoated Superheater Tubes in Two Different Biomass-Fired Boilers

**Wu, Duoli; Dahl, Kristian Vinter; Madsen, Jesper L.; Christiansen, Thomas Lundin; Montgomery, Melanie; Hald, John**

*Published in:*  
Applied Energy Materials

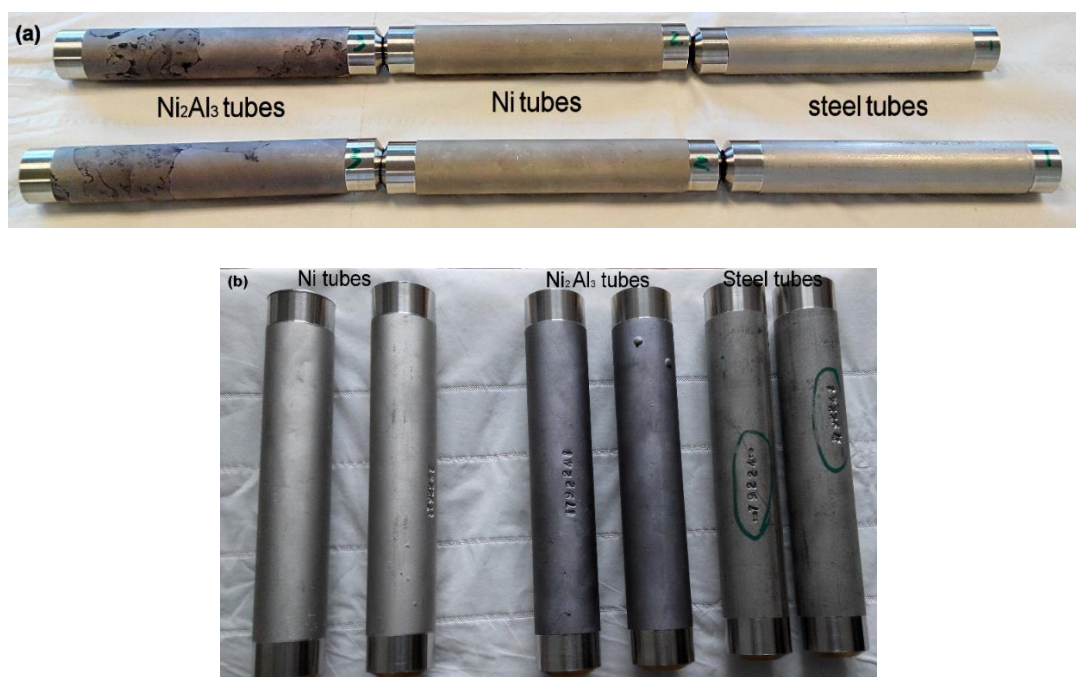
**Figure 1.** Appearance of the test tubes for (a) Esshete 1250 and (b) TP347H.

For aluminizing, the Ni coated tube sections were embedded in pre-mixed pack powders (10 wt. % Al + 8 wt.% AlCl<sub>3</sub> + 82 wt.% Al<sub>2</sub>O<sub>3</sub>), which were put into a cylindrical metal crucible. The crucible was then placed in the tube furnace with flowing argon. The furnace was heated to 650 °C with a heating rate of 18 °C/min, and maintained at this temperature for 6 h. The samples were afterwards cooled inside the furnace by switching off the power while maintaining the argon flow. After aluminizing, the Ni<sub>2</sub>Al<sub>3</sub> coated tubes were ultrasonically degreased in acetone and subsequently dried with ethanol. The coating was removed by machining from a 2 cm wide area from both ends of the Ni<sub>2</sub>Al<sub>3</sub> coated tubes prior to welding. The tubes after preparation are shown in Figure 1. The discoloration area on the Ni<sub>2</sub>Al<sub>3</sub> tubes (Figure 1a) is due to a thin (around 2 μm) Al<sub>2</sub>O<sub>3</sub> layer, which was probably related to surface oxidation during furnace cooling or the last part of the pack aluminizing process. Destructive examination from similar locations revealed that the Ni<sub>2</sub>Al<sub>3</sub> coating beneath the thin layer was intact and uniform. The bubbles visible on Ni and Ni<sub>2</sub>Al<sub>3</sub> tubes (Figure 1b) were probably due to hydrogen gas introduced during the Ni-plating process.

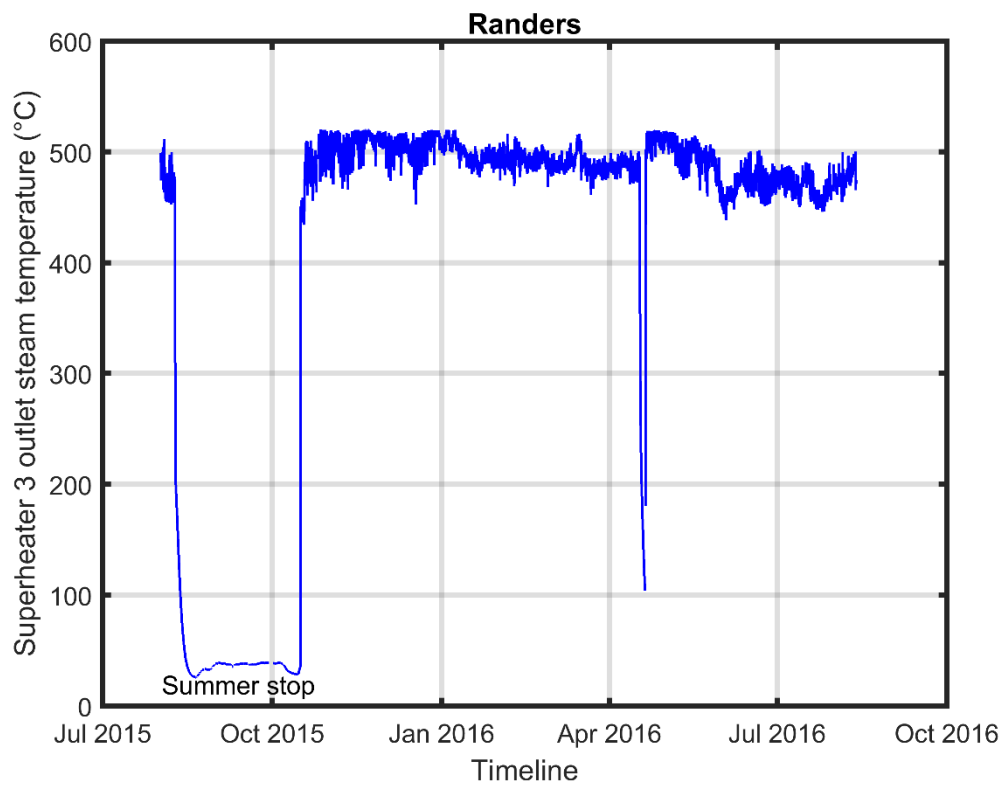
**Figure 2.** The outlet steam temperature data for the exposure period in Randers.

The operating conditions for the two CHP plants are also different. At Randers it is preferred to run at part load rather than shutting the plant down when the heat demand is low, and as shown in Figure 2, has only had one shutdown during the exposure period. However, at MSK the plant is run under cyclic conditions with daily start/stops in the beginning and end of the heating season (Figures 3 and 4). This means that at MSK the boiler runs at full load when in operation. This difference in operating conditions can also be seen when comparing the temperature histograms, which is broad for the Randers plant, and narrow for the MSK plant (Figure 5).

The temperature data during the exposure period from Randers and MSK (Figures 2-5) show significant differences. The average test tube steam outlet temperature in Randers was 512 °C, while in MSK it was 544 °C. The significantly higher average steam temperature at MSK than at Randers would obviously increase the degree of fireside corrosion. Randers also has a broader temperature range with a significant amount of hours below 500°C where there would be minimal corrosion for an austenitic steel. As has been previously observed for these types of steels,<sup>5</sup> corrosion increases significantly with increase in temperature and this is probably the main reason for the higher corrosion rates of the steel tubes observed for the MSK plant (Table 4). Another important factor is the thermal cycling of the plants. The plant in Randers has only had one shutdown during the entire exposure period and otherwise the operation temperature has been relative stable (Figure 2). This is in complete contrast to the MSK plant where frequent thermal cycling resulted in severe exposure conditions. At the MSK plant there has been three full shutdowns, but during autumn and late spring, there was thermal cycling every day between 200 and 540 °C (Figure 3 and Figure 4) resulting in 213 start/stop cycles (Table 2). This is with high certainty the reason behind the spallation of both Ni and  $Ni_2Al_3$  coatings in the MSK boiler.

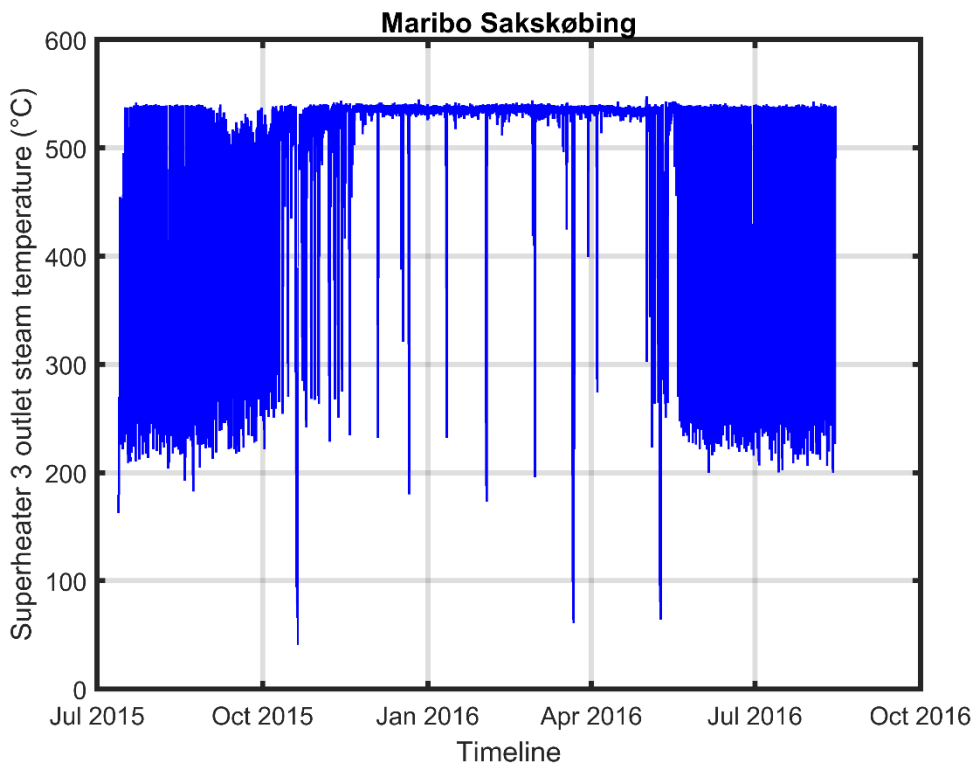
**Figure 3.** The outlet steam temperature data for the exposure period in MSK.

Since there are many thermal cycles at MSK (Figures 3 and 4), the most probable explanation for the spallation of the  $\text{Ni}_2\text{Al}_3$  coating lies in the difference in thermal expansion coefficients between the steel, Ni, Ni-Al intermetallics forming at the interface and the  $\text{Ni}_2\text{Al}_3$ . The coefficients of thermal expansion (CTE) for the steels, Ni, NiAl and  $\text{Ni}_2\text{Al}_3$  are depicted in Figure 19. For the

power plant exposure temperature interval between 300°C and 600°C as shown in Figures 3 and 4, the CTE for  $\text{Ni}_2\text{Al}_3$  differs significantly from the CTE for Ni, NiAl and steels. A full stress analysis is outside of the scope of the present paper, however, as the CTE for  $\text{Ni}_2\text{Al}_3$  and Ni are quite different, thermal stresses could be expected which would lead to the spallation of the  $\text{Ni}_2\text{Al}_3$  coating in MSK. The spallation of Ni from the steel was probably related to the corrosion attack of the underlying steel which led to a weak adhesion between Ni and steel.

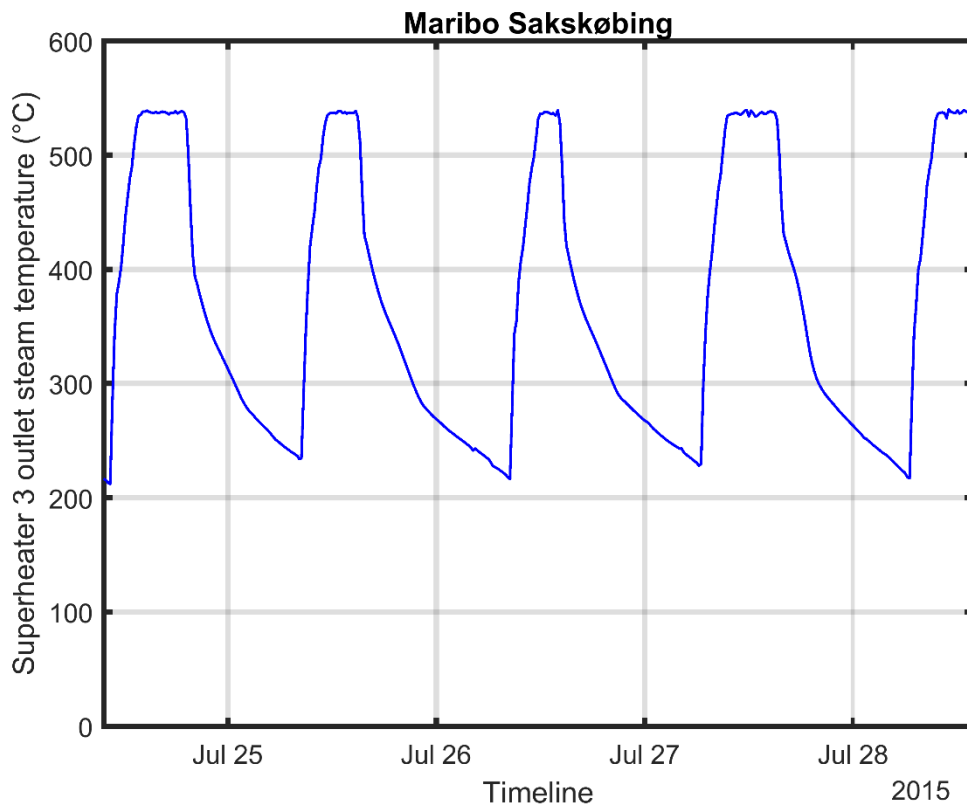
**Figure 4.** The outlet steam temperature data showing the daily cycle in MSK.

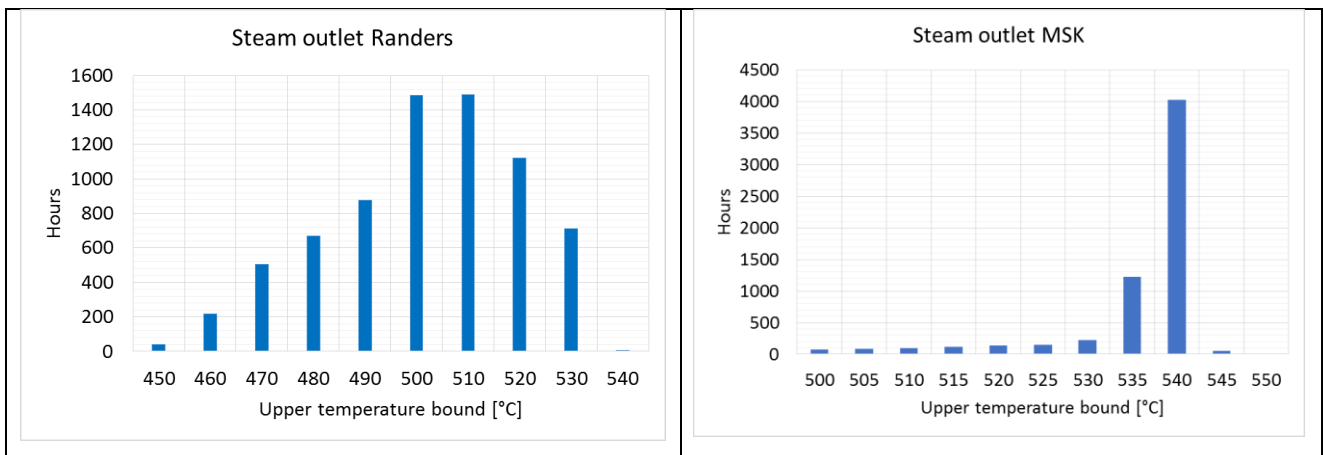
**Figure 5.** Temperature histograms for Randers and MSK.

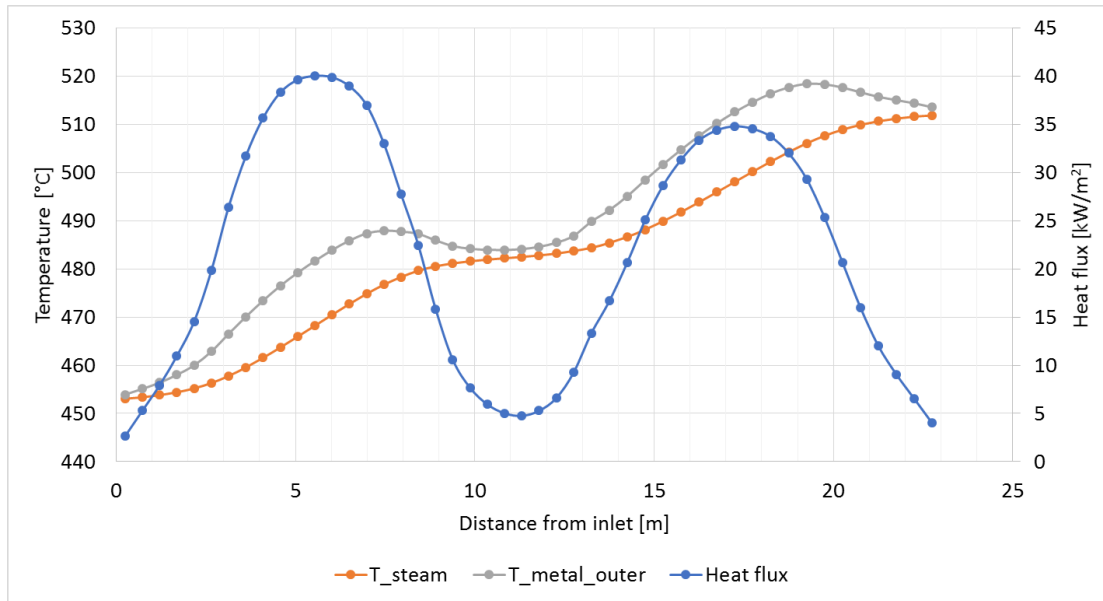
**Figure 7.** Calculated steam and outer metal temperature of SH tube from inlet to outlet in Randers. The test tube was placed from 18-20 m from the inlet.

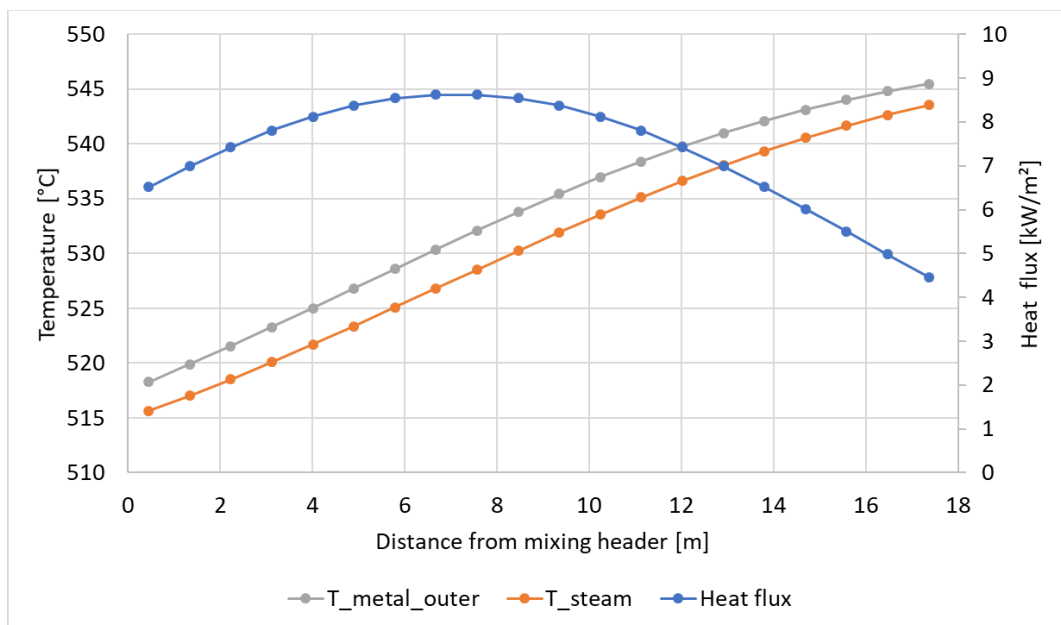
**Figure 9.** Calculated steam and outer metal temperature of SH tube from mixing header to outlet in MSK. The test tube was placed from 15-17 m close to the outlet.

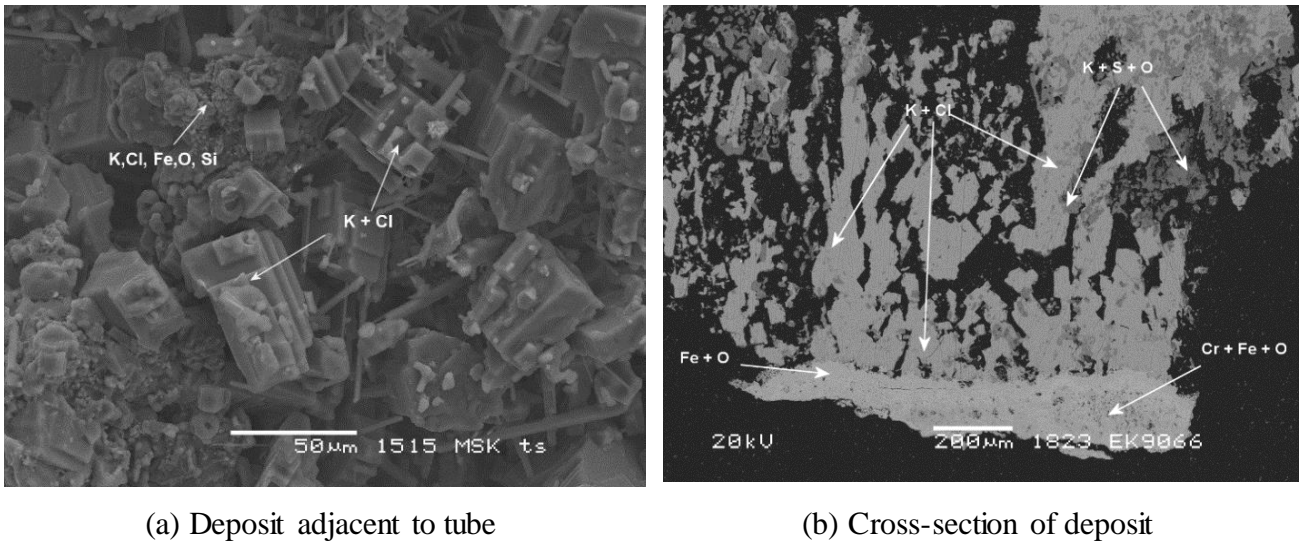
**Figure 13.** SE micrograph of surface morphology and BSE micrograph showing the composition of deposit from MSK (a) deposit adjacent to tube, (b) Cross-section of deposit.

Faceted cubic structures were typical on the unprepared deposit from MSK (Figure 13a), where the cubic structures had a composition corresponding to KCl. The KCl was in direct contact with the surface oxide and there were remnants of iron oxides on the surface. Cross sections of the dry polished deposit also showed that KCl is present adjacent to the oxide surface and there was only occasionally K, S, and O (presumably potassium sulphate) present (Figure 13b).

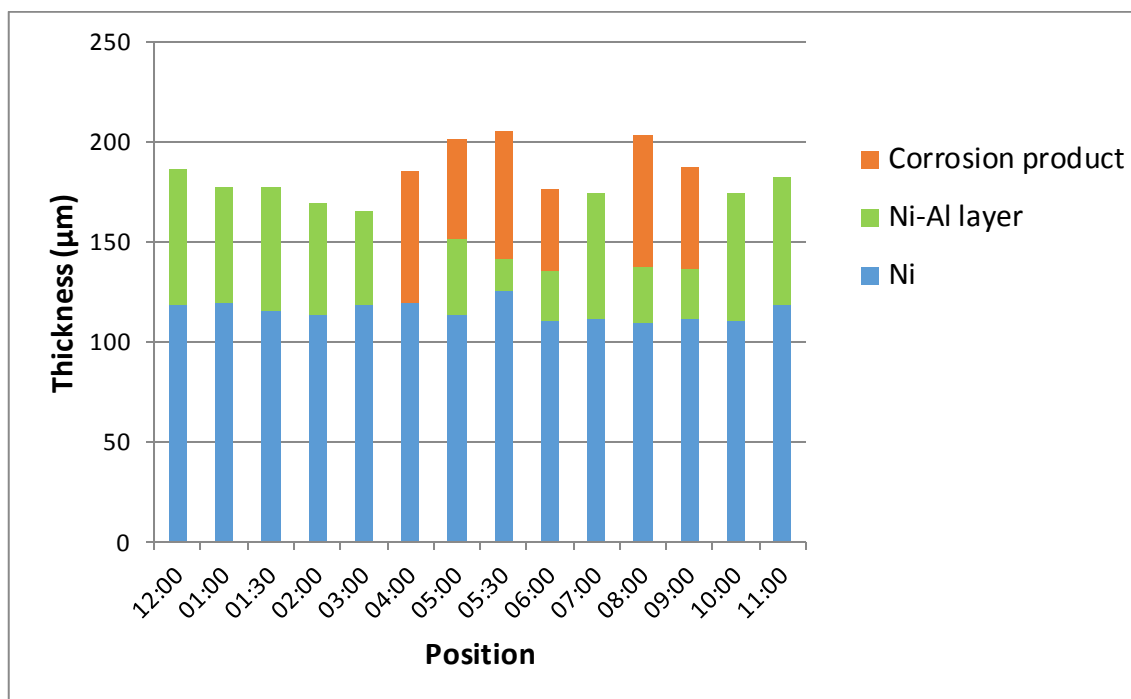
**Figure 17.** Residual thickness of layers around the circumference of the  $\text{Ni}_2\text{Al}_3$  coated tube in Randers.

The coating thickness was measured after exposure in 12 positions clockwise around the circumference of the  $Ni_2Al_3$  coated tube as shown in Figure 17 where 12:00 is the flue gas direction. The coating thickness around the  $Ni_2Al_3$  coated tube is asymmetric. The deposit growth is typically asymmetric around a superheater tube depending on the flue gas flow conditions that vary around the tube. The attack at areas opposite the flue gas may be due to the varying deposit parameters on the upstream (12:00) compared with the downstream (06:00) part of the tube.<sup>34</sup>
