## Rehabilitation of an important cultural and architectural heritage: the traditional adobe constructions in Aveiro district

D. Silveira, H. Varum & A. Costa Civil Engineering Department, University of Aveiro, Portugal

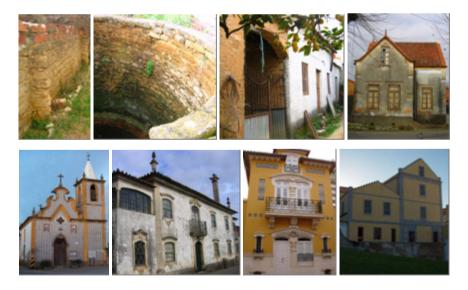
Figure 1: Examples of existing adobe constructions in Aveiro district.

The old Aveiro fire station building, the church of Quintãs, and the old flourmill building recently converted by the University of Aveiro into a space for science results diffusion, among many others, are just good examples of existing adobe buildings in Aveiro district with important socio-cultural value.
