Assessment of Seismic Performance of Adobe Structures in Pakistan and Portugal

SUMMARY:

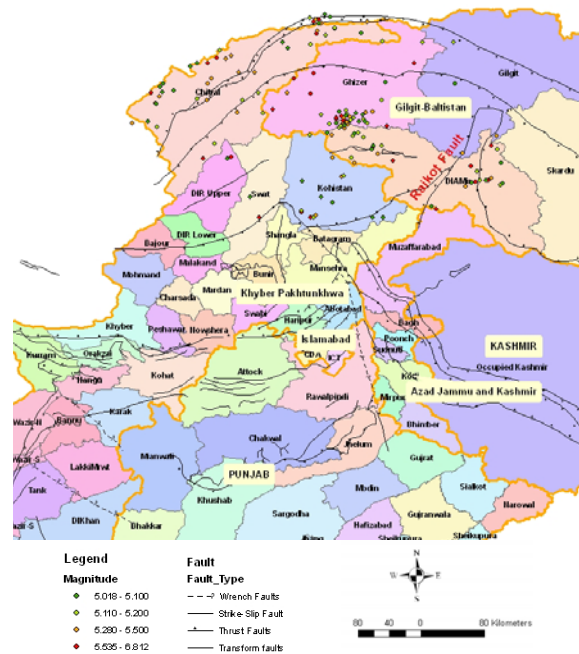
**Figure 2.1.** Faults and recorded earthquakes around Gilgit-Baltistan**Table 2.2.** Building Typology in Portugal (INE 2001)

The fault system around Gilgit-Baltistan is shown in Figure 2.1. It is noted in Figure 2.1 that the region is surrounded by several active faults. Hindu Kush and Pamir are considered to be seismically active regions (Nowroozi, 1971). The earthquakes of magnitude 5 and above in this region are also illustrated in Figure 2.1. These data have been taken from different sources such as International Seismological Centre (ISC), National Earthquake Information Center (USGS), Pakistan Meteorology Department (PMD), British Geological Survey (BGS), etc. No damage to adobe buildings due to earthquake has so far been recorded in the area. This may partly be attributed to the ground characteristics of this mountainous region.

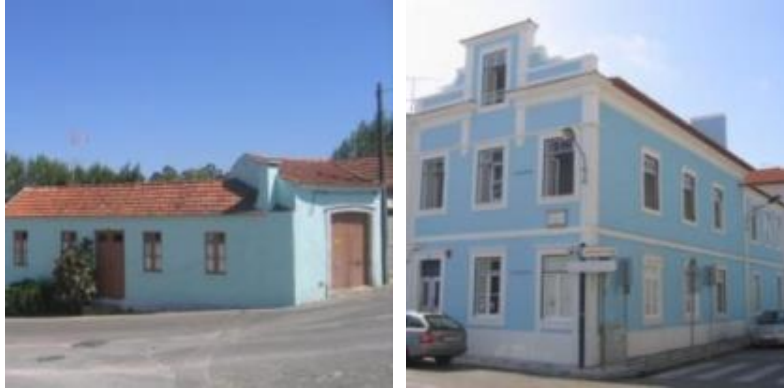
Figure 4.3. Single and double storey adobe houses in Aveiro

In urban areas most of the buildings consist of one or two floors and, in rural areas, buildings with only one floor predominate (Silveira, 2010; Silva, 2010) (Fig. 4.3). Most buildings present simple geometry, with a rectangular geometry in plan, and regular configuration in height. The details of construction are discussed as under.
