ANALYSIS AND QUANTIFICATION OF DAMAGE IN POLYMER COMPOSITE MATERIALS

Keywords: Composite materials, Drilling damage, Damage quantification, Mechanical testing

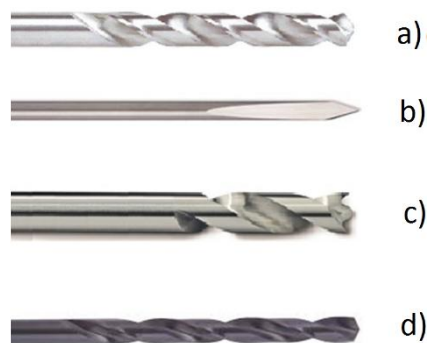
Figure 1: Drill geometries used: a) Twist; b) Dagger; c) Brad; d) HSS.

The Twist drills are very commonly used in composite drilling. The Dagger drills have a very sharp angle and require a long exiting space for completing the hole at the nominal diameter. The Brad drill has cutting edges with sickle shape, tensing the fibers before cutting, which results in a cleaner hole. All these drills are made of tungsten carbide.

The High Speed Steel drills are geometrically identical to Twist drills but are made of high speed steel, a material that is not recommended for fiber composites drilling due to the abrasiveness of the reinforcement phase, producing larger damage areas around the hole.

There were used five types of drilling using four types of drill geometry: Twist (TWI), Twist with previous drilling of lower diameter (TPD), Dagger (DAG), Brad (BRA) and High Speed Steel (HSS), as presented in Figure 1.

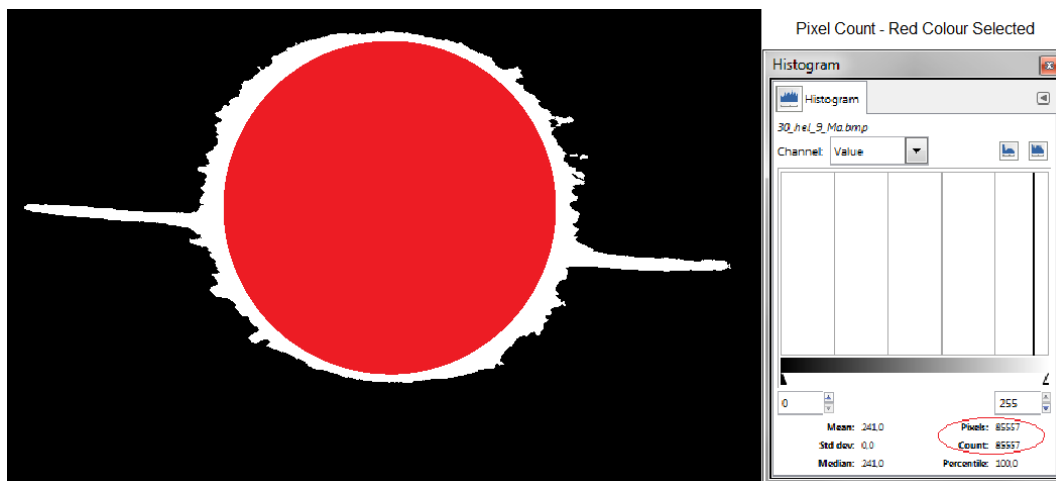
Figure 7: Example of a damaged area determination with colour histogram from GIMP®.

The colour histogram tool of the GIMP® software gives an account of the total number of pixels by colour. Filling the circular drill area in the binary image with a third colour (for instance, red) allows for the determination of the hole (red) and damaged (white) areas, in pixels (Figure 7).

With the determination of the damaged area accomplished, it was possible to use one of the existent damage criteria. The Damage Ratio, as presented in [19], was selected for this work. As this criterion considers the damaged area, it seems more appropriate when, as in Figure 7, the damaged area has a long delamination in a single direction, thus increasing the Delaminated diameter while the real area does not match to such an elevated value.

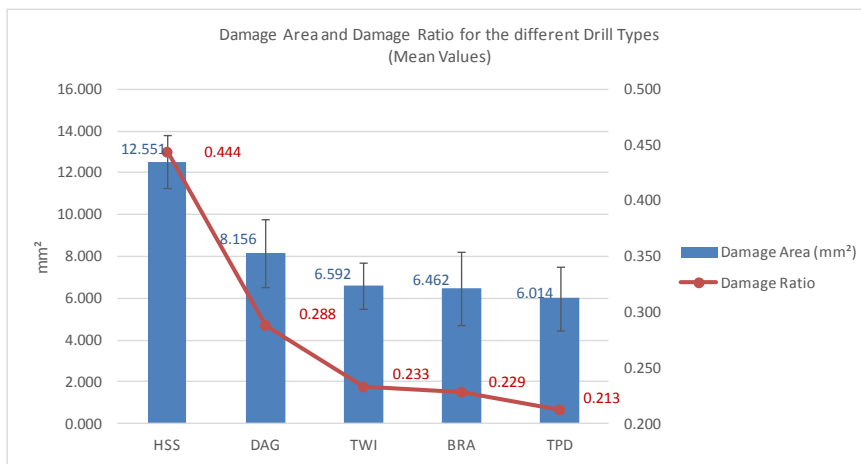
Figure 9: Average values of Damage area and Damage Ratio for the several drills used.

From the experimental procedure described above, it was possible to derive the results of the Damage Ratio grouped according to the type of drill used as is presented in Figure 9.

The holes drilled with Twist or Brad drills had the smallest damaged area and, consequently, the lower values of the Damage Ratio. Moreover, the use of the pre-drilling had reduced the damaged area by around 9%, showing that this can be a good procedure when trying to have no-damage holes. The holes with HSS drills were the most damaged, as expected.

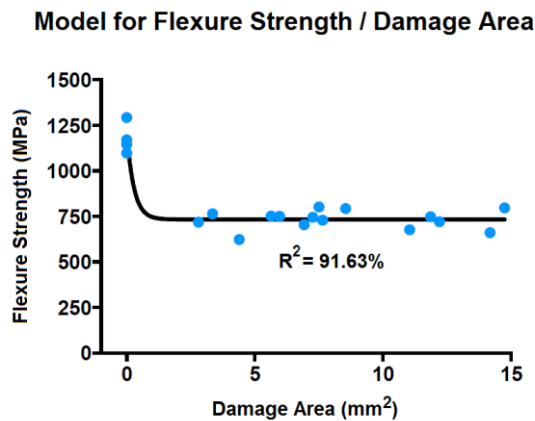
Figure 10: “Plateau” model describing the relation between Flexure Strength and Damage Area.

The next step was the analysis of the results from the Three point bending test and the comparison with the non-drilled coupon, as a reference value, identified as coupons 100_0.1 to 100_0.4. Resulting values of Flexure strength were calculated not considering the existence of a hole and are presented in Table 4. As expected, the flexure strength of the drilled plates was lower than the reference plates but there was a large scattering of the results from the drilled plates, as can be better observed in Figure 10.

Therefore it was analyzed if this scattering was more important than the damaged area and the Prism5® statistical tool was used to find a correlation, returning a plateau model also visible in Figure 10, with an asymptote around 733 MPa and a correlation of 91%. It is possible to conclude that the existence of a hole is the highest factor for this strength reduction and the damage extension importance is not relevant when we consider the Three point bending test for the evaluation of damage extension consequences.

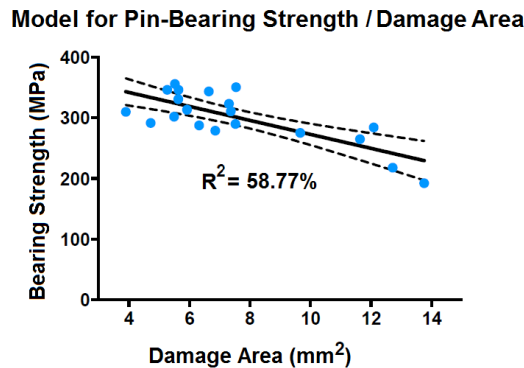
Figure 11: Linear Regression describing the relation between Pin-bearing Strength and Damage Area.

The final step was the performing of the Pin-Bearing test. Considering the test setup with the use of an anvil causing compression on the drilled wall, it was not possible to use the reference coupons with no hole. The results are presented in Table 4 and in Figure 11. The results of this mechanical test turn out evident that, on the whole, the pin-bearing strength decreases as the damaged area increases. This outcome was expected and is in accordance with previous results presented in several papers referred along this study.

As for the precedent results, Prism5 ® was used for data correlation, and the final result is also presented in Figure 11. Based on the data correlation, it was possible to conclude that for a 1 mm² increase in the damaged area, the pin-bearing strength reduces by around 11.5 MPa, with a 95% confidence interval between 9.3 and 13.8 MPa. This is evidenced by the negative slope of the correlation line that can be seen in Figure 11.
