SINKHOLE DISTRIBUTION AND DENSITY OF WATERLOO QUADRANGLE MONROE COUNTY, ILLINOIS

Illinois Geologic Quadrangle Map
IGQ Waterloo-SD

Samuel V. Panno, Julie C. Angel, Dan O. Nelson, C. Pius Weibel, Donald E. Luman, and F. Brett Denny
2008

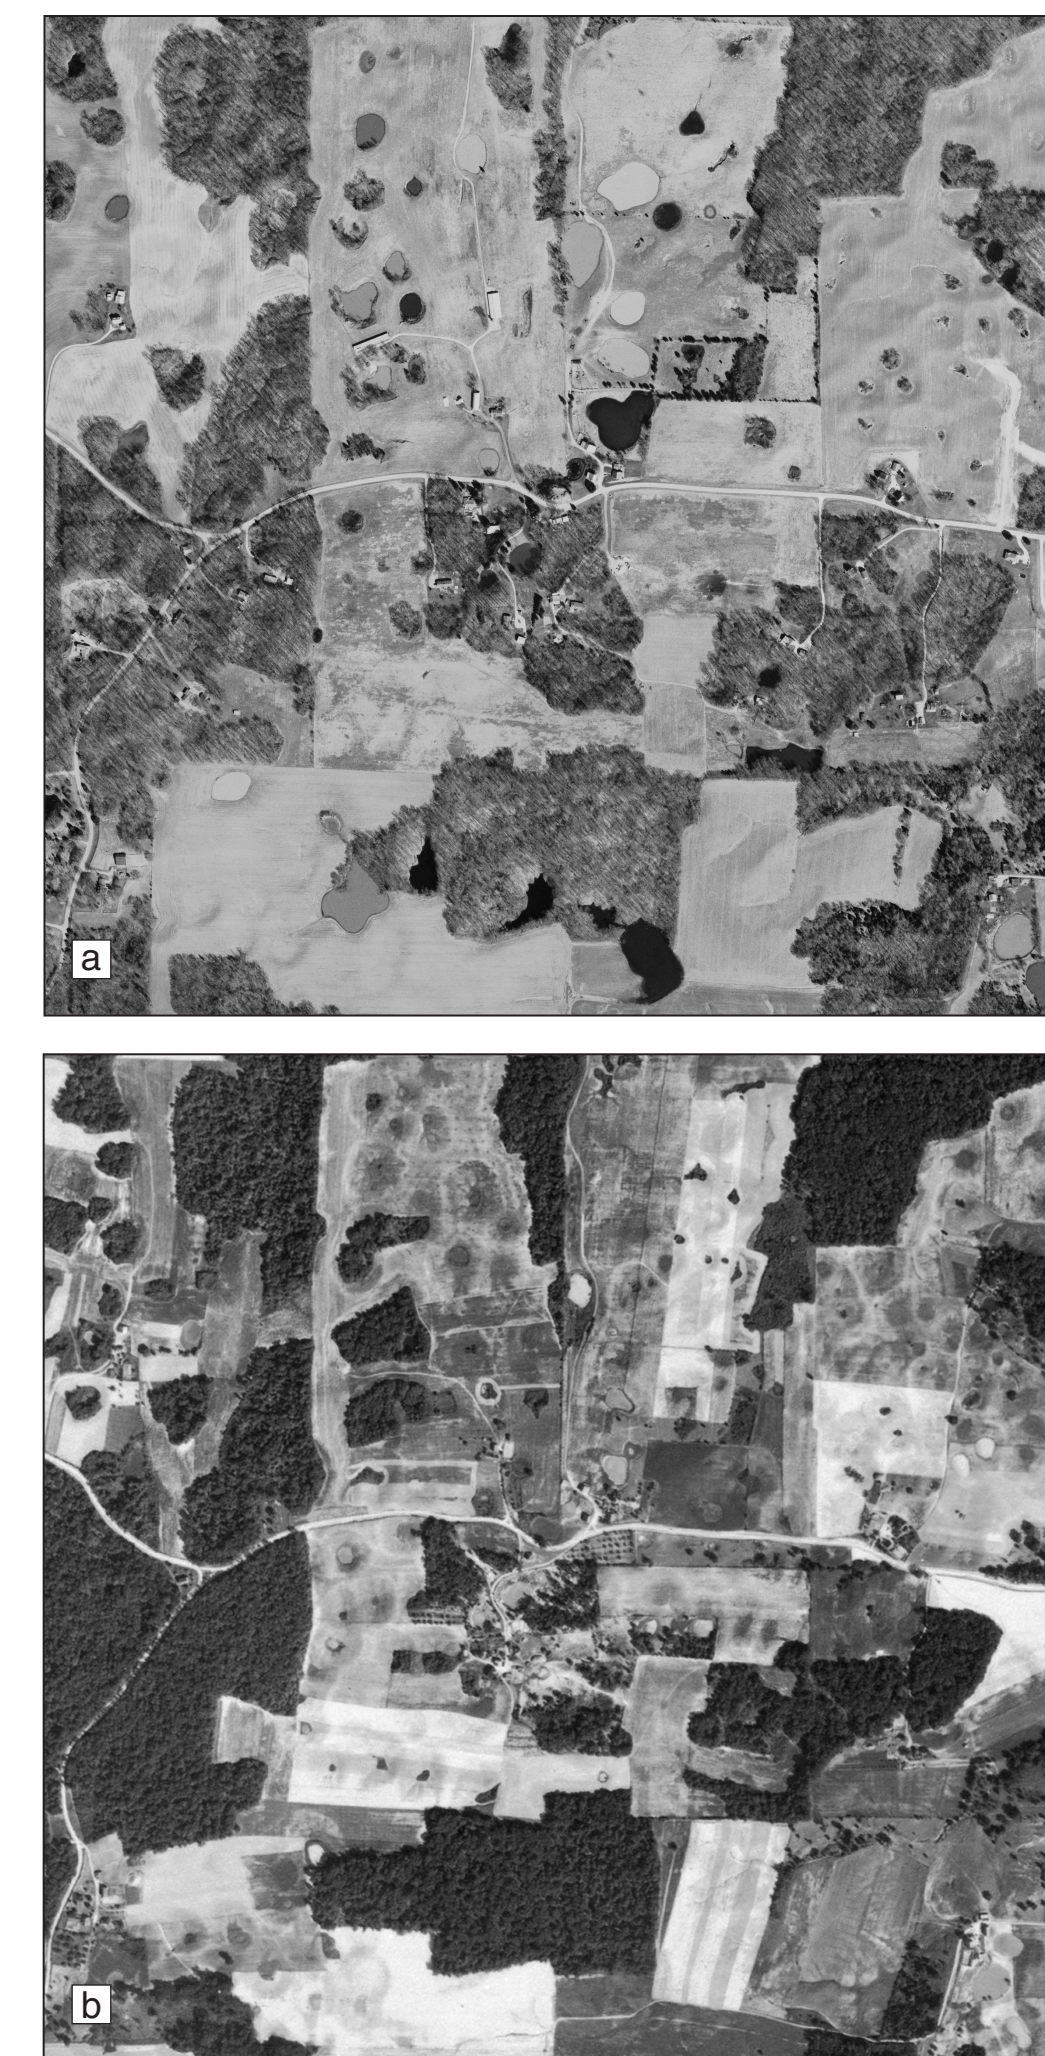
Figure 1 Aerial photographs of a particularly karstified section of the Waterloo Quadrangle, taken over half a century apart, show how agricultural activities have changed the terrain. Figure 1a is derived from a U.S. Geological Survey Digital Orthophoto Quarter Quadrangle (DOQQ) produced from aerial photography acquired on March 6, 2005, showing Section 29, T2S, R10W. Figure 1b is from a digitized U.S. Department of Agriculture aerial photograph taken on September 5, 1940, and illustrates the same one-square-mile area. Comparison of these two images reveals a number of changes that have occurred on the landscape during the 65-year interval. The 2005 image shows sinkholes that have been remediated using stand pipes and then later filled in to increase cropland area. It is interesting to note that because of the early, leaf-off acquisition date of the 2005 image, sinkholes can be discriminated within many of the wooded areas. In comparison, subtle, near-surface circular patterns diagnostic of sinkholes are quite apparent in the 1940 image in many of the agricultural fields on this image. Note how these distinctive patterns have largely been erased in the 2005 image because of decades of use with modern, large-scale farming equipment and further obscured by the widespread adoption of conservation tillage methods. Scale 1:12,000.
