CONSTRUCTION CONDITIONS Natural Hazards Map

Villa Grove Quadrangle, Douglas County, Illinois Christopher J. Stohr

Natural Hazards, Construction Conditions and Materials of the Villa Grove Quadrangle

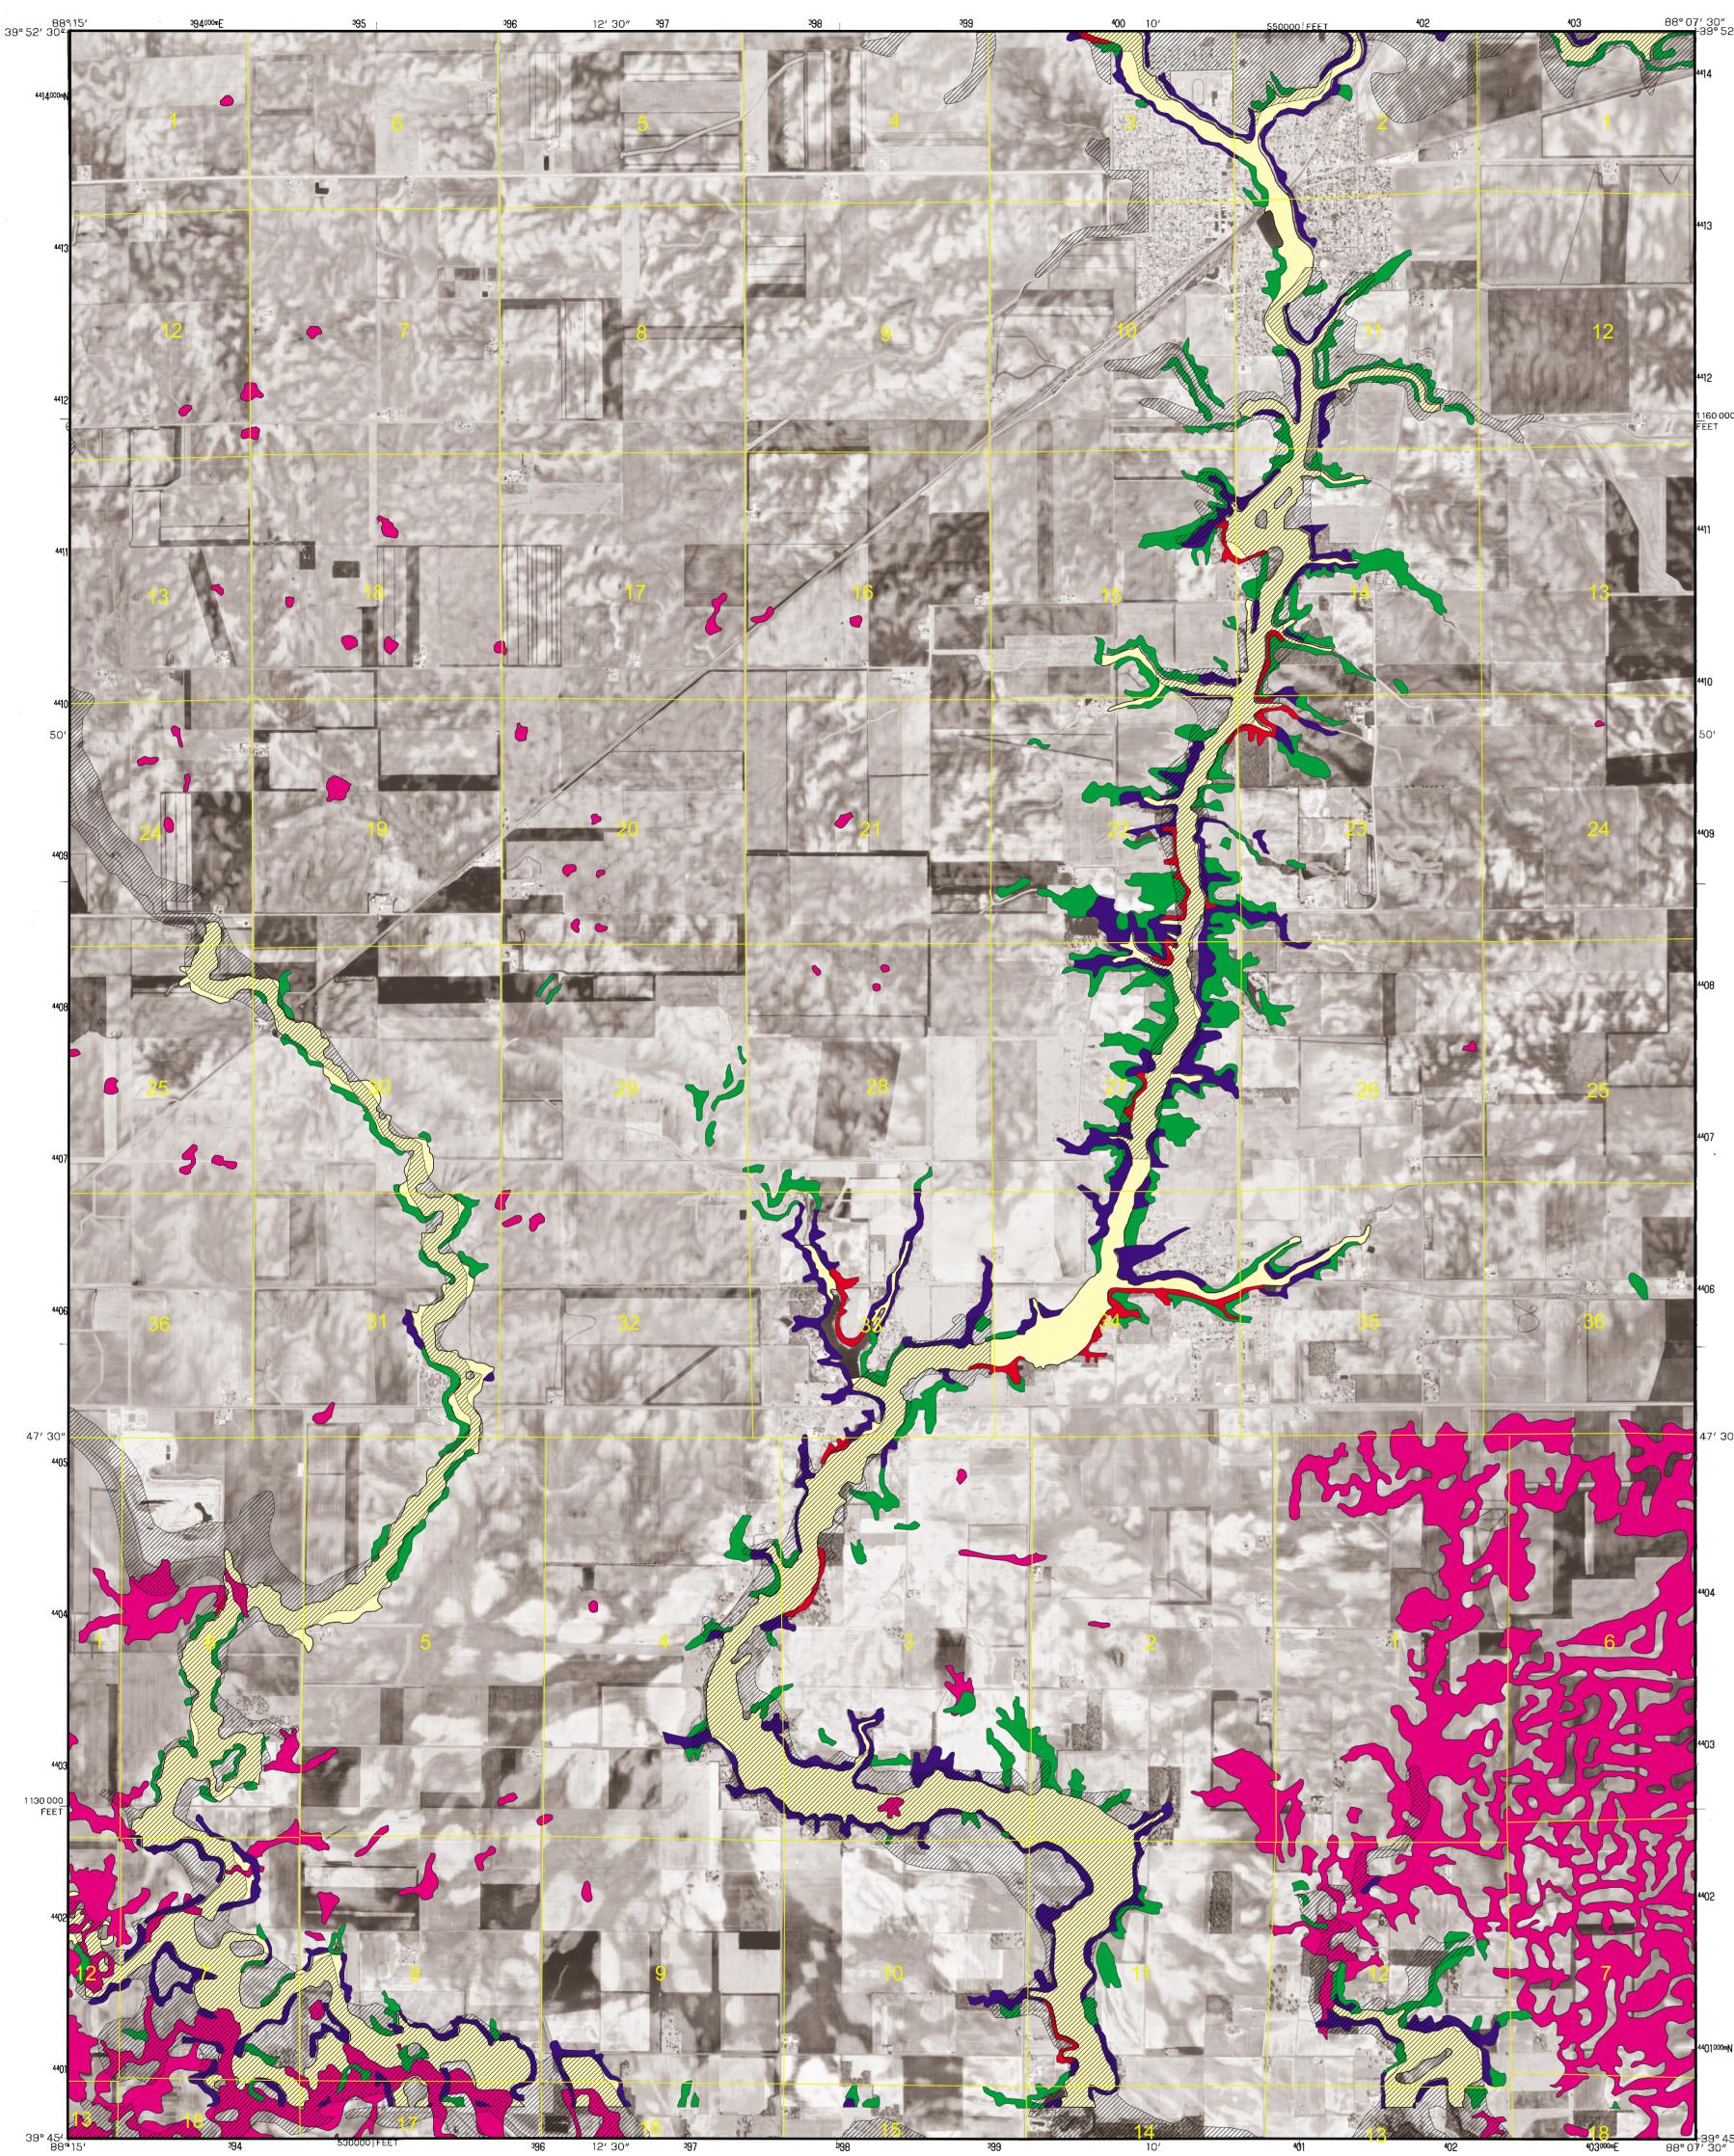
FEMA Flooding Recurrence 100 yr flood Potentially flood-prone alluvium	Percent Slope 4-7 7-12 18-40
Shrink-swell susceptibility	
High to very high

In the Villa Grove Quadrangle, natural hazards include flooding, poorly drained lake deposits, unstable slopes, high susceptibility to frost, and adverse shrink-swell characteristics.

seasonal, the chance of flooding and flash flooding is prevalent throughout the year. Areas susceptible to flooding lie within the 500- and 100-year floodplain. The outline of the 100-year flood boundary digitized by the Illinois State Water Survey from 1:24,000-scale Flood Insurance Rate Maps and Flood Hazard Boundary Maps (FEMA, 1985) prepared for the National Flood Insurance Program is shown on the Natural Hazards map (left). The area shown as susceptible to flooding is for insurance purposes and may not represent all of the areas subject to flooding. Conservative design would consider the mapped alluvium as potentially flood-prone where not otherwise designated within the 100-year floodplain.

banks of rivers and streams. The Natural Hazards Map shows where slopes exceed 4% and are eroded, indicating the potential for slope instability. Cut banks along the Embarras River are the steepest and most susceptible. On-site investigation is
