### 6.3 DISPLACEMENT DAMAGE AND SELF-HEALING IN HIGH-ENTROPY ALLOYS: A TEM WITH *IN SITU* ION IRRADIATION STUDY

Matheus A. Tunes<sup>1,2</sup> ([tunesm@ornl.gov](mailto:tunesm@ornl.gov)), Philip D. Edmondson<sup>2</sup>, Vladimir M. Vishnyakov<sup>1</sup> and Stephen E. Donnelly<sup>1</sup> [<sup>1</sup>University of Huddersfield, <sup>2</sup>Oak Ridge National Laboratory]

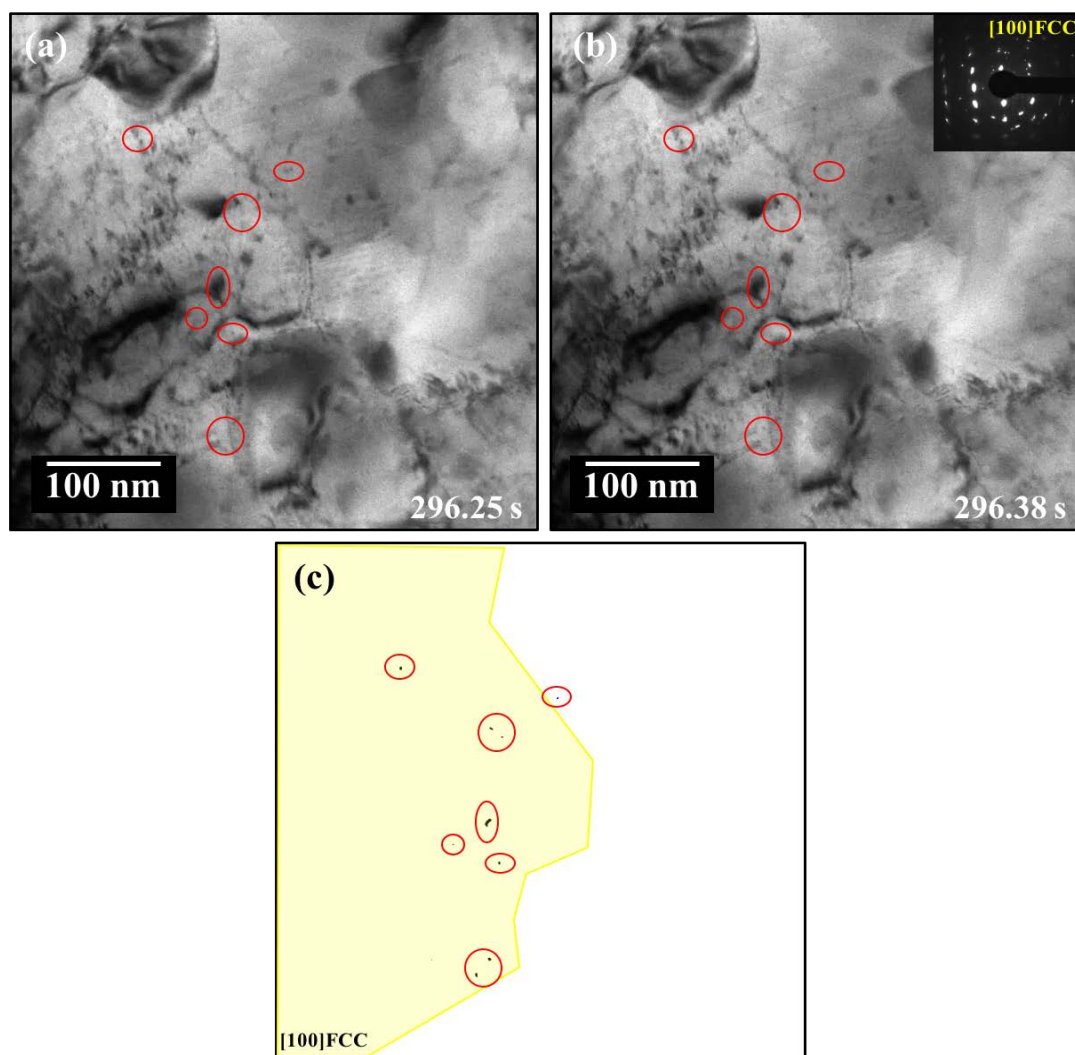
**Figure 49. BFTEM images of the FeCrMnNi HEA irradiated with 30 kV Xe ions at 773 K showing (a) and (b) two adjacent frames and (c) the image computed with MATLAB and representing the difference between (a) and (b): exhibiting the black-dots that appeared between the frames.**

Figure 49 shows the first two image frames (49a-b) within the analyzed temporal interval and the combined MATLAB image (49c) with the computed difference between the two images. The images were taken in the Bright-Field TEM (BFTEM) mode. Throughout the experiment, black-dots were preferentially observed in a grain where the crystallographic direction was indexed with the software Crystallmaker [4,5] and data available in the literature. The highlighted grain is orientated so that the electron beam is approximately aligned along the [100] zone-axis of the face-centred cubic (FCC) structure.

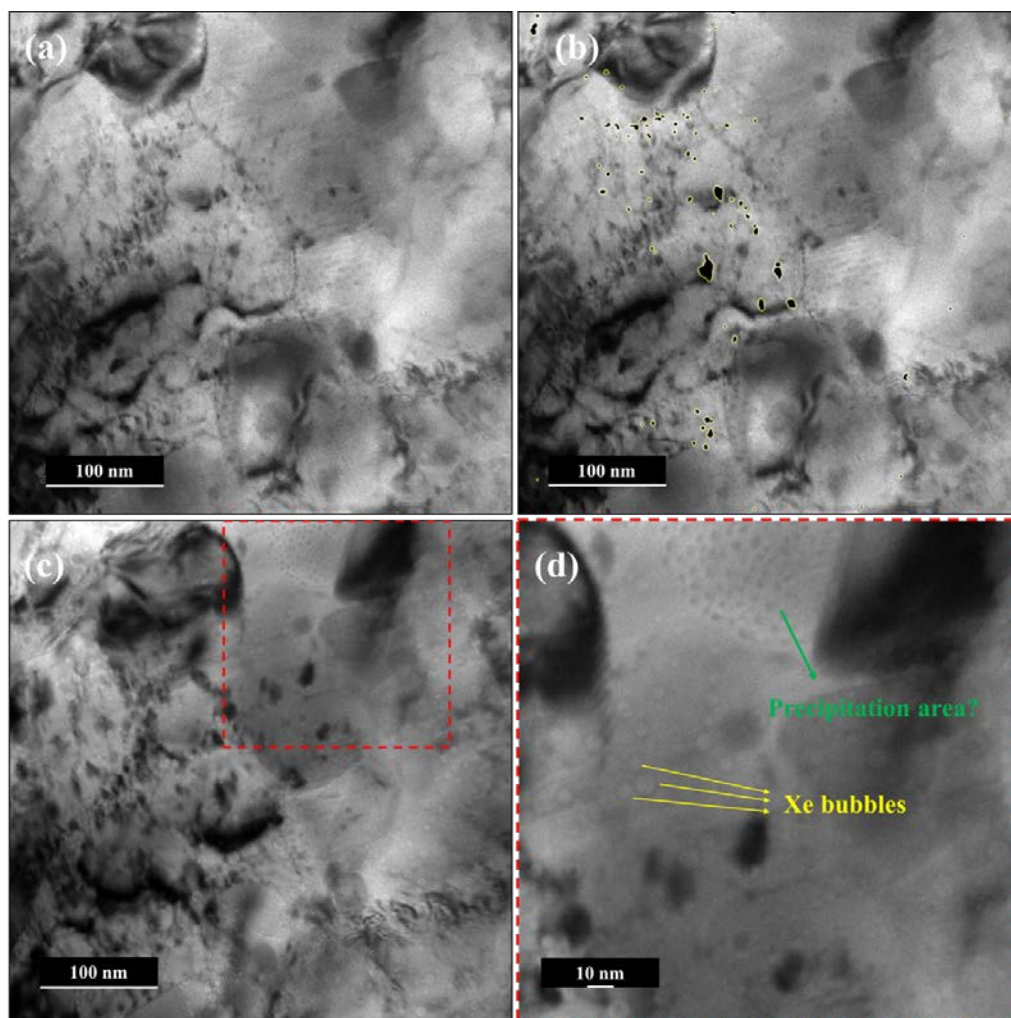
**Figure 50.** BFTEM images showing (a) the final microstructure of the 16<sup>th</sup> frame and (b) the same microstructure as (a) with the superposed information of the black-dots within the 16 frames analysed. The micrograph (c) is a BFTEM underfocused image with defocus degree of  $-1 \mu\text{m}$  of the same region at  $2.6 \times 10^{16} \text{ ions}\cdot\text{cm}^{-2}$  (24 dpa).

Figure 50 exhibits (50a) the final microstructure of the 16<sup>th</sup> frame and (b) the same final microstructure with the superposed information of all black-dots detected in the 16 frames analyzed. The comparison shows that the majority of the black-dots were annihilated within 2 seconds of irradiation at 773 K. Image (c) is an under focused BFTEM image that was taken at a dose of  $2.6 \times 10^{16}$  ions·cm<sup>-2</sup> (24 dpa) where Xe bubbles are observable. The area shown in (d) also exhibits a region of a possible secondary phase formed during irradiation. Further investigation is underway.
