Liu, Z., Li, P. and Srikanth, N. (2019) Effect of delamination on the flexural response of [+45/-45/0]_{2s} carbon fibre reinforced polymer laminates. *Composite Structures*, 209, pp. 93-102.

**Effect of delamination on the flexural response of $[+45/-45/0]_{2s}$
carbon fibre reinforced polymer laminates**

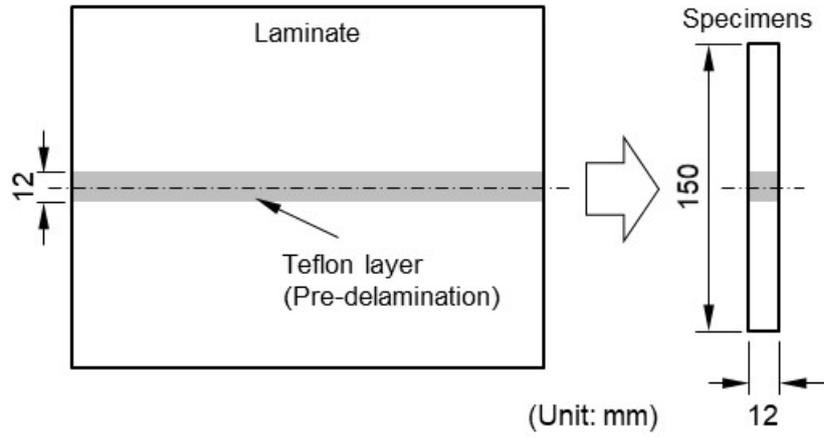
Figure 1: The schematic of the carbon fibre reinforced polymer (CFRP) laminate with an embedded Teflon layer as the pre-delamination, and the rectangular specimens machined from the laminate by waterjet cutting.

Fig. 1 The schematic of the carbon fibre reinforced polymer (CFRP) laminate with an embedded Teflon layer as the pre-delamination, and the rectangular specimens machined from the laminate by waterjet cutting.

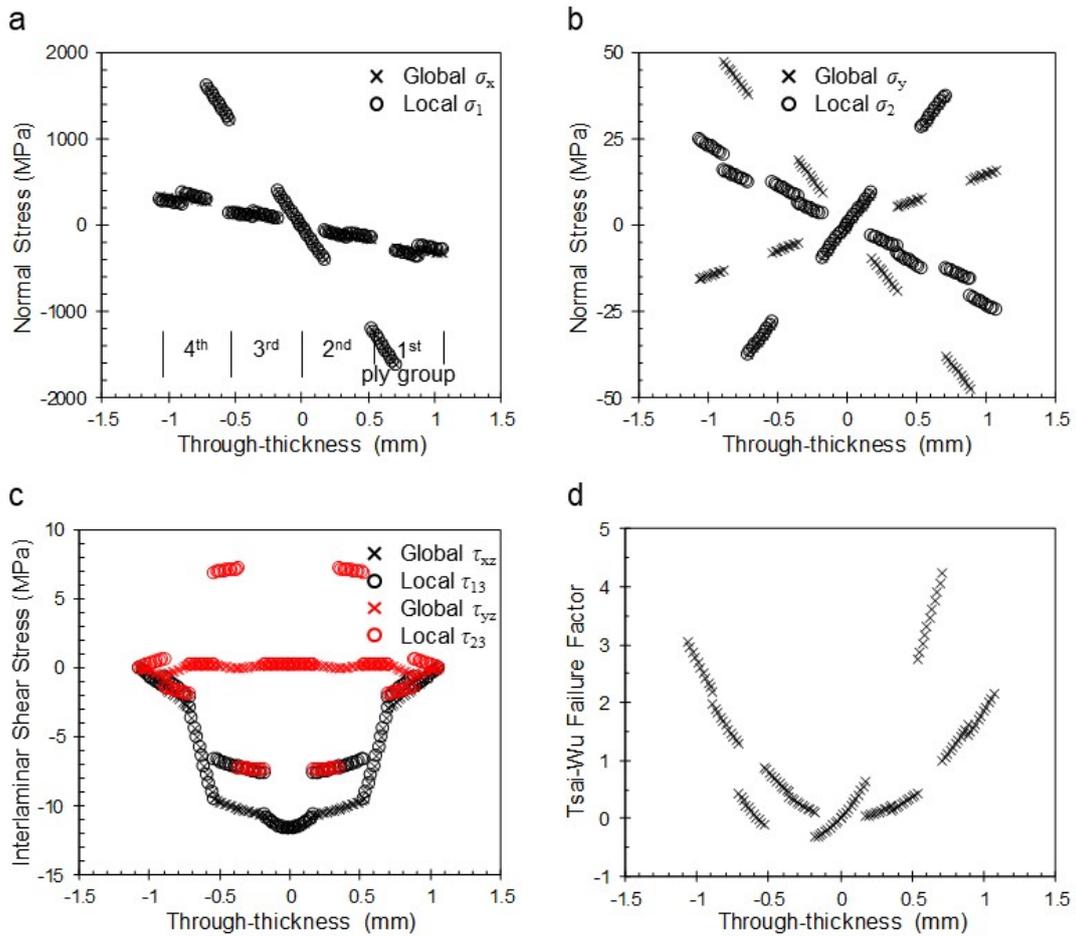
Figure 2: The predictions of (a) in-plane longitudinal normal stresses, (b) in-plane transverse normal stresses, (c) interlaminar shear stresses, and (d) Tsai-Wu failure factor in the CFRP laminate with no pre-delamination (NPD) subjected to static three-point bending at the failure load 343 N using classical laminate theory.

In the [+45/–45/0]_{2s} laminate with no pre-delamination, only the normal stresses σ_1 (compressive) and σ_2 (tensile) in the 0 ply of the 1st group exceed the longitudinal compressive strength X_c and the transverse tensile strength Y_t , respectively (refer to Fig. 2(a, b) and Table 2). The highest Tsai-Wu failure factor (>1.0) also exists in the same ply (Fig. 2(d)). Therefore, the fibre failure and transverse cracking (matrix cracking and fibre/matrix debonding) occur in the 0 ply of the 1st group as shown in Fig. 5. After the failure in this 0 ply, the stresses re-distribute and they can concentrate in the adjacent plies, e.g., both the +45 and –45 plies in the 1st and 2nd groups. The normal stresses (σ_1 and σ_2) and Tsai-Wu factor in the +45 and –45 plies of the 1st group are relatively greater than those in the 2nd group (Fig. 2(a, b, d)). Thus this new stress concentration results in the failure in the neighbouring +45 and –45 plies of the 1st group in the NPD laminate (Fig. 5).

Fig. 2 The predictions of (a) in-plane longitudinal normal stresses, (b) in-plane transverse normal stresses, (c) interlaminar shear stresses, and (d) Tsai-Wu failure factor in the CFRP laminate with no pre-delamination (NPD) subjected to static three-point bending at the failure load 343 N using classical laminate theory.

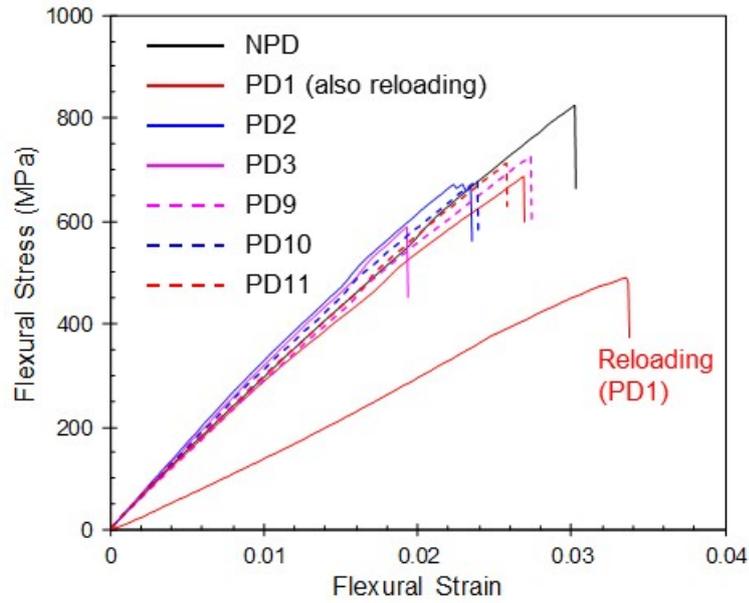
Figure 3: The representative flexural stress–strain curves of CFRP laminates with or without the pre-delamination subjected to static three-point bending and subsequent reloading. Note that the reloading curve is shown for the PD1 specimen only.

Fig. 3 The representative flexural stress–strain curves of CFRP laminates with or without the pre-delamination subjected to static three-point bending and subsequent reloading. Note that the reloading curve is shown for the PD1 specimen only.

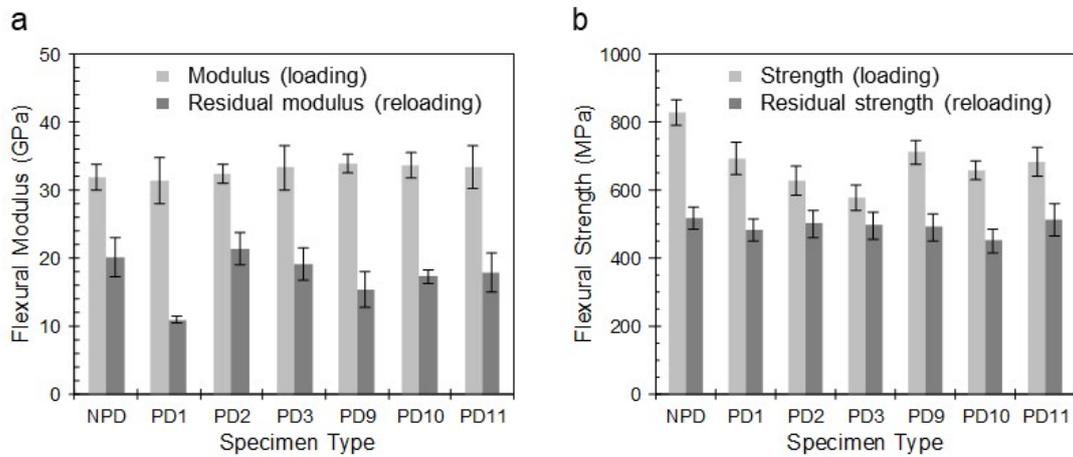
Figure 4: (a) Flexural modulus and (b) flexural strength of CFRP laminates as a function of pre-delamination location.

The embedded pre-delamination has little influence on the initial flexural modulus but has a significant impact on the flexural strength at failure in the laminates (Fig. 4). The modulus of the seven laminates at initial loading is almost the same because the interlaminar plane of pre-delamination damage is perpendicular to the bending load direction. The pre-delamination reduces the flexural strength and strain at failure (Figs. 3 and 4). But the extent of such negative effects on the strength can be different, depending on the location of the embedded pre-delamination. Specifically, the flexural strength of the [+45/-45/0]_{2s} laminate is more sensitive to

Fig. 4 (a) Flexural modulus and (b) flexural strength of CFRP laminates as a function of pre-delamination location.

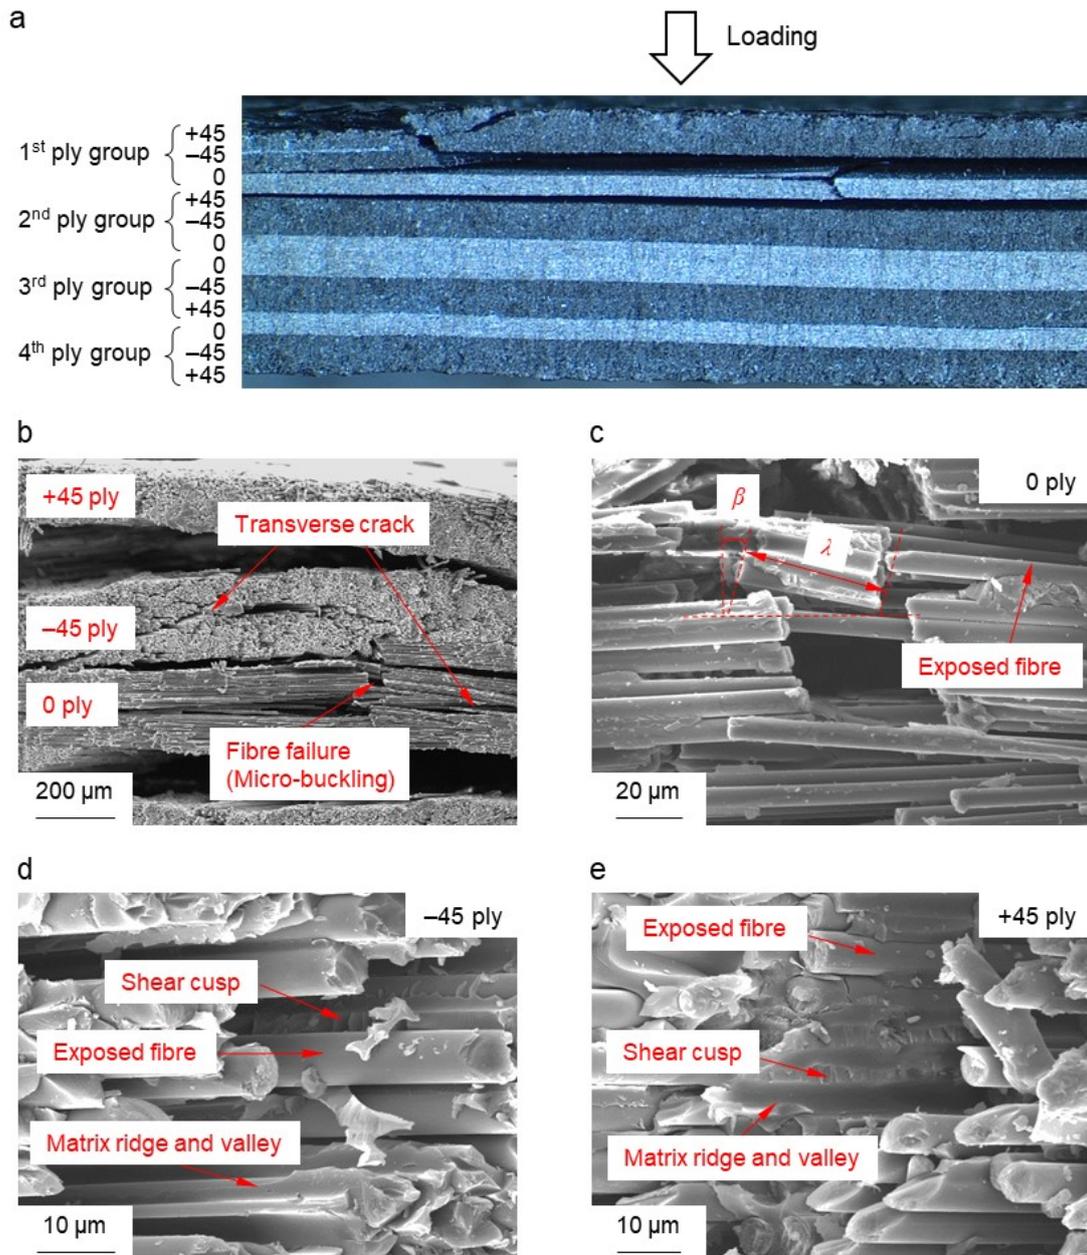
Figure 5: The CFRP laminate with no pre-delamination (NPD) after static three-point bending testing: (a) optical image of the through-thickness edge; (b–e) SEM images of the edge surface in the 1st ply group near the failure site. The overview of the failure in the 1st ply group is shown in (b) while the details in each ply are in (c–e).

Fig. 5 The CFRP laminate with no pre-delamination (NPD) after static three-point bending testing: (a) optical image of the through-thickness edge; (b–e) SEM images of the edge surface in the 1st ply group near the failure site. The overview of the failure in the 1st ply group is shown in (b) while the details in each ply are in (c–e).

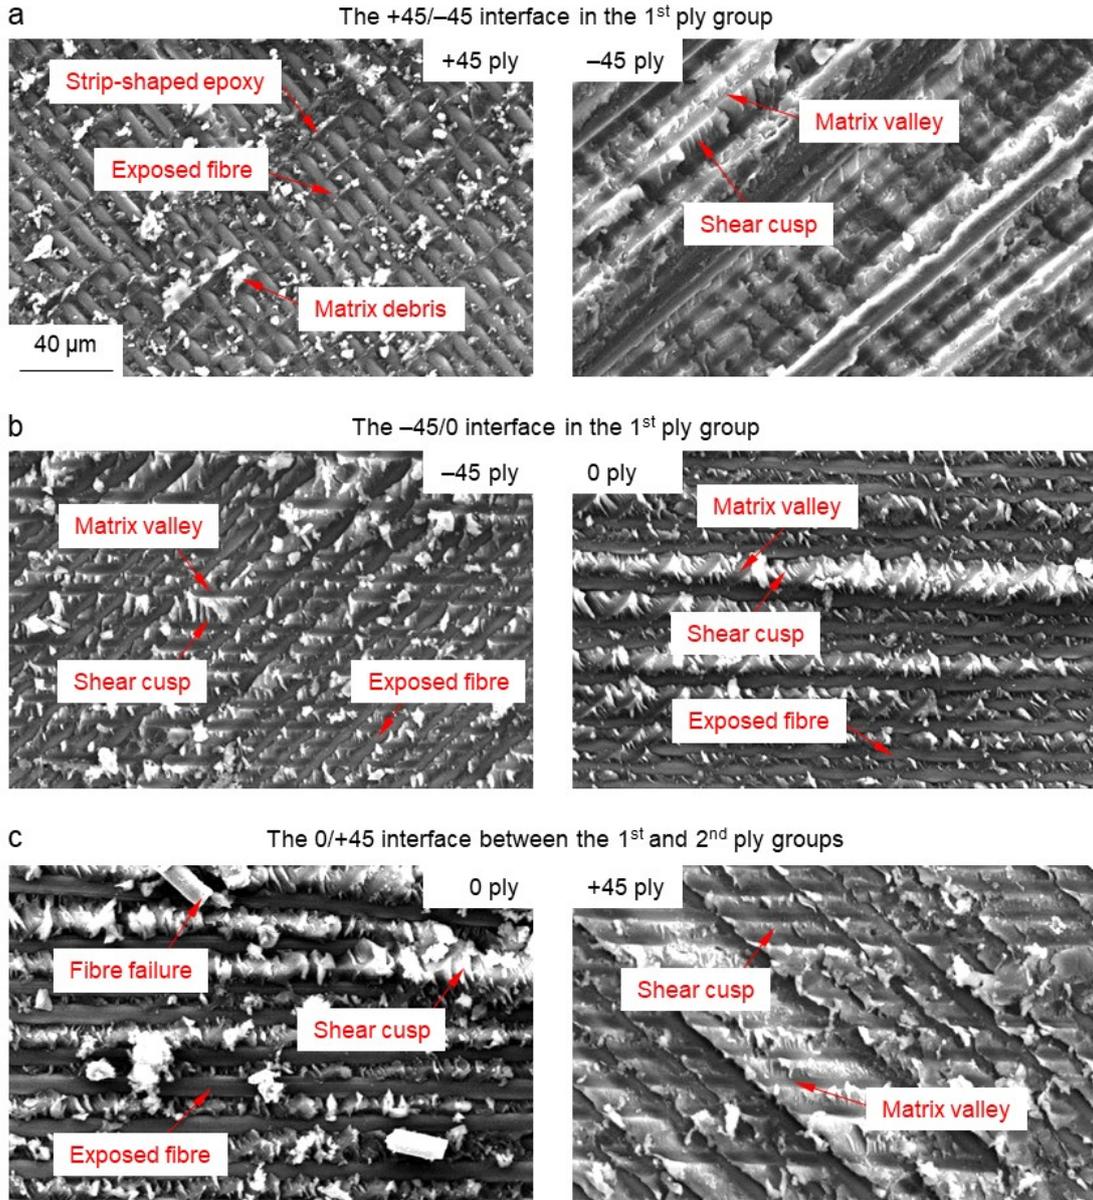
Figure 6: SEM images of the delamination surfaces in the ply interfaces in the 1st groups in the CFRP laminate with no pre-delamination (NPD).

Fig. 6 SEM images of the delamination surfaces in the ply interfaces in the 1st groups in the CFRP laminate with no pre-delamination (NPD).

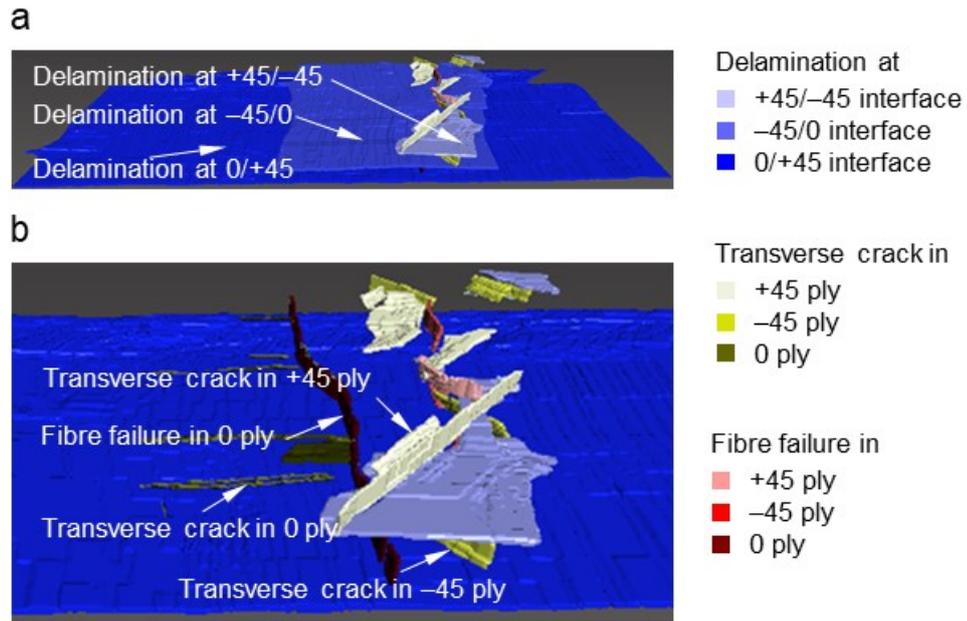
Figure 7: X-ray microtomographic observations of the damage in the CFRP laminate with no pre-delamination (NPD) subjected to static three-point bending. The delamination in the 1st ply group is denoted in (a) while the transverse cracks and fibre failure are in (b). The delamination at the -45/0 interface is hidden in (b) to better illustrate the damage.

Fig. 7 X-ray microtomographic observations of the damage in the CFRP laminate with no pre-delamination (NPD) subjected to static three-point bending. The delamination in the 1st ply group is denoted in (a) while the transverse cracks and fibre failure are in (b). The delamination at the –45/0 interface is hidden in (b) to better illustrate the damage.

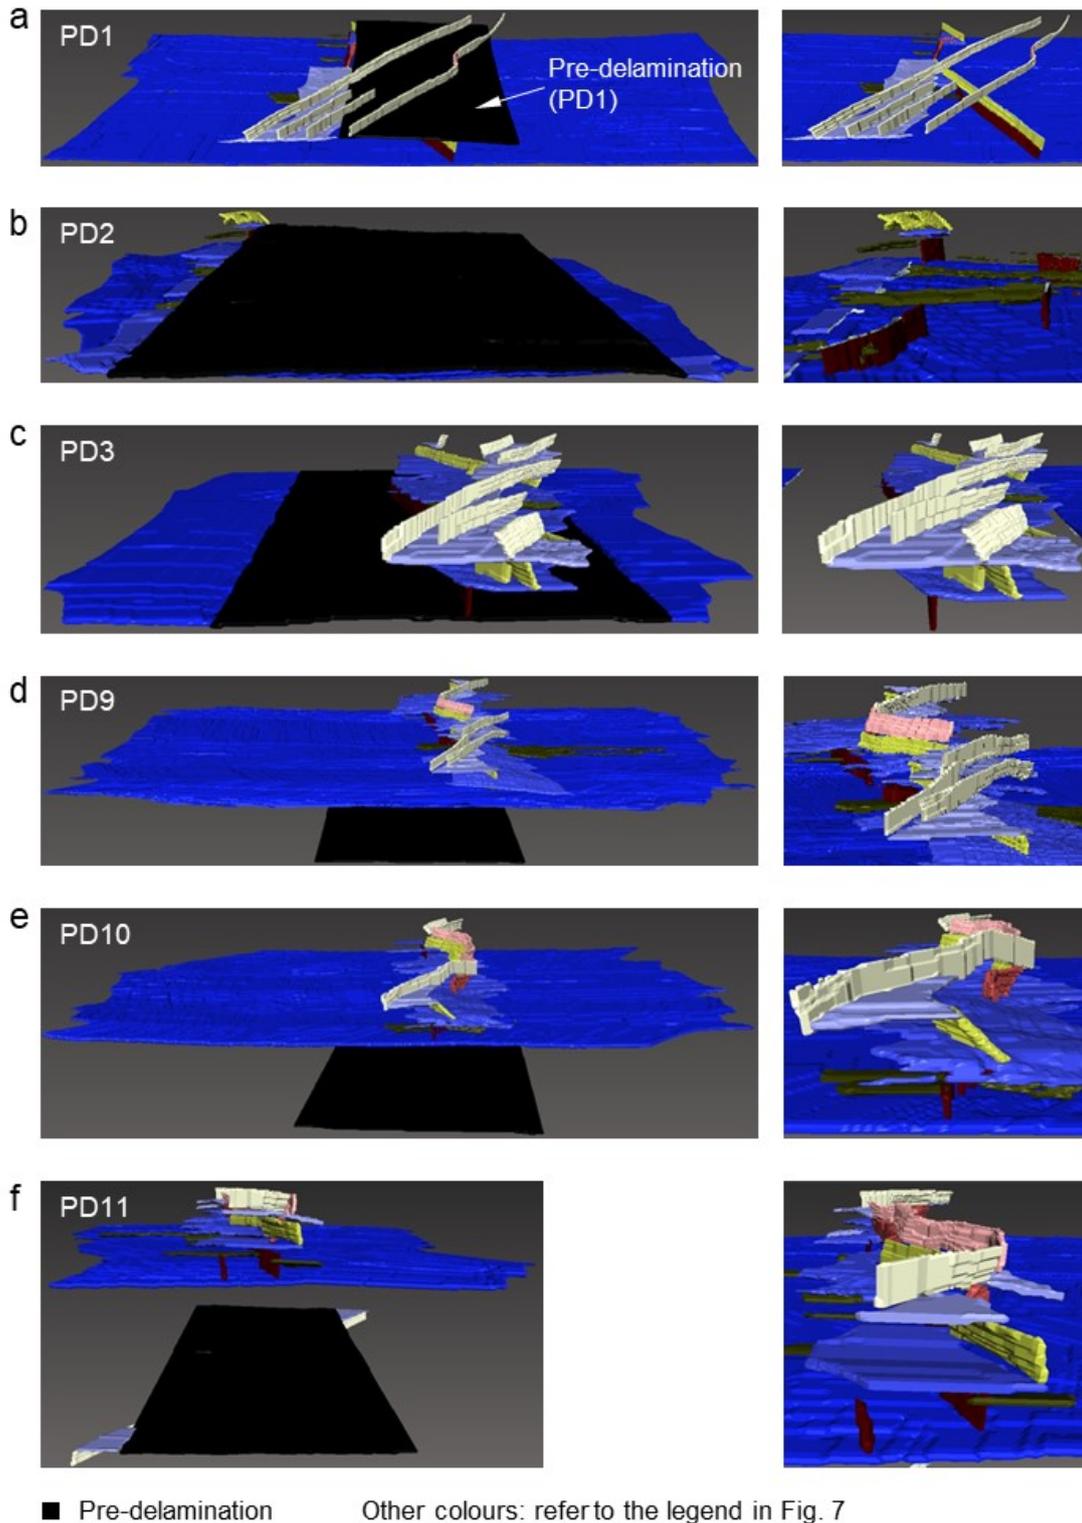
Figure 8: X-ray microtomographic observations of the damage in the CFRP laminate with the pre-delamination at different interfaces subjected to static three-point bending. The 3D overview of the damage in the laminate is illustrated in the left figure, while the damage in the 1st ply group is detailed in the right figure in which the pre-delamination is hidden.

Fig. 8 X-ray microtomographic observations of the damage in the CFRP laminate with the pre-delamination at different interfaces subjected to static three-point bending. The 3D overview of the damage in the laminate is illustrated in the left figure, while the damage in the 1st ply group is detailed in the right figure in which the pre-delamination is hidden.

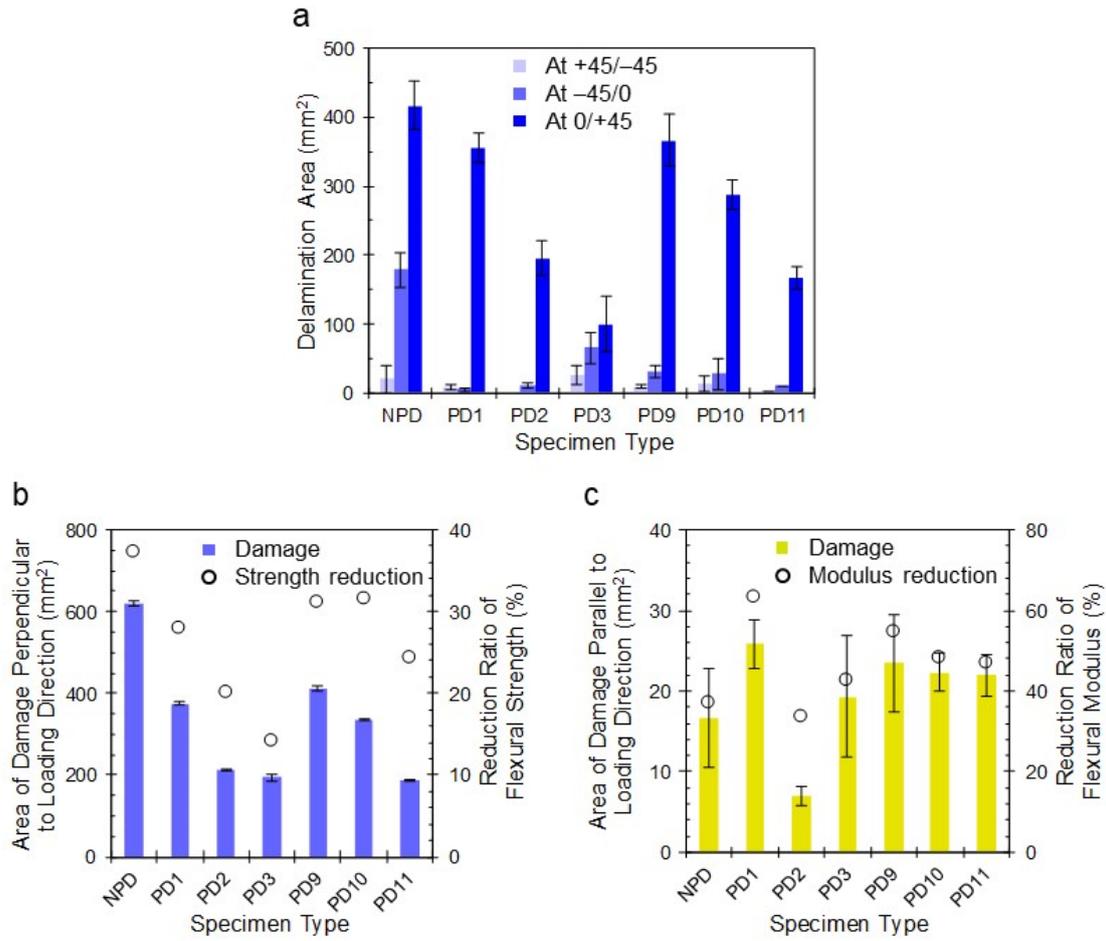
Figure 9: (a) Projected delamination areas at the three interfaces in the 1st ply group in the CFRP laminates as a function of pre-delamination location. (b) Comparison between the areas of the damage perpendicular to the loading direction and the reduction of flexural strength by reloading. (c) Comparison between the areas of the damage parallel to the loading direction and the reduction of flexural modulus by reloading. The pre-delamination is excluded from the calculation of the delamination damage. The error bars for the reduction of flexural properties are not shown in (b, c).

Fig. 9 (a) Projected delamination areas at the three interfaces in the 1st ply group in the CFRP laminates as a function of pre-delamination location. (b) Comparison between the areas of the damage perpendicular to the loading direction and the reduction of flexural strength by reloading. (c) Comparison between the areas of the damage parallel to the loading direction and the reduction of flexural modulus by reloading. The pre-delamination is excluded

from the calculation of the delamination damage. The error bars for the reduction of flexural properties are not shown in (b, c).
