Real time debonding monitoring of composite repaired materials via electrical, acoustic and thermographic methods

S. A. Grammatikos, E. Z. Kordatos, T. E. Matikas, A. S. Paipetis *

Dept. of Materials Engineering, University of Ioannina, 45110 Ioannina, Greece

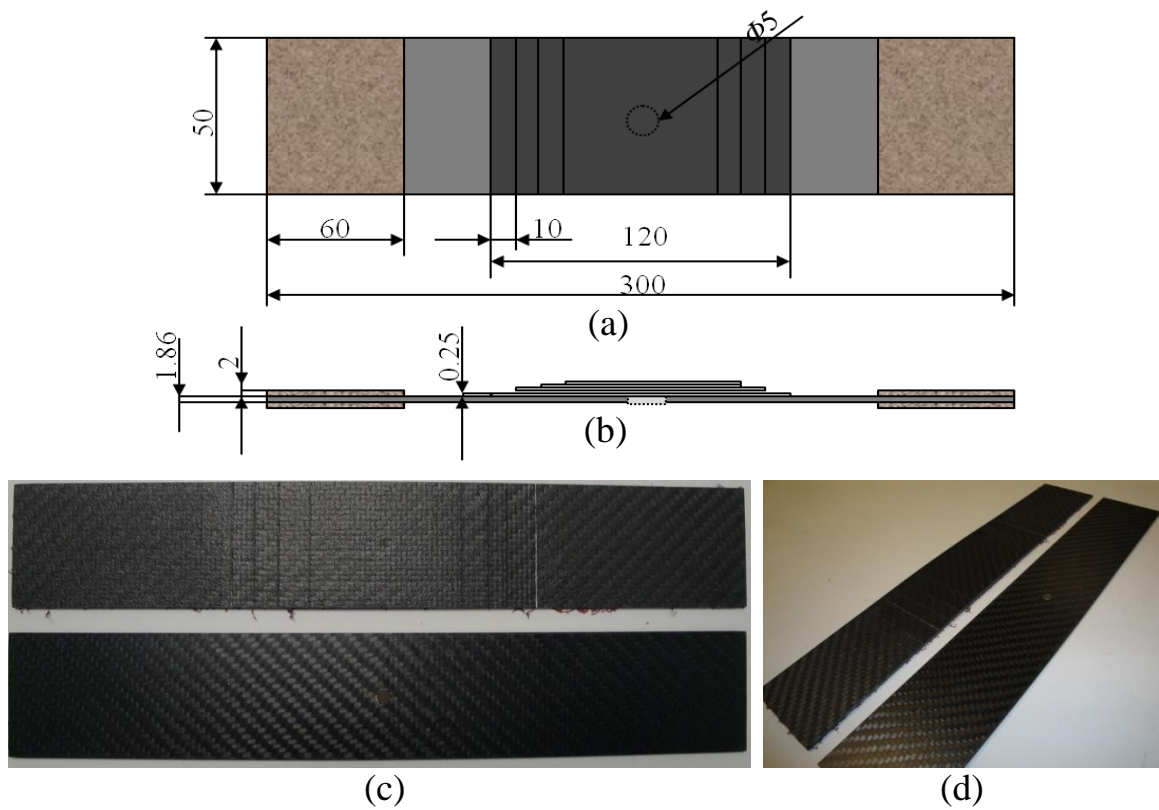
Figure 1. (a, b) Schematic configuration of the employed specimen, (c, d) snapshots of both front (patched) and back side of the specimens.

The patch was applied in layers using the conventional wet lay-up, using a tapered geometry in order to minimise the high shear stress fields at the edges of the repair. The pre-impregnated layer dimensions were 120x50mm² (1st ply), 100x50mm² (2nd ply), 80x50mm² (3rd ply) and 60x50mm² (4th ply) (Fig.1). Curing of the patch on the substrate was performed in an autoclave as following: (i) reaching of 0.98 bar vacuum condition, (ii) increase of vacuum pressure to 6.2 bar, (iii) increase of temperature at 120 °C with 3 °C /min rate, (iv) retain stable vacuum pressure and temperature for 10 min, (v) decrease of temperature at 80 °C with -3 °C /min rate and finally (vi) vacuum pressure release. In Fig.1 the final coupon configuration is depicted. Finally 50x60 mm² end tabs were attached on the composite coupons using high shear adhesive (Epibond 1590 A/B, Huntsman), in order to prevent failure at the gripping area.

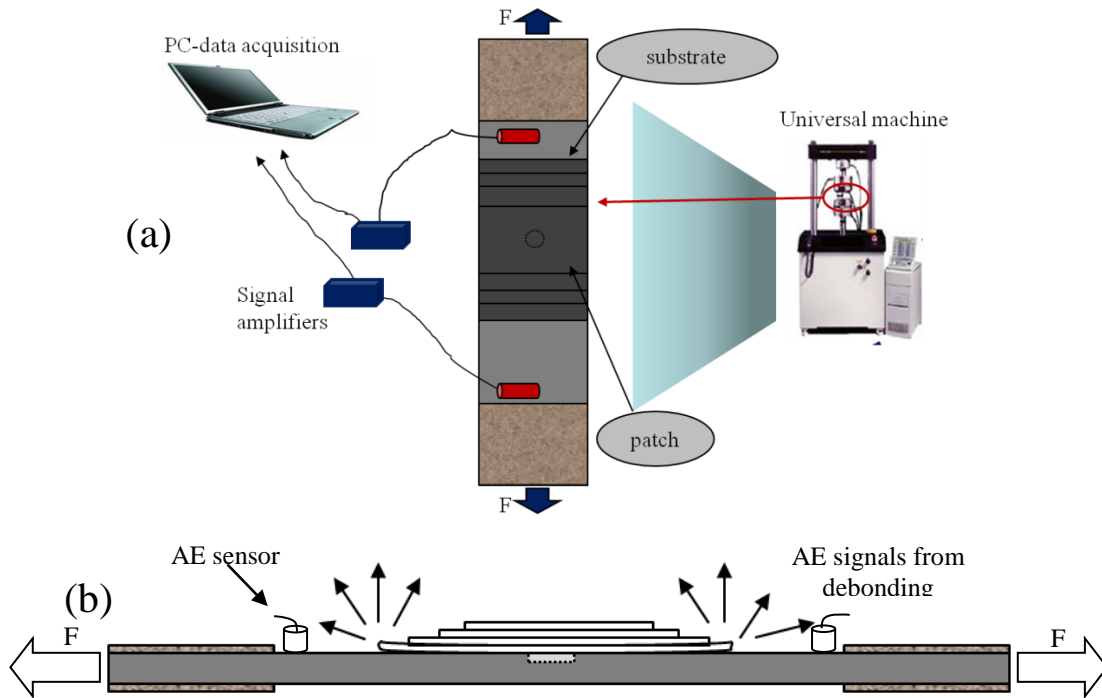
Figure 3. (a) Schematic representation of AE technique, (b) AE signal measurement principle.

For the Acoustic Emission monitoring, two broadband piezoelectric transducers (Pico, Physical Acoustics Corp., PAC) were attached on the specimen as shown in Figs.3a and 3b at specific distance (80mm). Ultrasonic gel was applied for the acoustic coupling. The pre-amplifier gain was set to 40 dB. After performing a pilot test, the threshold was also set to 40 dB, in order to avoid electronic/environmental noise. The signals were recorded employing a two-channel PCI-2 monitoring board of PAC with sampling rate of 5 MHz.

As is depicted in Fig.3b the propagation of the patch debonding front of the patch causes the generation of AE hits. The simultaneous recording by the two broadband AE sensors allowed for the location of the events due to debonding, along the length of the specimen. Thus, cumulative AE signals on either side of the patch along the loading axis may represent the length of the debonding front or else, the critical damage of the repaired material.

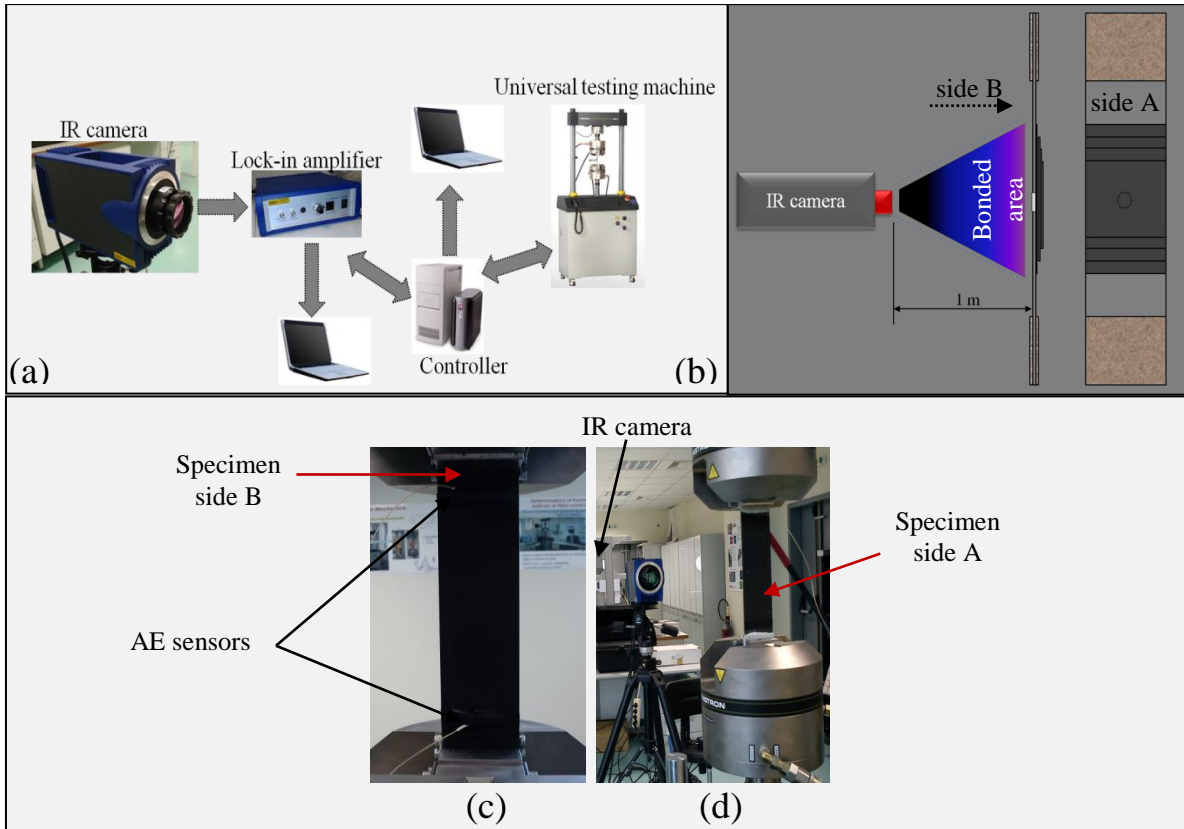
Figure 4. (a) Schematic of the thermographic experimental setup (b) recorded field of view of the thermal camera

For the thermographic inspection, the Jade 510-CEDIP-MW infrared camera was used (Fig.4). The camera employs a cooled indium antimonide (InSb) detector (3-5 μm), with a frame rate from 50-150 Hz and a focal plane array (FPA) pixel format of 320x240. The thermal sensitivity of the camera is lower than 25 mK at 25 $^{\circ}\text{C}$ and the resolution 0.001 $^{\circ}\text{C}$. The camera was employed in lock-in mode at a frame frequency of 50 Hz. The cyclic loading imposed by the loading frame was 5 Hz. For the purposes of this work, the camera was positioned at approximately 1 m distance from the specimen in order to include the whole patched area in the Field Of View (FOV) of the camera (Figs.4a and 4b). At this distance the corresponding field of view was 208x156 mm^2 with a lateral and perpendicular resolution of 0.65 mm/pixel. Figs.4c and 4d are snapshots of experimental setup of the second pair; IrT versus AE. In the aforementioned configuration the cyclic loading is the source of thermal excitation of the material. As has been shown in a previous publication, debonding is manifested in the amplitude domain as a distinct discontinuity in the greyscale area, delineated by a hot zone which indicates the stress concentration at the debonding front.

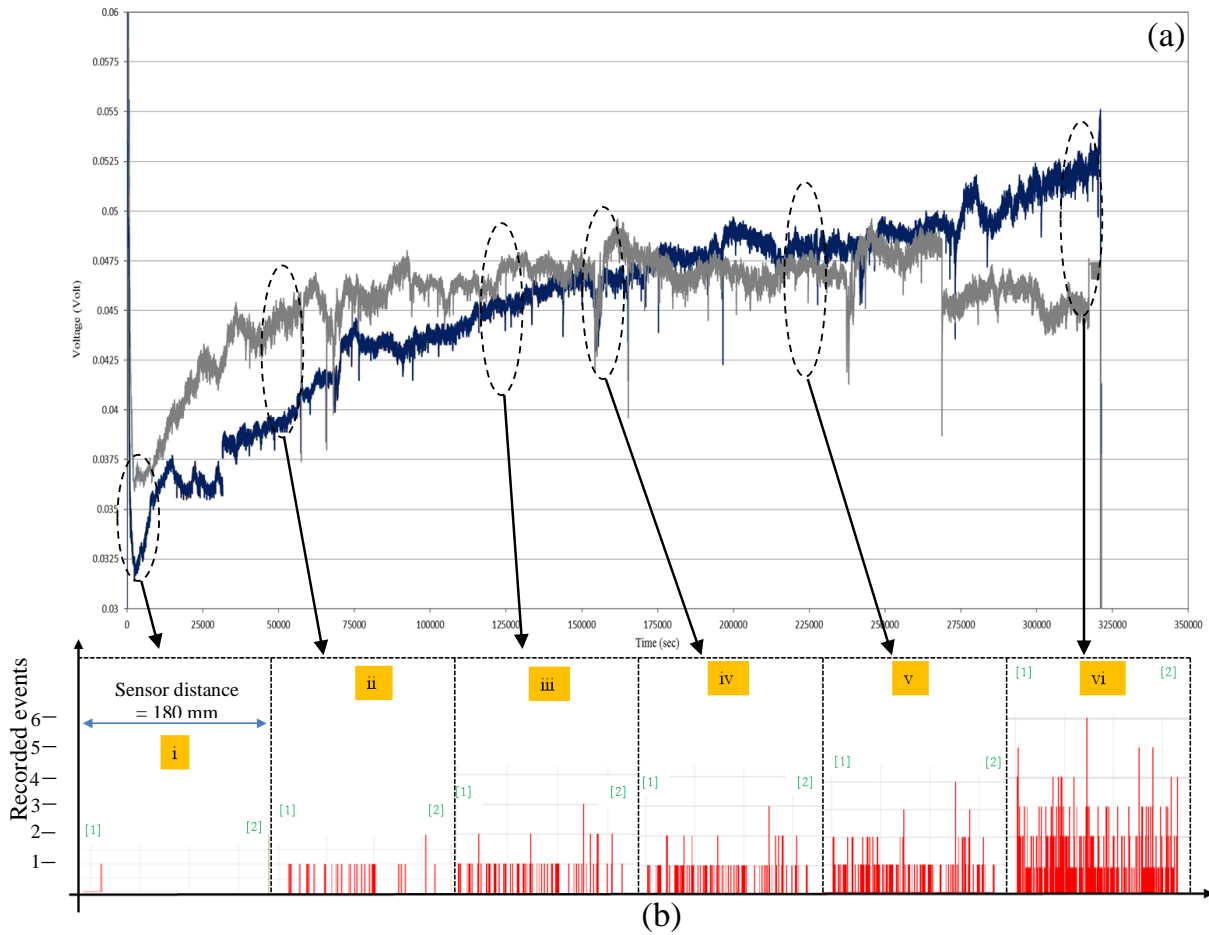
Figure 5. (a) Electrical potential changes along with (b) the acoustic emission signals during the fatigue mechanical testing.

Fig.5 depicts the electrical potential changes (Fig. 5a) and the acoustic activity (Fig. 5b) recorded during the fatigue mechanical testing of one of the two tested coupons as a function of the loading cycles. The bottom side indicates the side at which the load was introduced by the loading frame. Both EPCM channels are depicted. The polarity was chosen so that increase in potential values corresponds to increase in the resistance of the monitored closed circuit, which would be the expected result from the propagation of the debonding front. With the selected formality, relative potential increase corresponds to increase in “potential drop” due to electrical resistance increase. AE activity snapshots are overlaid on the EPCM graphs indicating the location of the recorded events at specific instances during the experiment corresponding at the indicated EPCM measurements. The cumulative AE hits for the total duration of the experiment are shown in Fig.5b.

For both the top and the bottom side, the recorded noise is of a typical amplitude of 5 mV and high frequency. As was observed, this frequency is approximately 5 MHz which is indicative of the fact that it is not system noise but corresponds to the real time resistance fluctuations within individual fatigue cycles. The same phenomenon was observed in the case of fatigue of plain composite coupons [13]. Additionally, there is a superimposed electrical potential oscillation of approximately 15 mV amplitude for 25 kcycles period, manifested as “drops” and “peaks” in the potential along the fatigue cycles. It may be postulated that these changes are attributed to local disruptions of the electrical conductive path between the repair and the substrate mirroring the debonding evolution of the patch from the substrate. In this case, the patch should exhibit “stick-slip” behaviour as critical failure progresses. Finally, there is a large scale change with monotonic parts which is independent of the aforementioned oscillations. The discontinuity recorded at approximately 270 kcycles is not readily explained but may be attributed to sudden change in a part of the electrical circuit independent of the interrogated repair, such as the contact resistance of the copper wires. The recorded large scale electrical potential change (EPC), as described in the previous paragraph, is distinctly different from the top to the bottom side. For both sides the EPC exhibits a steep decrease in the initial few loading cycles. As should be noted, the

Following the aforementioned decrease, the EPC is differentiated from the top to the bottom channel. The top channel (grey line) exhibits a small increase in potential of approximately 10 mV from its minimum value and thereafter the potential values oscillate around a mean (0.045-0.047 V) value, suggesting the existence of the “stick-slip” mechanism, which however has reached a steady state. However, the EPC for the bottom channel exhibits a monotonic increase until the specimen failure. This increase is more than 30 mV from the minimum recorded value. The sudden potential drop at the end of the fatigue life obviously indicates loss of continuity due to specimen failure, which occurred with the critical failure of the bottom part of the patch followed by brittle transverse failure at the vicinity of the notch. Obviously, EPCM was successful in identifying the most probable failure site of the patch coupon, as after the initial stage, progressive critical failure was clearly manifested as monotonic potential increase of the bottom part of the coupon. The relative potential increase values as a function of fatigue life fraction for the bottom part of the coupon is shown in Fig.6. Summarising the aforementioned observations, EPCM (i) is capable of identifying the real time resistance fluctuation within individual fatigue cycles (ii) indicates the characteristic stick-slip behaviour which relates to the progressive debonding of the patch due to fatigue and most importantly (iii) is capable of clearly identifying the preferential side of failure of the patch.

As far as AE is concerned, the acoustic events as recorded at the same time with the electrical potential values are shown in Fig.5b. Snapshots of the cumulative acoustic events are presented as a function of the sensor positions. Events correspond to acoustic activity recorded within the time difference that sound travels within the length of the coupon. The differential arrival time allows for the calculation of the location of the sound source. The acoustic events which reflect the presence and location of damage start to appear from the edges of the repair (critical damage) moving along the centre of the specimen indicating the debonding of the repair. As should be noted the bottom part of the coupon (blue EPCM channel in Fig. 5a) corresponds to the right side and the top part (grey EPCM channel in Fig. 5a) to the left side of the event location snapshots. The activity corresponding to the bottom channel appears consistently to be higher and this is indicative of the part where failure is most likely to take place. In the final stage of the test and prior the final failure of the specimen, the recorded acoustic events are concentrated in the centre of the specimen. At the same region the coupon eventually failed due to the presence of the circular notch (sub-critical damage). Summarising, AE (i) is consistent with the observations made by EPCM and (ii) is capable of detecting subcritical failure at the end of the debonding process.

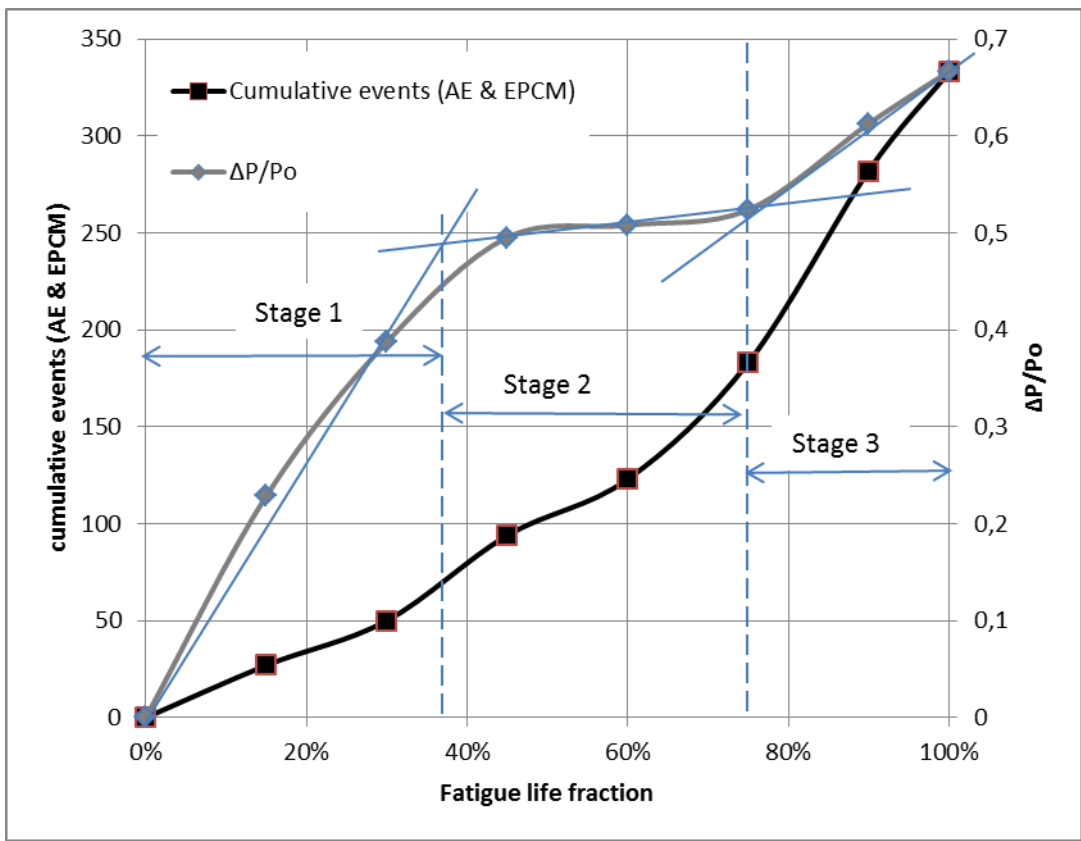
Figure 6. Cumulative AE events and relative potential change as a function of fatigue life fraction; Fatigue life stages that may be defined with EPCM, are not obvious with AE.

Fig.6 depicts the cumulative events as a function of fatigue life fraction together with the relative potential change recorded by EPCM as a function of fatigue life fraction. As can be easily observed, both techniques exhibit a monotonic

increase. It may be postulated that three fatigue life stages may be defined with EPCM as indicated by the successive changes in the slope of the depicted curve, i.e. the onset of damage marked as stage 1, the increase in damage rate marked as stage 2 and finally the rapid deterioration that inevitably leads to failure (stage 3). AE is not as efficient in clearly identifying all stages of the fatigue life. As should be noted, the potential change is typical of a fatigue life diagram as in a typical fatigue case, stage 1 should exhibit a higher damage rate than stage 2. Finally, Fig.7 depicts the cumulative events vs. the relative potential change. This may be regarded as typical benchmarking or calibration graph for EPCM against AE. As can clearly be the benchmarking scheme of both NDE methods is efficient in highlighting the fatigue stages with approximately linear interdependence for each fatigue life stage. Indicative of the potential of the benchmarking approach is that the fatigue life stages are more clearly defined in figure 7 than independently for both techniques (figure 6).

Fig.6 and 9 clearly show that EPCM and IrT are capable of identifying three distinct fatigue stages. These stages are better highlighted, when EPCM and IrT are interrelated with AE acoustic emission activity. In this way, the fatigue life stages are clearly defined. Interestingly enough though, the fatigue life stages are almost identical in the fatigue life fraction representation for the two studied configurations; i.e. stage 1 ranges ends at approximately 35-45% and stage 2 at approximately 60%. In other words, provided that the correlation between the AE activities in the two scenarios is satisfactory, an indirect cross validation of IrT and EPCM may be performed; Fig.11a depicts the AE activity vs. lifetime fraction and Fig.11b depicts the correlation of the cumulative events as recorded for the two distinct configurations. It is interesting to note that the fatigue life stages are clearly defined via the cross correlation of the results for the two distinct configurations. Moreover, the cross correlation of the acoustic activity for the two NDE scenarios presents an envelope which is directly relevant to the uncertainty provided by the indirect benchmarking of IrT vs. EPCM as concurrent monitoring was not feasible with both techniques. Fig.12 depicts the benchmarking of IrT against EPCM; within the uncertainty of the approach, the indirect benchmarking of the two methodologies can be performed successfully in order to define the fatigue life stages as a function of the fatigue life fraction, providing a universal benchmarking for the two “incompatible” NDE methodologies (Fig.12).

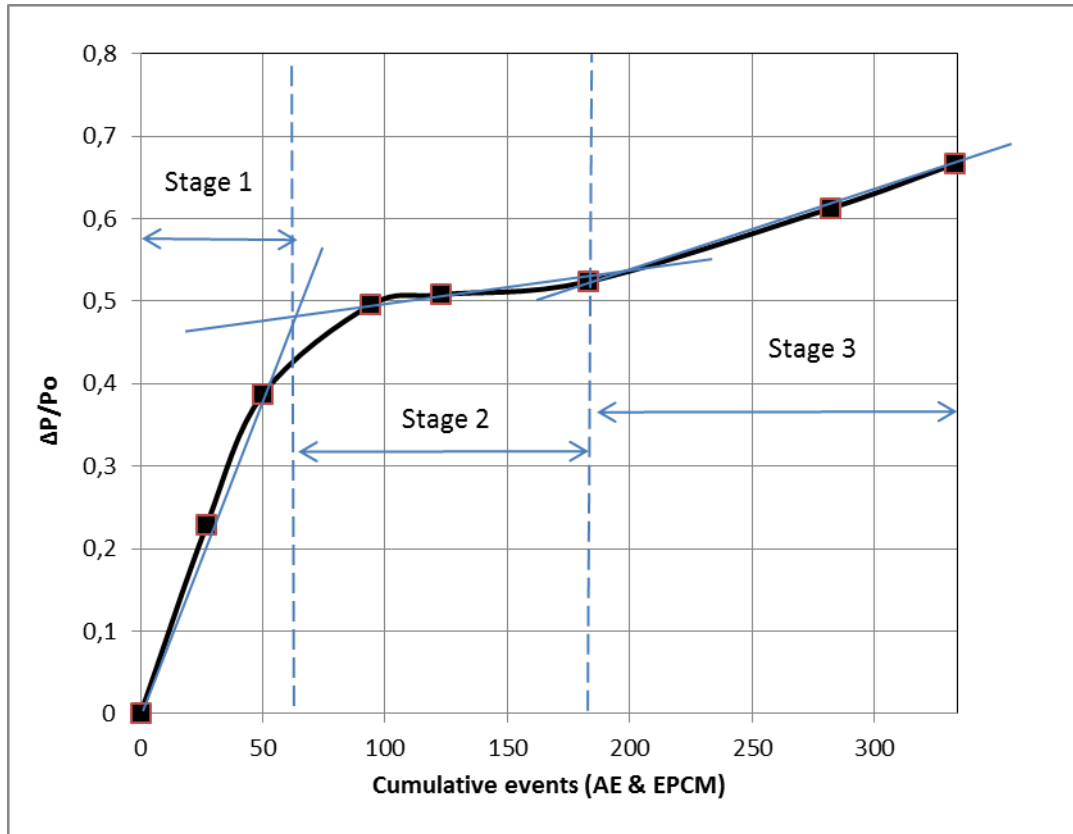
Figure 7. Cumulative AE events vs. relative potential change

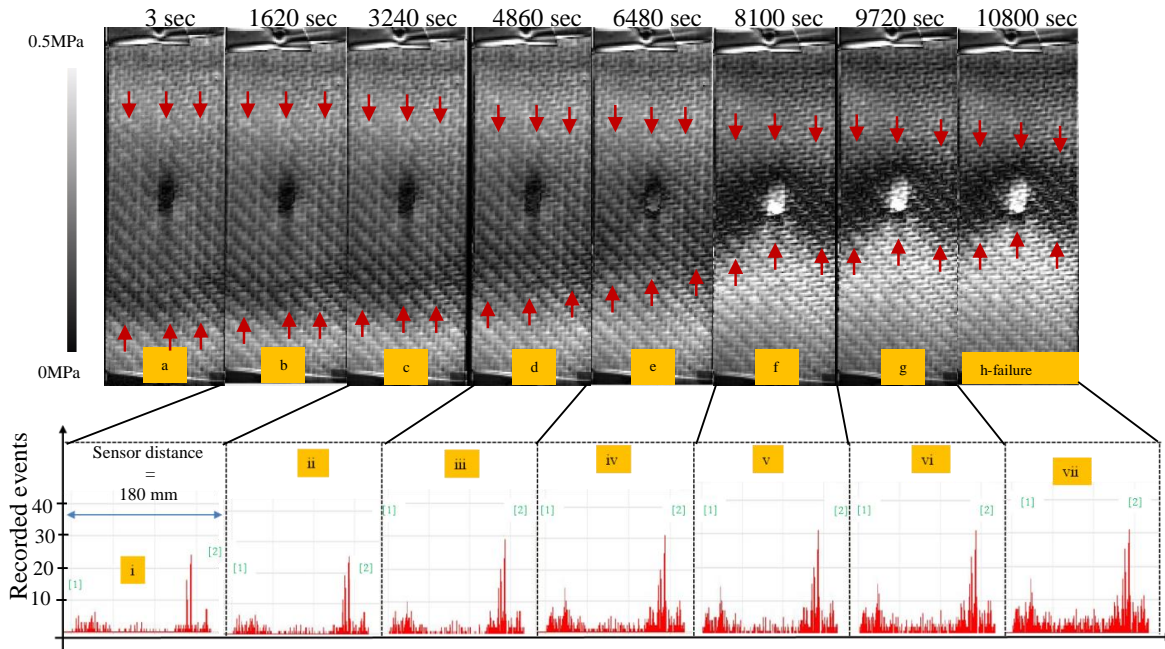
Figure 8. Thermal images and acoustic events during fatigue mechanical loading at 80% of the σ_{uts} of the substrate.

In the second testing configuration, IrT was employed together with AE simultaneously to the mechanical testing. Amplitude images at specific load cycles are shown in Fig.8. As was observed, debonding initiated at the 80% of the σ_{uts} . Hence, only amplitude images at that load level are presented (Fig.8).

As is depicted in Figs.8a-h, stress concentration areas are present at the edges of the repair (critical damage) or at the loci where high stresses are expected to appear and are manifested in the amplitude domain as regions of increased intensity [26]. With fatigue loading, the high amplitude region is constricted from the bottom side towards the center of the specimen, implying that as debonding progresses, the debonded bottom area is practically relieved from stresses which are concentrated towards the middle of the coupon. As can be seen from the amplitude image series, the progress of critical damage of the coupon continued until the complete debonding of the bottom side of the repair from the substrate, which consistently failed in a transverse brittle manner at the notch edge. As is expected, the exposed “artificial” damage that is the circular notch caused a stress concentration leading to subcritical failure. The arrows on amplitude images show the direction of the patch debonding from the substrate.

Along with the thermal assessment, acoustic events were recorded at the same timing. In Figs.8i-vii snapshots of the event location are presented for distinct cycles. As can be seen in Fig. 8i, there is considerably more acoustic activity on the right hand side which corresponds to the bottom part in the thermograph (Fig. 8a). As the fatigue progresses, the acoustic pattern is consistent (Fig. 8ii-vii), with considerably higher acoustic activity on the side that debonding is clearly discerned in the thermographic images (Fig. 8b-h). Additionally, in Figs.8i-vi the acoustic events indicate that the debonding process initiated from the edges of the patch and expanded towards the centre of the specimen where the circular notch is present. To summarize, similarly to the previous experimental configuration (EPCM & AE), there is more activity at the side which corresponds to the bottom part of the repaired coupon (in this representation corresponds to the right hand side of the location snapshots). The distribution of the acoustic activity is indicative of the failure site and was confirmed by the catastrophic failure of the specimen; after the complete debonding of the bottom side of the patch from the substrate, the acoustic events appear to develop and basically concentrate around the loci of the artificial notch (in the middle of the specimen) until the catastrophic final failure of the coupon (sub-critical failure). In this configuration as well, AE is able to identify the location of damage as well as to verify what was efficiently observed from the thermal assessment.

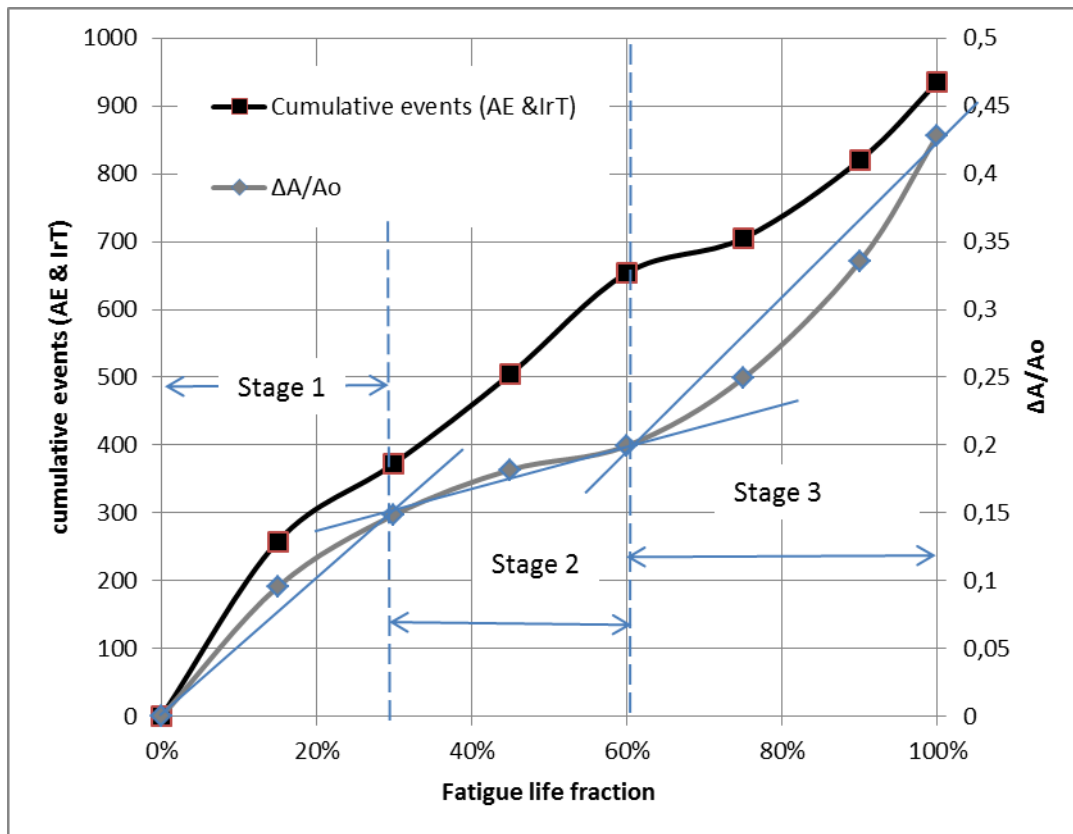
Figure 9. Cumulative AE events and relative debonded area as a function of fatigue life fraction. Distinct fatigue life stages may be discerned with both methodologies

Fig.9 depicts both the relative debonded area and the recorded cumulative AE events vs. the fatigue life fraction. As in the previous configuration, three distinct fatigue life stages are discernible with IrT, whereas this distinction is not obvious in AE. Again, the three fatigue stages as observed via the thermographic monitoring are typical of a fatigue life diagram, i.e. the initial fast damage progression stage (stage 1) is followed by a decreased rate (stage 2) and finally accelerates until failure (stage 3), indicating that the thermographic assessment provides a more reliable representation of damage which may also be readily quantified. This effect is more clearly depicted in Fig.10, where the cross correlation of the two methodologies are presented; in this representation all three stages may be clearly defined, with the acoustic activity being directly proportional to IrT data for each consecutive stage.

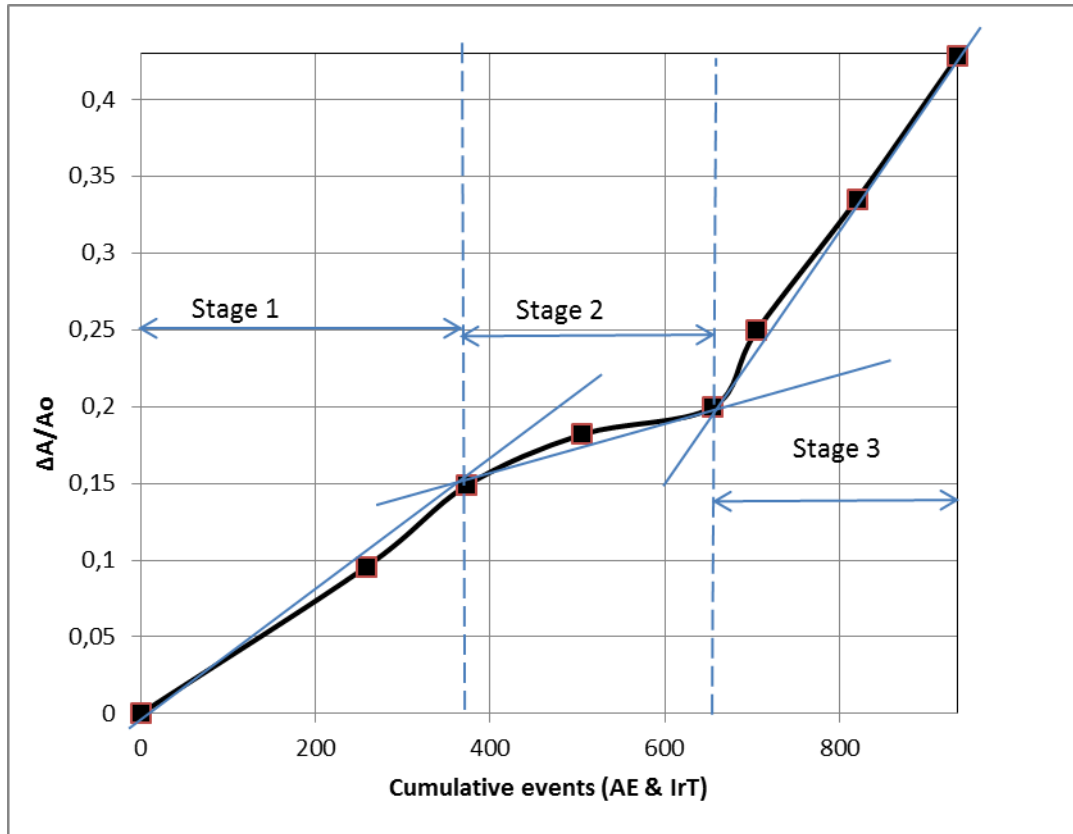
Figure 10. Cumulative AE events vs. relative area change

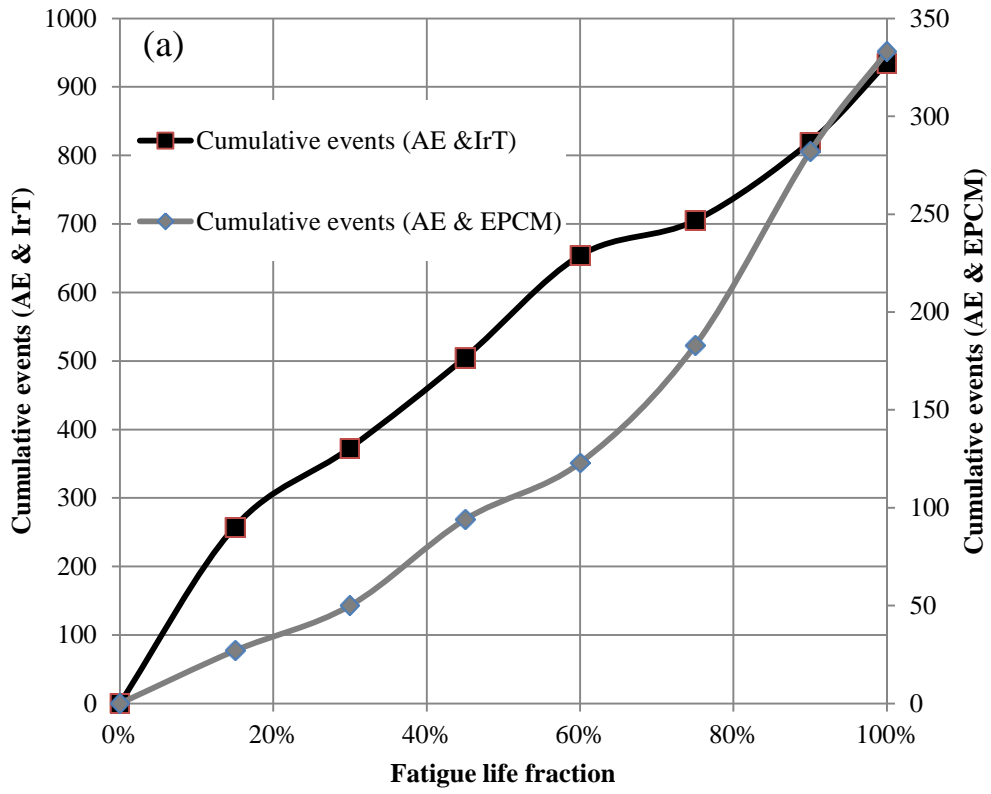
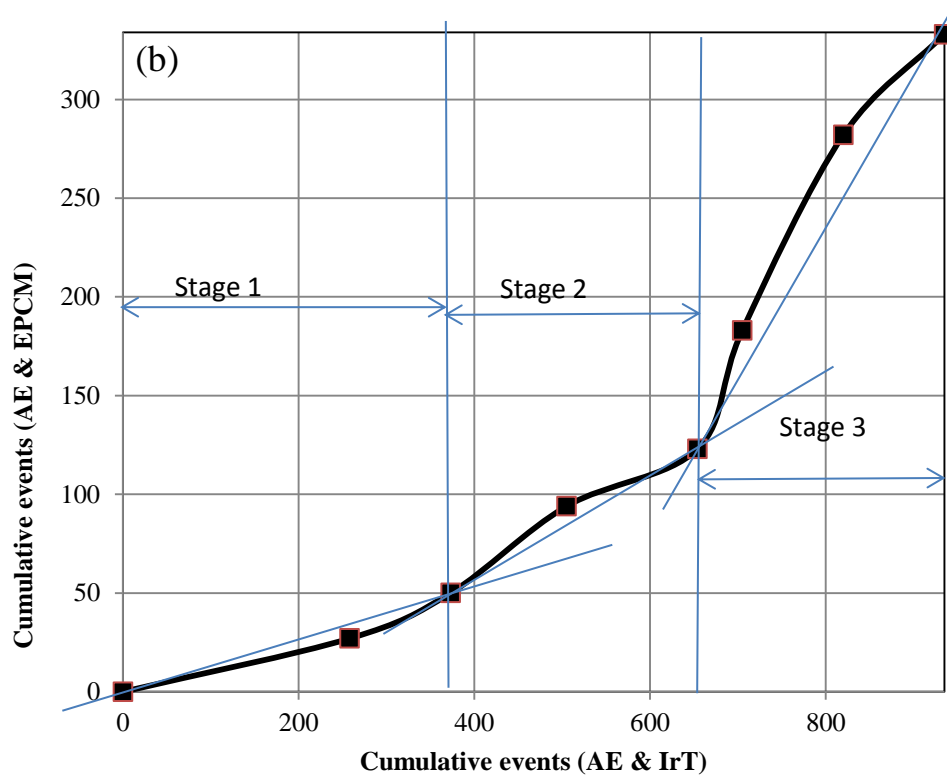
Figure 11. (a) AE activity vs. lifetime fraction and (b) correlation of the cumulative events as recorded for the two distinct configurations

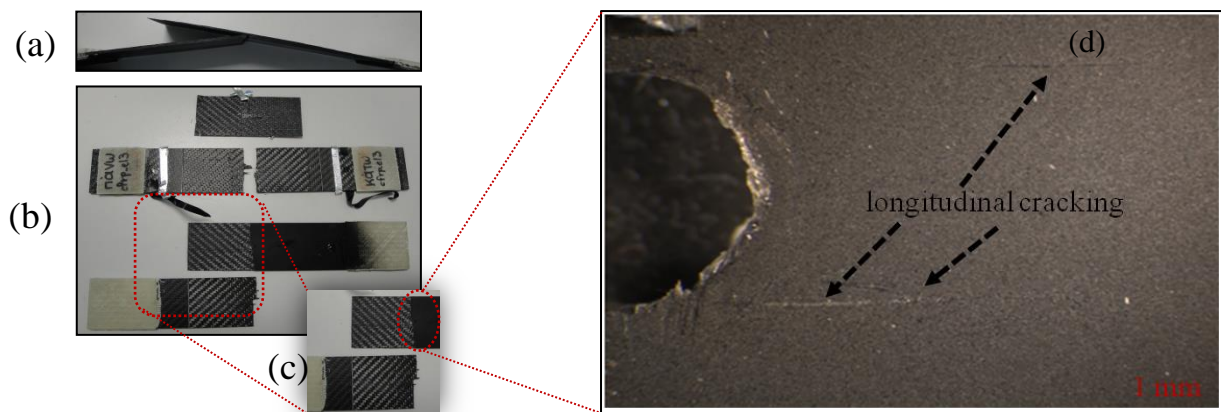
Figure 13. (a, b, c) Post failure images, (d) image taken via a stereoscope.

Fig.13 depicts post failure images (Figs.13a,b,c) as well as stereoscopic (Fig.13d) of a representative tested coupon. Longitudinal cracking (horizontal lines) on the surface of the upper side of the broken specimen are visible in Fig.13d. The post mortem images indicate the consistent type of failure as well as the characteristic behaviour of the composite where longitudinal cracks blunt the stress concentration at the edge of the notch.
