COMPRESSION AFTER IMPACT STRENGTH OF A BUCKLING RESISTANT, TOW STEERED PANEL

A.T. Rhead^{1*}, R. Butler¹, W. Liu¹, B.C. Kim² and S.R. Hallett²

Keywords: *Compression after impact, tow-steering, damage tolerance*

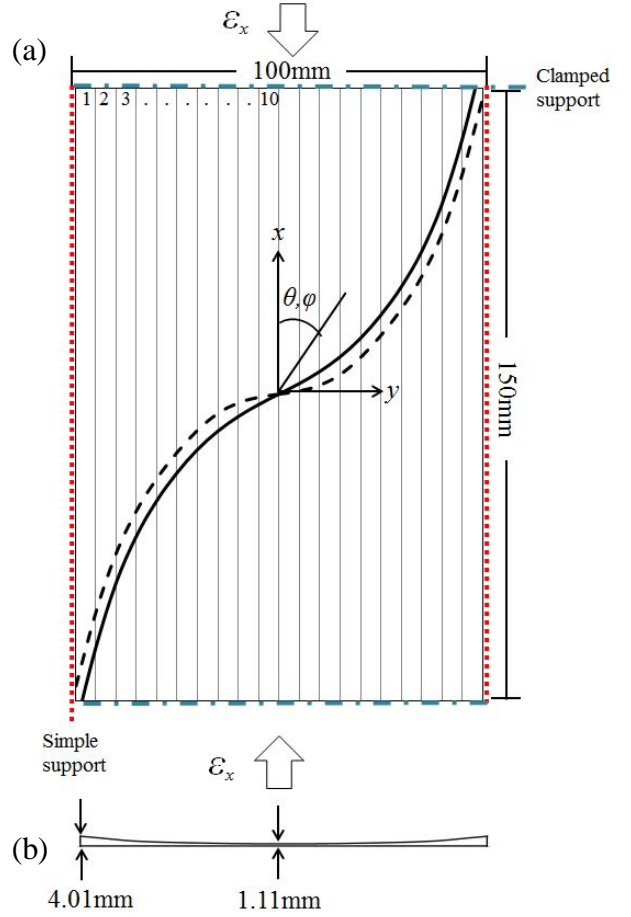
Fig. 1 Optimized CTS steered laminate showing (a) fiber angle distributions for θ (solid curve) and φ (dashed curve) and (b) thickness distribution across the width. Sides are simply-supported and loading edges clamped. Load is applied as axial strain ϵ_x . Strip numbers in the top left corner correspond to Table 1.

used to optimize a CTS panel with stacking sequence $[+\theta/-\theta/-\varphi/+\varphi]_s$ (where θ and φ vary across the panel width, see Fig. 1). Optimization minimizes mass subject to buckling and CTS manufacturing constraints [4]. Boundary conditions and panel dimensions for the optimization are given in Fig. 1. Panel dimensions were chosen to allow the use of supports conditions similar to those in ASTM standard D7137 [9] during experimental CAI testing. The material properties $E_{11} = 163$ GPa, $E_{22} = 6.8$ GPa, $G_{12} = 3.4$ GPa, $\nu_{12} = 0.28$, $G_{1C} = 200$ J/m² and $\rho = 1584$ kg/m³ were assumed.

A half panel comprising ten unique 5mm strips was optimized in the VICONOPT model. The full panel being produced by mirroring strips about the mid-line of the panel, see Fig. 1(a). In each unique strip the fiber angle is free to vary (within CTS radius of curvature constraints) resulting in a prismatic structure with fiber angle varying across the width of the panel. A sensitivity study on the number of strips was conducted in [5]. Steering of CTS fiber tows results in a fiber angle dependent increase in tow thickness from t_0 (unsheared) to t_θ (sheared) where,

Table 1 gives the fiber angles θ and φ and associated lamina thicknesses t_θ and t_φ for each unique VICONOPT strip in the optimized design. During the manufacturing process interpolation across the strips is used to produce a design with continuous fiber paths, see Fig. 1(a).

By steering from low stiffness fibers in the center of the panel to high stiffness fibers at the edge, the optimized design redistributes load from the center of the panel to regions near the boundary that would typically be supported by stiffeners, see Fig. 1. Angle dependent thickening of tows also redistributes stress to the edge of the panel further alleviating stress in the center and increasing buckling capacity.

An analysis of the location of impact damage in Fig. 2(b) indicates that the extent of the damage is contained almost entirely within a 15mm wide band. Comparison with Table 1 and Figure 1 indicates that this band coincides with strips 3, 4 and 5 in Table 1. Hence, as a first approximation, the average of the fiber angles and lamina thicknesses of these strips is

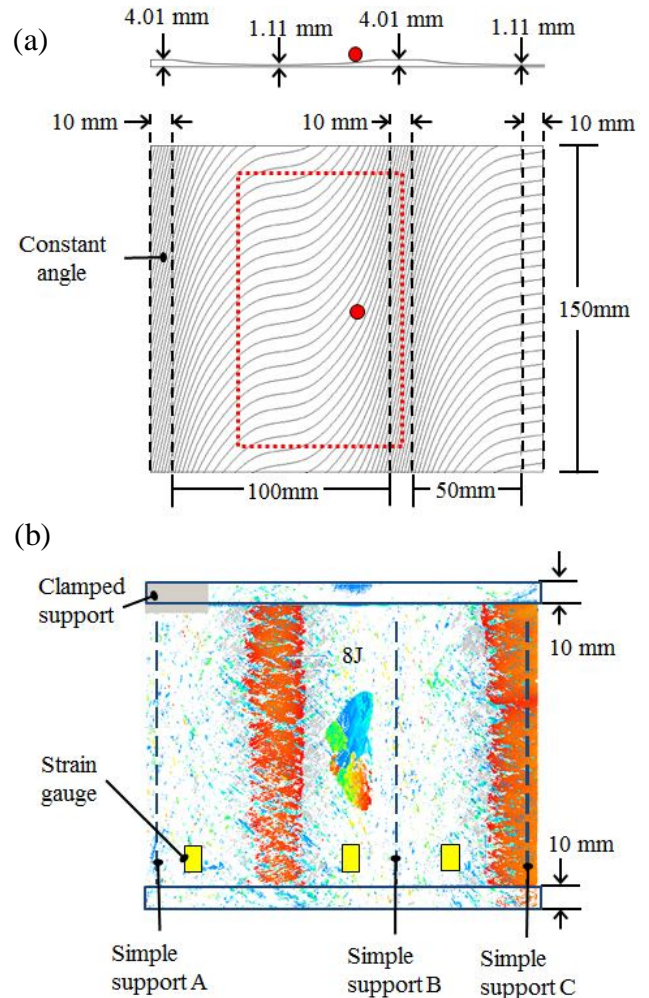
Fig. 2 (a) Cross-sectional thickness distribution, impact window (broken boundary) and panel dimensions. The impact point is shown with a dot. (b) Ultrasonic C-scan of Panel 2 showing impact damage and positions of CAI test fixture supports and strain gauges.

The CTS test panels (see Fig. 2) are an extended version of the panel described in Fig. 1. As noted in Section 2 the stiff outer regions of the optimized panel are highly stressed and integral to the panel's strength. The steep fiber angles in these regions are also intolerant to damage [6]. This combination makes the outer edges of the design critical for damage and hence a near edge location is chosen for impact. However, impact too close to the panel edge may lead to premature interaction of damage with edge effects and supports both during impact and compression loading. In order to avoid this, test panels were manufactured with an additional half panel. Two CTS panels were manufactured from 7mm wide (in the unshered state) carbon fiber reinforced plastic (CFRP) tape [4]. Material properties are the same as those in Section 2. The extended panel has a VICONOPT buckling load of 194kN at $\epsilon_x = 6587$ microstrain.

The CTS process results in one flat laminate face (against the tool) and a concave face with varying thickness, see Fig. 2(a). Note that the thickness variation builds throughout the laminate during lay-up and does not only exist on the surface. This results in an uneven distribution of material about the laminate mid-plane. Following cure this uneven distribution produces a small curvature across the width of the laminate. Central deformation of the curvature is toward the flat surface which becomes slightly convex. In order to ensure level surfaces for contact with vertical supports in the CAI tests, additional 10mm wide constant fiber angle regions were included in the panel manufacture as shown on Fig. 1(a). Similarly, horizontal edges were potted in resin to ensure a flat contact at the clamped supports.

16mm hemispherical tup. During impact, panels were clamped over an 75 x 125mm ASTM D7136 [10] impact window. As shown in Fig. 2 the long window edge was aligned with the position of the central simple support that would be used in the CAI fixture (Fig. 3). This provides consistency in support conditions across the impact and CAI tests. In order to avoid supports interfering with the formation of damage, impact was delivered away from the edge of the window. Following impact, C-scan images of the damage were taken using an Ultrasonic Sciences Ltd. C-scan system and a Nikon XT225H X-Ray Computed Tomography (XRCT) system.

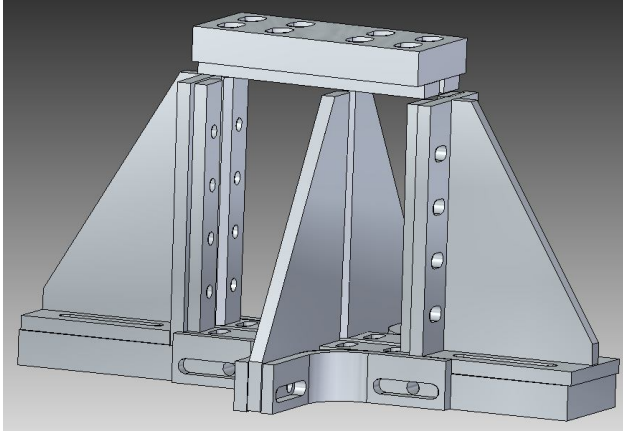
Fig. 3 CAI test fixture. ε_x is applied vertically. The three vertical simple supports and two horizontal clamped supports match those shown in Fig. 2.

A modified CAI fixture based on the ASTM D7137 standard test fixture [9] was used to hold the panels during compression testing, see Fig. 3.

The ASTM CAI window is maintained in one half of the fixture, see the left hand side of Figs. 2 and 3. In a departure from ASTM D7137 top and bottom supports were clamped rather than guided to prevent edge brooming failures. Note that the cure-induced curvature of the panel is restrained along its horizontal edge when it is placed in the clamped supports. Support positions in relation to the fiber distribution and impact location can be seen in Fig. 2. Compressive displacement was applied to the two panels at a rate of 0.1mm/min using an Instron 5585H electric test machine. Vertical in-plane strains were monitored throughout all tests by pairs of back-to-back strain gauges placed on areas of equal thickness, see Fig. 2. Out-of-plane displacement and axial strain of the flat (non-impact) face, relative to an unloaded reference state, was also captured throughout by a Limes Digital Image Correlation (DIC) system employing a stereo pair of Photron SA3 cameras. Testing of Panel 2 was interrupted following audible cracking and both an XRCT-scan and a C-scan were performed before the specimen was reloaded and tested to failure.

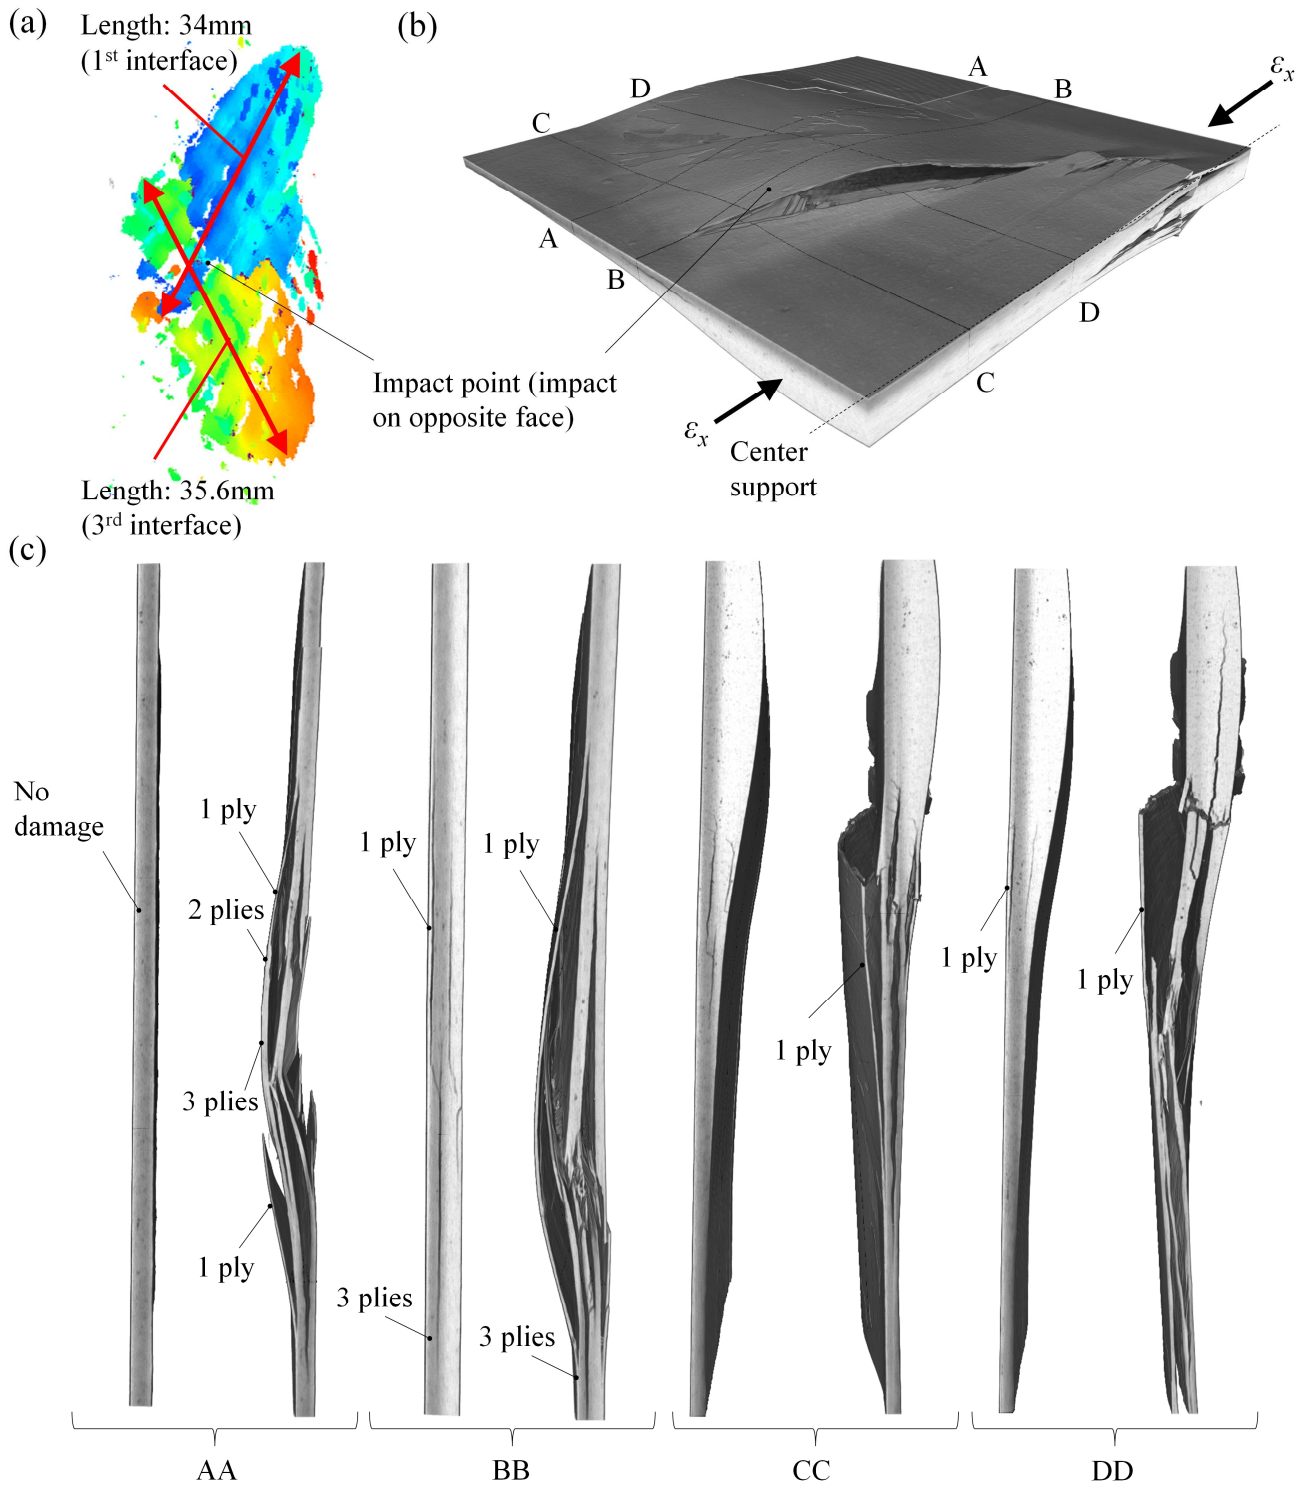
Fig. 4 (a) C-scan of damage in Panel 2 prior to CAI testing. (b) XRCT scan of Panel 2 showing damage extent following failure. (c) Cross-sections at locations AA, BB, CC and DD through (b); left hand images are following impact and right hand images following failure. Non-smooth rectangular areas on the surface of the 3D view are artifacts of the visualization process.

Impacts to both panels produced damage that was essentially identical in delamination size and morphology. As can be seen from the C-scan image in Fig. 4(a), overall delamination size was considerably larger than might be expected; an 8J impact to a straight fiber laminate would typically be entirely contained within a 40mm diameter circle. Colors in Fig. 4 indicate depth from the non-impact surface. Note that the transition of colors within individual delaminations indicates a variation in depth and hence sublaminates thickness. Post impact XRCT scans (Fig. 4(c)) demonstrate that the damage morphology has the usual ‘spiral staircase’ pattern of interconnected delaminations and interplay cracks. The only exception being that one half of the delaminations that would normally form in a symmetrical ‘peanut shaped’ pair have extended toward the stiffened boundary and the steeper fibers in this area, see Figs. 2(b) and 4(a). As impact occurred on the non-smooth surface of the panels, dent depths were difficult to determine but were certainly shallower than the industrial threshold depth (0.3mm) for BVID. However, visual and XRCT inspection identified surface cracking on both surfaces following impact, see Fig. 5. This suggests that damage may actually be classified as clearly visible despite the dent depth. Such cracks followed the edges of near surface delaminations.

Figure 4 shows XRCT images of Panel 2 following failure with cross-sections near the impact point. Sublaminare buckling and delamination growth is evident at the 1st and 3rd ply interfaces from the top (non-impact) surface. Delaminations are also seen to bridge multiple depths i.e. cross-section AA in Fig. 4(b) shows a buckled sublaminare made up of a

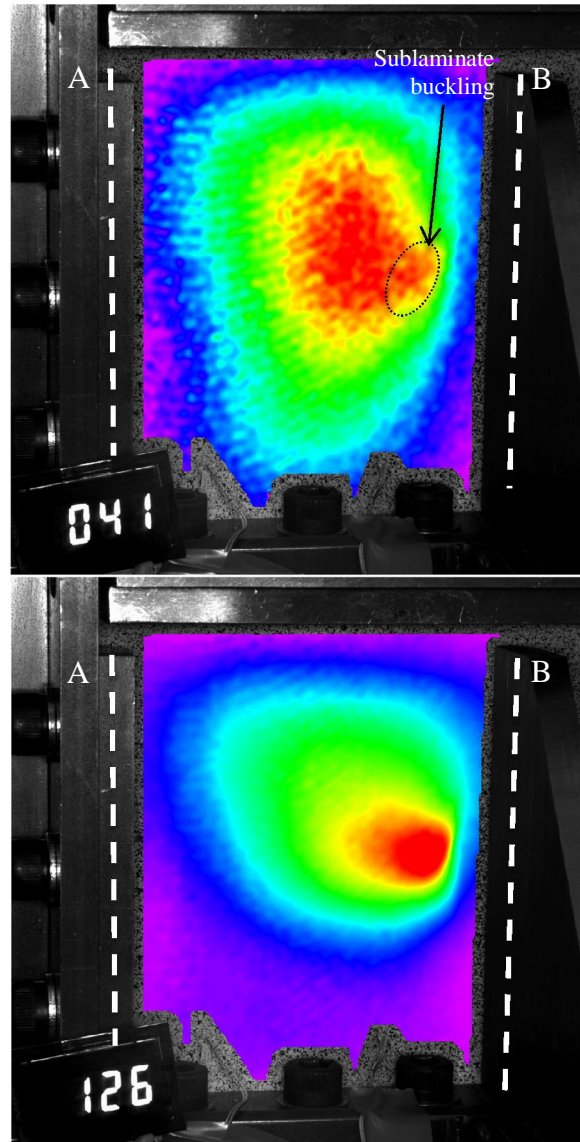
Fig. 6 DIC images of impacted area of Panel 2 (a) showing the early stages of sublaminare buckling and bending deformation, (b) immediately prior to the first loading being halted. Central areas (red) are closer to the reader. The LED screen displays the compressive load in kN. Broken lines are approximate positions of simple supports from Fig. 2(b).

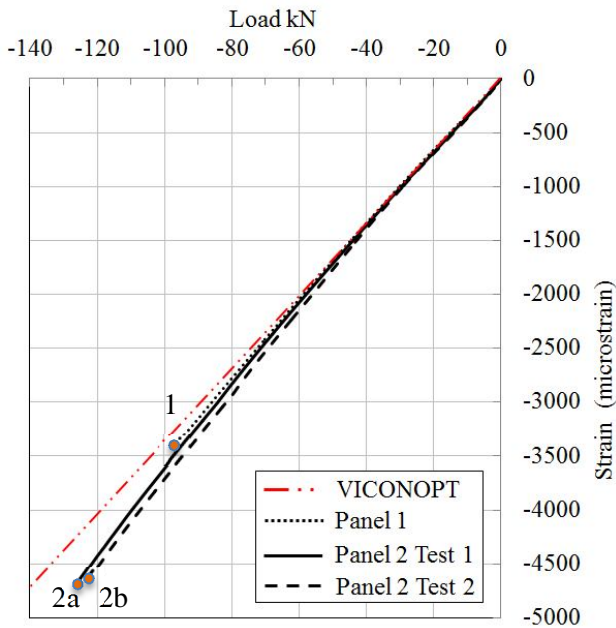
Fig. 7 Load vs. average strain gauge readings for Panel 1 and both Panel 2 test runs. Theoretical VICONOPT stiffness is also shown. End of test load: 1 at 95kN, 2a at 126kN and 2b at 122kN.

Both panels were tested to failure. However, Panel 1 failed when the central simple support on the impact face side gave way following full panel buckling. Hence, any analysis of this panel is limited to loads well below the failure load. Both panels exhibited sublaminates buckling prior to failure as was captured on the DIC system, see Fig. 6. Based on delamination orientation and vertical position, a comparison of Figs. 2(b), 4 and 6 indicates that sublaminates buckling occurred above a delamination at the first interface. From the outset of loading, out-of-plane deflection of the panel in the same direction as the sublaminates buckle and initial panel curvature (toward the flat face) occurred. This deflection continued to grow until failure. Figure 7 shows a comparison of average strain gauge readings versus load for all three tests on Panels 1 and 2.

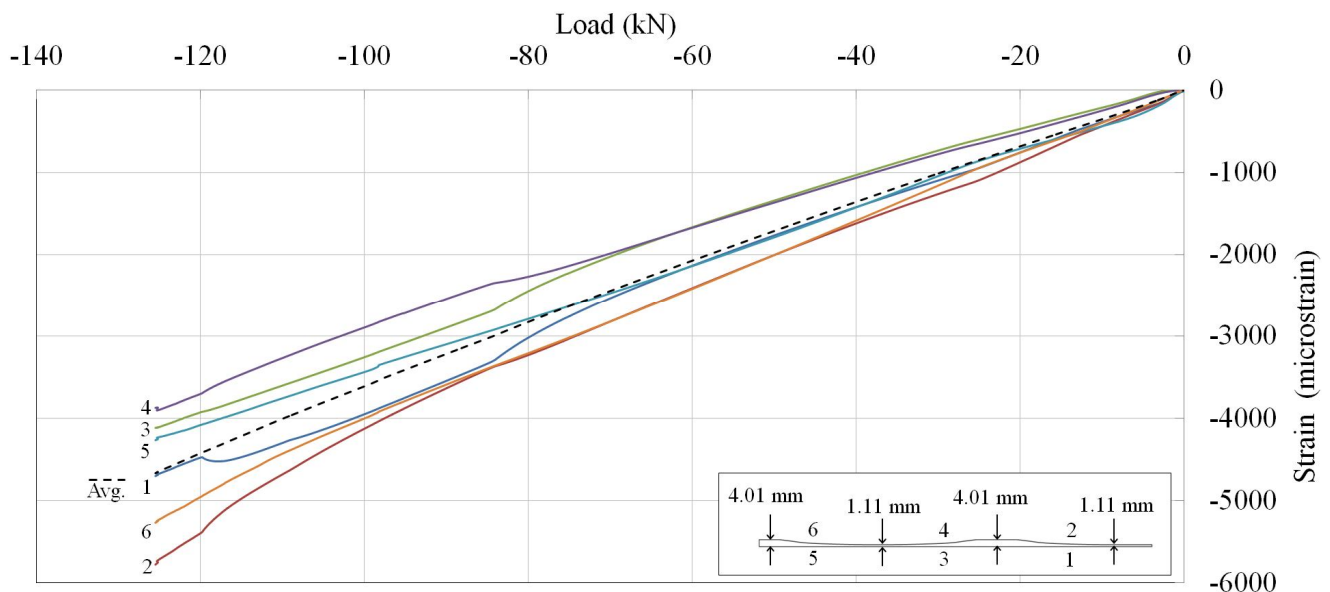
Fig. 8 Load vs. strain gauge readings for Panel 2 test 1. The inset shows strain gauge locations, also see Fig. 2(c).

The theoretical VICONOPT load-strain line is also shown. Figure 8 shows the strain gauge output versus load plot for Panel 2 during its first loading. Gauges 3 and 4 (see Figs. 2(c) and 8) were located in line with the damage and hence the lower strains recorded by this pair of gauges are expected. A change in stiffness of these gauges at approximately 35-40kN corresponds with detection of sublaminare buckling on the DIC images (37kN). Divergence in strain gauge output between 70 and 85kN and the restiffening that follows are a consequence of full panel buckling being prevented by the central simple supports. From 90kN onward, kinks in strain gauge traces in Fig. 8 are characteristic of damage events and were accompanied by cracking sounds. The first loading of Panel 2 was halted at 126kN following significant cracking sounds. XRCT scans taken when the test was halted indicate that an existing surface crack on the impact face had extended toward the central simple support, see Fig. 5. The crack had also joined with delaminations close to the non-impact face, creating a crack running through almost the entire thickness of the panel. However, in-line with DIC data, preliminary interrogation of ultrasonic C scans and XRCT scans taken when testing of Panel 2 was halted revealed no obvious sign of delamination growth, i.e. the surface crack extension does not appear to be linked to
