# **EVALUATION OF SENSYS WIRELESS VEHICLE DETECTION SYSTEM: RESULTS FROM ADVERSE WEATHER CONDITIONS**

Prepared By  
**Juan C. Medina**  
**Rahim F. Benekohal**  
**Ali Hajbabaie**  
University of Illinois at Urbana-Champaign

Research Report ICT-11-81

A report of the findings of  
**ICT-R27-58**  
**Evaluation of Wireless Detection Systems at  
RR Crossings & Signalized Intersections**

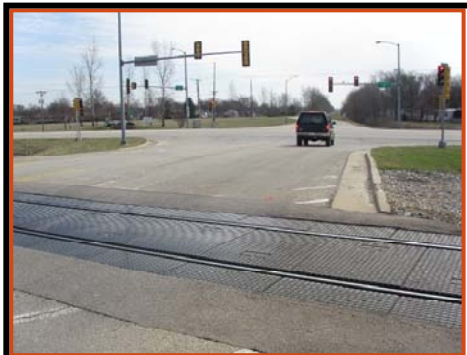
B - Eastbound approach.

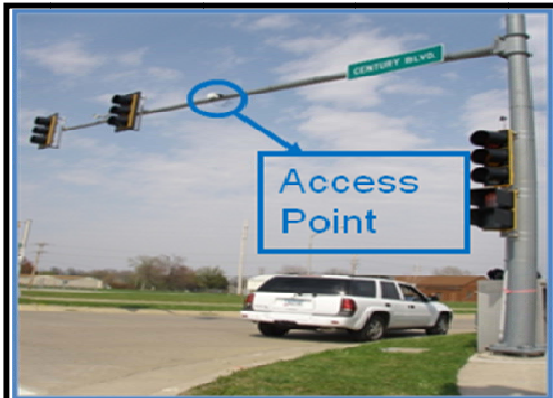
B - Detail access point.

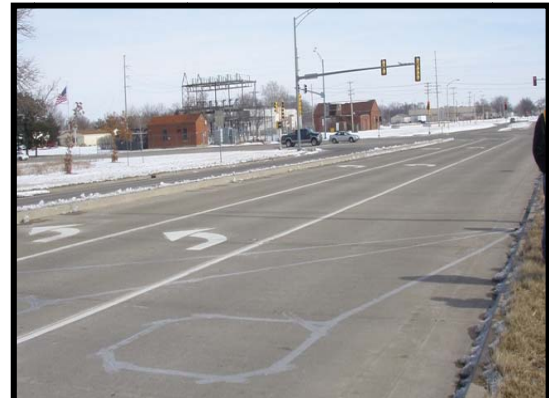
C – Eastbound approach.
