## Sample preparation and characterization of artificially aged aircraft coatings for microstructural analysis

# Sample preparation and characterization of artificially aged aircraft coatings for microstructural analysis

*Air Force Research Laboratory, Materials Directorate, Wright-Patterson Air Force Base, Ohio 45433-7750, United States*

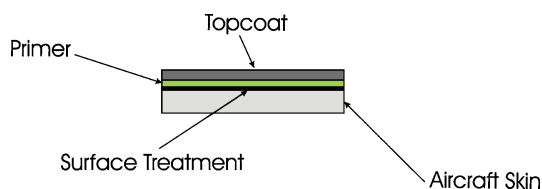
Fig. 1. Components of U.S. military aircraft coating system.

In general, military aircraft utilize a three-layered coating system comprised of a conversion coating, primer, and topcoat as shown in Fig. 1. The conversion coating layer is an aluminum surface treatment that primarily promotes adhesion of the primer to the substrate. The thin (10–20  $\mu\text{m}$ ) aluminum oxide coating is deposited through an electrolytic process involving sulfuric and chromic acid immersion [1]. It is then sealed and densified by boiling in water. Chromium salts are dissolved within the oxide film during the sealing process to help protect aircraft structures from corrosion on the underlying aluminum by inhibiting oxidation and by modifying the local acidic/alkaline (pH) chemistry of the surface.

The primer layer overcoats the treated aluminum surface to provide additional corrosion protection and promote adhesion of the topcoat. The primer is typically epoxy- or polyurethane-based with added corrosion inhibitors such as strontium chromate. The primer has a high pigment volume concentration (PVC) resulting in a porous, brittle coating with no durability [2]. The topcoat layer serves as the outermost barrier to the environment. The most important feature of the topcoat is to impart camouflage features such as proper color (typically gray shades) and low surface gloss (sheen). The low visual gloss feature requires that the topcoat contain high PVC of inorganic pigments and flattening agents to produce a rough uneven surface. This scatters reflected light and reduces glint from the sun, which helps to avoid visual detection. Details of the organic coating chemistry are provided elsewhere [3].

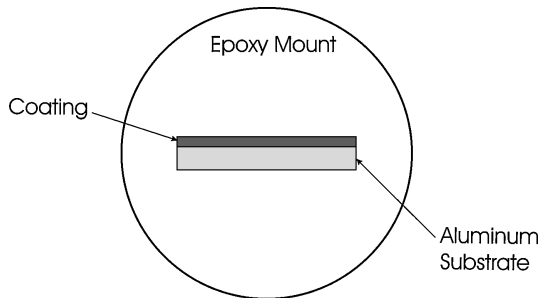
Fig. 2. Schematic of mounted sample.

The coatings were sectioned into 25 × 6 mm samples using a shear and then vacuum mounted in epoxy using a leg clip at one end. The configuration of the mounted sample is shown in Fig. 2. The samples were ground using 240, 320, 400, and 600 grit SiC papers with water. During each step of the grinding process, the sample was rotated 90° and observed using a light optical microscope (LOM) to ensure that scratches induced from the previous step were removed. The grinding process was continued using a rotating wheel with 800 grit SiC paper at 100 RPM for 15 min with water continuously applied to complete the rough polishing. Light pressure was applied manually. The best results for degraded samples were obtained by reducing the amount of time spent on 800 grit SiC paper to 10 min.

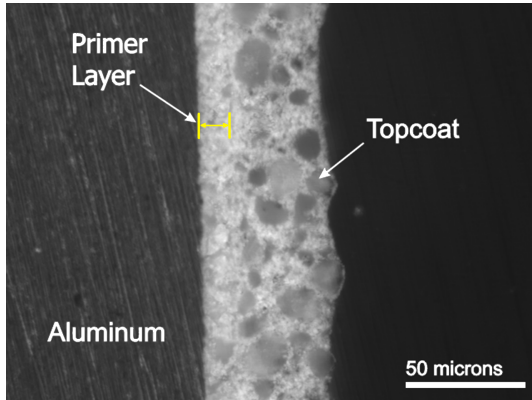
Fig. 3. Sample A (no QUV exposure) after proposed metallographic preparation.

The proposed preparation method of grinding through 800 grit resulted in minimal damage to the coating system for both the before and after QUV exposure, as shown in Figs. 3 and 4. Continuing the grinding process on 1200 grit SiC paper at 100 RPM resulted in the attack of the primer layer at the interface of the aluminum as shown in Fig. 5.

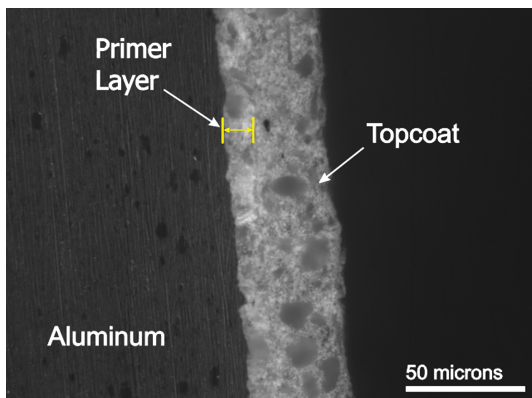
Fig. 4. Sample C (2016 h exposure to QUV) after proposed metallographic preparation.

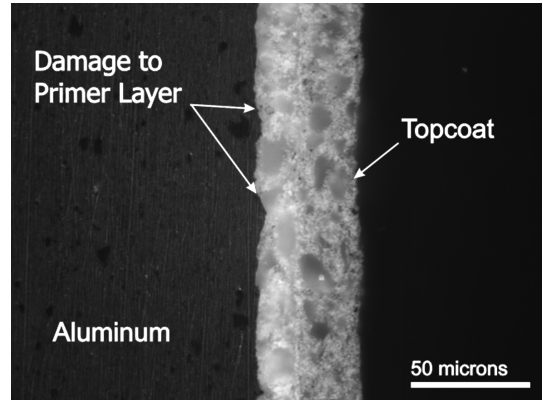
Fig. 5. Damage to primer layer as a result of grinding on 1200 grit SiC paper; Sample C.

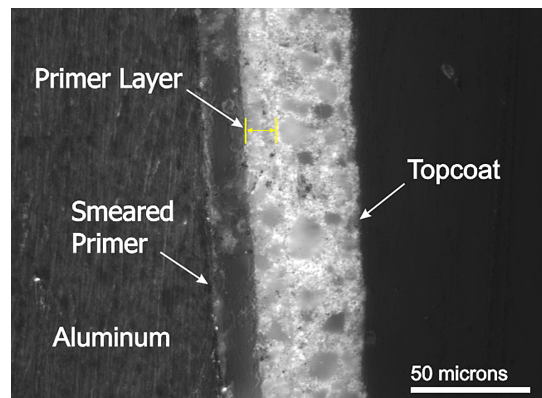
Fig. 6. Cross-section of coating polished by diamond lapping; Sample C.

Several attempts were made with diamond lapping films under different conditions. Diamond lapping films consists of precision graded diamond particles resin bonded to a polyester film backing to achieve a finer finish. In the extreme case, the sample was ground using 400 and 600 grit SiC papers with water and then polished using 30 and 15  $\mu\text{m}$  diamond lapping films at 150 RPM. The primer layer smeared into the aluminum, creating a “double” primer layer as shown in Fig. 6.

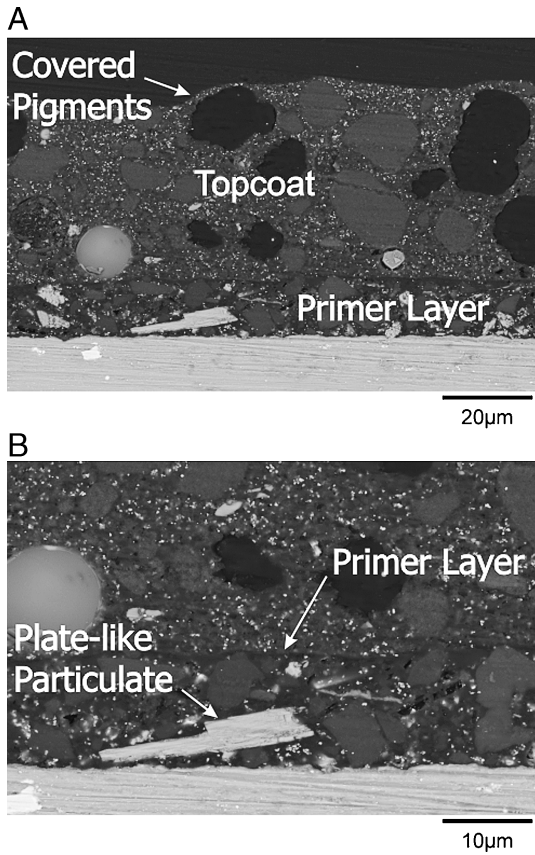
Fig. 7. Backscatter secondary electron SEM images; Sample A, no QUV exposure: A) and B); same area at two magnifications.

The SEM images for the control Sample A reveal a non-porous topcoat with surface pigments covered by a thin layer of polymer shown in Fig. 7. The primary pigments of the topcoat are titanium dioxide (10–20 wt.%) and carbon black (3–5 wt.%). Carbon black is added to the topcoat to produce the gray color. The remaining contents include siliceous filler, a small amount of flattening agent and organic pigment. Fig. 8 provides the overall view of Sample A exhibiting the variation in thickness of the topcoat and primer over the substrate. Large black pigments dispersed throughout the topcoat are visible. Fine scratches are observed across large pigments at higher magnifications. Glass beads are intact and scattered randomly throughout the topcoat. It is believed the coating manufacturers include these beads to physically roughen the surface and impart a low gloss finish. Microscopic inspection during this study found the distribution of these spheres throughout the topcoat, not necessarily at the surface. The primer appears to be heavily loaded with a variety of particulates of a different morphology than the topcoat. More specifically, non-spherical, plate-like particles (mica) are abundant within the primer. The primer also contains strontium chromate (25–30 wt.%) and siliceous filler.

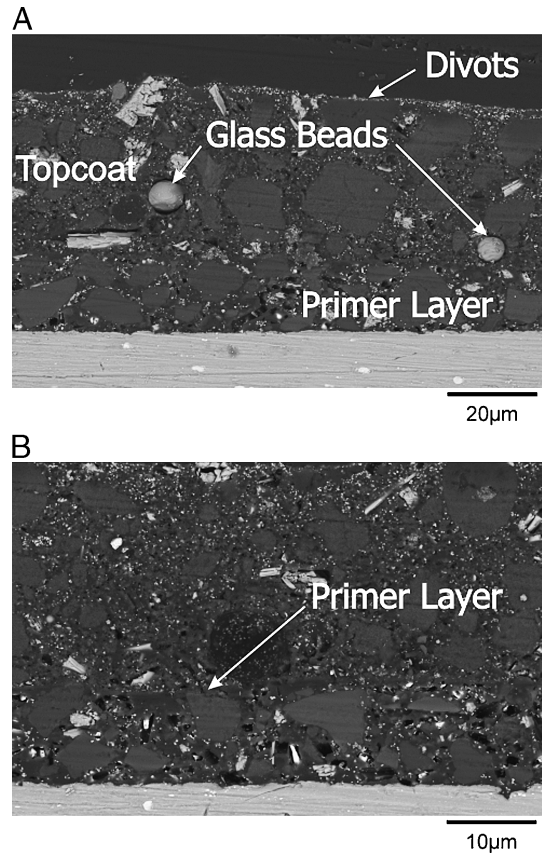
Fig. 9. Backscattered electron SEM images; Sample B, 756 h exposure to QUV: A) and B); different areas at two magnifications.

appears to be rough; however, the roughness differs from the control in that divots are created at the surface shown in Fig. 9. The surface appearance is due to the degradation of the polyurethane resin system and release of pigments through chalking. Large black pigments are not as prevalent. Some of the

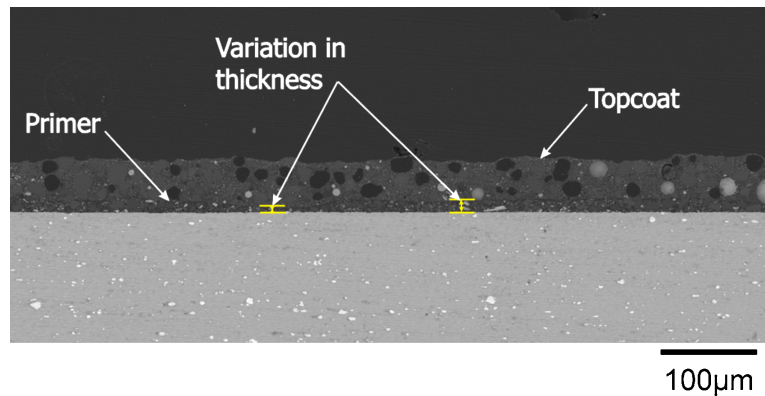
Fig. 8. Backscatter SEM image viewing typical coating microstructure; Sample A.

carbon and boron) appear darker in the image; higher atomic mass components (metals, glasses) appear lighter. The primer layer and topcoat are clearly evident in addition to the precipitates of the aluminum alloy.

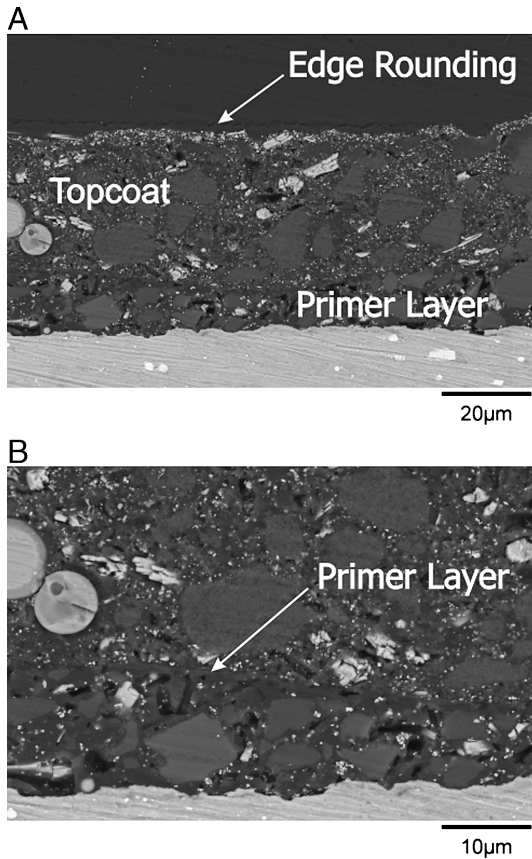
Fig. 10. Backscatter secondary electron images; Sample C, 2016 h exposure to QUV.

apparent in degraded samples as shown in Fig. 10. The bulk of the topcoat and primer coatings appears to be substantially degraded when compared to images of Sample A. It is evident in Fig. 11 that some of the plate-like particulates from the primer have migrated into the topcoat. This observation is not considered to be the result of the preparation method. There are no signs of drag marks through the coating and increased porosity observed using secondary mode indicates that smearing is not a factor. The mechanism for the migration of these particulates from the primer to the topcoat after aging is not understood.

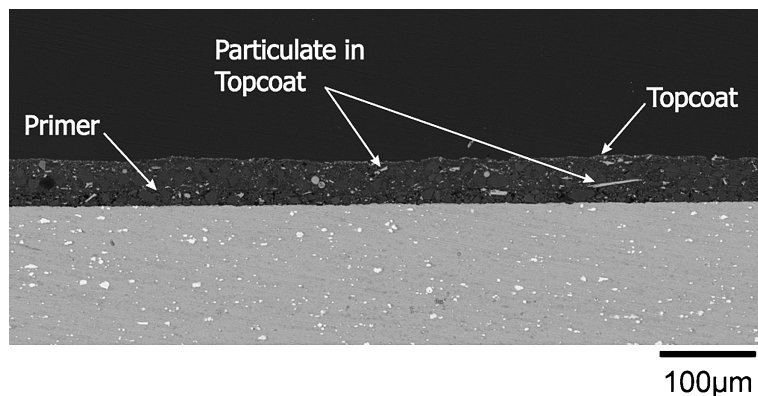
Fig. 11. Backscatter SEM image viewing degraded microstructure; Sample C.

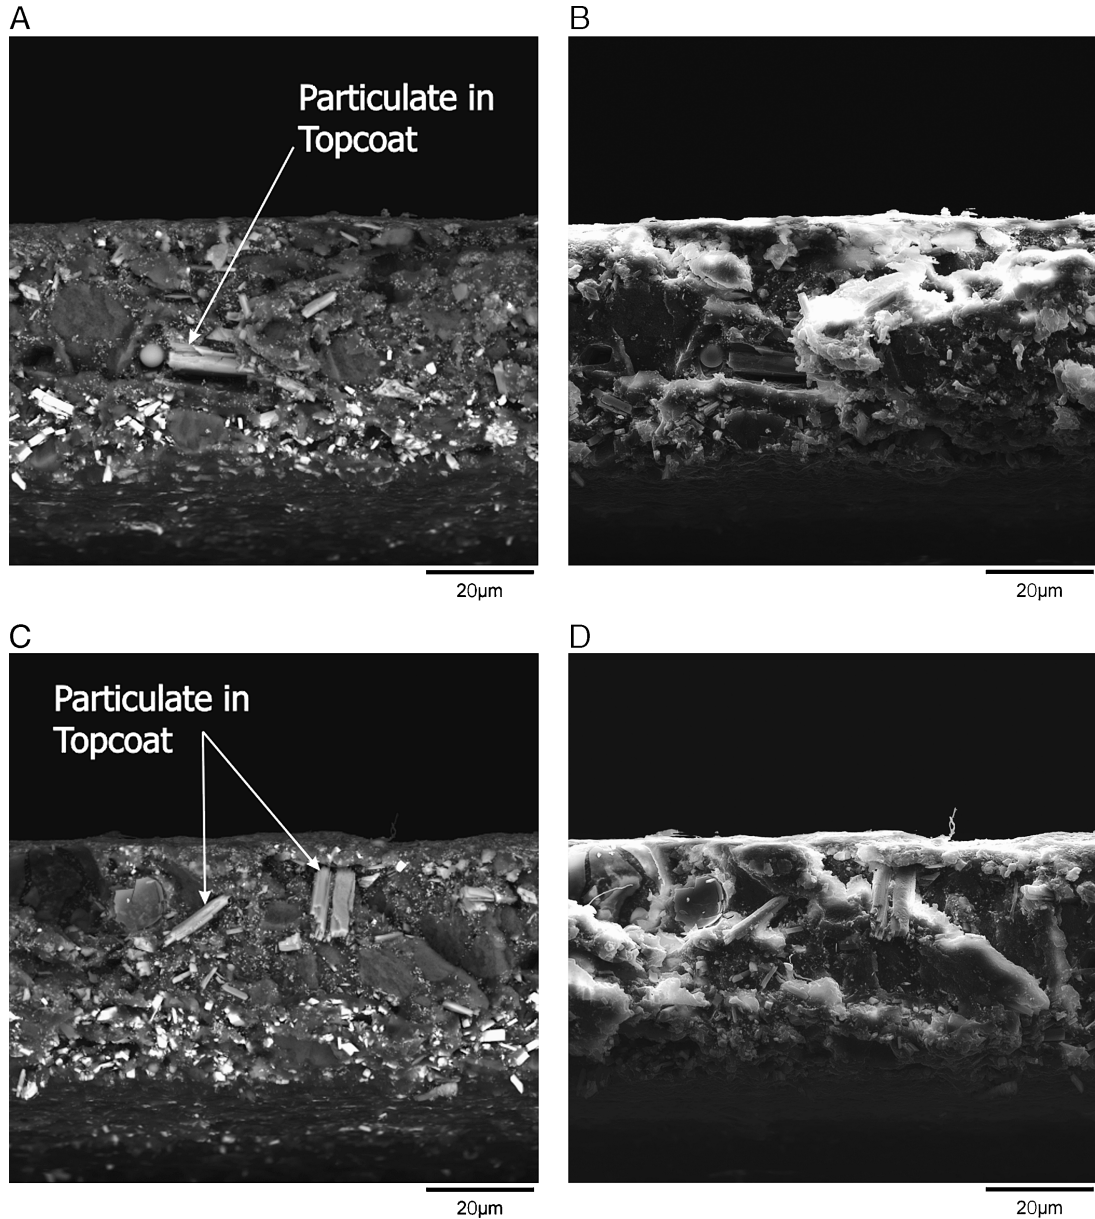
Fig. 12. SEM images of the edge of Sample C. A) Backscattered electron image. B) Corresponding secondary electron image. C) Backscattered electron image, second area. D) Corresponding secondary electron image, second area.

sample was examined. This sample was sheared from an exposed section of the panel and then carbon coated on the long edge to conduct electrons. The sample was placed vertically in a clamp allowing the edge to be viewed in the SEM.

In both pairs of SE and BSE images shown in Fig. 12, the particulate is surrounded by the topcoat effectively holding the particulate in position. These images of the edge confirm that the particulate movement is not due to the preparation method. This observation suggests that the UV radiation penetrates the topcoat and causes the degradation of the underlying primer. The UV transmissivity of the topcoat was therefore examined.

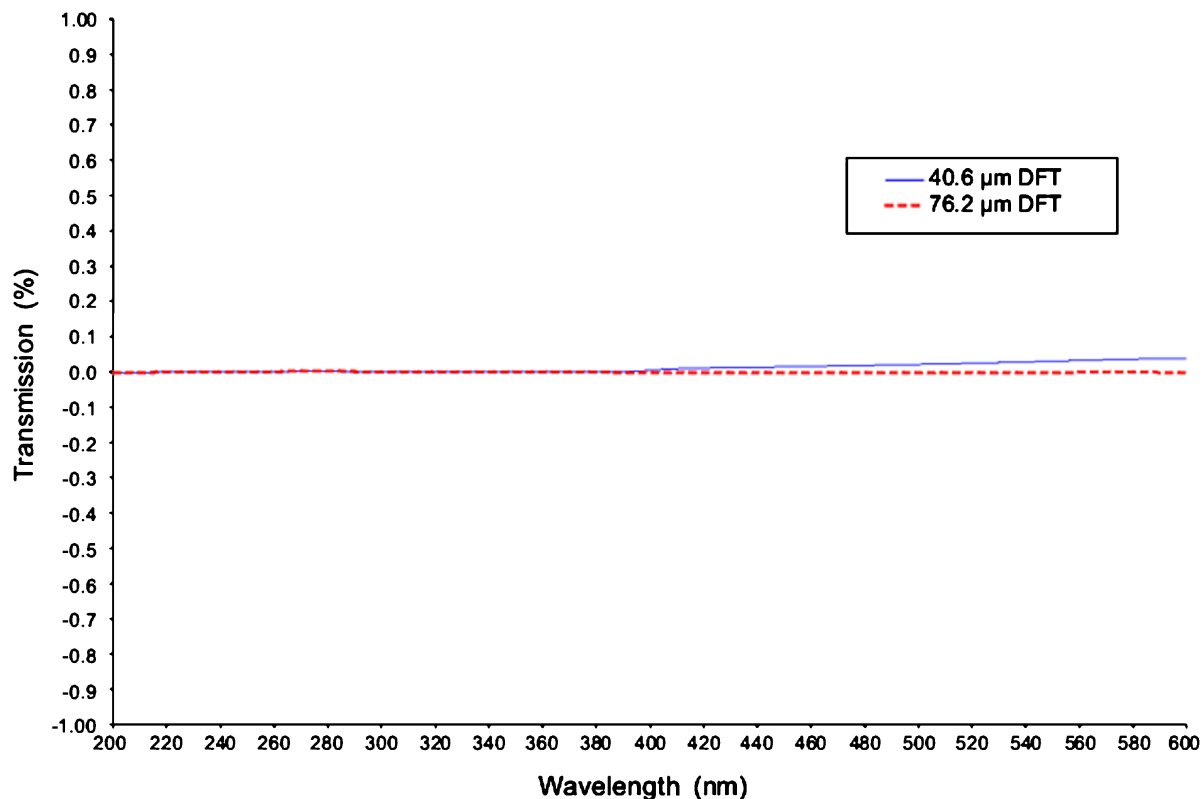
Fig. 13. Free film UV transmission spectra for two dry-film thicknesses (DFTs).

(3.0 mils), respectively. The UV transmission was then measured for each film<sup>5</sup>. The initial UV scans resulted in 0% transmission for the 40.6 and 76.2 μm free films indicating that the topcoat is opaque to UV irradiation. However, when the transmission scale is plotted from -1% to +1%, minute transmission in the visible region of the 40.6 μm film is revealed.

Fig. 13 is the UV transmission spectra with the expanded scale showing increasing transmission above 400 nm. The transmission maximum for the 40.6 μm film is 0.04% at 600 nm.

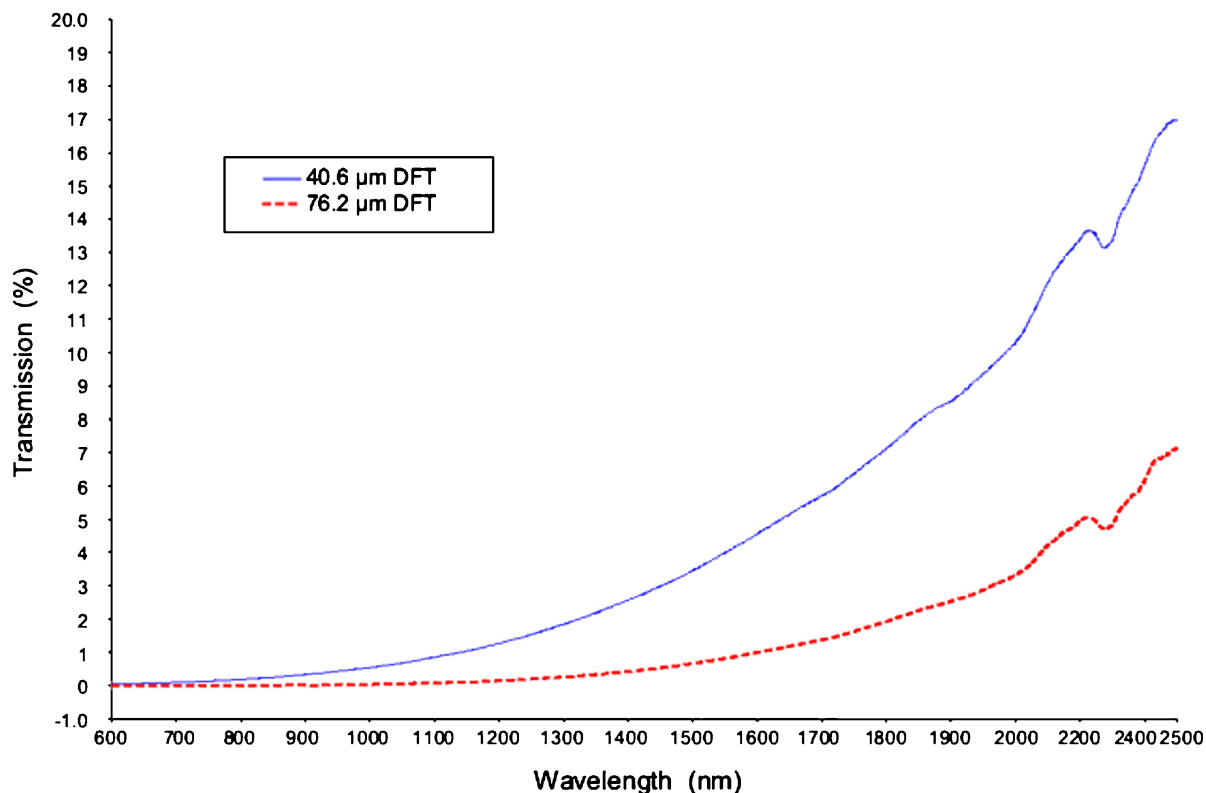
Fig. 14. Transmission spectra of the near-infrared region.

The spectrum yielded significant transmission of near-infrared energy as shown in Fig. 14. It also illustrates the transmission as a function of thickness. The 40.6 μm film has a transmissivity of about 16% at 2500 nm while the 76.2 μm film has approximately half this level. A greater transmissivity for the

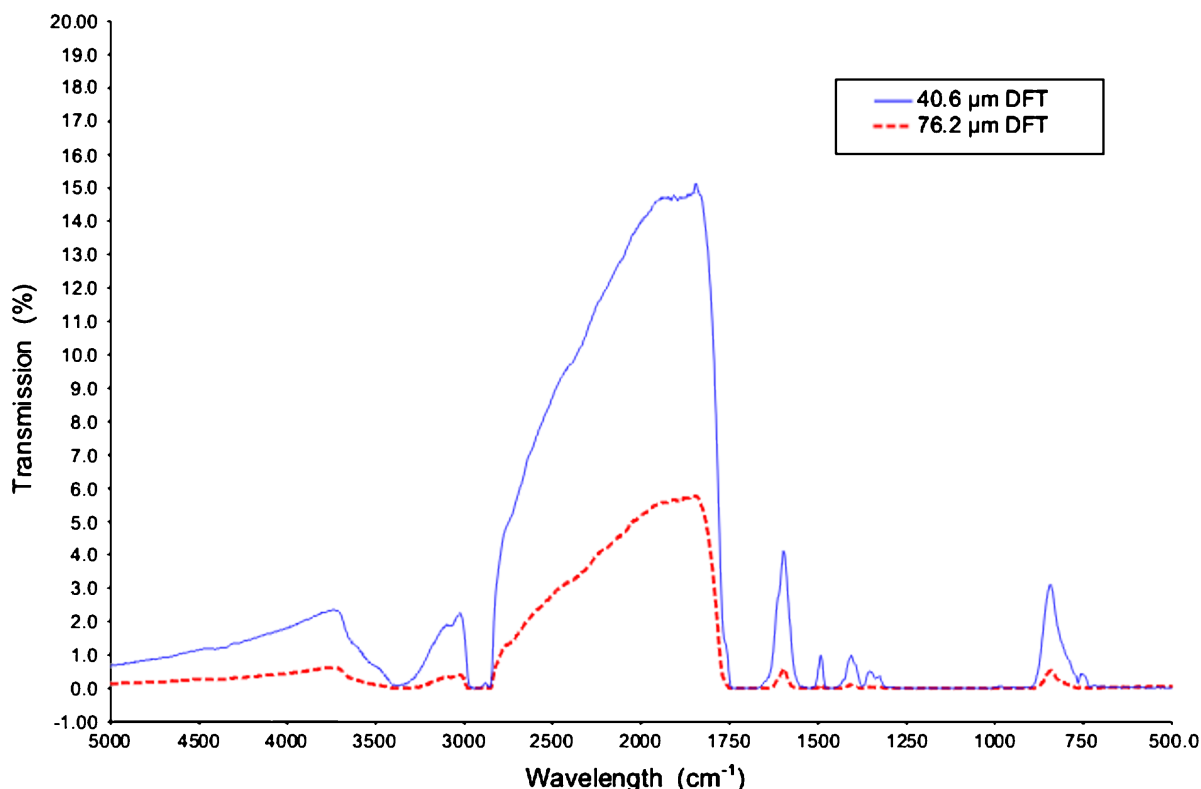
Fig. 15. Transmission spectra of the mid-infrared region for two dry-film thicknesses (DFTs).

The transmission spectrum in the mid-infrared region was obtained using Fourier Transform Infra-Red spectroscopy (FTIR) shown in Fig. 15. Spectral peaks are observed and denoted by wavenumbers. A broad transmission band from approximately 2780 to 1780  $\text{cm}^{-1}$  dominates the spectra.

The free film data suggests that it is possible for UV irradiation to penetrate the topcoat and cause damage to the underlying primer. However, it is more likely that the degradation observed in the epoxy primer is caused by thermal radiation indicated by the IR spectra.
