Risk Assessment Due to Debris Flows in  
Paz de Río-Colombia

Carlos Eduardo Rodriguez\*

## **Risk assessment due to debris flows in Paz de Río-Colombia**

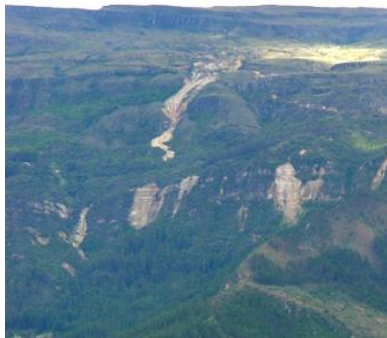
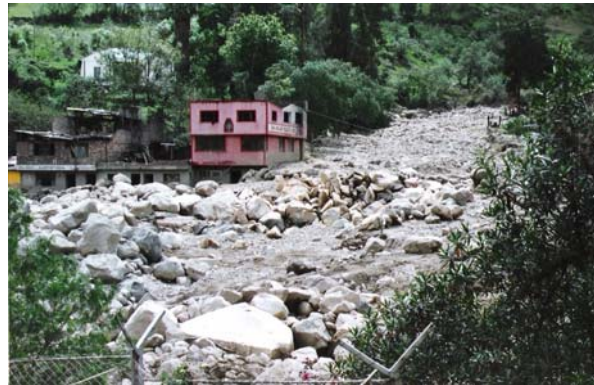
**Figure 1.** Left image is an overview of the upper part of the creek where a large slide is active. Right image shows sediment deposits after the 1995 debris flow, town shown is Santa Teresa.

In 1933 the town of La Paz was destroyed by a earth flow and translated to a new location near the Chicamocha river and the named Paz de Río. This town was located in front of the mouth of the La Chapa creek, which started to generate catastrophic debris flows in 1963. Basin deforestation and cropping jointly with extensive landsliding have been considered the main causes of this process. Pictures in Figure 1 show the upper

and lower parts of the basin. By 1985 the large slide (Mesa Alta Landslide) observed on the left image of Figure 1 was mobilised by intense rainfalls and favoured by constant tectonic activity along the complex faults system present in the area. Since the occurrence of this landslide two large debris flows have been observed in 1986 and 1995, the flow in 1995, which partially destroyed the Santa Teresa town at the bottom of the basin, is observed on the right image in Figure 1.

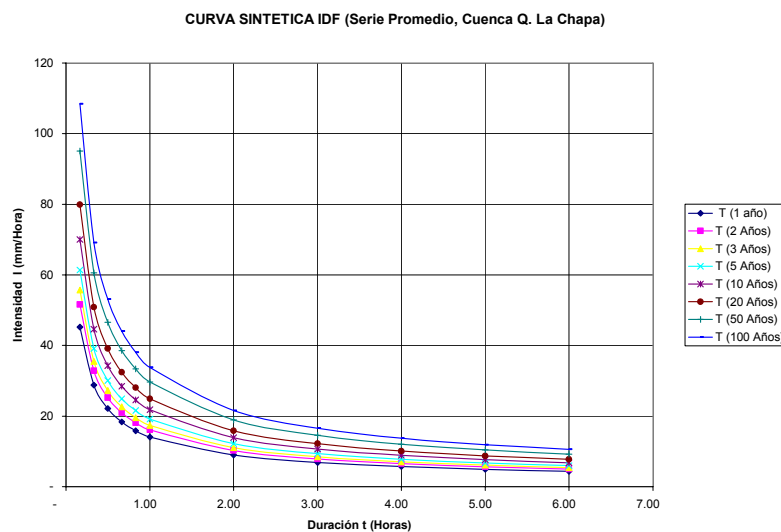
**Figure 4.** I-D-F curves for La Chapa basin, based on data for three stations around the area.

**Climate and hydrology.** The area shows a bi-modal annual rainfall distribution with peka values in April and October, whereas the driest months are January and July. Annual rainfall is between 800 and 1100 mm. Rainy months show rainfalls between 120 and 170 mm. The I-D-F curves averaged for the La Chapa basin is shown in Figure 4.

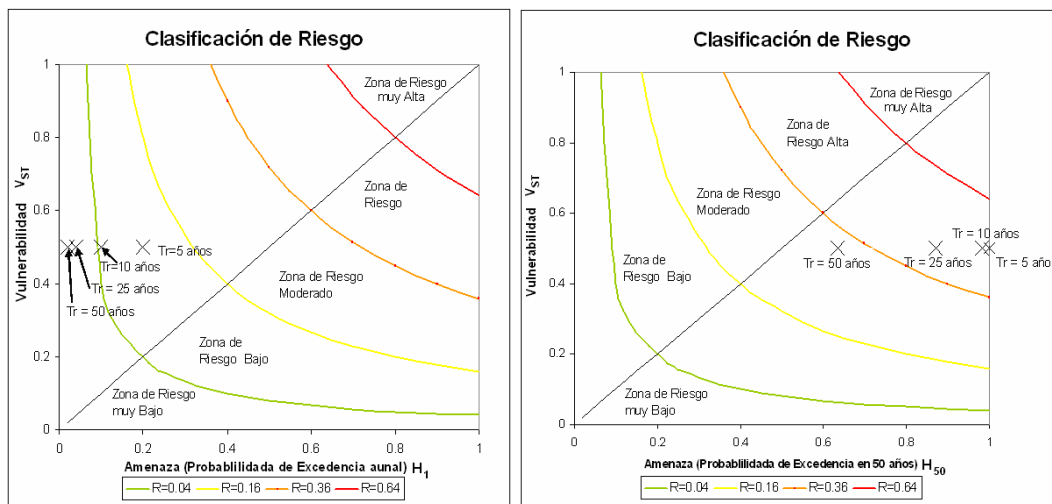
**Figure 9.** Risk assessment for La Chapa basin. Graphs show the annual probability of deaths (left) and probability of deaths in 50 years (right).

Physical and social vulnerability were combined in order to define a Damage Index, which was defined as proposed by Leone (1996). This Damage Index was interpreted as a Vulnerability Index which was combined with hazard in order to define risk by using the model proposed by Liu and Lei (2003). Results are shown in Figure 9, which presents the risk space defined by Liu and Lei and the points representing the average vulnerability and hazard of the area. This figure shows the annual probability of deaths is low even for events with return periods of 50 years. On the other hand it can be seen that the probability of deaths in 50 years is very high suggesting that risk management actions must be taken in the short time.
