AVIATION ARCHAEOLOGY: HISTORY, THEORY, PRACTICE AND DIRECTION

A Dissertation

DOCTOR OF PHILOSOPHY

August 2018

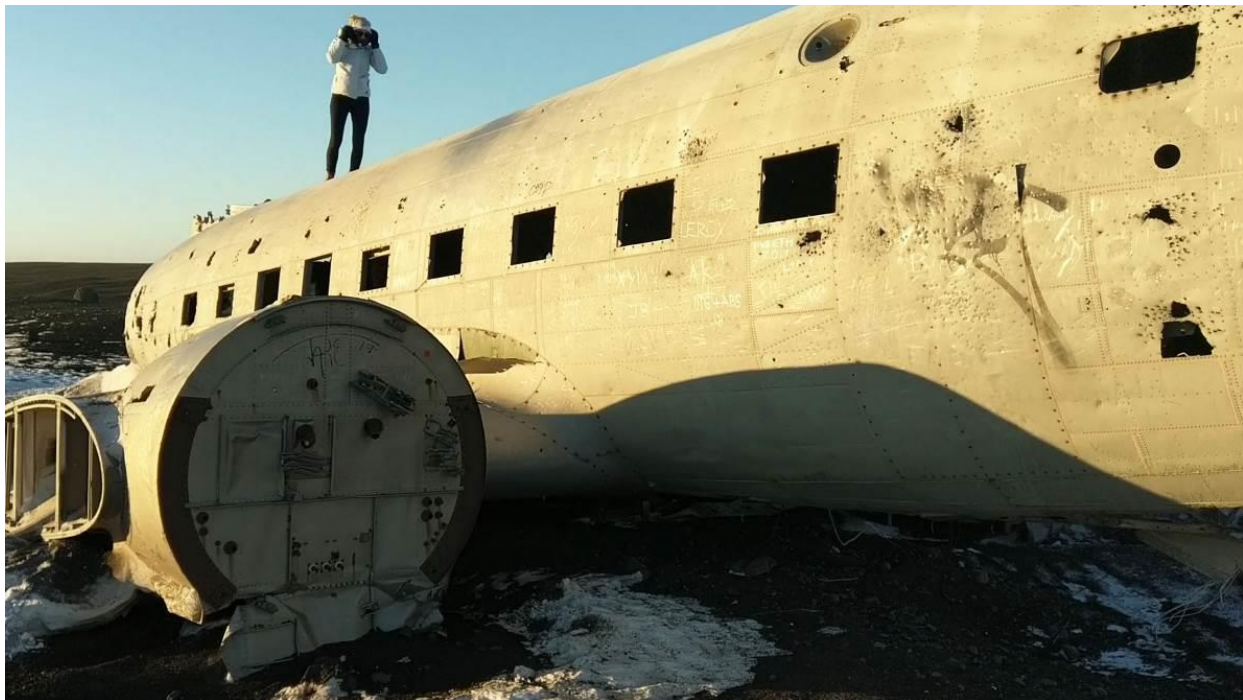
Figure 2.4- Etched and spray-painted graffiti mar the skin of this US Navy C-117 aircraft, wrecked on the beaches of Iceland in 1973. Local farmers used to use it as a target for gun practice, and now tourists use it as a climbing ground. Photo by the author.

their value is tied to authentic parts, either with or without provenance. This fact places a monetary value on aircraft parts that exist in wreck sites today. Souvenir hunting, while not as prevalent now as in the last three decades, still exists, as does historical site vandalism (Figure 2.4).

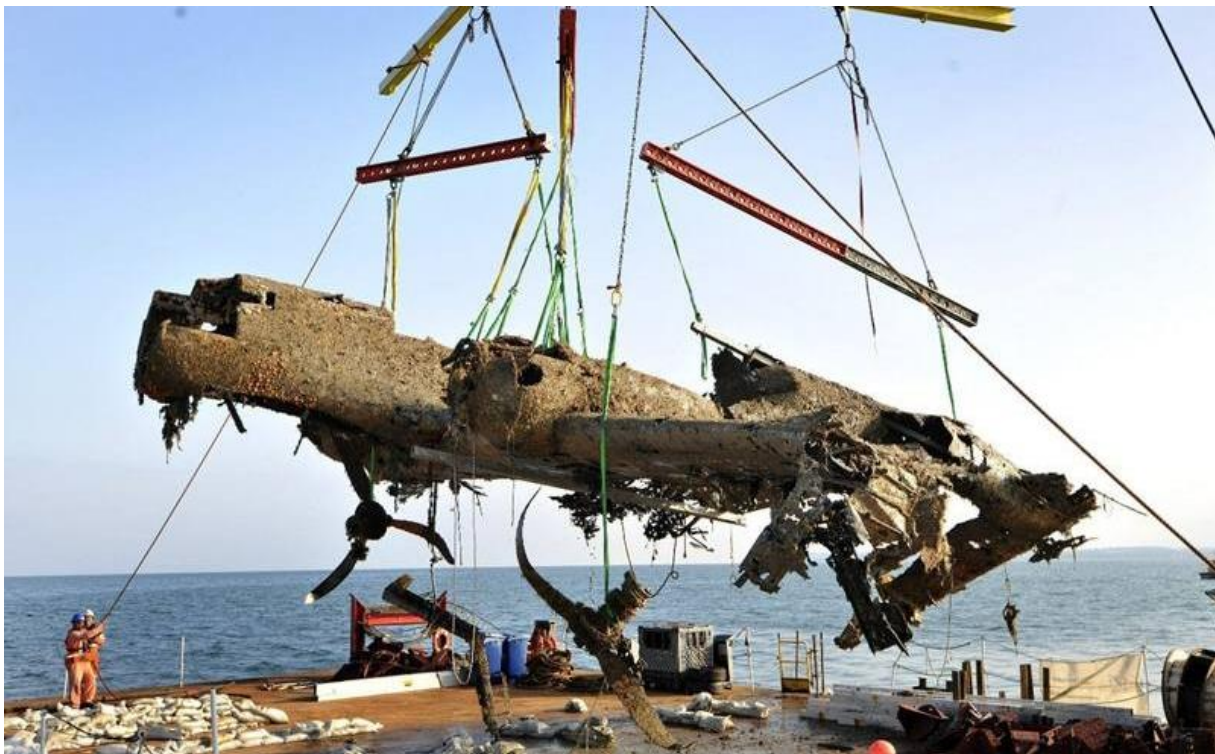
Figure 2.8- Contractors lift the Dornier Do 17 from Goodwin Sands in 2013. Reprinted from Symonds 2014.

traditionally carried out salvage work with varying levels of documentation. To date (and in published record) the only full, archaeological excavations and recovery of an aircraft wrecks is are Swedish ‘Catalina Affair’ DC-3, which was shot down over the Baltic in 1952 and excavated in 2004, and two wrecks in Dutch waters by an archaeological contract firm, Leemans Speciaalwerven.⁵⁶ The Royal Air Force Museum in London contracted Wessex Archaeology to perform a recovery feasibility survey on a German aircraft off the coast of Kent in 2010 (Figure 2.8). The Dornier Do 17, which was raised by engineering contractors for the RAF Museum, also benefited from extensive data visualization (Figure 2.9).⁵⁷

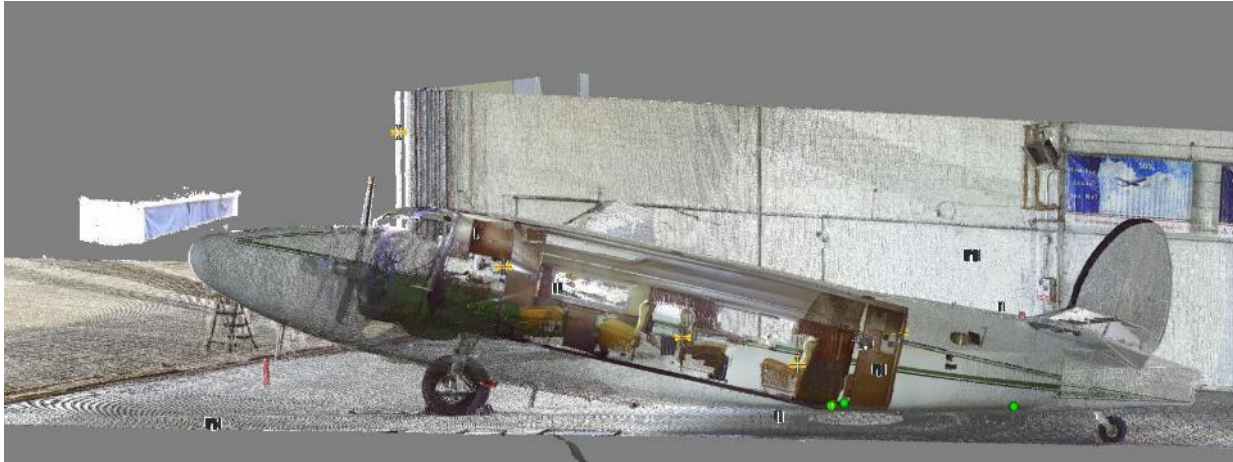
Figure 2.11- A 3D scan of the interior and exterior of a Lockheed Lodestar at The 1940 Air Terminal Museum in Houston, TX. Model by R. Warden, assisted by L. Champagne and the author.

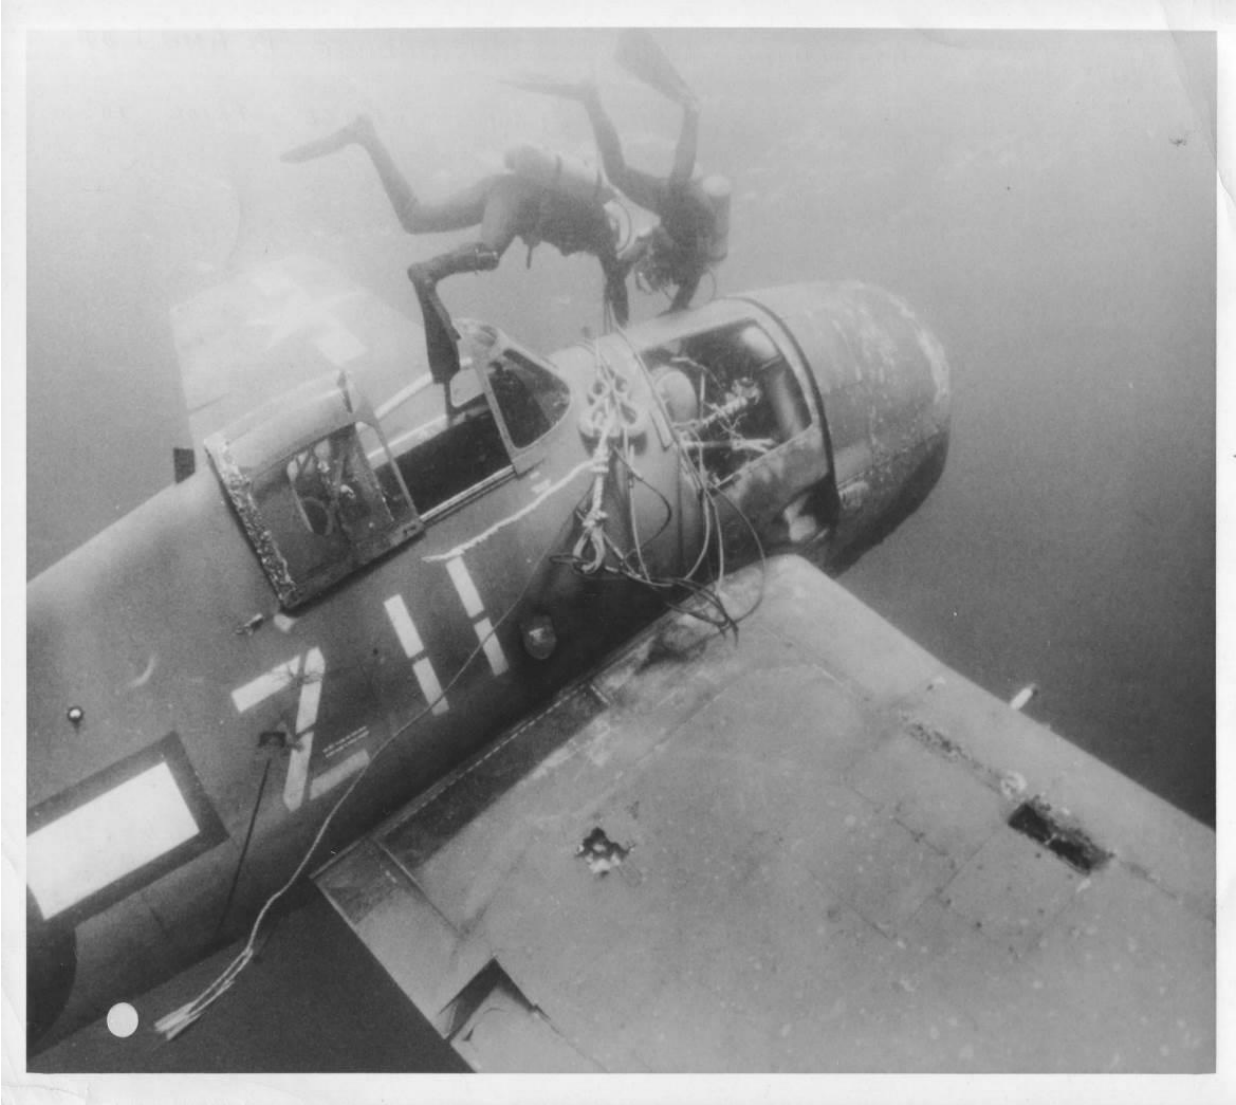
Figure 2.13- Divers rig F6F-3 Hellcat BuNo 66237 for lifting. Reprinted from Stafford 2008.

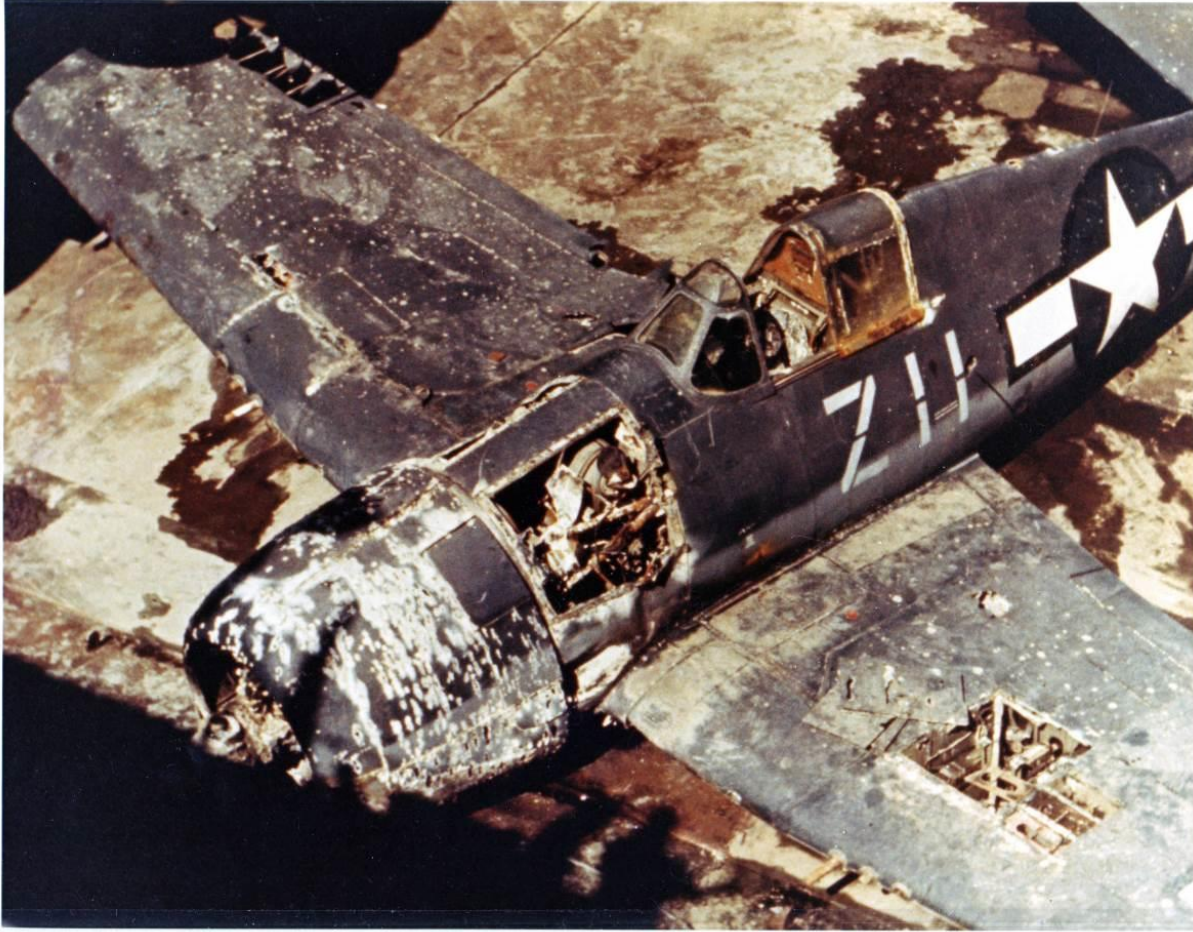
Figure 2.14- The Hellcat immediately after recovery in 1970. Reprinted from Stafford 2008.

In March of 1970 Lockheed's research submarine *Deep Quest* discovered an F6F-3 Navy Hellcat off the coast of San Diego, California, in excess of 1000 m below the surface.⁶⁶ The aircraft had been lost in 1944 but the pilot, Robert F. Thomas, escaped and was rescued. Upon seeing the aircraft during its recovery he commented, "it was the greatest fighter of them all, but it floated about as well as it glided --like a brick."⁶⁷ Scientists aboard the submersible took still pictures and video because they were surprised at the seemingly sound structure and by the fact that the aluminum surfaces appeared not to have degraded. The navy decided to salvage the aircraft, and in October of 1970, on its second attempt, *Deep Quest* used its manipulation arms to secure a lifting line to the aircraft.⁶⁸ The aircraft was lifted to a depth where divers could help control the Hellcat's recovery onto the waiting Navy dry dock vessel *White Sands* (Figure 2.13). Upon recovery, the Hellcat was in beautiful condition with only minimal structural damage; surprisingly the paint, plexiglass windows, and most components were almost completely intact and little corrosion had occurred (Figure 2.14).

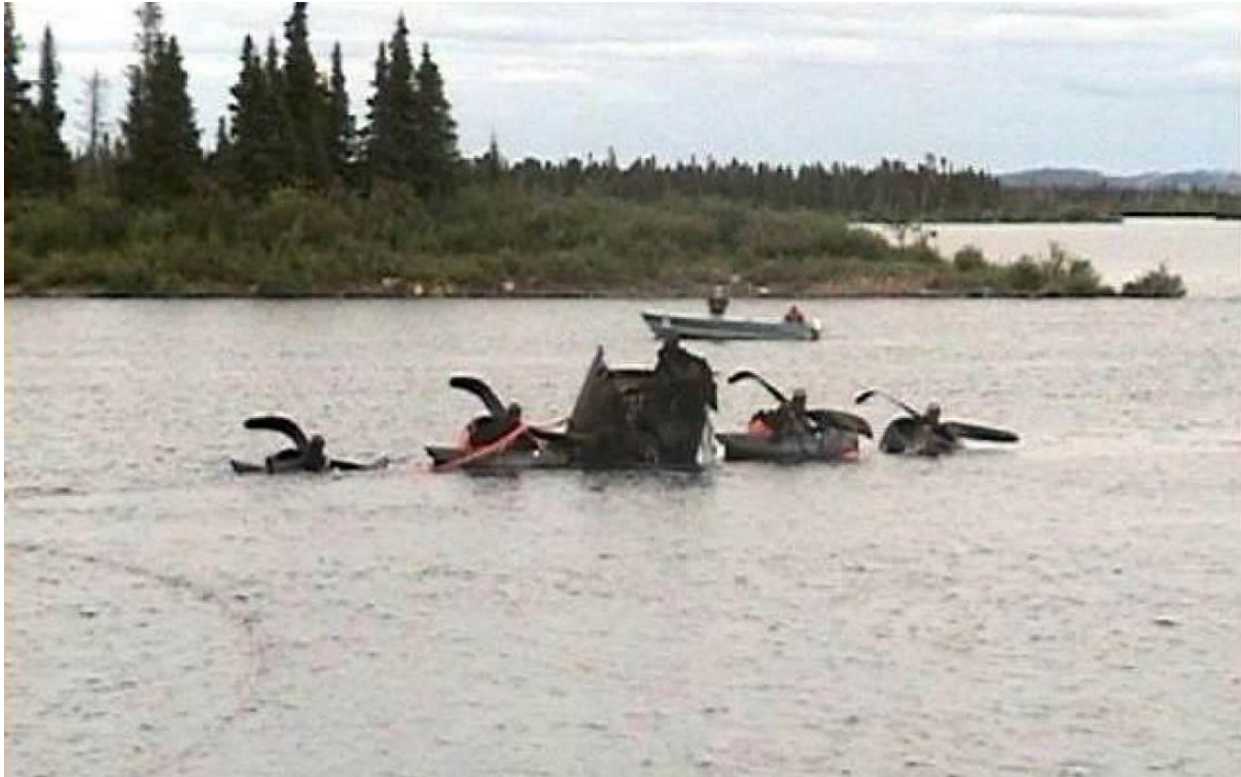
Figure 2.17- The B-17 as it first came to the surface supported by list bags. Reprinted from Skanes 2005.

The recovery took place in August 2004 (Figure 2.17). The salvage company documented the aircraft and its interior underwater by video survey, noting the aircraft's condition and missing parts. A sonar survey of the rest of the area did not reveal the missing tail or nose sections. The B-17 was secured and lifted using a set of purpose-made float bags with 31,750 kg capacity. Once on the surface, the B-17 was washed to remove river sediment and the recovery team began towing the aircraft to shore, which took 58 hours.⁷⁹ The project archaeologist submitted the final report in 2005 after the successful recovery.

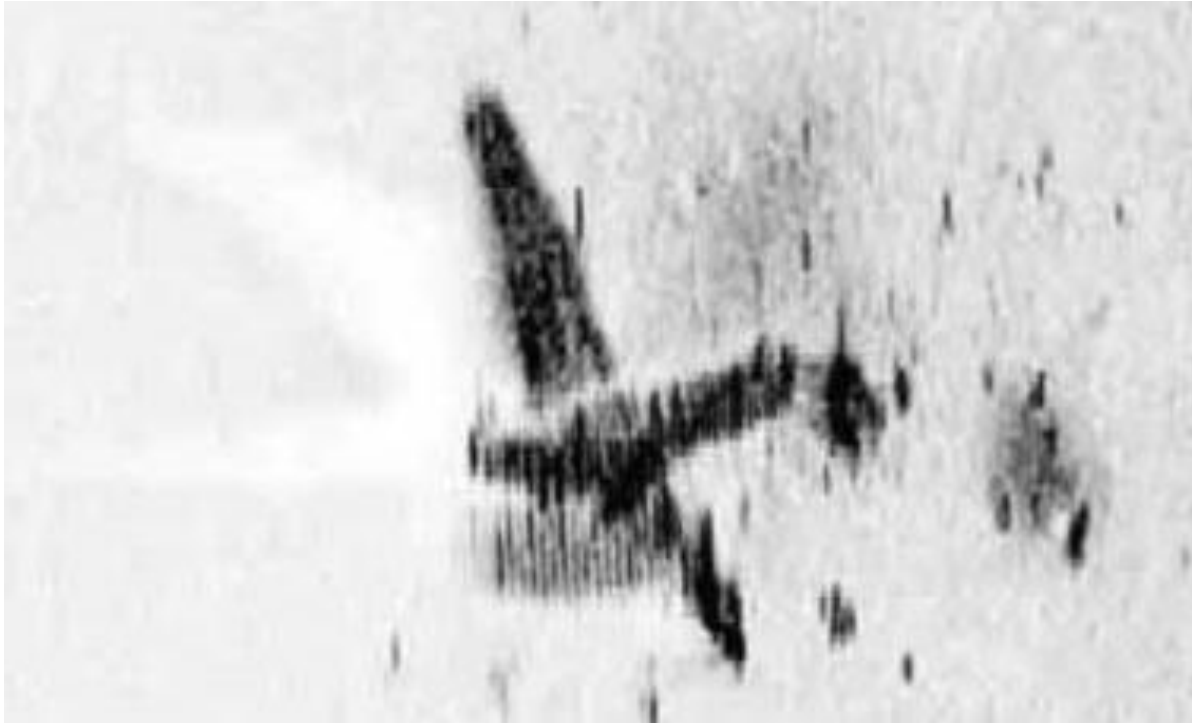
Figure 2.19- Sonar scan of ‘The Catalina Affair’ DC-3. Reprinted from LUTAB 2007.

The DC-3 was found on sidescan sonar on June 16, 2013, just over 61 years after it had been lost, by a team from Deep Sea Productions and Marin Mätteknik AB (MMT), a Swedish maritime operations company (Figure 2.19). MMT and Deep Sea Productions video surveyed the wreck site to establish its identity using a Tritech SeaKing ROV with HD cameras and lights, and equipped with a CTD for water chemistry readings. The aircraft was verified by the type and the presence of the painted Swedish Crowns insignia on the fuselage and wings. The insignia also served to call into question the portion of the Soviet pilot testimony that no insignia was apparent on the aircraft when he shot it down. It was later discovered that one of the insignias on the fuselage was pierced with bullet holes.⁸⁴

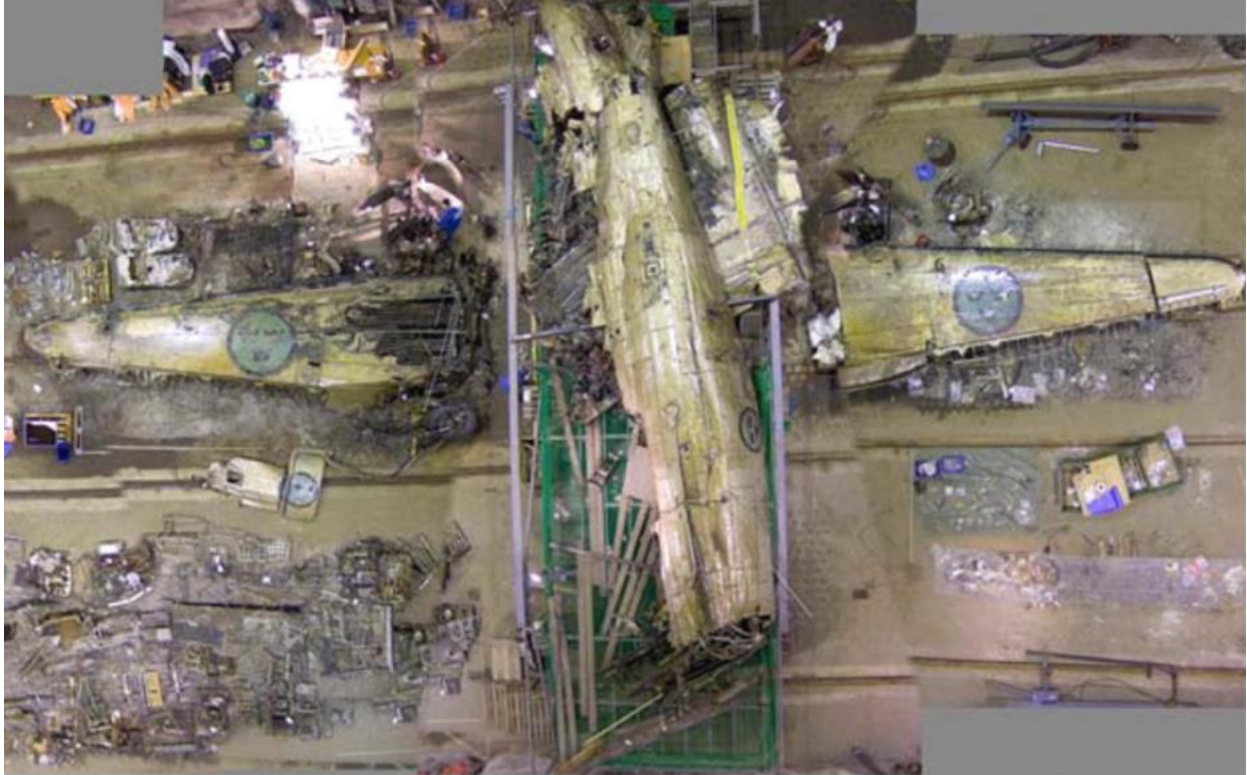
Figure 2.22- The DC-3 after it was raised and arranged for forensic study. Reprinted from LUTAB 2007.

The entire site was taken to a submarine bunker and reconstructed for analysis, after which the interior of the aircraft was excavated and the finds recorded (Figure 2.22). Remains of three other crew members were found. Examination of the aircraft showed that bullets, shrapnel, and equipment were violently moving around the interior of the fuselage, making it unlikely crew members had survived the attack or the crash event. Interestingly, however, the interior manual lock on the passenger door was shown to have been moved to the open position. Regardless, no other crew members have ever been found.

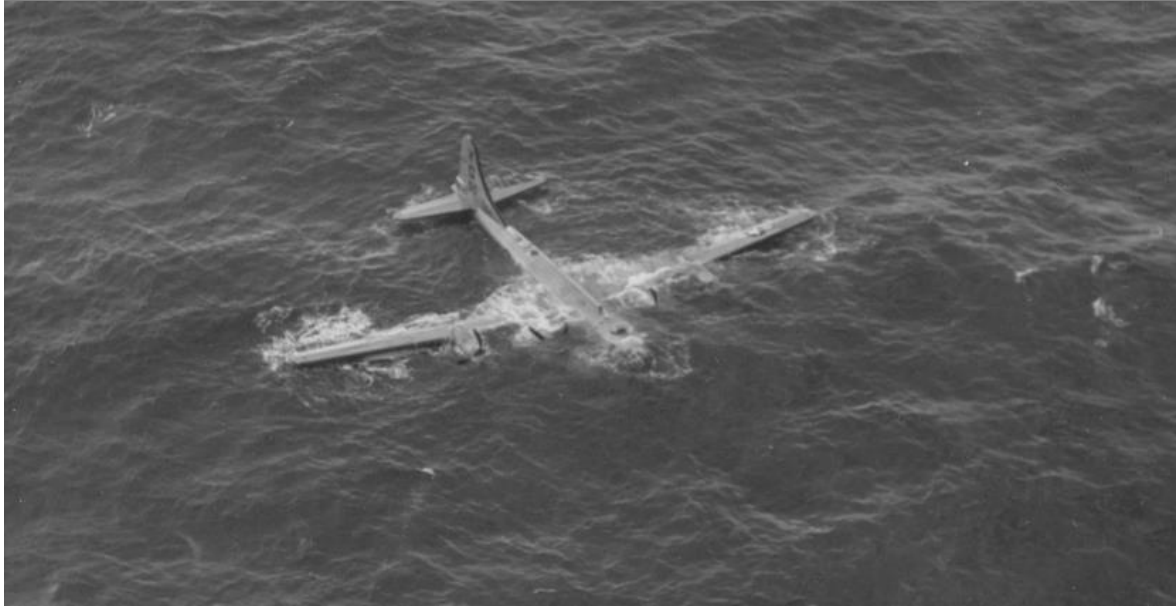
Figure 3.1b- A B-29 ditches successfully off Iwo Jima in WWII. Reprinted from Keeney 2014.

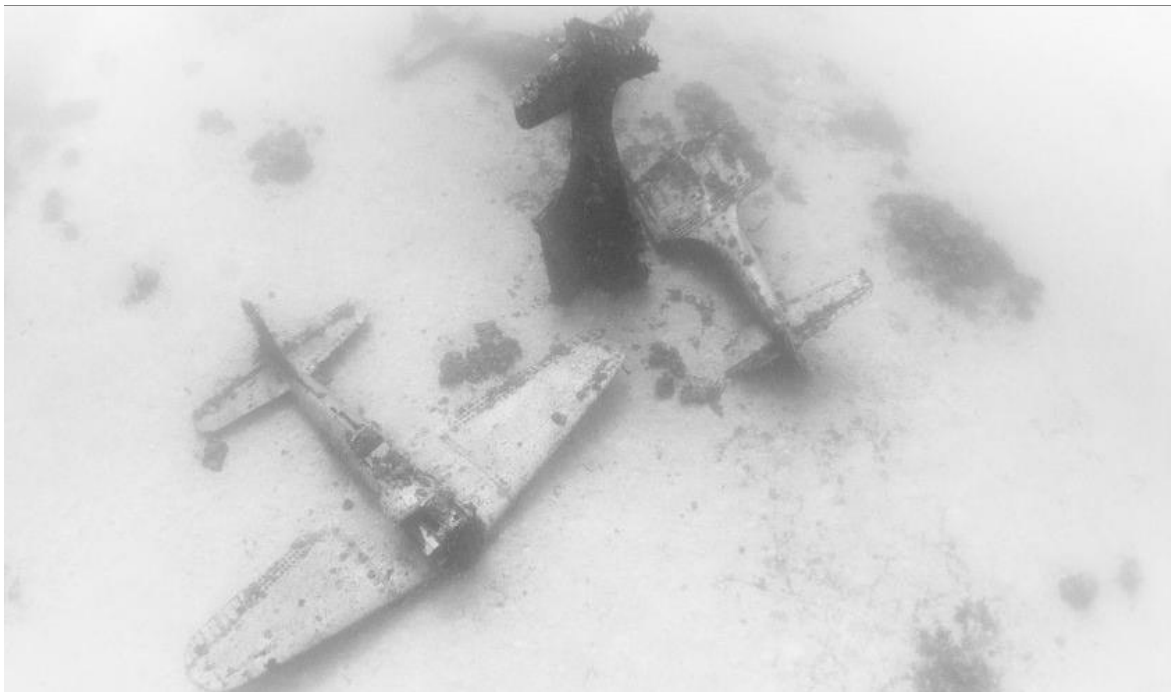
Figure 3.1g - A dump site for WWII aircraft off the Marshall Islands. Note the missing engines and wings from three of the aircraft. Photo by Brandi Mueller/AP, reprinted from Cenciotti 2015.

Multiple aircraft or close, but disassociated parts can exist in dump sites. Site formation and historical research often provide obvious clues as to whether a site is dumped aircraft parts or not, such as uniform groupings, missing or extra parts, or incorrect types mixed in. WWII dump sites, especially, can contain other military surplus items such as vehicles or tanks commingled with aircraft. Researchers have also noted 'sites' where the remains of one or more aircraft have been arranged to appear as a wreck site to encourage tourist visitation.¹²²

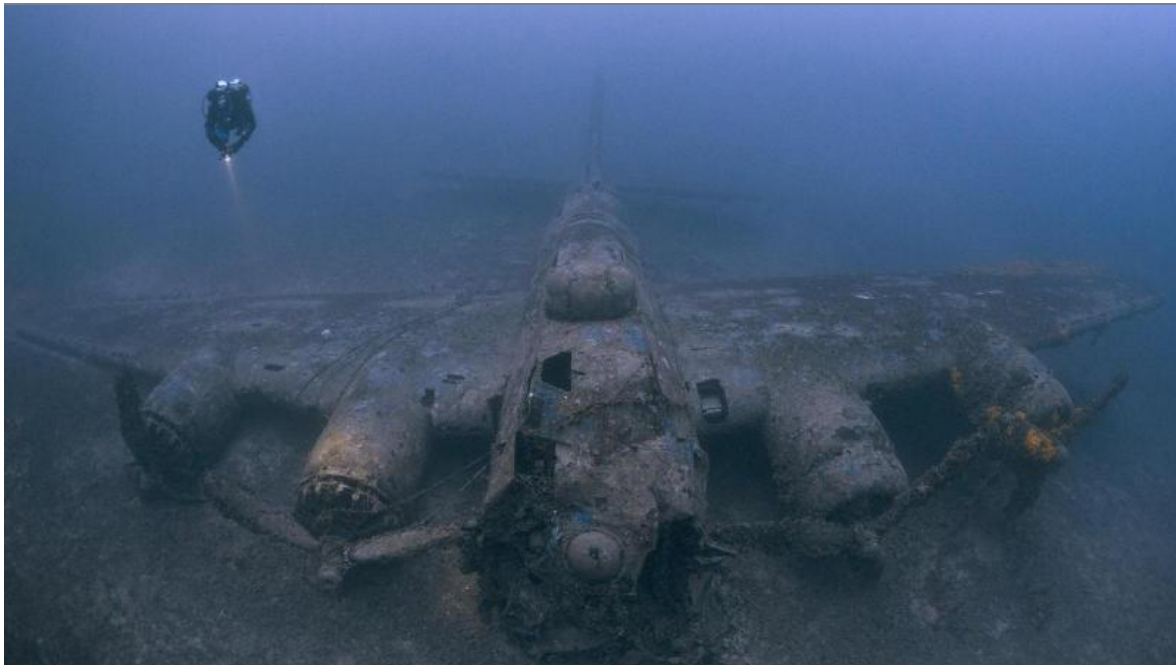
Figure 3.2b - A WWII B-17 wreck in 72 m off Vis, Croatia. The aircraft successfully ditched- damage to the nose is a combination of flak, possible bottom impact, and corrosion damage. Photo reprinted from Underwater 360 2018.

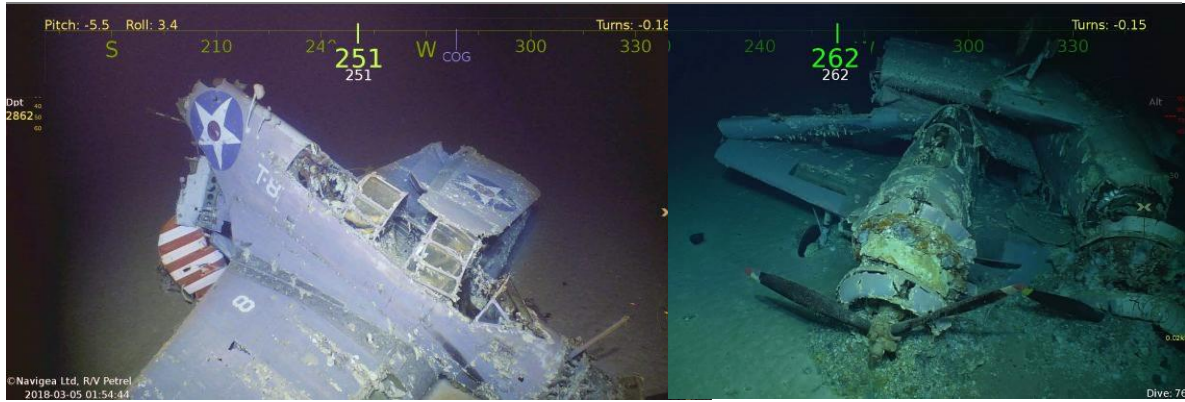
Figure 3.2c - Bright paint and organic covers on the flight control surfaces of this TBD Devastator remain remarkably intact (L). Aircraft from this site, the USS Lexington aircraft carrier, are all in similar condition and show deepwater preservation (2800m+). Note the comparatively accelerated deterioration of the engines (R) and the corrosion products fanning out from them on the sea floor. Photos reprinted from Paul Allen's website (The Editors 2018).

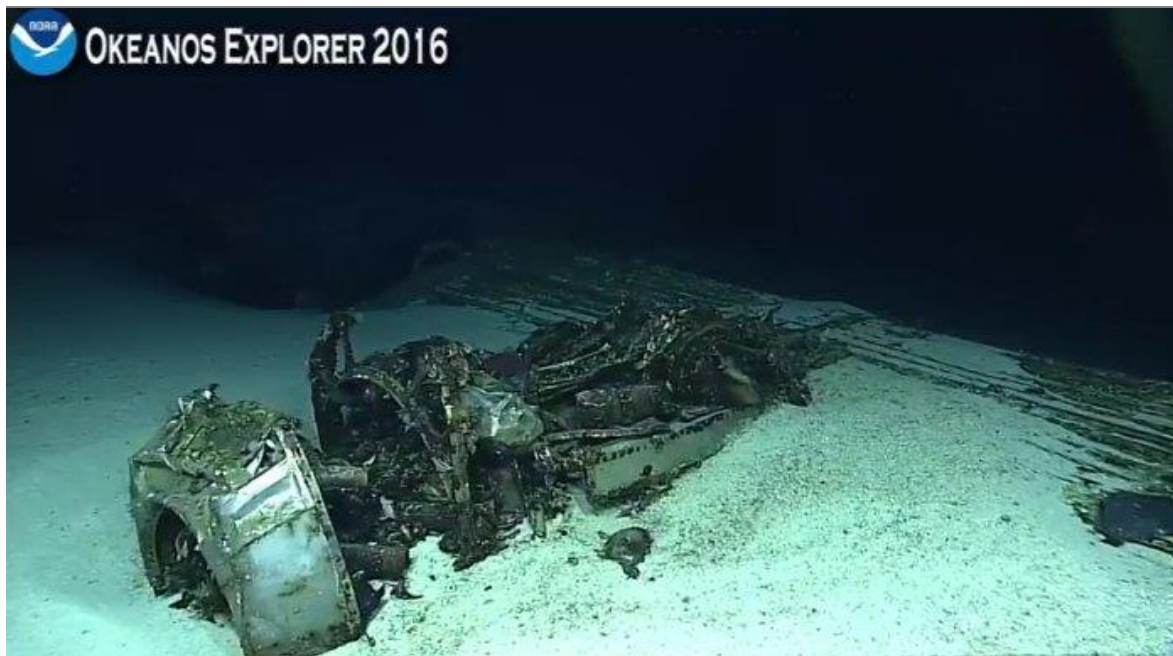
Figure 3.2d - An inverted WWII B-29 at 380 m found off Saipan. Shifting sands have worn away the exposed wing skin, showing the structure underneath. Note the scour pattern in front of the engine and the relatively excellent condition of the stainless steel cowling. Photo courtesy NOAA Office of Ocean Exploration.

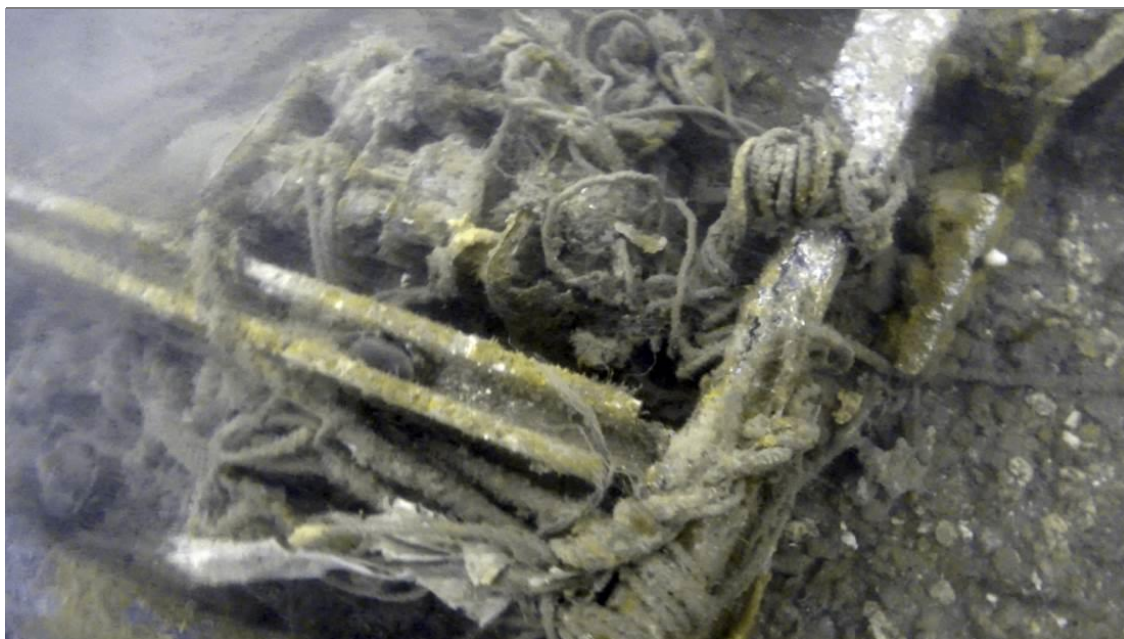
Figure 3.2g - Netting and rope wrapped around the structural interior of a B-17 wing in the English Channel. The shifting sands have scoured away the skin over time. Photo courtesy of The BentProp Project, Ltd.

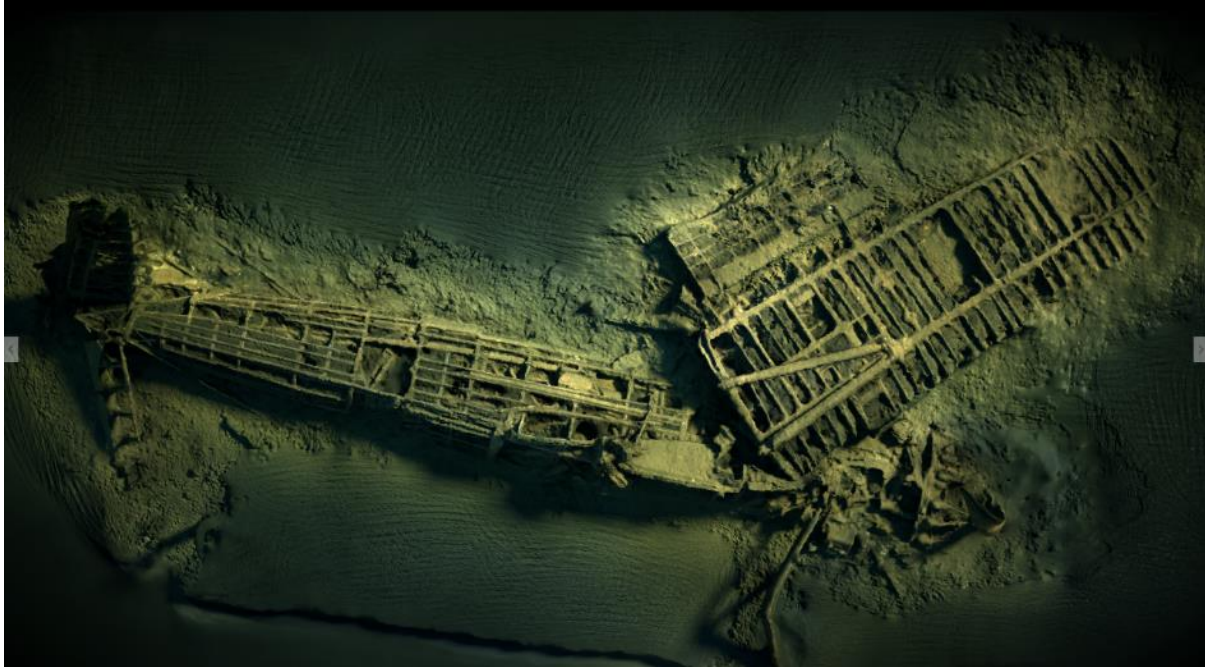
Figure 4.4- Data Visualization of an Arado 196-3 aircraft, Sweden. Model by Ingemar Lundgren, Ocean Discovery, photo courtesy of A. McWilliams.

Aviation archaeology 3D modeling projects provide both documentation for the sites as well as a potential display unit to engage public interest. For example, a team of Norwegian technology students who discovered a WWII Halifax bomber off the coast of Trondheim in 300 m in 2016 created a 3D model from the ROV video and sent the information to Norsk Luftfartsmuseum in Norway.¹⁵⁷ As part of 2017 fieldwork in Saipan, East Carolina University's Maritime Studies Program and contractor Kota Yamafune created 3D models of several deteriorating aircraft sites in shallow water (Figure 4.3).¹⁵⁸ An archaeologist for a collaborative University/State Government survey effort in Sweden reported baseline condition assessment on a rare Arado 196-3 aircraft off Karlskrona, including a 3D model of the site (Figure 4.4) in order

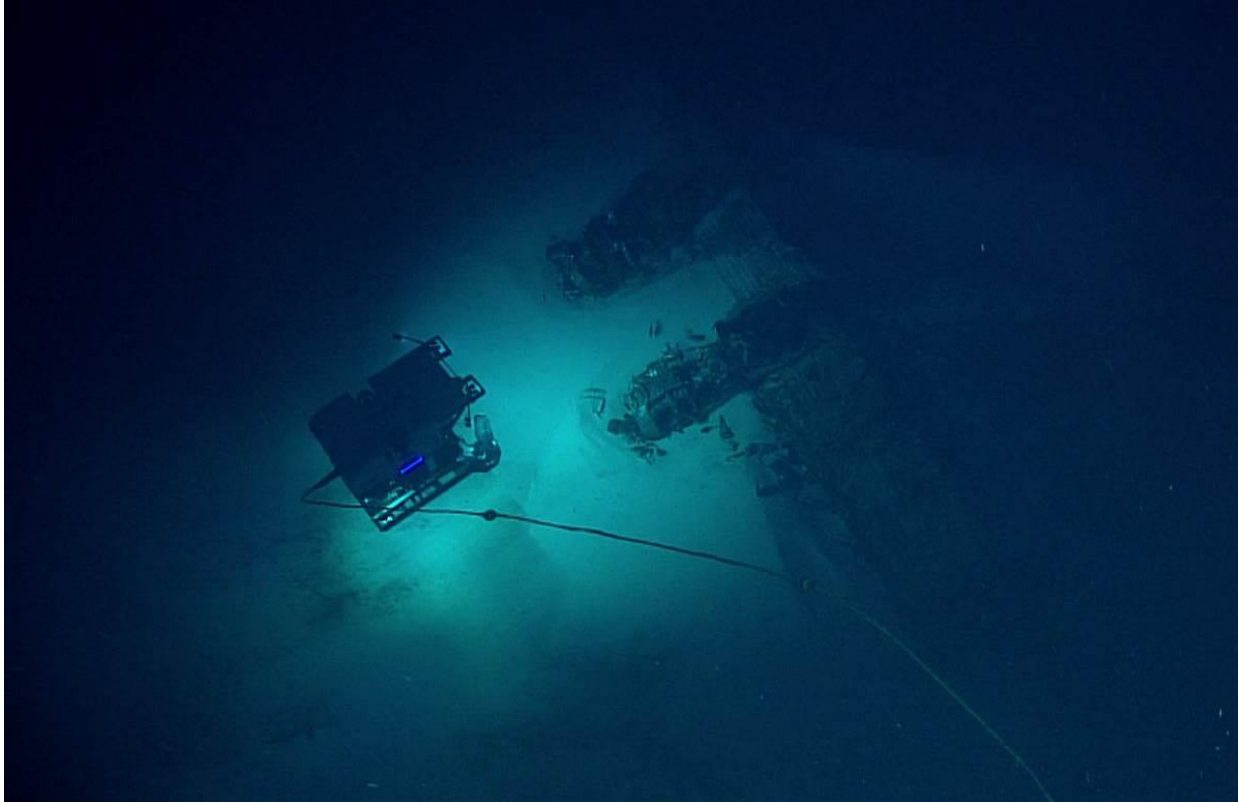
Figure 4.5- ROV *Deep Discoverer* imaging the B-29 wreck site as seen by ROV *Seirios*. Photo courtesy of NOAA Office of Ocean Exploration and Research, 2016 Deepwater Exploration of the Marianas.

The wreck site is largely disarticulated and is missing several sections. The first wreckage group seen on camera was the inverted center wing section of a B-29-type airframe, three engines attached to the wing, and an associated debris pile of large and small objects directly aft of the wing (Figure 4.5). The second grouping located was the forward gunner's turret surrounded by parts from that section of the fuselage (Figure 4.6). The third group of wreckage was the horizontal stabilizer and some small deteriorated pieces (Figure 4.7). In between each group were several smaller pieces of wreckage, one of which was the pilot or co-pilot's seat next to a flak jacket. Organic remains from the wreck also include two parachutes and some remnants of the doped fabric on the flight control surfaces (Figure 4.8). Most of the thin aluminum surface skin has been scoured away by sand movement. Site formation, including the separation of the wreckage groups, missing sections, and damage to the engines' nacelles and turbochargers suggested a catastrophic surface impact and breakup, with possible fire and loss of life.¹⁶¹

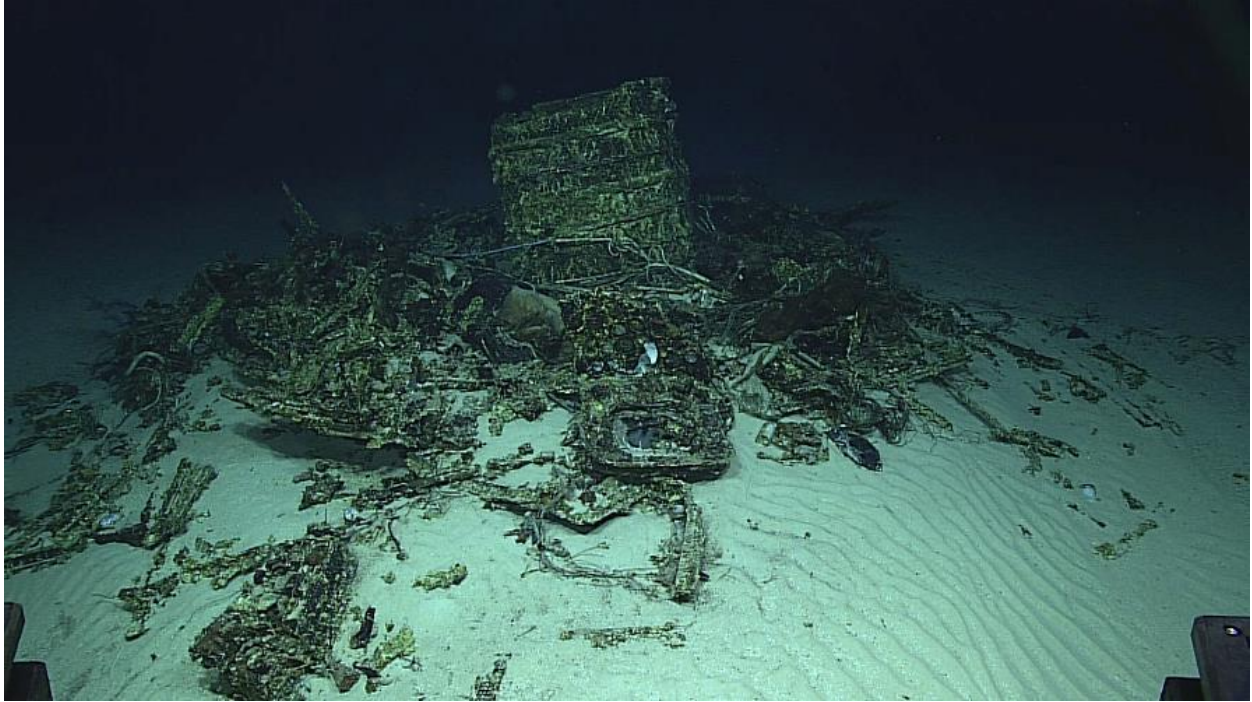
Figure 4.6- Remains of the top turret and the navigator's instrument panel and window. Photo courtesy of NOAA Office of Ocean Exploration and Research, 2016 Deepwater Exploration of the Marianas.

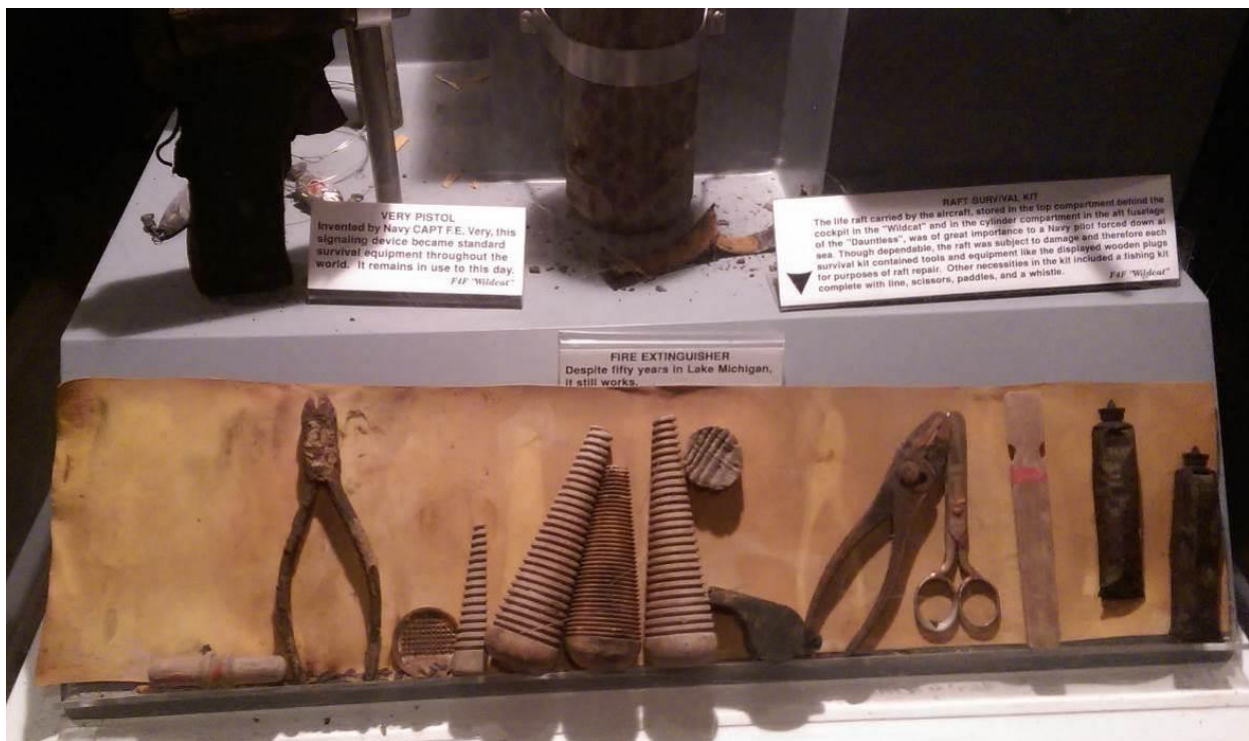
Figure 5.1- Deteriorated pieces surround artifacts recovered from aircraft sites in Lake Michigan, on display at the National Naval Aviation Museum. Photo by the author.

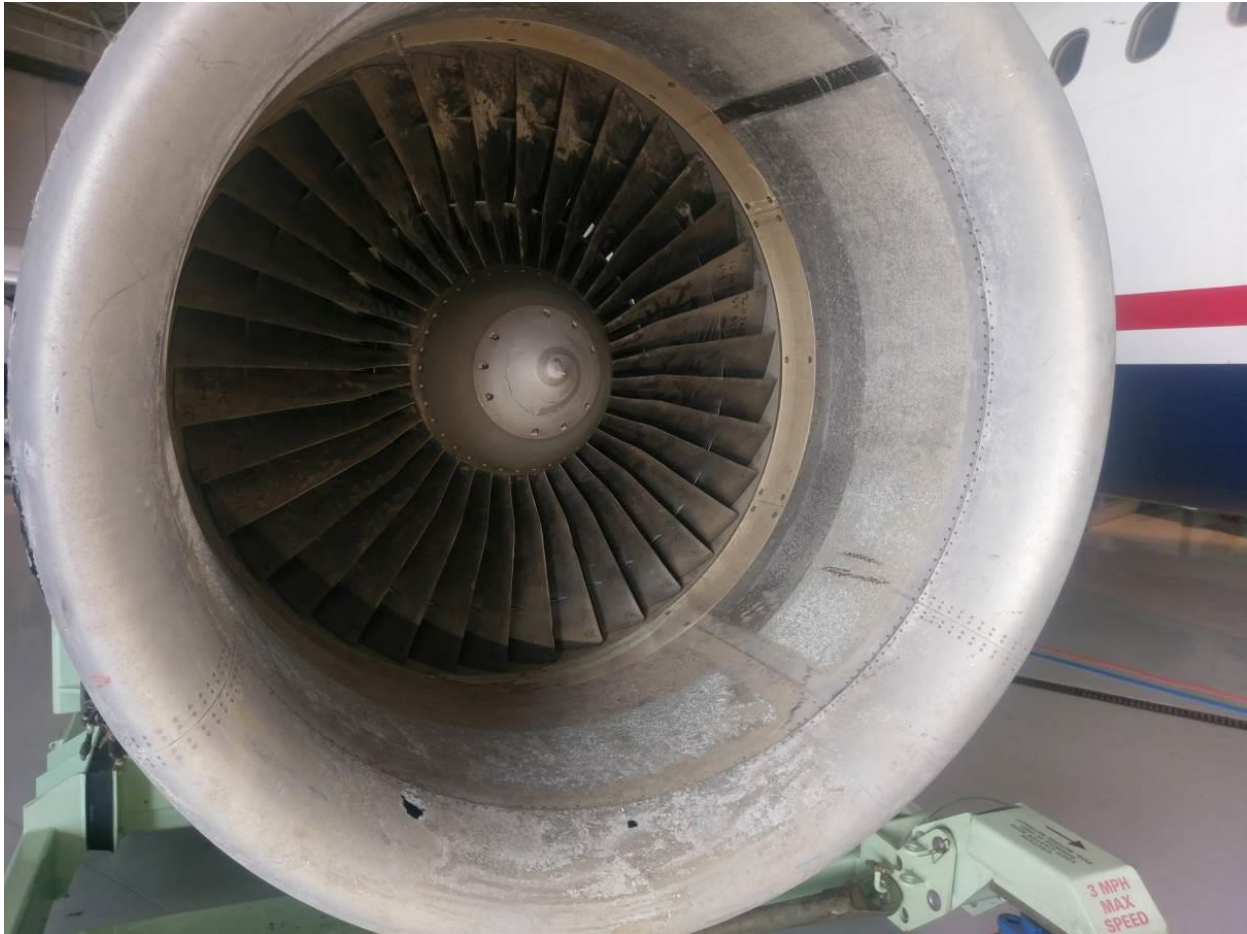
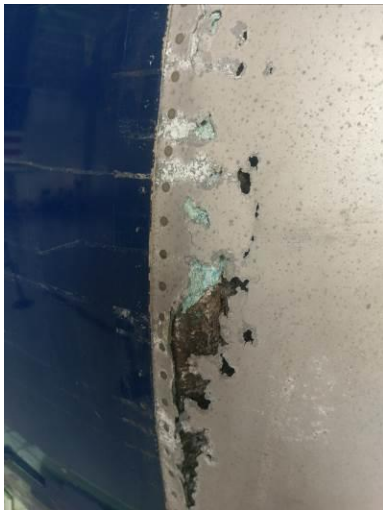
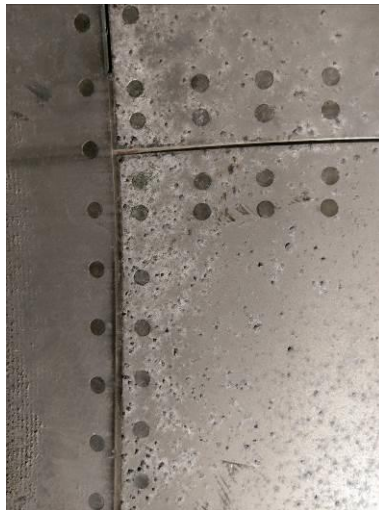
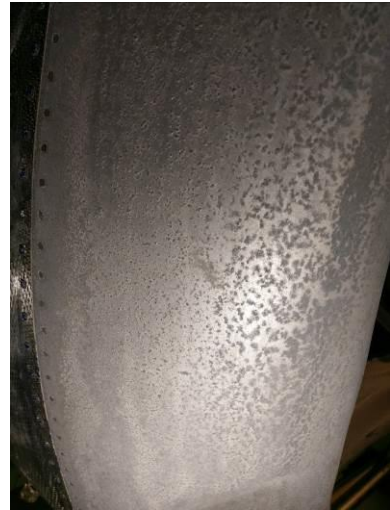
Figure 5.2- An interesting set of corrosion products appear on the two GE CFM56-5B4/P turbofan engines of the 'Flight 1549' Airbus A320-214 aircraft that crashed in the Hudson River in 2009. These engines were only submerged for a few days in brackish water, but did not undergo any conservation treatment and have consequently developed a range of issues. These engines will be treated in 2019 by a team of archaeologists, conservation specialists, museum professionals, and airline maintenance professionals. Photos by author with permission from the Carolinas Aviation Museum.

More recent projects, like the Sola Heinkel and the F-1 engines, show a crossover in the influence of both traditional aircraft corrosion inhibitor products and museum conservator treatments. Corrosion inhibitors that have been specifically developed for aircraft should prove effective in treatment, and it seems like they are effective at chloride removal as well.¹⁶⁸ Treatment methods, especially on modern aviation materials, will benefit in development with collaborative efforts from conservators, industry, and museum personnel (Figure 5.2).

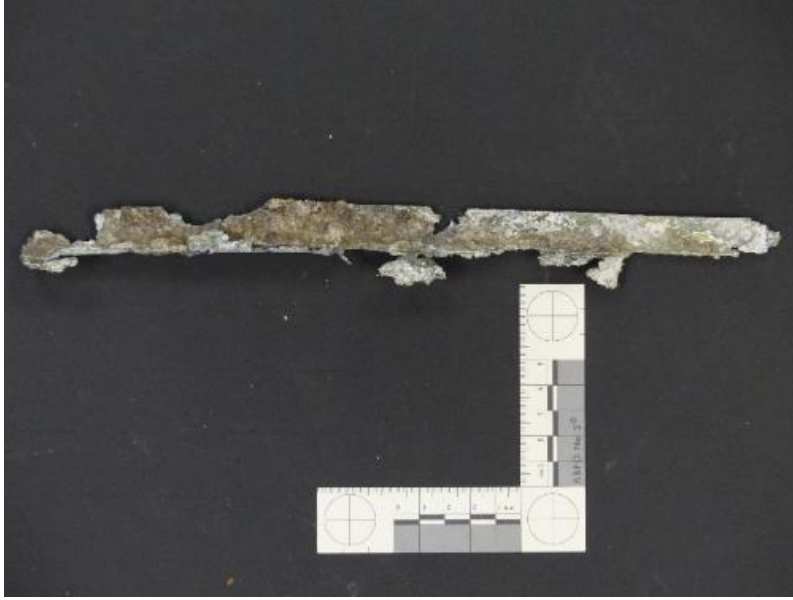
Figure 5.4- Sample RAFMDo01 is a fragile piece of stringer material that is pitting and exfoliating extensively. Photo by the author.

From the RAF Museum I acquired three pieces of Do 17 aluminum for conservation experimentation (RAFMDo01-03) (Figures 5.4-5.6). The samples of Dornier Do 17 material show a range of corrosion products and decay rates, including pitting, rust and exfoliation. They also represent a collection of treatment considerations including original paint, ferrous rivets, and one sample, RAFMDo02 appears to have a leather covering glued to the aluminum.

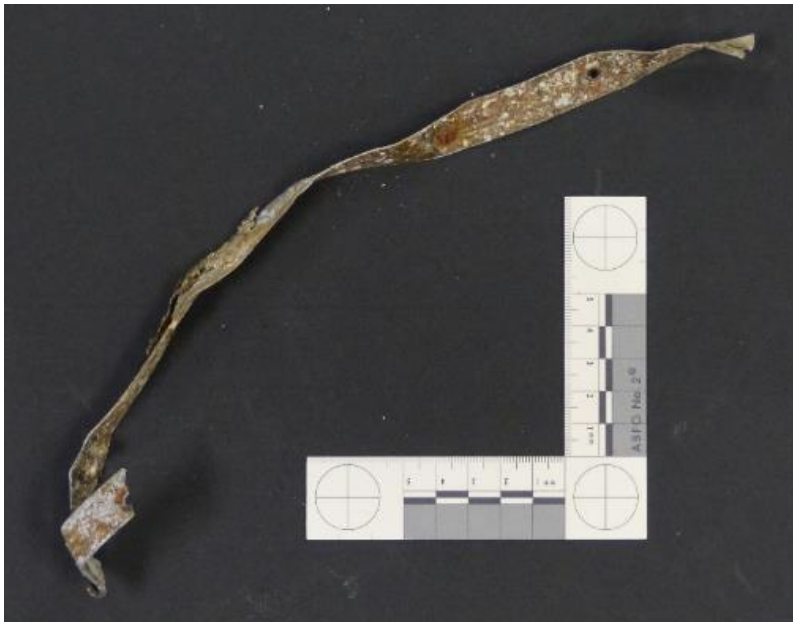
Figure 5.5- RAFMDo02 is also long and thin, but is in a much better state of preservation than RAFMDo01. There are remains from a suspected leather covering, which was glued to the piece. The leftover glue covers the piece. There are rust spots from iron rivets, and a small amount of blue copper corrosion product. Photo by the author.

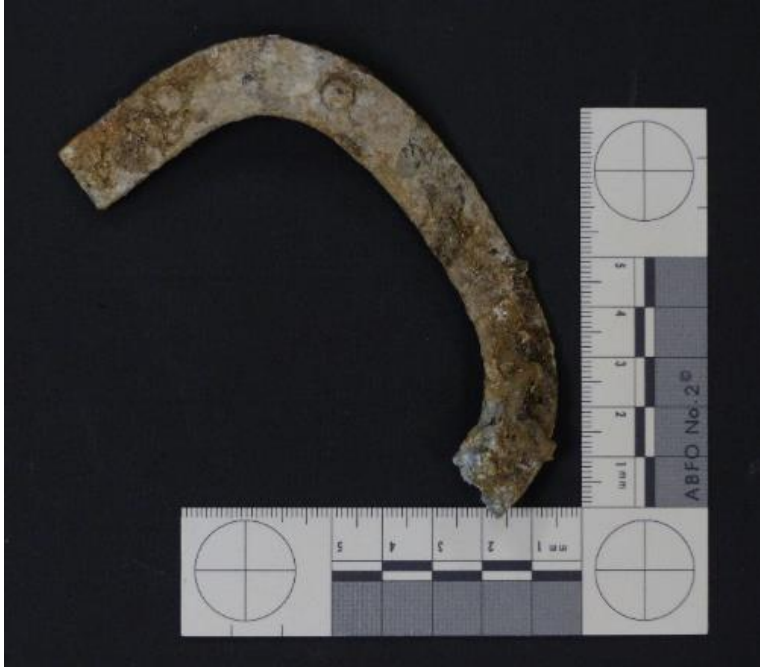
Figure 5.6- RAFMD03 is a cast aluminum curved object with four aluminum rivets and one ferrous rivet. The ferrous rivet is surrounded with rust. The object was painted with a light blue paint and remnants of it remain on the surface along with dirt. Photo by the author.

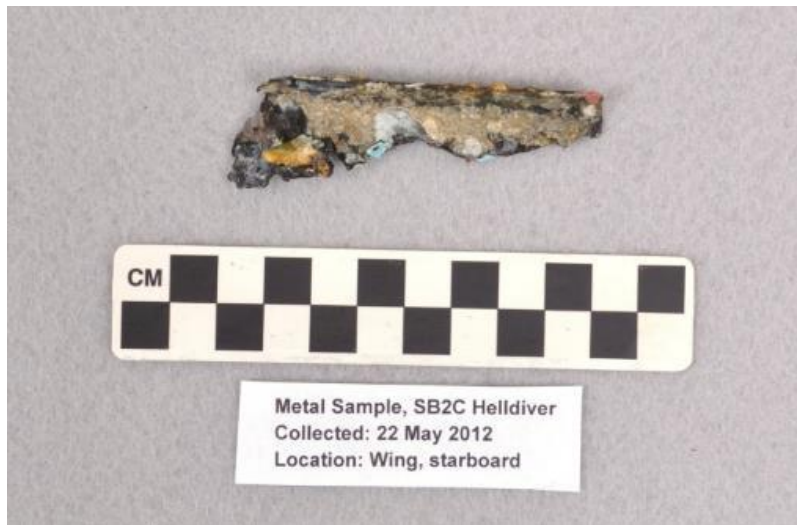
Figure 5.7- UABSB2C01 aluminum sample outward side. It appears that the outwards angled side of the metal sample is plated with a thin layer of metal that is different from the structural metal; i.e. a laminate, or alclad. Photo courtesy Kate Morrand, NHHC UAB lead conservator.
