AVIATION ARCHAEOLOGY: HISTORY, THEORY, PRACTICE AND DIRECTION

A Dissertation

DOCTOR OF PHILOSOPHY

August 2018

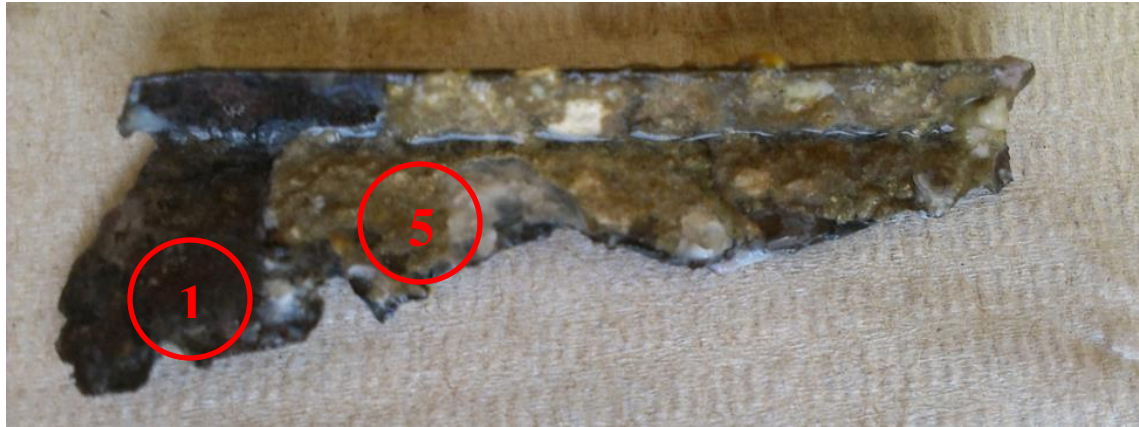
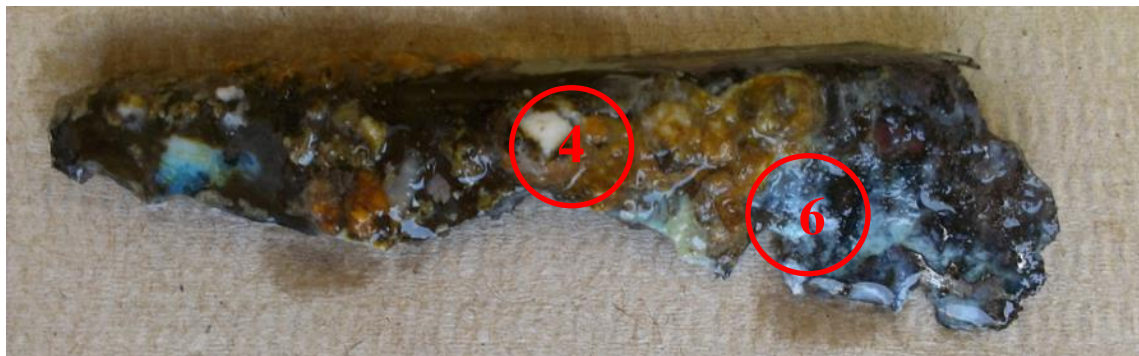
Figure 5.11- XRF sensor locations on sample UABSB2C01. Photos by the author.

The XRF reading will vary according to where on the artifact you place the sensor (Figure 5.11). I used a vacuum on three different samples areas on UABSB2C01 in order to check the difference in peak height, and the difference is apparent in sample areas 1, 3 and 4 (Figure 5.12).

Figure B.1- Refer to Figure 5.11, page 139 for locations of Helldiver sample UABSB2C01. XRF by the author.

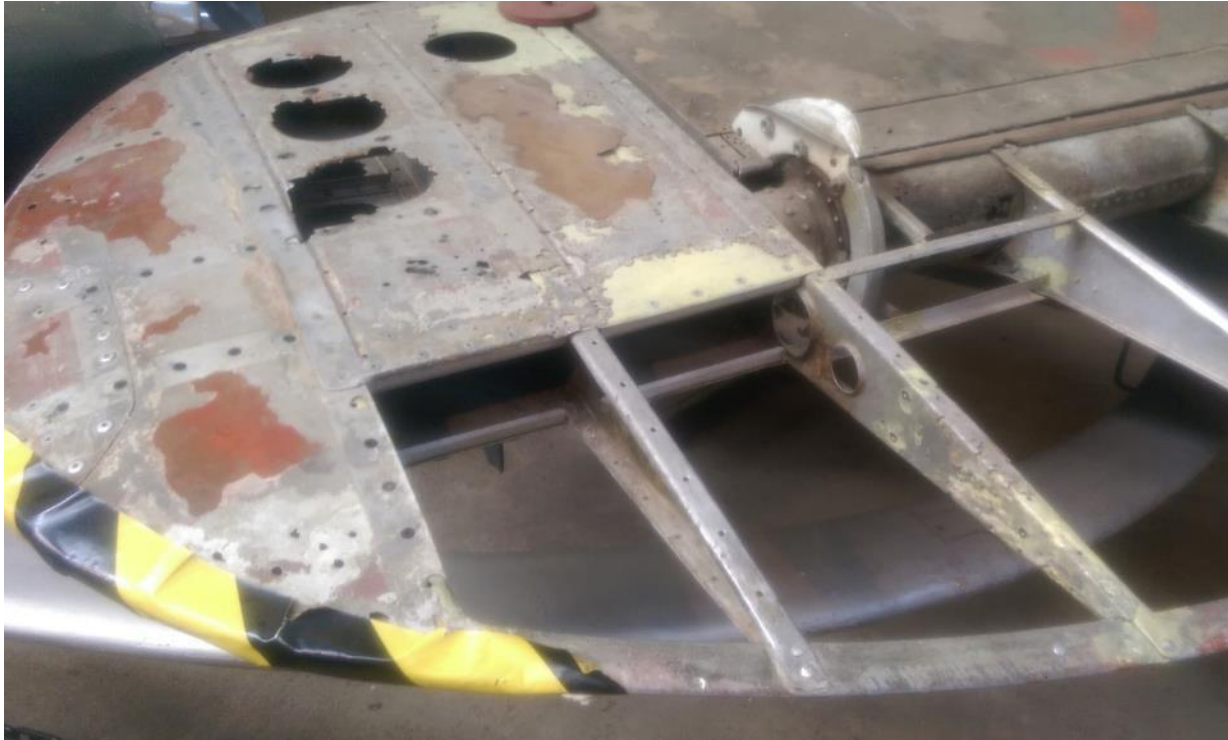
Figure 5.13- This Wellington bomber was recovered from Loch Ness in 1985 and is on display in Brooklands Aviation Museum, UK. It has been restored by placing compromised material on top of new material to retain the original shape. Burgess notes: “in this example, a middle ground was found between the competing demands of archaeology, which requires material to be kept in an ‘as is’ condition, and those of aircraft enthusiasts who wish to reconstruct aircraft to an ‘as new’ condition.”¹⁹¹ Photo by the author.

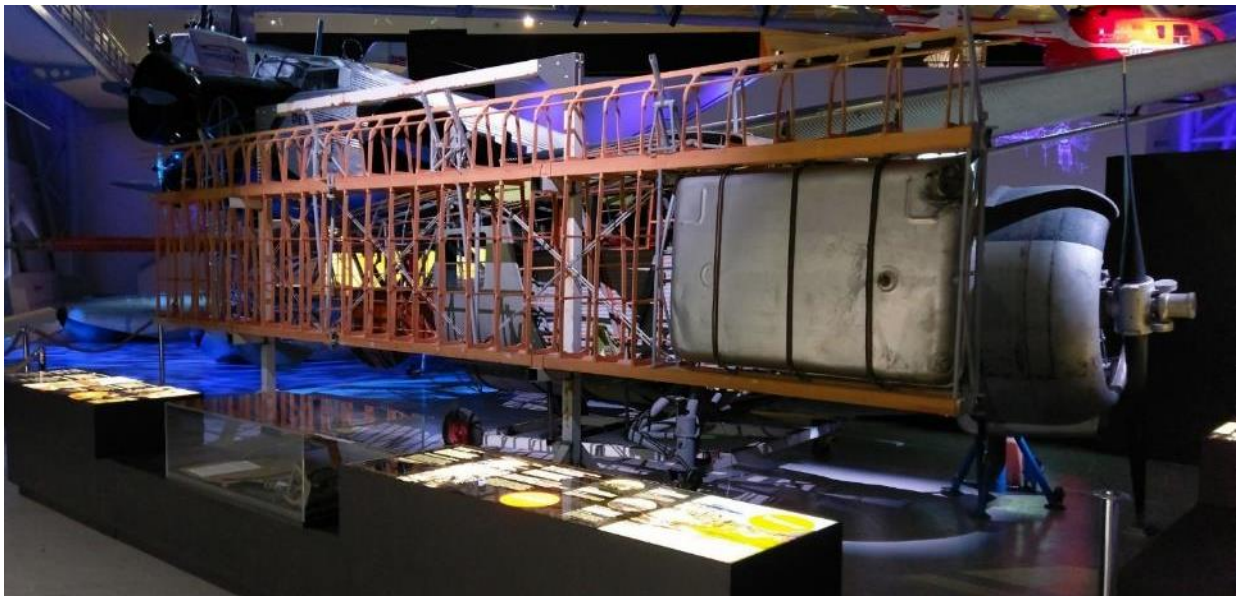
Figure 6.5- The side view of the Norseman exhibit, showing the wing construction details. Interpretive panels show information on display ethos and examples of pre-restored artifacts. Photo by the author.

We decided to display the aircraft as is, in consideration of where it is located in the museum: in its current state it is the last near-complete aircraft the visitor sees before exiting, and immediately before a space dedicated to interpreting various functions and systems (Figures 6.4 and 6.5). So in a sense this exhibit sets up the visitor to engage and ask questions. Displaying a partially-restored aircraft is not a profound concept, as many exist in exhibits all over the world. In creating the interpretation, however, I included both the history of Norseman aircraft in Norway, this particular Norseman, and then also highlighted the history of the restoration team and their contributions to the museum over the years (Figures 6.6-6.8). I used the narrative to point out which aircraft in the exhibit were restorations, as well as their in situ environments and conditions. The interpretation then expanded even further to discuss the differences in the aircrafts' conservation, preservation, and restoration, and what various aircraft components look like prior to restorative work.

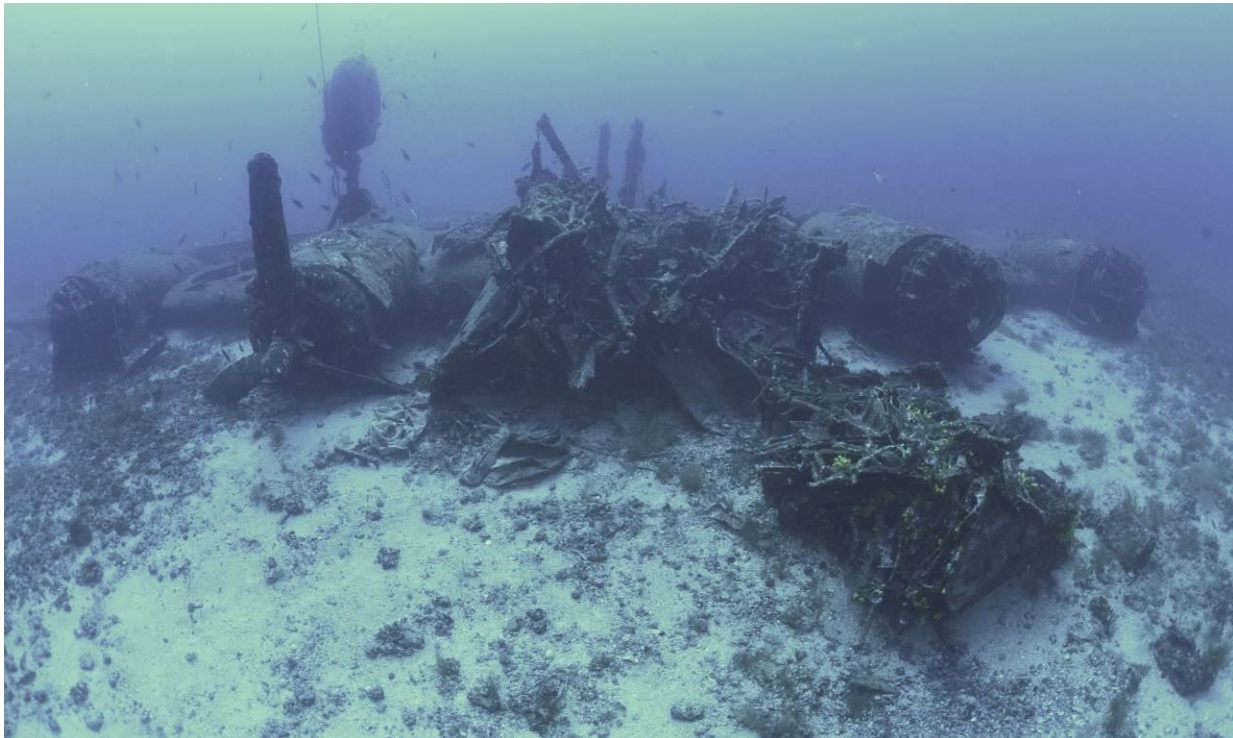
Figure 7.19- *The Tusamerican* center section. The cockpit lies in the front right. Photo by Danijel Frka.

The wrecking event heavily damaged the rest of the fuselage in the forward section and almost completely detached it from the wing section. The flight engineer's compartment remains attached, but the floor and some side fuselage have been ripped away. The cockpit's instrument control panel and yokes connects to the rest of the fuselage by a small area of skin, but the assembly lies open and away towards the starboard inboard engine (Figure 19). There is no evidence of the navigator's compartment, except for a small piece of skin and structure around 3-4 m in front of the cockpit area. The nose gunner's turret lies around 30 m south of the wing center section, near to the ridge drop-off (Figure 20). The nose guns were removed in 2010 by the Ministry of Culture.

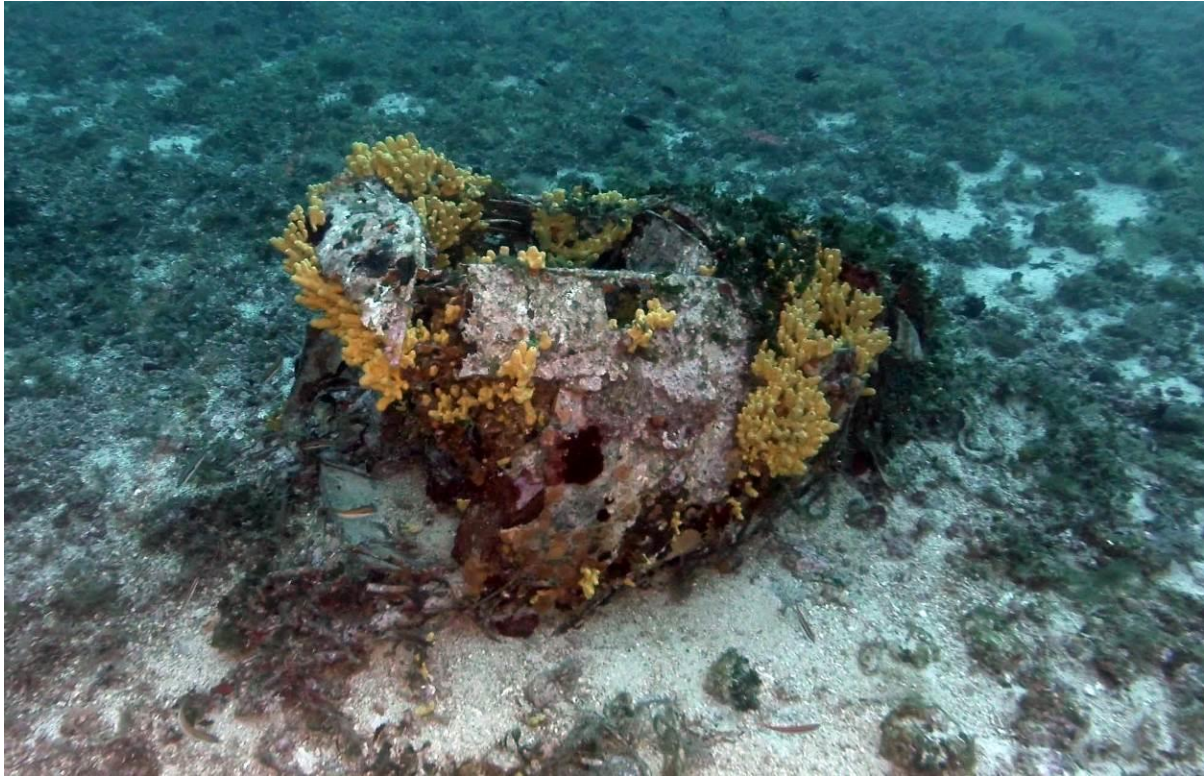
Figure 7.20- *The Tulsamerican's* disarticulated nose turret. Photo by Danijel Frka.

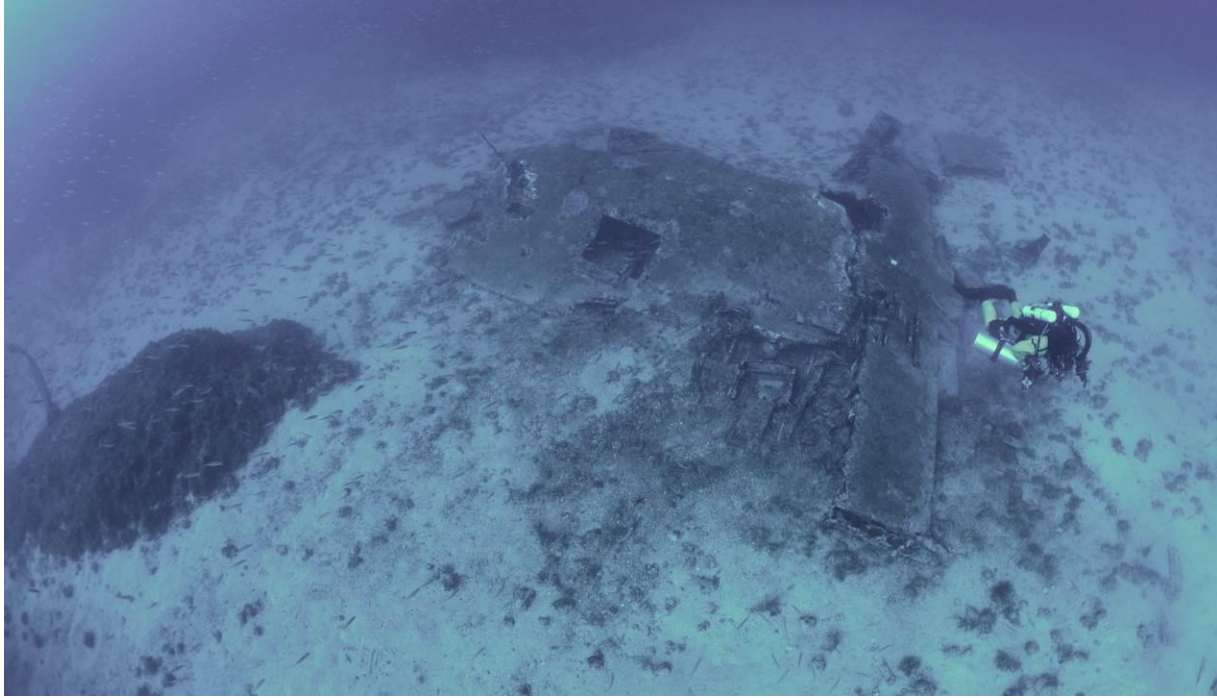
Figure 7.22- *The Tulsamerican* tail section. Note a propeller propped up against a boulder in the left part of the image. Photo by Danijel Frka.

The tail section of *The Tulsamerican* lies upright to the north of the center section just beyond the ridge drop-off at 52 m (Figure 21). The tail fuselage appears largely intact but somewhat flattened in the lower belly (Figure 7.22). Several oxygen tanks remain inside the tail, both pressurized and unpressurized, while more lie scattered in the vicinity. The ball turret fills the interior of the forward tail upper compartment and its transmission assembly juts out of the skin through a hole. Both machine guns in the side windows remain mounted in place. There is heavy damage to the tail assembly and the horizontal stabilizers appears broken. Both of the vertical stabilizers broke off either in the wreck or at deposition; the starboard one lies

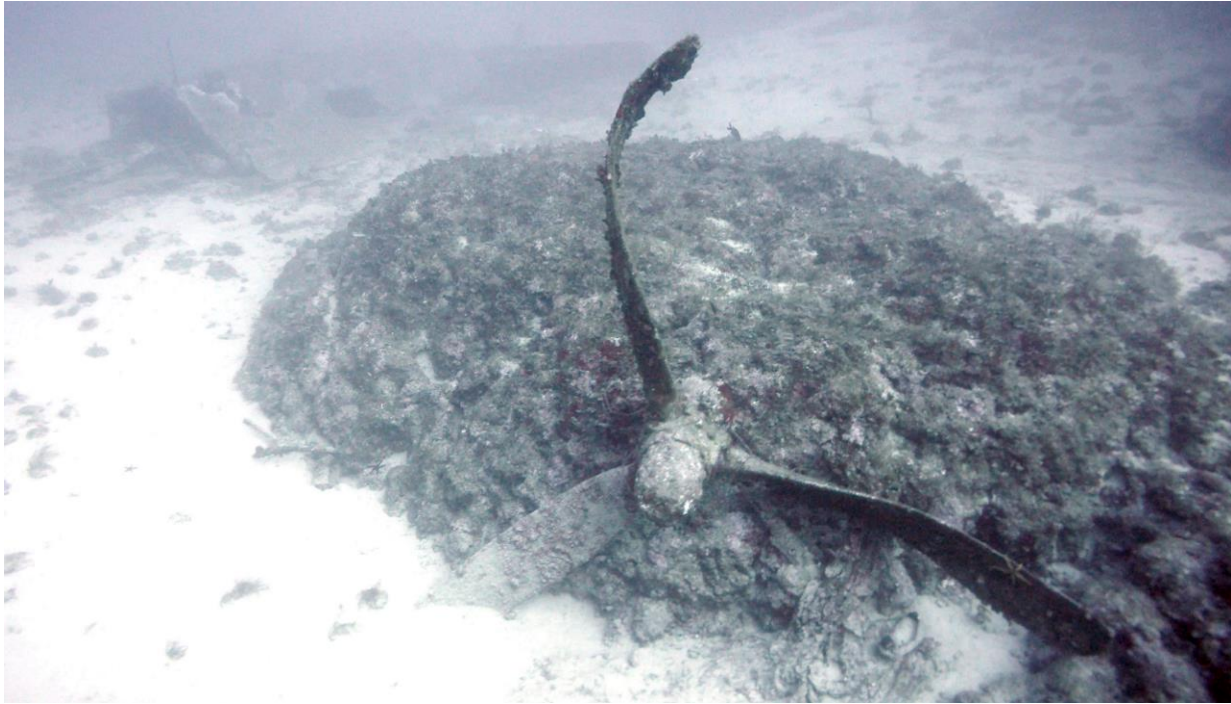
Figure 7.23- A propeller propped up against a boulder close to the tail section, which is visible in the far left. Photo by Andreas Sannerman.

Small, disarticulated pieces of the wreck lay scattered at this lower depth, the largest of which is a propeller laying propped up on a rock to the east of the tail section (Figure 7.23). A large sheet of bomb bay door lies nearby and closer to the ridge. Our team found two other propellers and more metal debris within 200 m of the tail section.

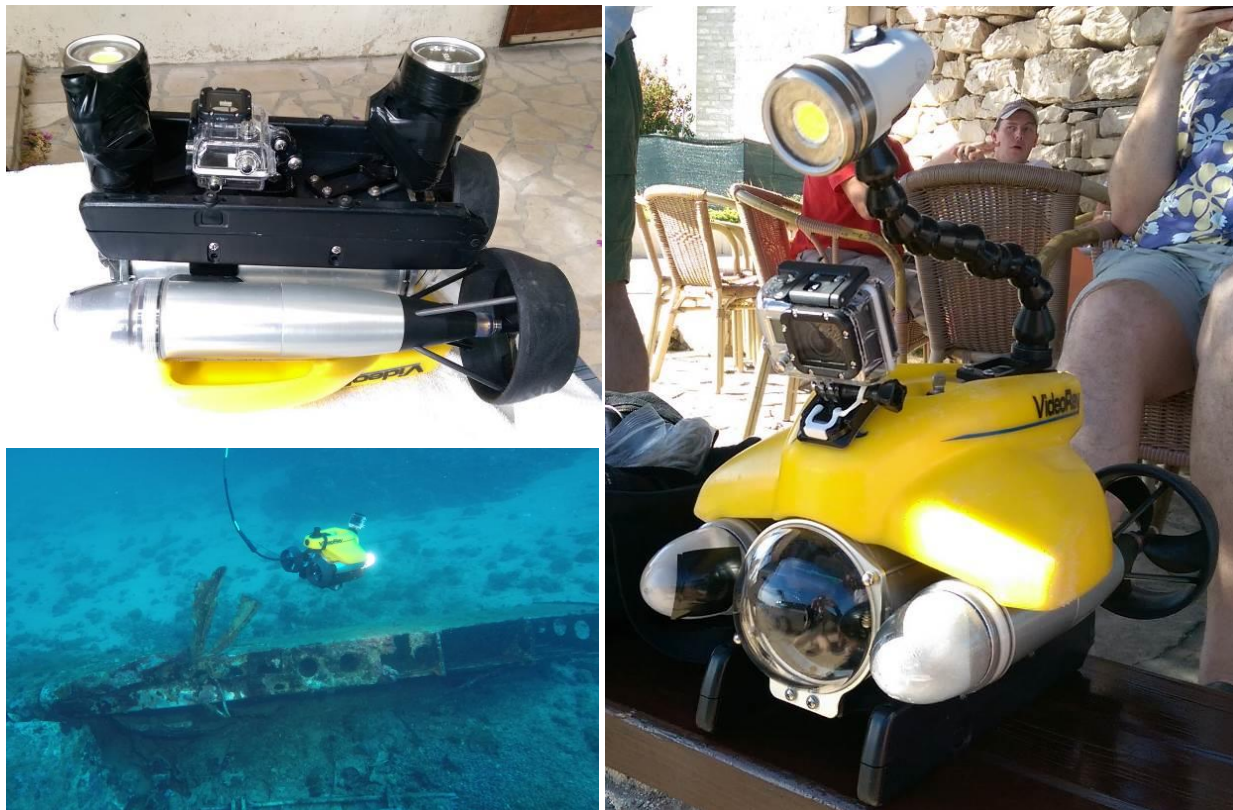
Figure 7.24- A VideoRay Pro4 ROV with GoPro cameras attached. Photos by the author.

The methodology of acquiring images for 3D modeling on shipwrecks has, over the past year, been modified for maximum efficiency.²³¹ Many aircraft wrecks present as dissimilar in deposition to shipwrecks and may contain upright or tall features perpendicular to the sea floor. Because of this, we used both divers and a mini VideoRay Pro 4 ROV equipped with GoPro 3+s and 4s to fly specific patterns over the wreck (Figure 7.24). For 2D photomosaic mapping, I

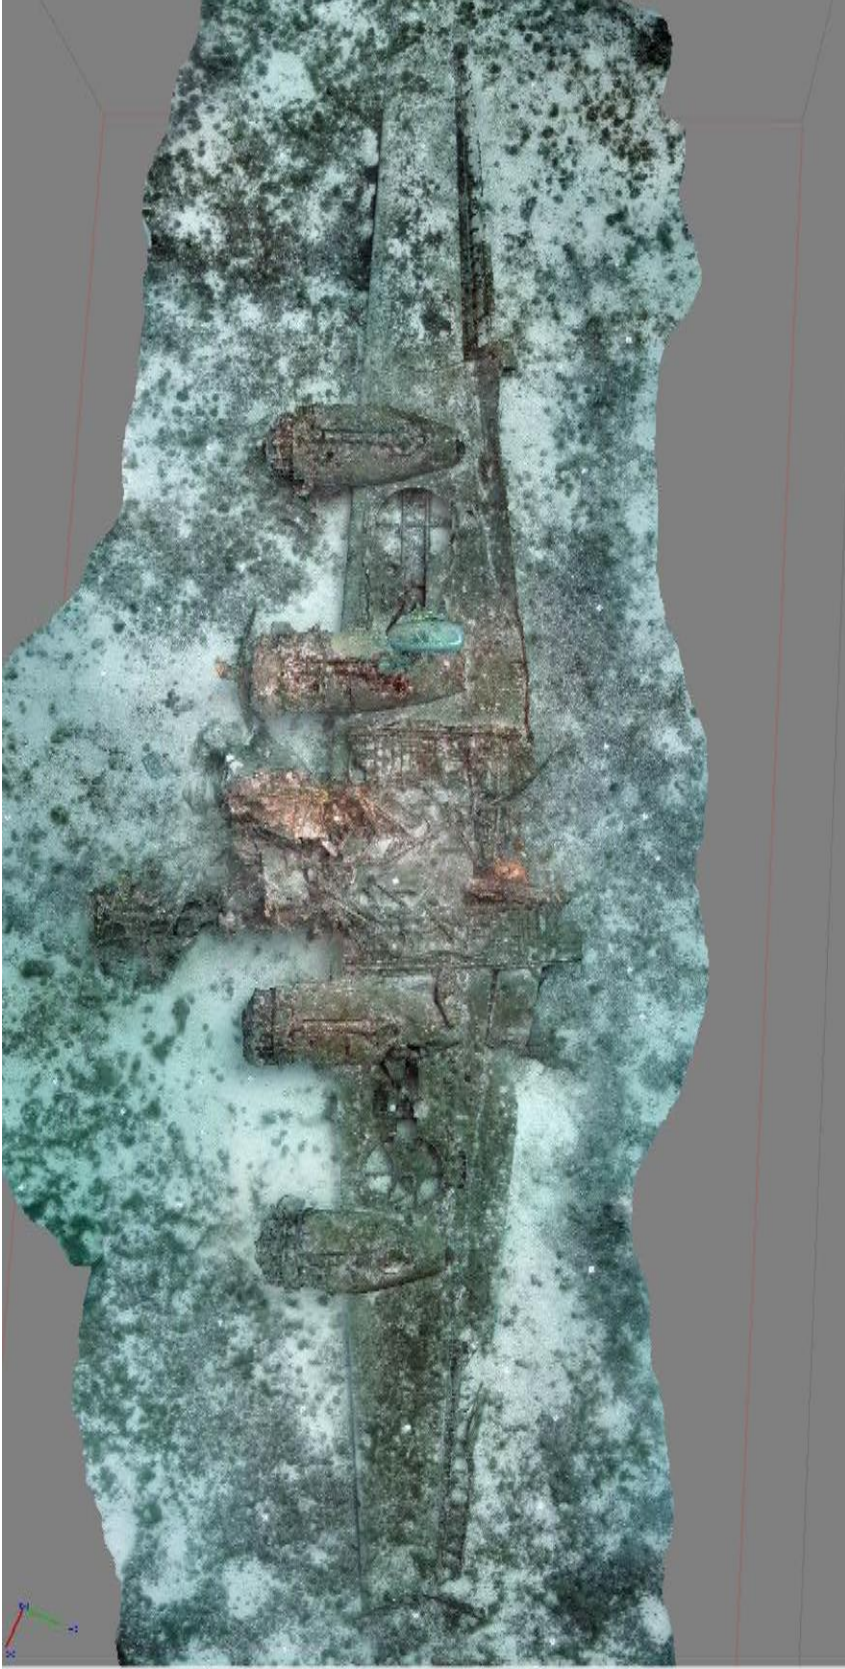
Figure 7.25- 2D view of the center section, *The Tulsamerican* wreck site. Model by the author.

instructed our ROV pilot to perform a modified mow-the-lawn pattern at different heights above the wreck in order to have good lighting for all areas and not cut off areas that were taller than the ROV was flying. This pattern was successful on the center section, but unreliable in terms of blurry photos on the tail section, usually because of the current (Figure 7.25). For the tail 2D photomosaic, I asked one of our project divers to swim the modified mow-the-lawn pattern, this time including a circular pattern around the propeller up against the boulder while switching camera angles to capture all surfaces with adequate lighting (Figure 7.26). The 2D models are impressive and provide measurable context for the wreck, but, as suspected, this pattern resulted in a loss of detail on the sides of the aircraft (Figure 7.27).

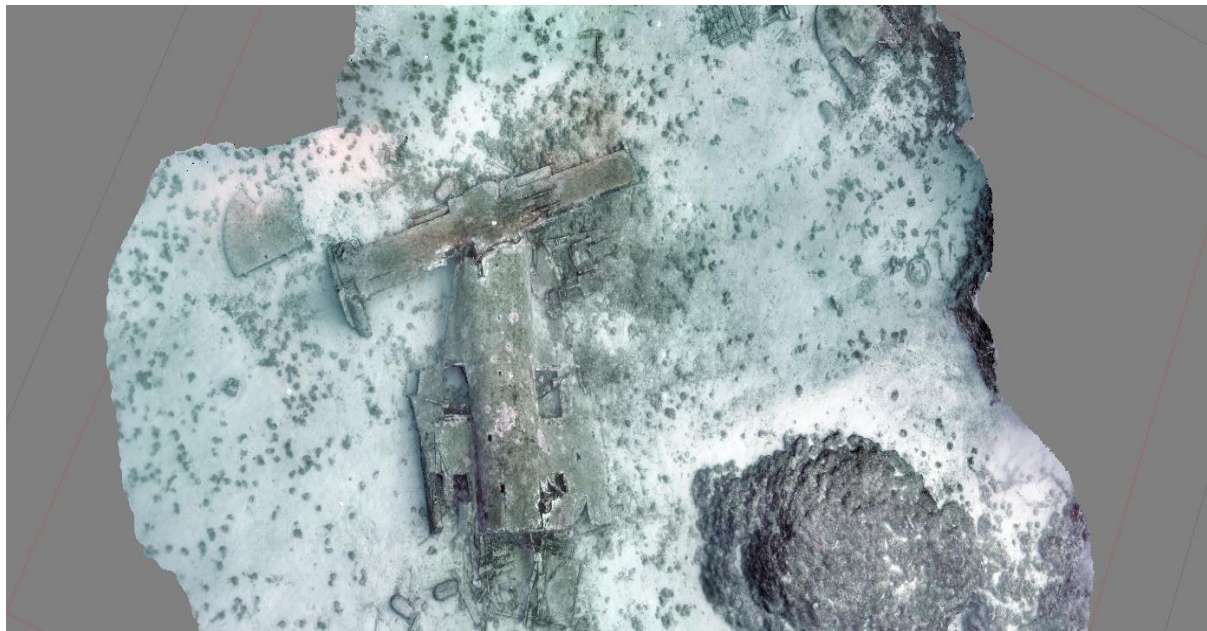
Figure 7.27- Bird's eye view of *The Tulsamerican* tail section site. Model by the author.

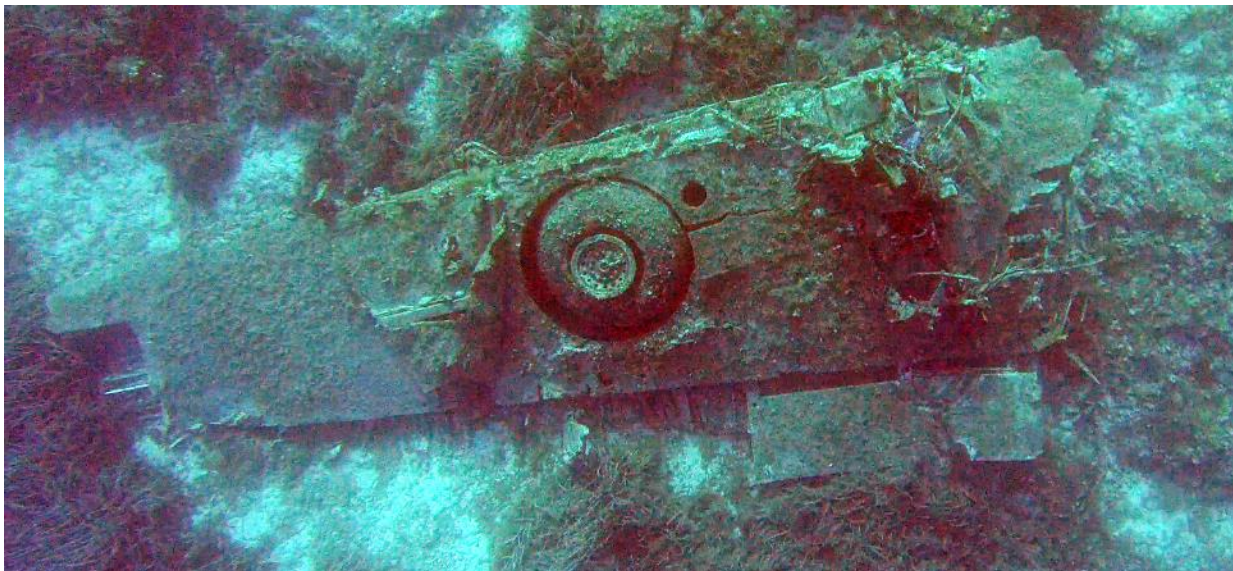
Figure 7.34- This B-24 starboard wing is located in a shallow bay on the northwest side of Vis at 14 m. It presents visually as intact except for either wreckage or drag damage, with almost no pitting loss or encrustation and only a thin layer of marine growth. Photo by Dr. Bridget Buxton.

Currently, there are three other B-24 starboard wings in known locations around the island that are under 40 m depth. Divers discovered two other complete B-24 wreck sites in 2016 near Bisevo at 90 m and Svetac at 110 m depth. For the experiment I took corrosion readings from, and performed visual analysis on, two of the aircraft wings- one at 14 m and the other at 31 m, and *The Tulsamerican's* wing. Each of these single-wing sections were netted and carried into shallow bays by local fishermen, where they were dumped prior to 1970 (Figures 7.34-7.35).

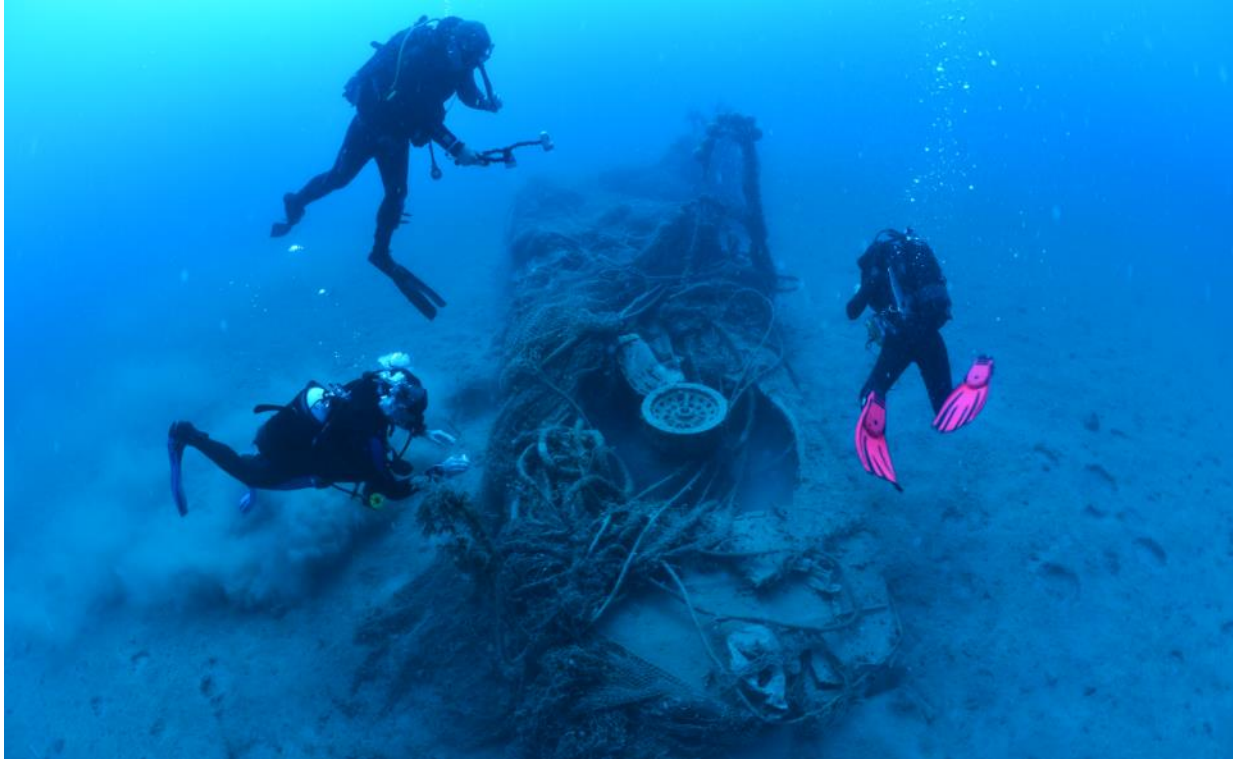
Figure 7.35- This B-24 wing lies close to the shore in the harbor of Komiza at 31 m deep. It was difficult to visually survey this wing as it is almost completely covered in netting. This starboard wing is missing both the leading and trailing edges, the tire, and the engines. Our team, the author on the right, is taking images for a 3D model and performing the corrosion potential analysis. Photo by Danijel Frka.

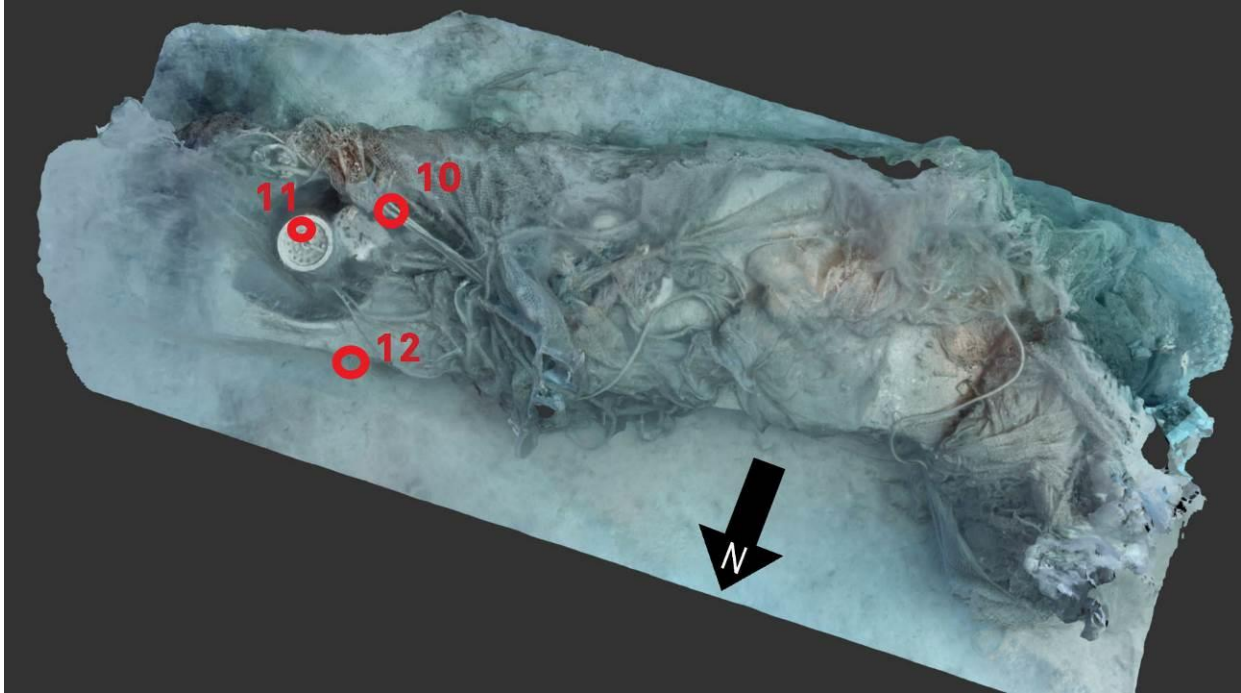
Figure 7.38 Measurement locations on B-24 Wing Komiza. Photo by the author.

I used a corrosion potential measurement device loaned from the Department of Materials Conservation at the Western Australian Maritime Museum. The device comprises two meters, a pH reader and a voltage reader, combined in a deepwater housing. The pH meter has a flat-surface measuring electrode with a rubber cuff and the voltage meter has a seawater reference electrode and a platinum pointer for metal contact. I took corrosion potential readings on multiple points on the skin and light structural areas of three starboard B-24 wings and pH

readings from two (Table 7.2) (Figures 7.36-7.38).²⁴³ I took the readings by placing the pH reader against a freshly scraped small surface area, followed by the tip of the voltage meter electrode. The next year, I observed that marine growth had reappeared over the scraped areas.

<i>B-24 Wing, Komiza</i>	Starboard wing, near wheel well and landing light	N/A (6.53)	-0.728	-0.2915	31.3m	10
<i>B-24 Wing, Komiza</i>	Metal wheel	N/A	0.728	-0.2915	31.5m	11
<i>B-24 Wing, Komiza</i>	Wing edge	N/A	0.728	-0.2915	31.9m	12

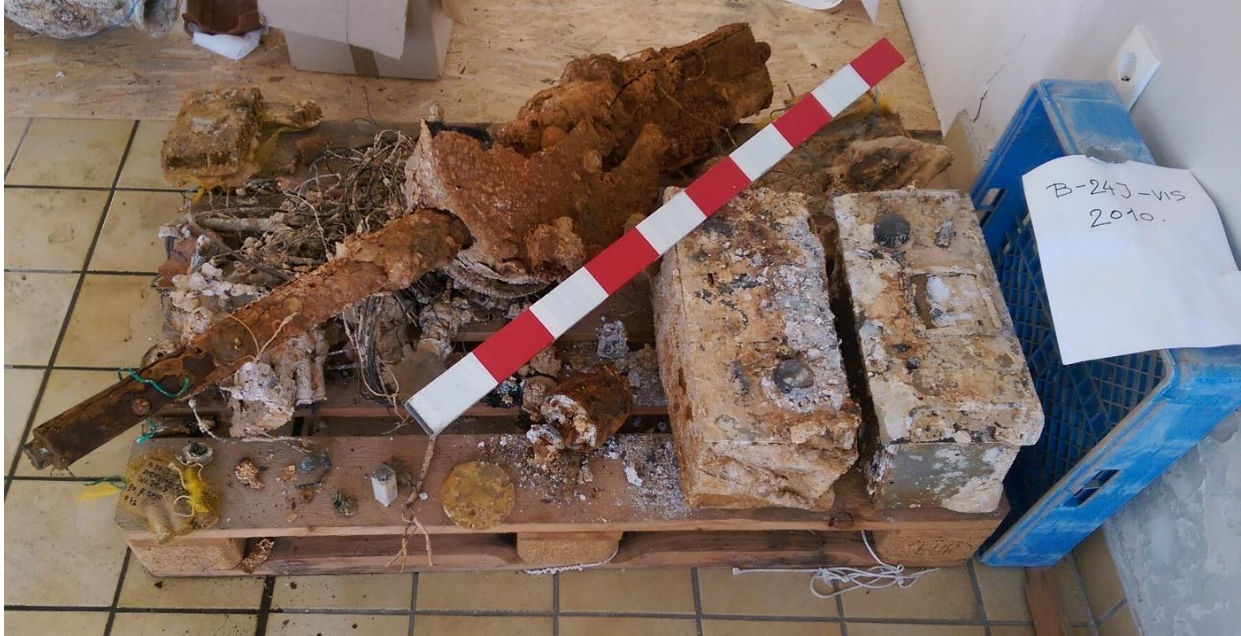
Figure 7.40- Artifacts removed from *The Tusamerican* site in 2010. Photo by the author.

The Croatian Conservation Institute removed several artifacts from *The Tulsamerican* site in 2010 prior to opening it for recreational diving. Ministry officials kept these artifacts in wet storage until 2013 when the conservation department of the Croatian Ministry of Culture was reorganized. Officials then removed the artifacts, except for one, from wet storage and placed them on a wood pallet in warehouse storage in Split (Figure 7.40). The artifacts consisted of a Browning machine gun and shells, two aluminum radios, a wallet, a flak jacket, a signal lamp, an electric plug, and other unidentified debris. Unfortunately, the items are quickly deteriorating. Only one artifact, the data plate removed from the cockpit, received conservation treatment. I documented these artifacts in 2014, including photos for a condition baseline and for 3D modeling. Artifacts from this wreck also exist in private collections.

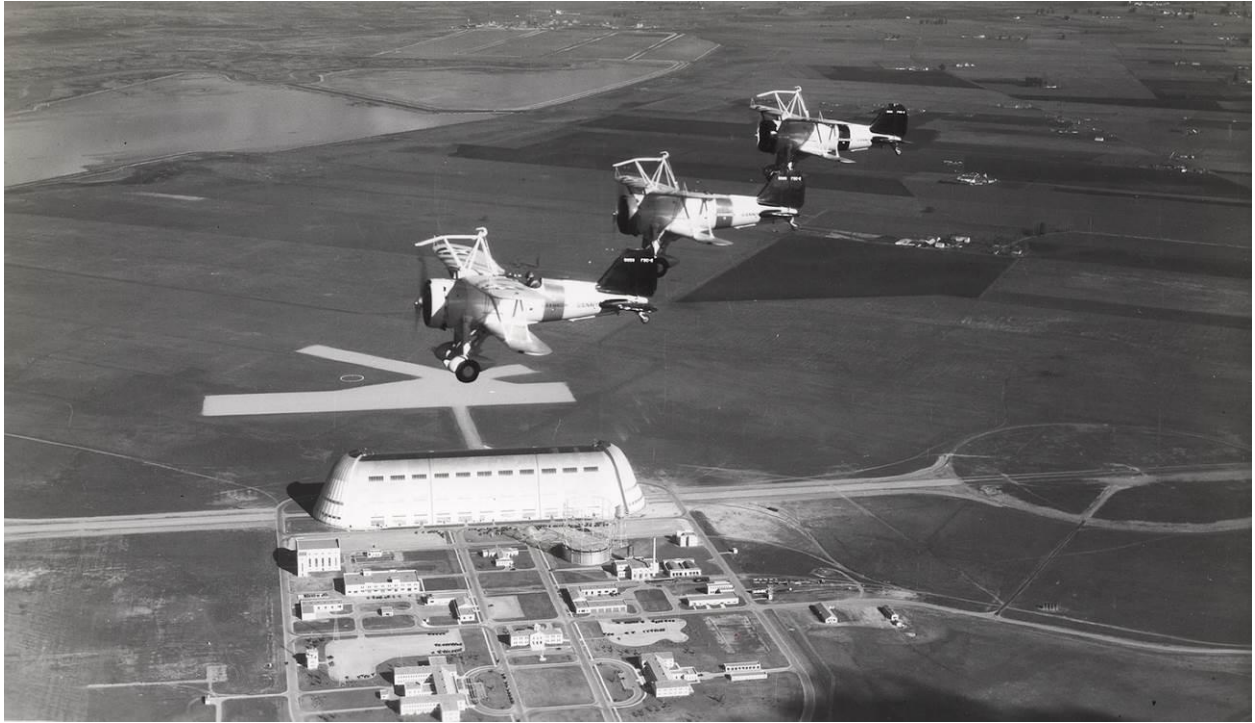
Figure 8.4- F9C-2 Sparrowhawk aircraft flying in formation over USS *Macon*'s hangar at Moffett Field, CA. Photo from the Wiley Collection, NASM.

The F9C type parasite aircraft is a light biplane with a steel and aluminum structure covered in doped fabric (Figure 8.4). The F9C-2s were designated ‘Sparrowhawk’ in keeping with the tradition of naming Curtiss fighters after hawks. F9C aircraft were planned to improve the scouting capabilities of the ZRS airships by the two working together in a mother ship/scout-type partnership. The US Navy chose them because of their small size, which allowed them to fit through the airship’s hangar door space, and low weight. The F9Cs were designed to launch, maneuver around the airship hangar, and ‘attach’ to the airship via a trapeze system lowered from the hangar (Figure 8.5). As such, the insignia for the aircraft was a stylized logo of a large circus performer man on a trapeze extending his arms to catch a smaller man (Figure 8.6).

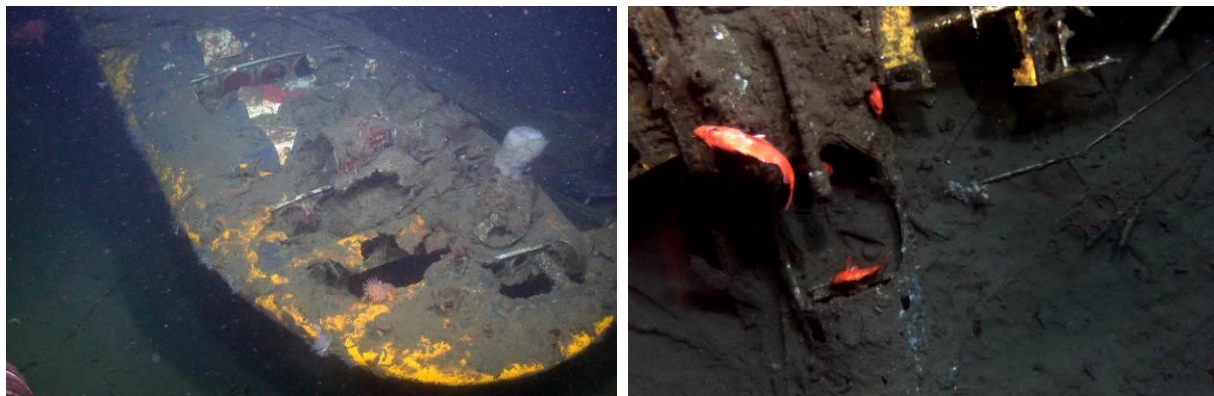
Figure 8.13- (L) Fabric skin and the remains of the US Naval insignia painted on the top of a F9C-2 Sparrowhawk wing, USS *Macon* field A in 2006. (R) Yellow wing fabric and blue fuselage skin on an adjacent biplane in 2015. Photos courtesy of NOAA/MBARI/OET.

The remains of *Macon* lie at 441 m deep approximately seven miles south of Point Sur, California and approximately three nautical miles west of the coastline (Figure 8.12). It is a sandy bottom with a significant amount of loose sediment and marine life. There is some small coral growth on the aluminum pieces but surfaces are mostly covered with a thin layer of marine biofilm or small biological creatures. Metal remains on site range from fragile and corroded to barely deteriorating. Stainless steel items, like the landing gear struts, the brass components of the trapeze hooks, and some aluminum pieces do not show any signs of decay while a large portion of aluminum aircraft and airship remains show exfoliation and pitting corrosion. Impressively, the doped canvas covering for the fuselage and wing surfaces remains present and visible on biplanes 1, 2, and 4, with Biplane 2 showing a clear partial US Navy insignia on the upper wing and Biplane 1 a clear marker band aft of the cockpit (Figure 8.13).

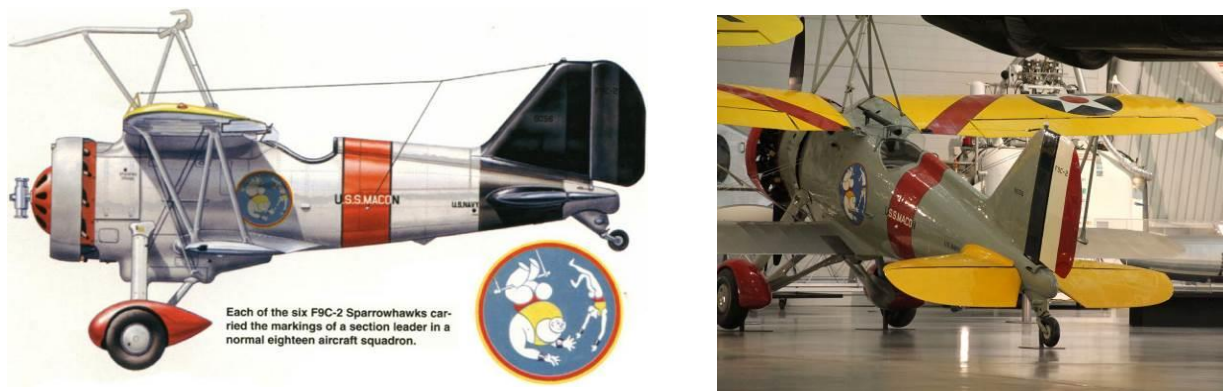
Figure 8.17- The markings of the F9C-2 Sparrowhawk aircraft. Photos courtesy of NASM.

Individual identification of each aircraft is not essential for understanding site formation and will not change any historical record, but adds to our further understanding and correct characterization of the site. Using video from both surveys, I made positive identifications of each aircraft by discerning the different squadron leader color worn by the aircraft on its wings, fuselage, and engine cowling (Figure 8.17).

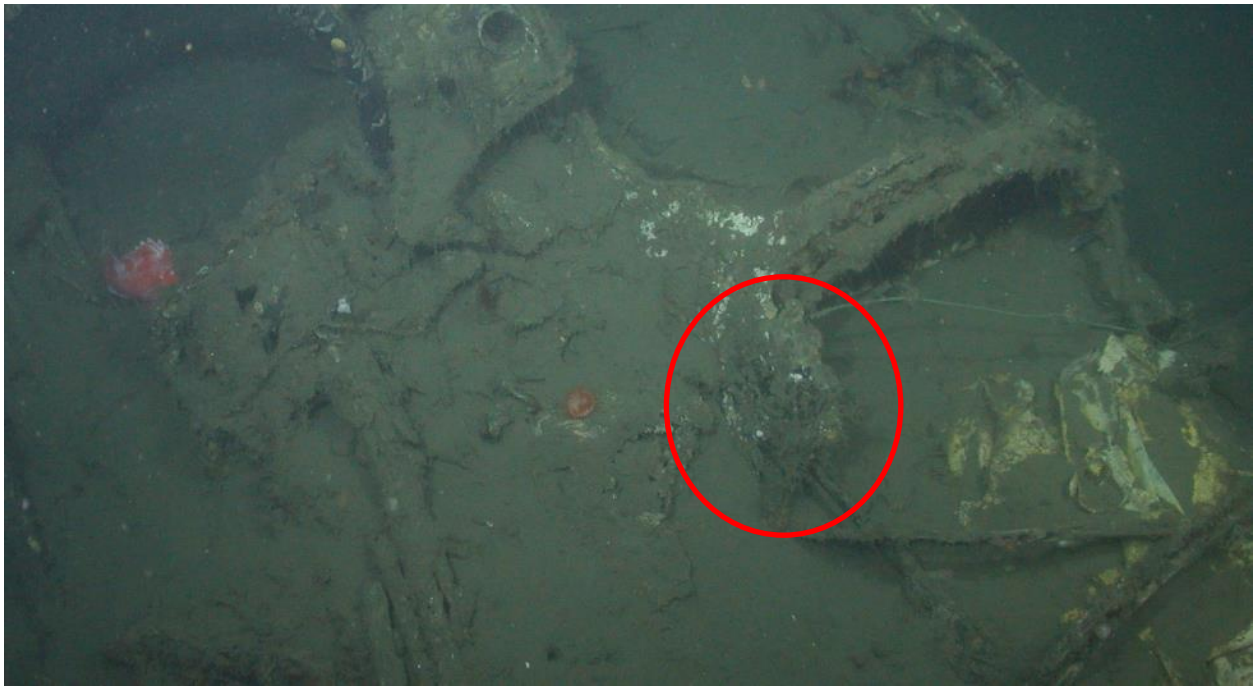
Figure 8.18- (Top) A faint yellow line on the wing top indicates the yellow chevron of 9061. (Bottom) Black paint is visible in the band behind the cockpit. Video stills courtesy of NOAA/MBARI.

amazing level of preservation. Still, a piece of wood debris covered the exact area where the wing chevron would be. In the final hours of the 2006 project the ROV pilot moved this debris and exposed the wing surface. A light line demarcated an area of faded yellow paint (Figure 8.18). None of the aircraft were wearing squadron leader colors in yellow, but F9C-2 9061 had been repainted from yellow to black in 1934. The paint chevron has faded substantially, likely from being in contact with decaying organics and as a result both layers of chevron paint are nearly gone. Only the bottom, yellow layer remains visible on the wing, but a medium-sized area of the fuselage aft of the cockpit can be seen on the port side and it appears black. This aircraft can be positively identified as Serial Number 9061.

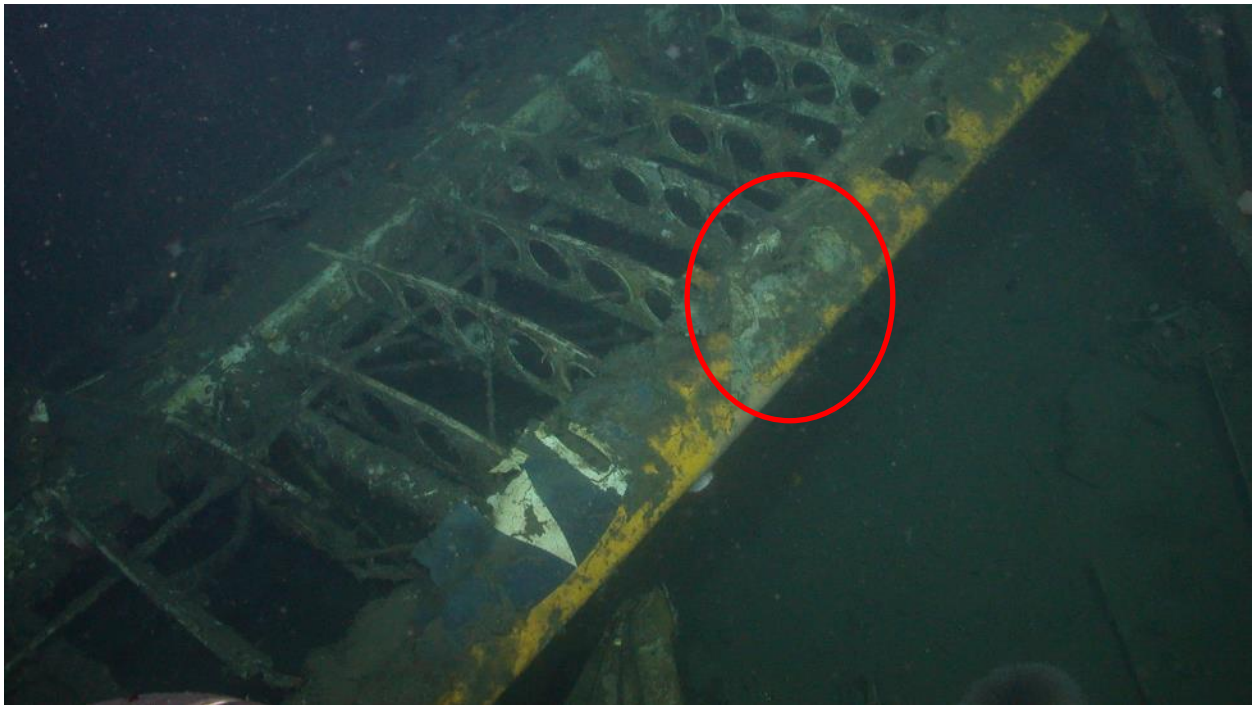
Figure 8.19- A faint blue line on the wing top indicates the blue chevron of 9060. Notice that the color of the chevron is fading faster than the bright blue and white of the nearby naval insignia. This indicates a different type of paint used and supports the idea that the black chevron faded off the yellow chevron of 9061. Video still courtesy of NOAA/MBARI.

Biplane 2 is next to Biplane 1 with its wings aligned to face slightly to the northwest (Figure 8.19). In 2006, during the NOAA/MBARI survey the leading edge of the starboard wing was visible and the forward end of a blue wing stripe could be seen. The 2015 survey revealed a striking blue color band visible on the fuselage aft of the cockpit. This aircraft can positively be identified as Serial Number 9060.

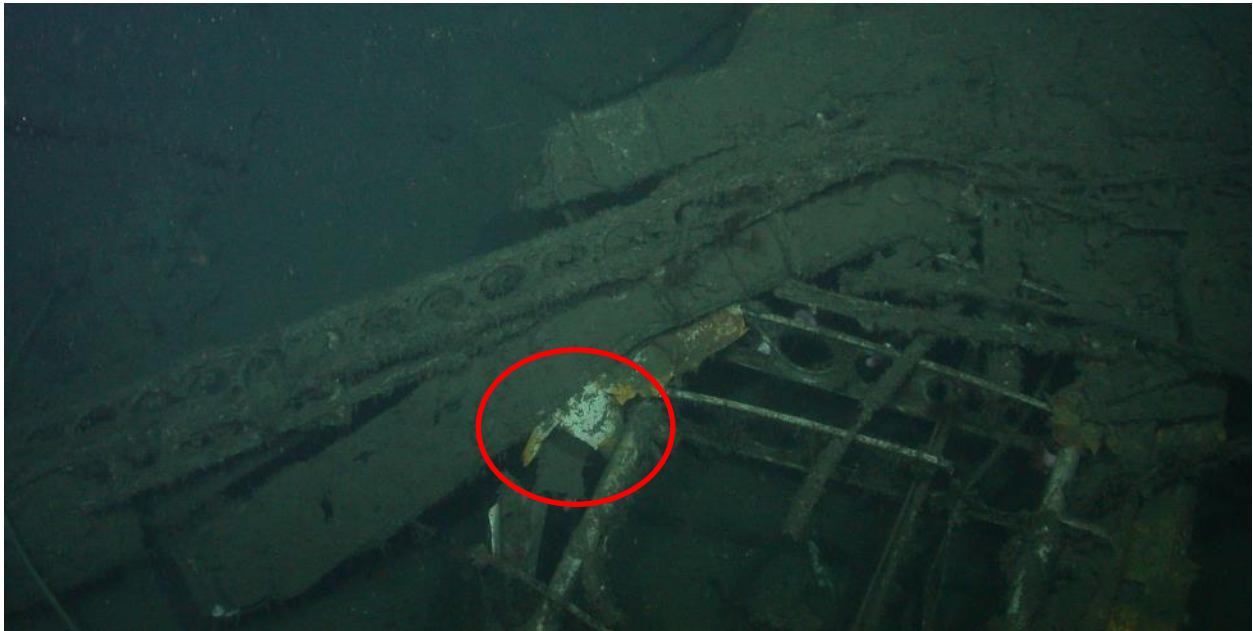
Figure 8.20- 2006 video of the NOAA/MBARI survey showing the port wing of Biplane 3, 9059, and the scrap of white chevron. Video still courtesy of NOAA/MBARI.

Biplane 3 is located southeast of biplanes 1&2 and is facing north. Like Biplane 1, there is a piece of wooden debris draped over the port wing section. Unlike the other biplanes, however, Biplane 3 is the most deteriorated and shows little evidence of wing fabric remains. The engine cowling and fuselage appear to be either crushed or buried deep underneath sediment and cannot be seen in both surveys. In the 2006 video one scrap of wing fabric with white paint remains visible in the chevron's location on the port wing (Figure 8.20). The rest of this chevron has disappeared with the fabric. Unfortunately, that scrap of fabric has also disappeared in 2015. This aircraft can be positively identified as Serial Number 9059.

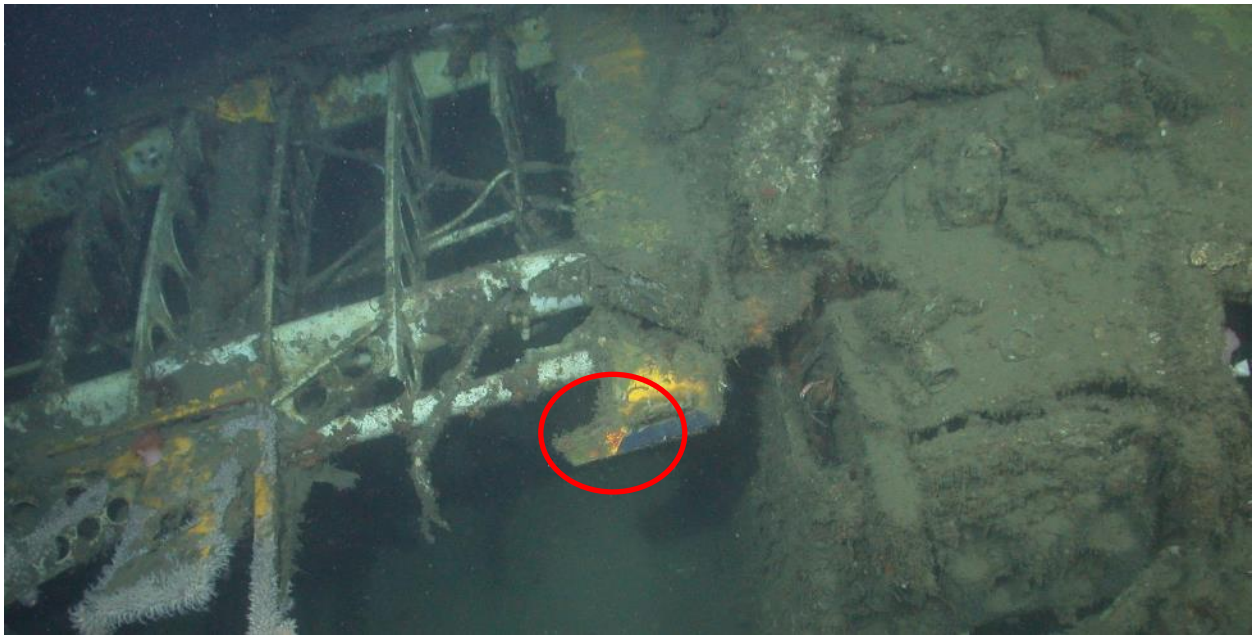
Figure 8.21- Biplane 4, 9058, with the remains of the red chevron visible on the wing edge. Video still courtesy of NOAA/MBARI.

Biplane 4 is situated to the northeast of biplanes 1&2 and faces southwest. This aircraft lists slightly upwards on its starboard wing and the port wing's outermost edge lies buried in sediment. In the 2006 and 2015 survey videos patches of bright red chevron can be seen on the port wing pull tabs and on the port leading edge (Figure 8.21). This aircraft can be positively identified as Serial Number 9058.
