AVIATION ARCHAEOLOGY: HISTORY, THEORY, PRACTICE AND DIRECTION

A Dissertation

DOCTOR OF PHILOSOPHY

August 2018

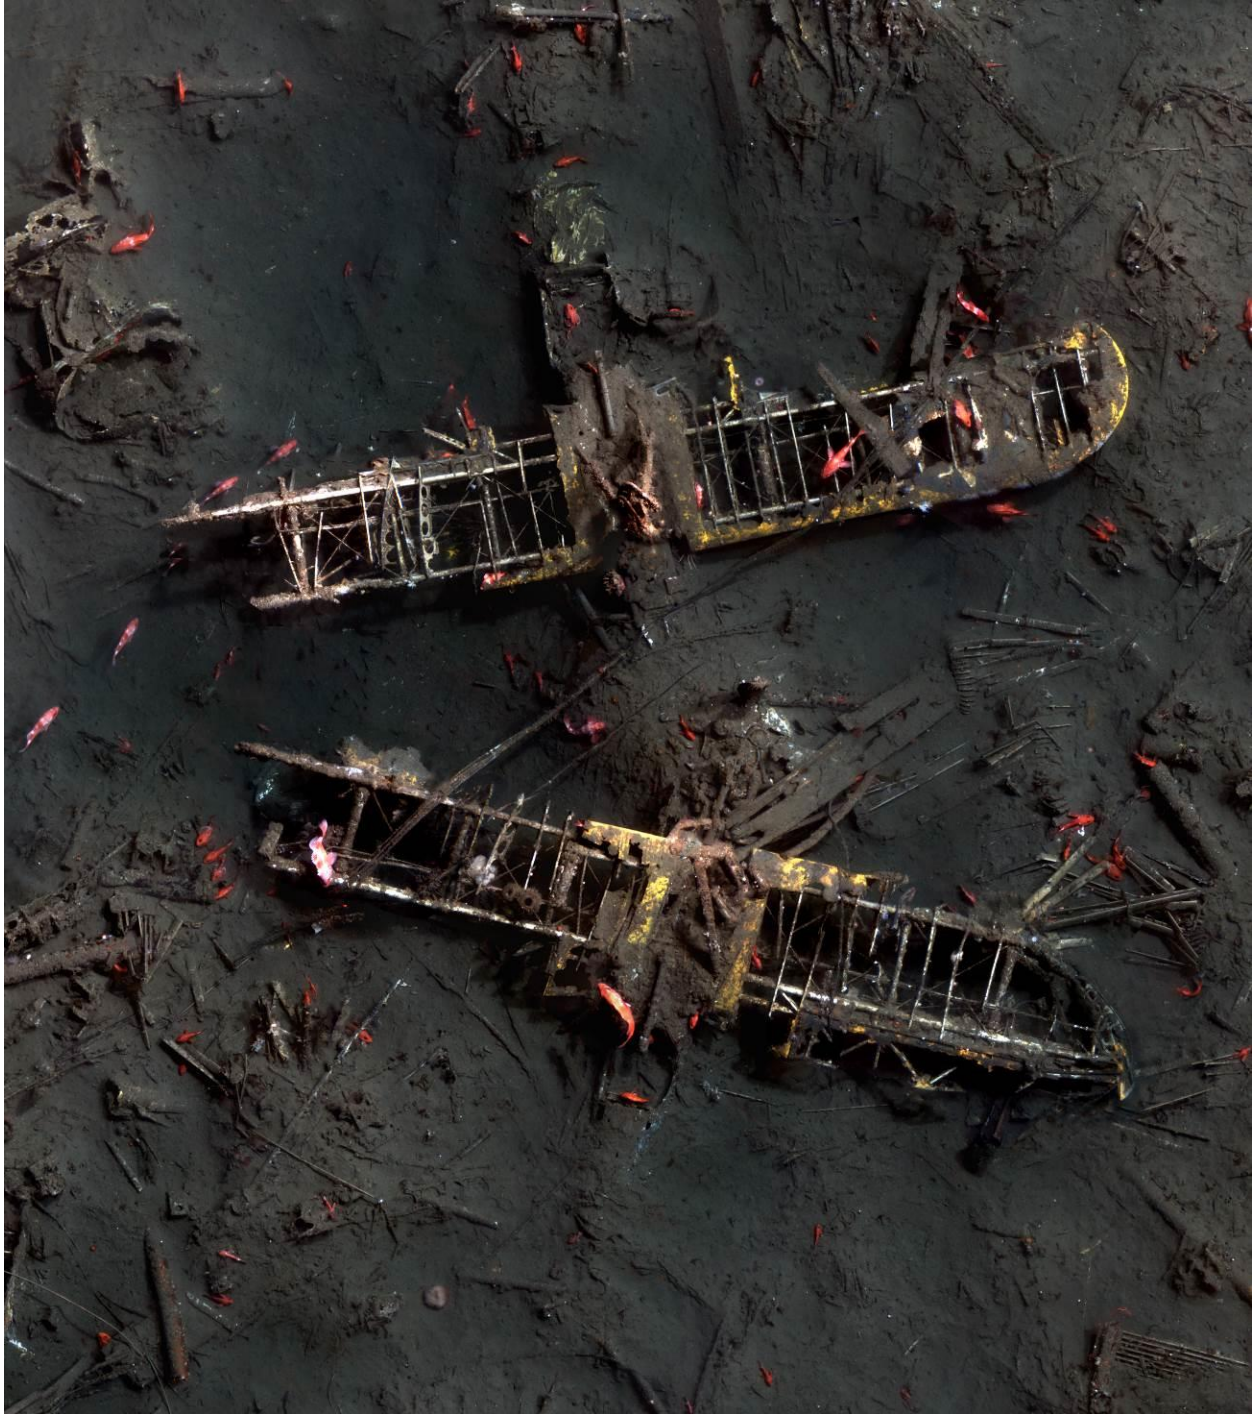
Figure 8.24- Photomosaic of Biplane 1 (top) and 2 (bottom) from the 2015 NOAA/OET survey. Photomosaic by Clara Smart, Roman Lab @ URI for NOAA, corrected by the author.

Macon's wreck site has been photographed and filmed at three points over the last 25 years. These three surveys serve as points on a timeline of deterioration that we can track through the comparison of several smaller wreck section. Biplanes 1&2 are the most photographed area of the wreckage. In 1992 National Geographic published the first photomosaic images of Biplanes 1, 2, and 4.²⁶⁵ The bird's eye images showed that the planes were intact, but associated with a large amount of various debris. It also showed that even though the aircraft were decaying, they retained some of the fabric covering the wing sections. A comparison of this same bird's eye view from photomosaics of 2006 images and 2015 images outlines the changes in the airplanes and surrounding area as well as highlights the development of camera technology and photomosaicking methodology over the same period (Figure 8.22-8.24).

There is relatively little change in the starboard wing between 2006 and 2015 except for the loss and movement of several ribs. We suspect this is due to fish movement from our observations of their activity during the survey. Increased sediment can be seen on the wing roots but no changes to the skyhook or gunsight are visible. Removal of debris covering the port wing surface during the 2006 survey exposed more of the naval insignia, but increased deterioration since then decayed more of the insignia's center. No ribs on the port wing are missing but a few appear to be jostled slightly out of place. The fuselage appears to be in the same condition as 2006, making this aircraft the most intact remaining today. The photomosaic is also the first that allows for studying the sediment's color, texture, and items that are hidden but still outlined on the sea floor.

Biplane 2 has experienced a significant level of structural deterioration between 2006 and 2015. On the wings especially, we see direct evidence of a breakdown in the strength of the aluminum structure. The port wing's aileron frame and attachment spar have disarticulated from the frame, the trailing edge spar is broken, and the broken piece is hanging off it where rib 12 would have been. The port wing lacks the leading edge after rib 3 and ribs 8-16. One flap of leading edge skin with the naval insignia is clinging to the leading edge, but now below the wing structure itself. The center section appears to be the only area that has not deteriorated significantly. Less debris covers this area and the skyhook, gun, sight, fuselage, and engine all remain intact. In the 2015 photomosaic the blue band aft of the fuselage appears visible, as well as the bright white of the engine shutter. Half of one wooden propeller sticks up out of the sediment. The deterioration of Biplane 2's starboard wing is also substantial, with a structural failure in the leading edge spar causing the collapse of the outer wing at rib 11. The aileron frame is somewhat intact closer to the fuselage and is missing closer to the wing tip. The leading

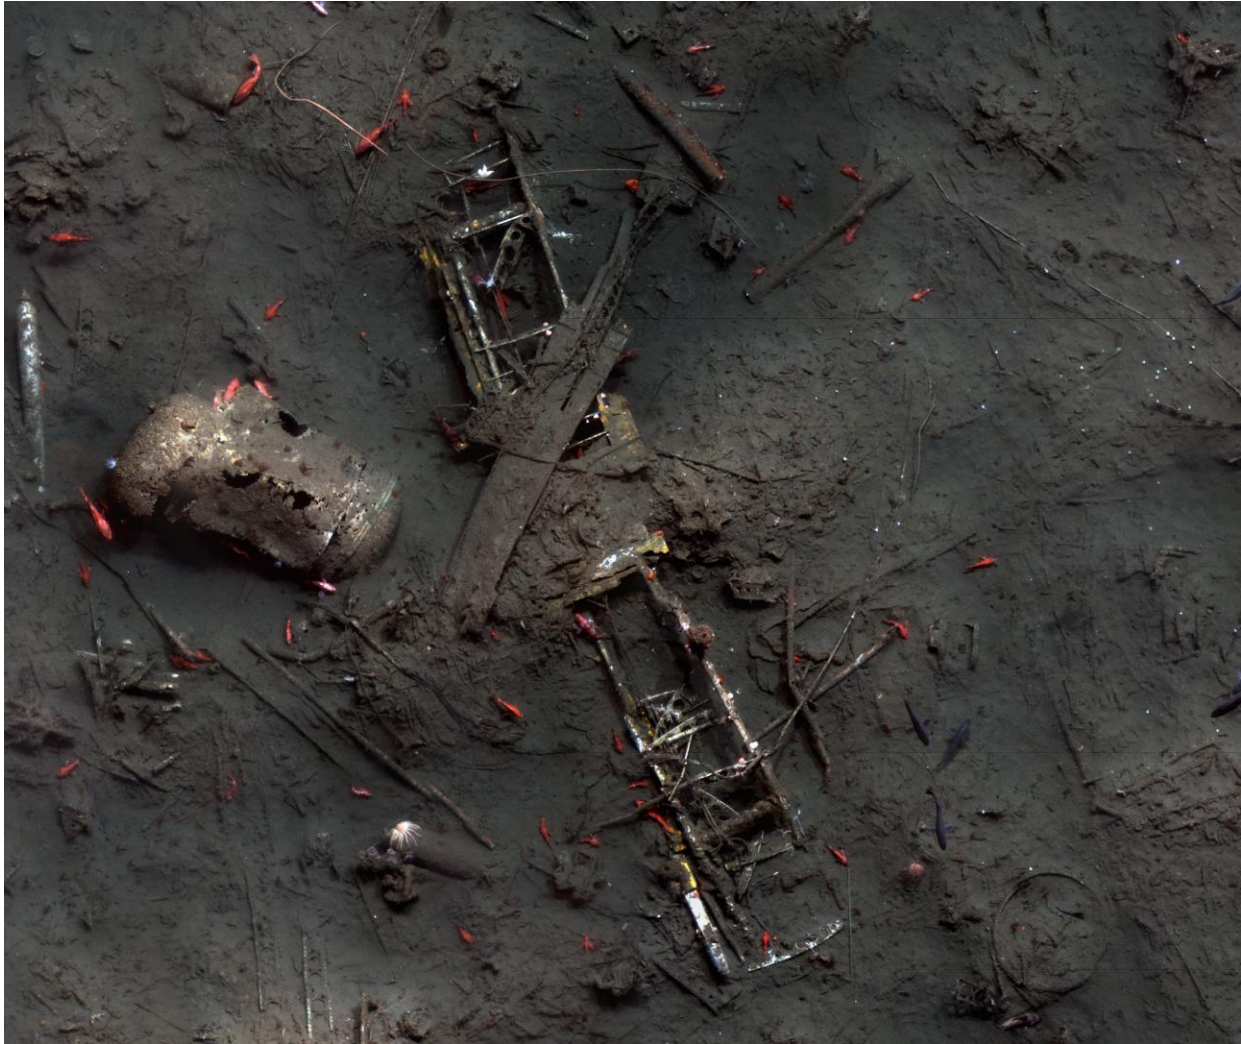
Figure 8.25- Photomosaic of Biplane 3 from the 2015 NOAA/OET survey. Photomosaic by Clara Smart, Roman Lab @ URI for NOAA.

Biplanes 3 was not photomosaicked consistently so the following deterioration summary is based on video and photos from each survey. In 1992 Biplane 3's wings appear to be supported by their lower struts and elevated off the sea floor. The skyhook lay on top of the center section but the US Navy recovered it near the end of the 1992 survey. In 2006 the starboard wing's leading edge retains fabric but the wing tip was either missing or buried in sediment. A large piece of wooden debris and airship frame lay across the middle of the wing. The port wing had no fabric covering and lacked ribs closer to the wing root, while the outer ribs remained in place. In 2015 the remains of Biplane 3 are the most deteriorated (Figure 8.25). The wings appear to have collapsed and retain no fabric, ailerons, and only few ribs. In the 2014 photomosaic, mounds both forward and aft of the center section indicate remains of the engine and fuselage, but nothing is identifiable through the sediment. The rate of deterioration appears consistent throughout each survey.

photomosaic shows a fuel can near Biplane 1, aft of the starboard wing, which is pitted to collapse throughout the middle section but the curved top is intact. This fuel can in 2015 has fully corroded on both its top and bottom. One fuel can aft of the port wing's trailing edge on Biplane 3 is nearly intact with only a few corrosion pits in the middle section in the 2015 photomosaic (Figure 8.25).

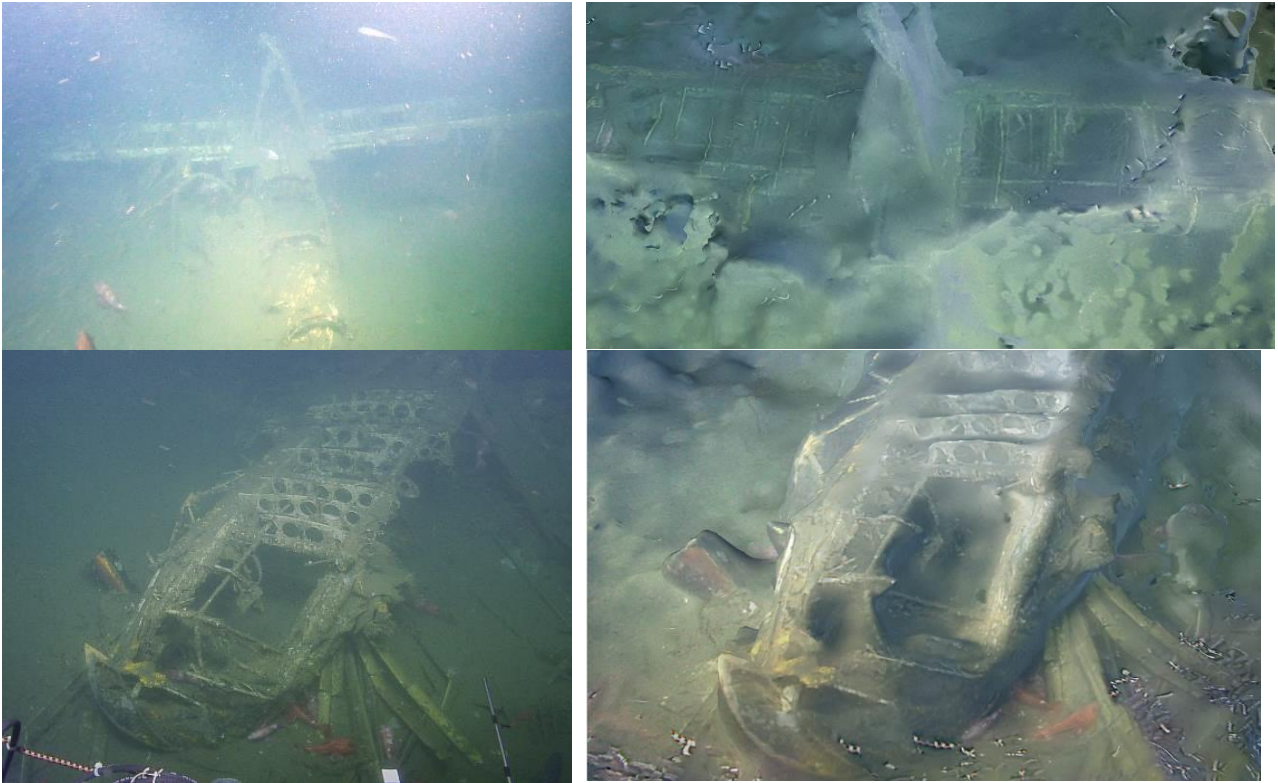
Figure 8.32- Average image quality versus the resulting area of the model. Model by the author, video courtesy of NOAA/OET.

As part of the 2015 survey I planned for, and we executed, a close-range circle pass of Biplanes 1 and 2 to obtain video for 3D modeling. This model is an excellent example of what is below a minimum acceptable standard for 3D modeling conditions, as the resulting model is noisy and incomplete (Figure 8.30-8.32). Because we began the survey at 04:00AM PST, we experienced optimal visibility for the photomosaicking portion of the survey. By the time we began the 3D modeling, the current had increased on site, sending billowing clouds of sediment in a roughly east to west direction. This created unequal conditions on aircraft sides for our ROV path in terms of maneuverability and position in front or behind sediment movement. Our shortened time frame on image acquisition reduced potential circles to one, although the onboard GoPro added what the program viewed as another pass. Still, this was not enough to make up for

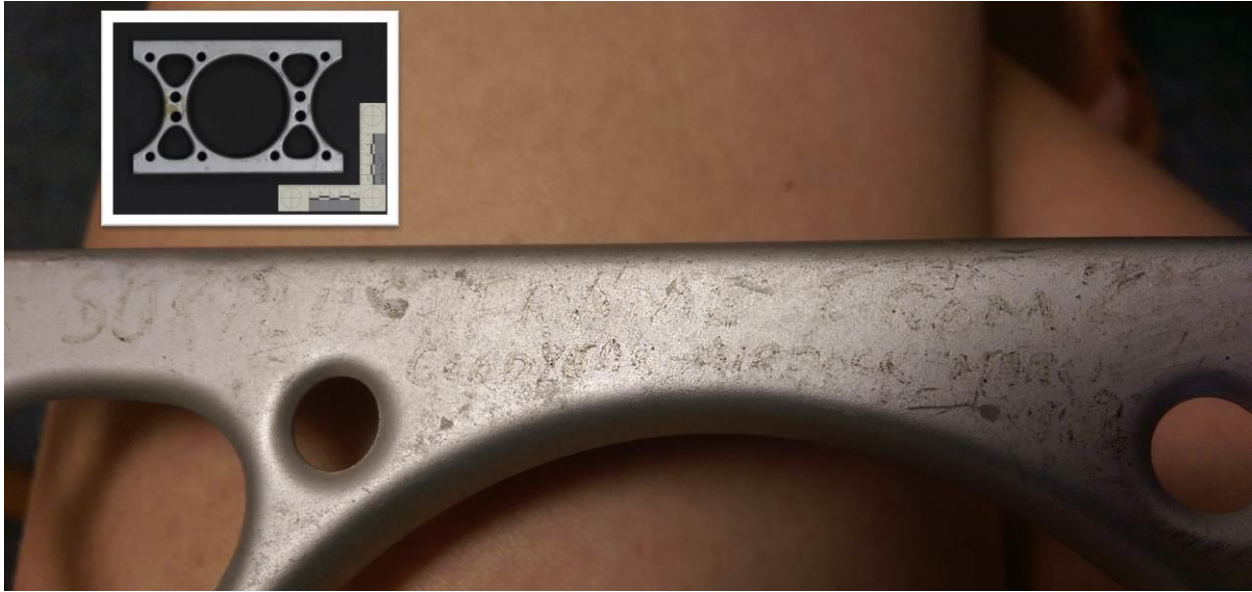
Figure 8.33- A piece of surplus *Macon* frame. Photo and inset by the author.

I had the opportunity to study several artifacts, both recovered from, or associated with, USS *Macon*, at the National Naval Aviation Museum (NNAM) in Pensacola, FL and the Moffett Field Museum in Mountain View, CA (Figure 8.33). The Moffett Field Museum piece, supposedly salvaged from *Macon*'s 1933 accident over the Rockies, had been covered with aluminum paint at some point in its history. With good light and a microscope I was also able to see the piece that they sent me was surplus from the airship's construction in 1933, or so it said, rather than from the repair work.

²⁶⁸ Interestingly, XRF analysis helped me determine that one sample provided by Moffett Field Museum for research is likely not, in fact, from the USS *Macon* due to the presence of titanium in the alloy, which was not common in aerospace manufacturing use until WWII. XRF of the other *Macon* frame pieces shows no titanium.

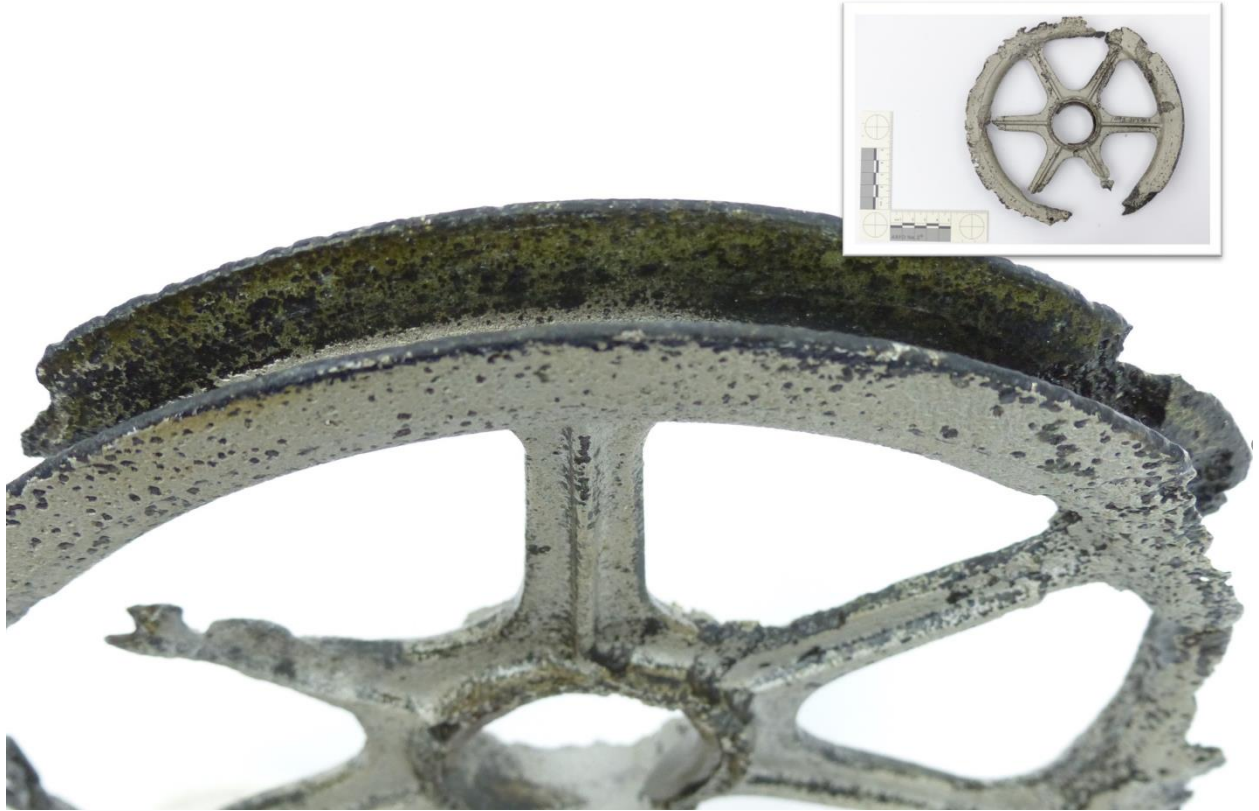
Figure 8.34- This piece of cast aluminum, recovered from the *Macon* wreck in 1991 and conserved by ECU as well, displays the brown wax no continued corrosion. Photo and inset by the author.

I also studied three aluminum artifacts recovered from the wreck site during the 1991 survey (Figures 8.34-8.36). Two out of the three metal artifacts salvaged from the archaeological site in 1991 were conserved at East Carolina University and had been either on display or in storage at the NNAM since then. The artifacts included a piece of aluminum frame from the airship similar to the one from the private collection. As I examined the pieces and read the conservation reports of the piece conserved by ECU, it was obvious that in both cases, the conservation method was highly experimental and overall thought to be in the artifact's best interests. Neither method had stabilized the artifacts nor protected them from further corrosion, but at the time (1991) there had only been one paper written on experimental methods.

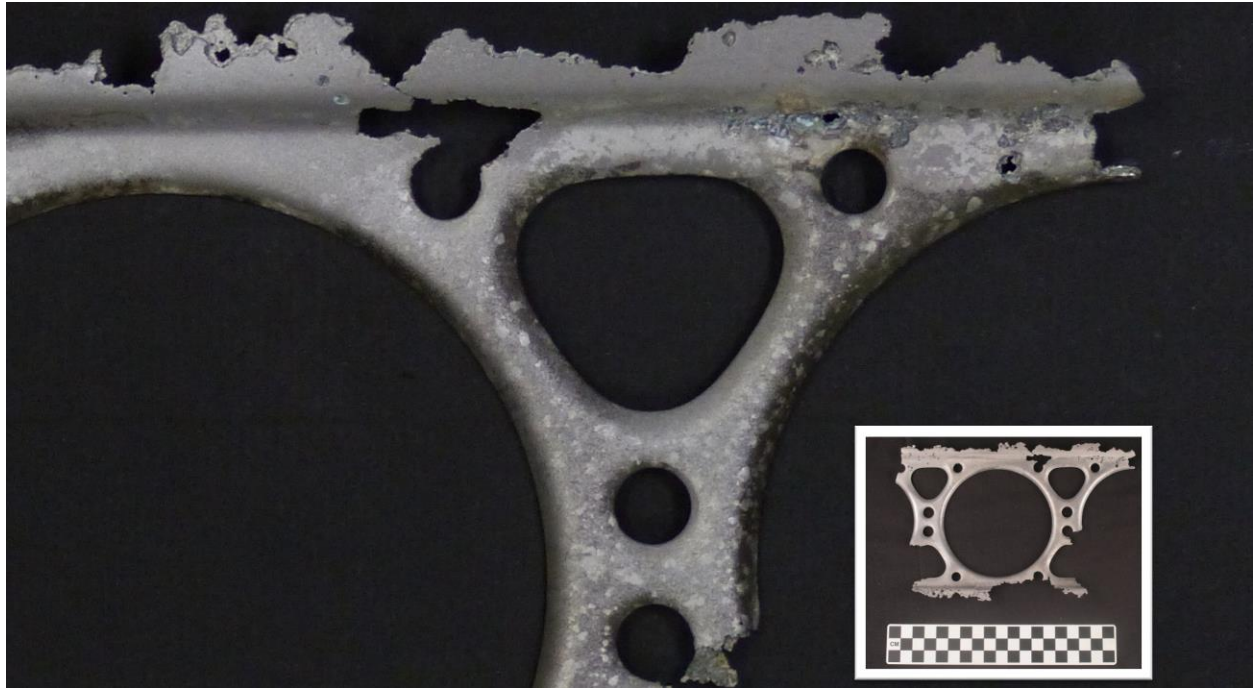
Figure 8.35- This piece, USMPC01, was recovered and given to a private collector in 1992 but did not receive any conservation treatment. It contains powdery blue copper corrosion products in its pits, but overall appears relatively unchanged since recovery. Photo and inset by the author.

Figure 8.40- Frame piece USMPC01 after treatment to remove the powdery blue copper corrosion products, as seen in Figure 8.35. Photo and inset by the author.

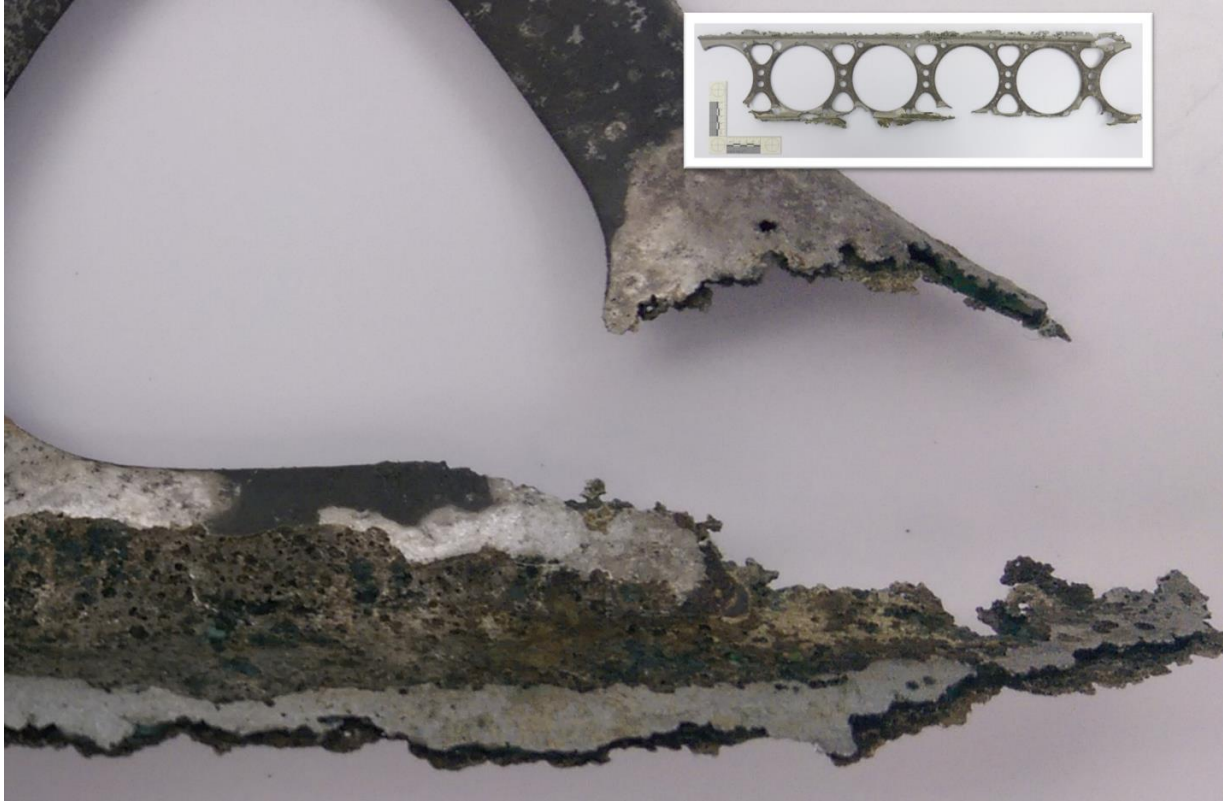
Figure 8.36- In this image the telltale brown microcrystalline wax indicated ER treatment common to iron artifacts at the time. The piece is currently also displaying green copper corrosion products, signaling continued pitting. Photo and inset by the author.

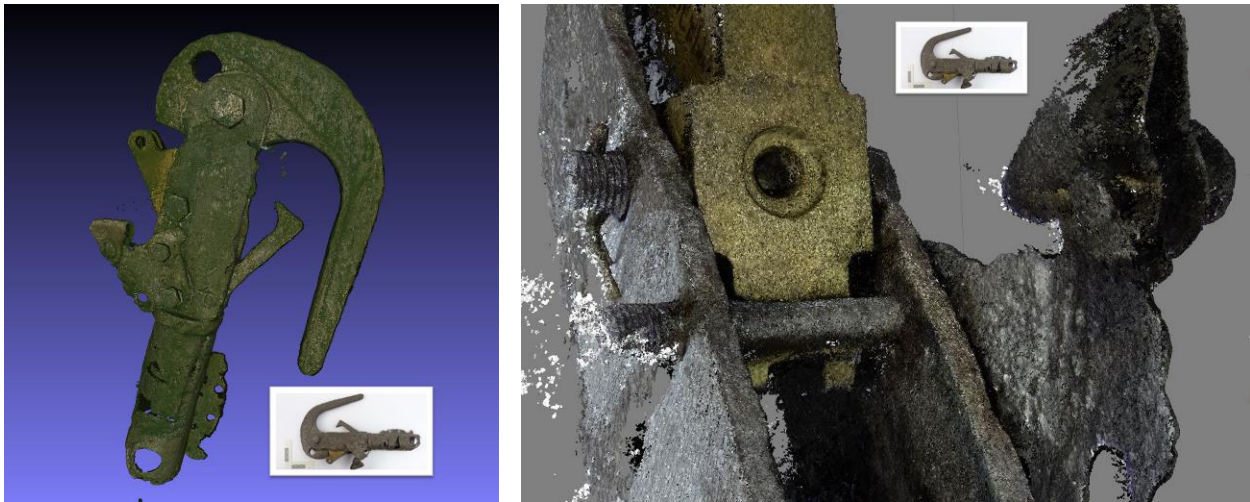
Figure 8.38- On the skyhook, the laser scanner produced a uniform point cloud and a good result, but the model appeared to be of low quality in resolution (L). Photocan software produced a simple point cloud of the hook from about 1000 images, which appeared to have more noise than the scanned model, but had a much higher level of detail (R). Models by the author.

much light during the photo-acquisition process. I discuss comparisons of the images below as dense point clouds without mesh or texture (Figures 8.37-8.39).

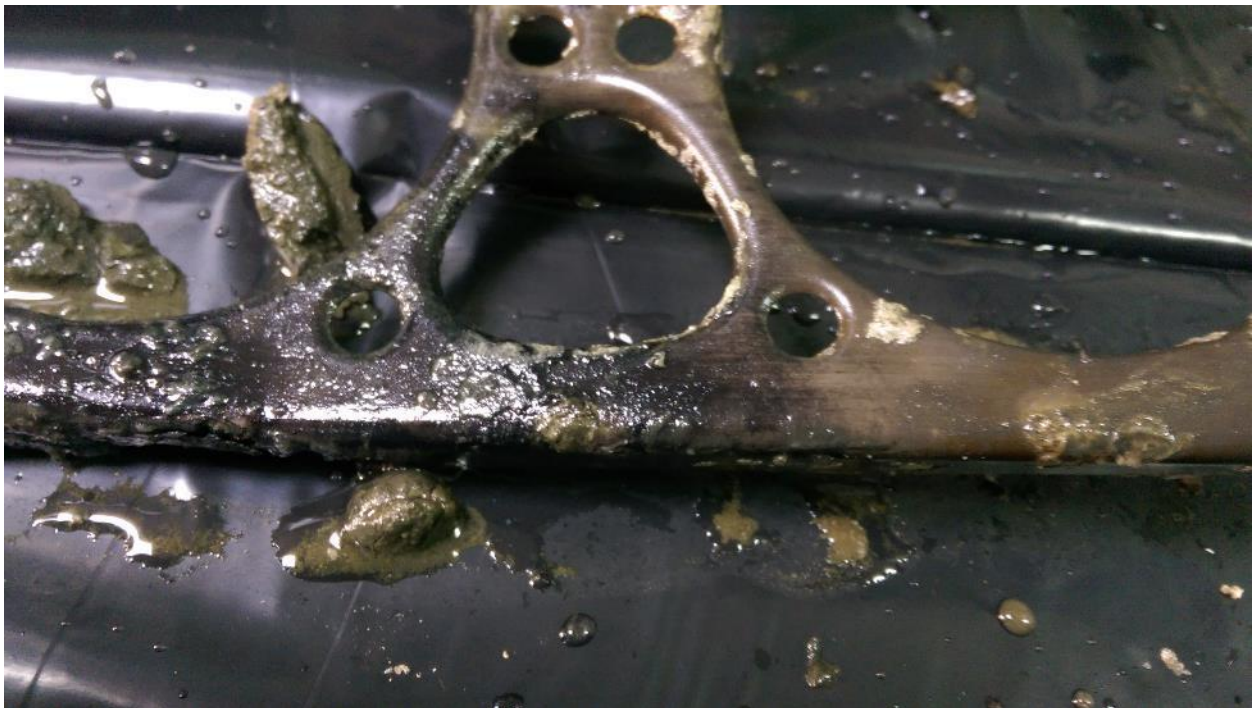
Figure 8.43- The demarcation line between the portion of the frame that was buried in sediment (L) and the side in the water column (R). Some pitted areas presented with black, maroon, and green corrosion products. Photo by the author.

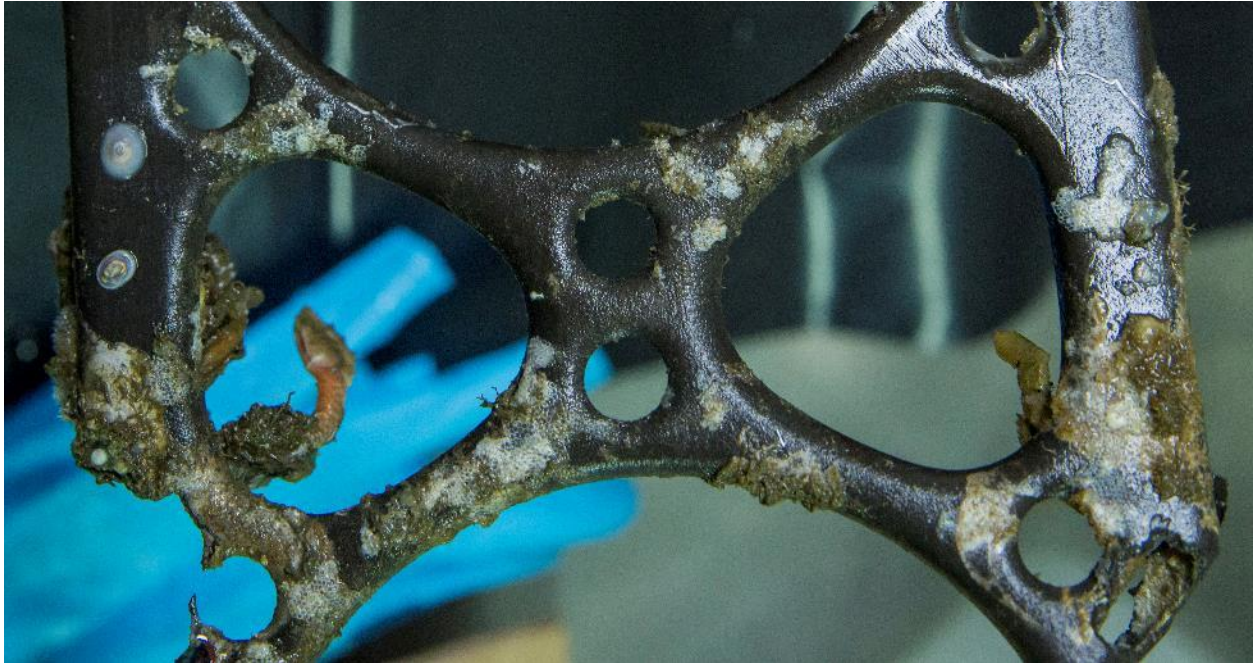
Figure 8.44- A sample of marine growth on the recovered frame piece. Also note the dark brown color of the metal surface. Photo courtesy of Juyle Newlin, OET.

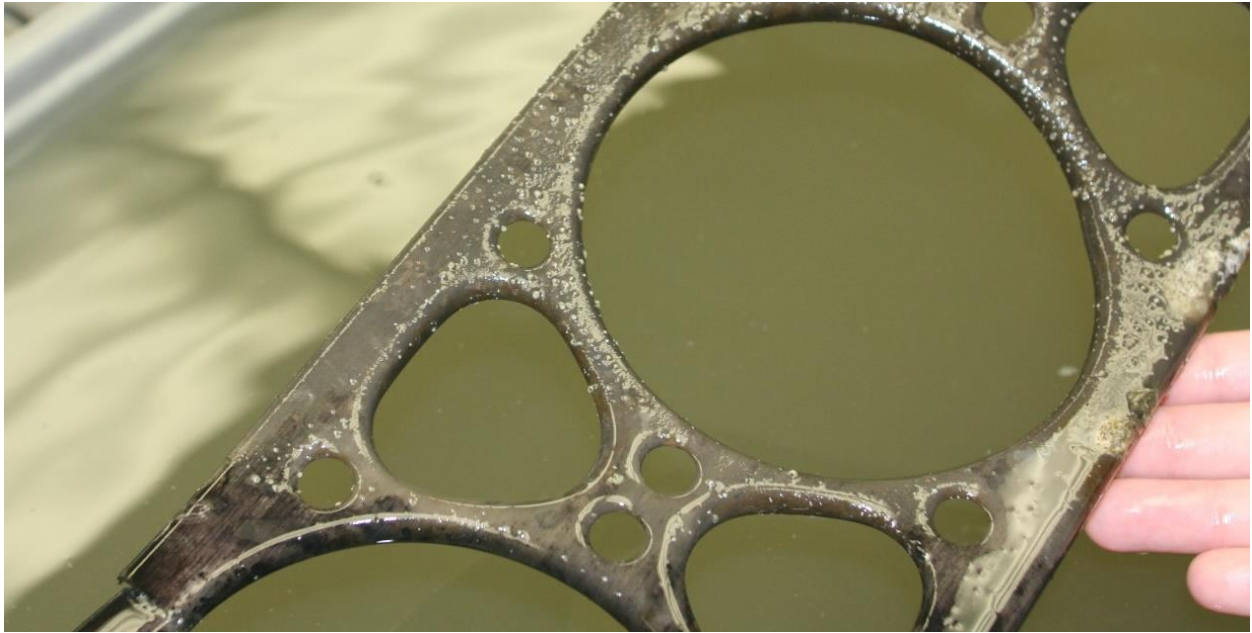
Figure 8.45- Soft nodules of corrosion products on the frame surface after a few days of conservation treatment. Photo by the author.

Together with Kate Morrand and Shanna Daniel from NHHC Underwater Archaeology Branch, I carried out the conservation at the NHHC Conservation Lab using the same methodology from my 2014 experiment. After receiving the frame piece at UAB's conservation lab, I placed it immediately into the citric acid solution. After a few days, the sediment and marine growth had been removed from the surface, and the metal was a lighter color. During these days, however, we noticed accelerated corrosion products present in the microscopic pits on the frame's surface (Figure 8.45). After being treated for about five days, the frame piece presented as closer to its original color, but with a series of stain patterns visible to the right side of the sample and black corrosion products surrounding larger pits (Figure 8.46). Two rivets

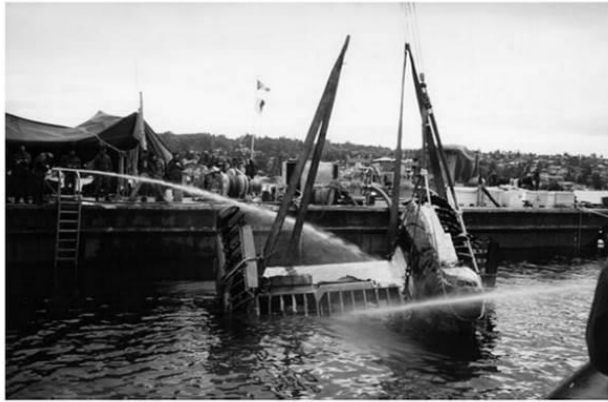
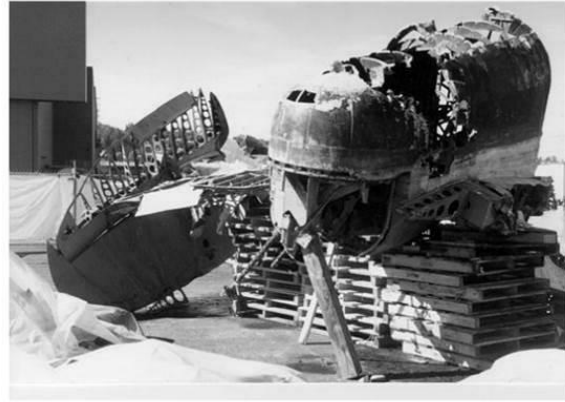
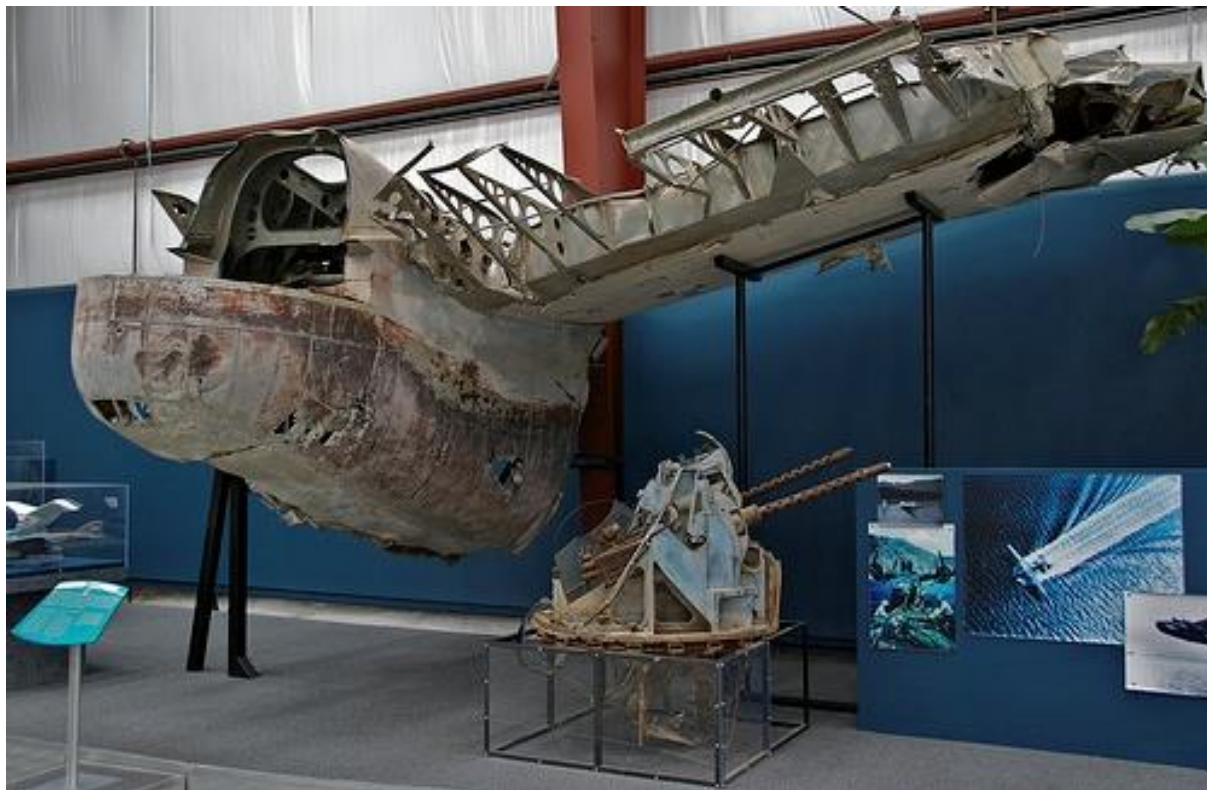
Tail section being raised less one stabilizer

Complete Martin twin .50 cal tail turret less glass

Figure 9.2- (Top) Images from the salvage of the PBM-5 59172 tail section. (Bottom) The tail assembly display at Pima Air & Space Museum. Top photos reprinted from Barth 1996, bottom photo courtesy of Pima Air & Space Museum.

rear fuselage and tail of the aircraft and a longitudinal splitting of the rest of the frame.²⁸⁰ The project team members continued raising the broken tail section to the surface, cleaned it, and NNAM loaned it to Pima Air & Space Museum in Tucson, AZ for display (Figure 9.2). In the remaining wreckage, Navy divers closed egress into the aircraft with mesh screens covering hatches and the now-exposed hole in the aft section. The tail section and tail turret are currently on display in Pima. Pima is also the home to the only fully-restored Mariner on display, and the two exhibits sit side-by-side creating an interesting comparison.

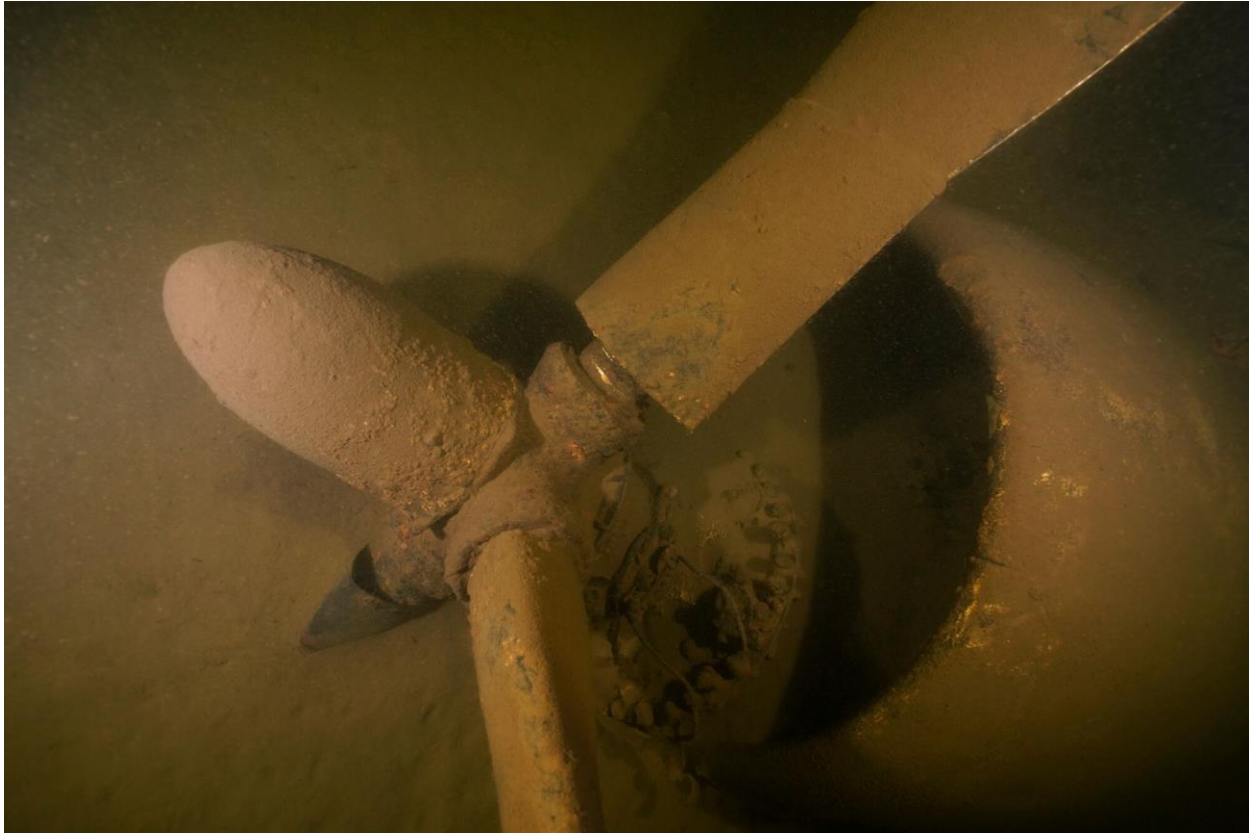
Figure 9.6- The port side engine cowling and propeller assembly of the PBM Mariner in Lake Washington. Photo by Kees Beemster Leverentz.

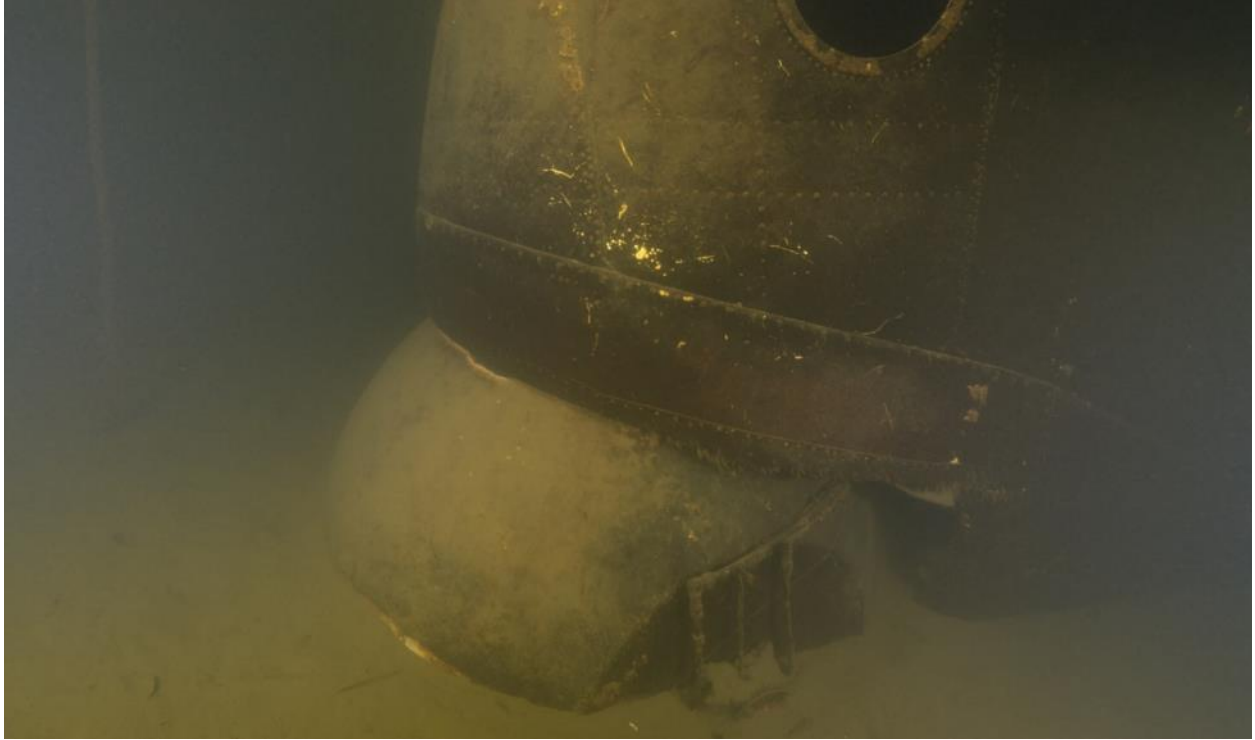
Figure 9.7- The PBM-5 nose and a portion of the nose ball turret above the sediment line. Sediment appears as lighter colored dusty patches on some vertical parts, and patches of aluminum shine from scratches. Photo by Kees Beemster Leverentz.

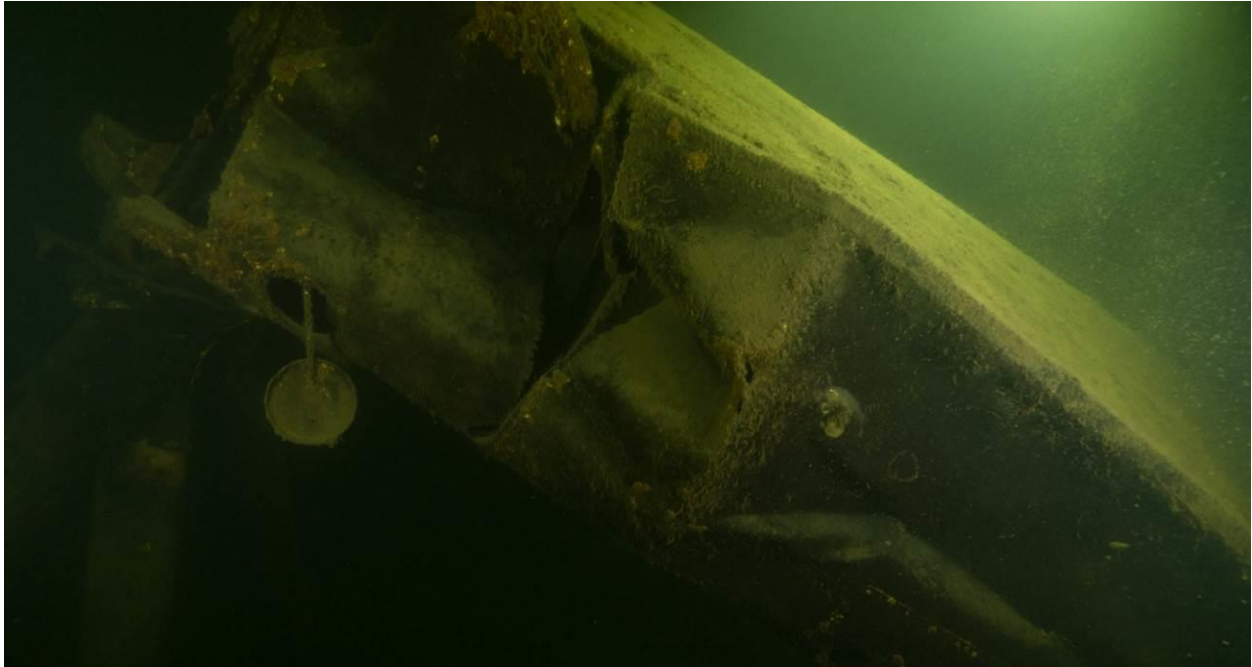
Figure 9.8- Part of the damaged port side pontoon float. Photo by Kees Beemster Leverentz.

surface. Both engines were used as attachment points during the recovery attempt, and now present as wrenched away from their mounts and angling slightly upwards and to the north. Half of both engines and two or more propellers on each engine show above the sediment layer. Engine 2 on the starboard side presents as intact with nearly all of three of the four propeller blades above the sediment level, pointing roughly at 300°, 30°, and 120°. The propeller assembly on Engine 1, port side, has been wrenched from its mount from the 1996 lifting attempt and only two propeller blades can be seen (Figure 9.6). Sediment covers the gull-type wing section outside of the inner-most part. The blue paint on the fuselage presents as a dark brown color on the fuselage, but the aluminum boat hull shines through patches of thin marine growth (Figure 9.7). The sediment layer ranges from a few millimeters to 0 mm on flat surfaces. The 1997 report records the port side pontoon float as in situ but damaged, and the starboard pontoon as missing (as well as the reported confusion in prior reporting for which float was missing).²⁸⁴ The starboard float went missing in between 1990 and 1996. The port float remains in situ presently, and we recorded it to document any further deterioration (Figure 9.8).

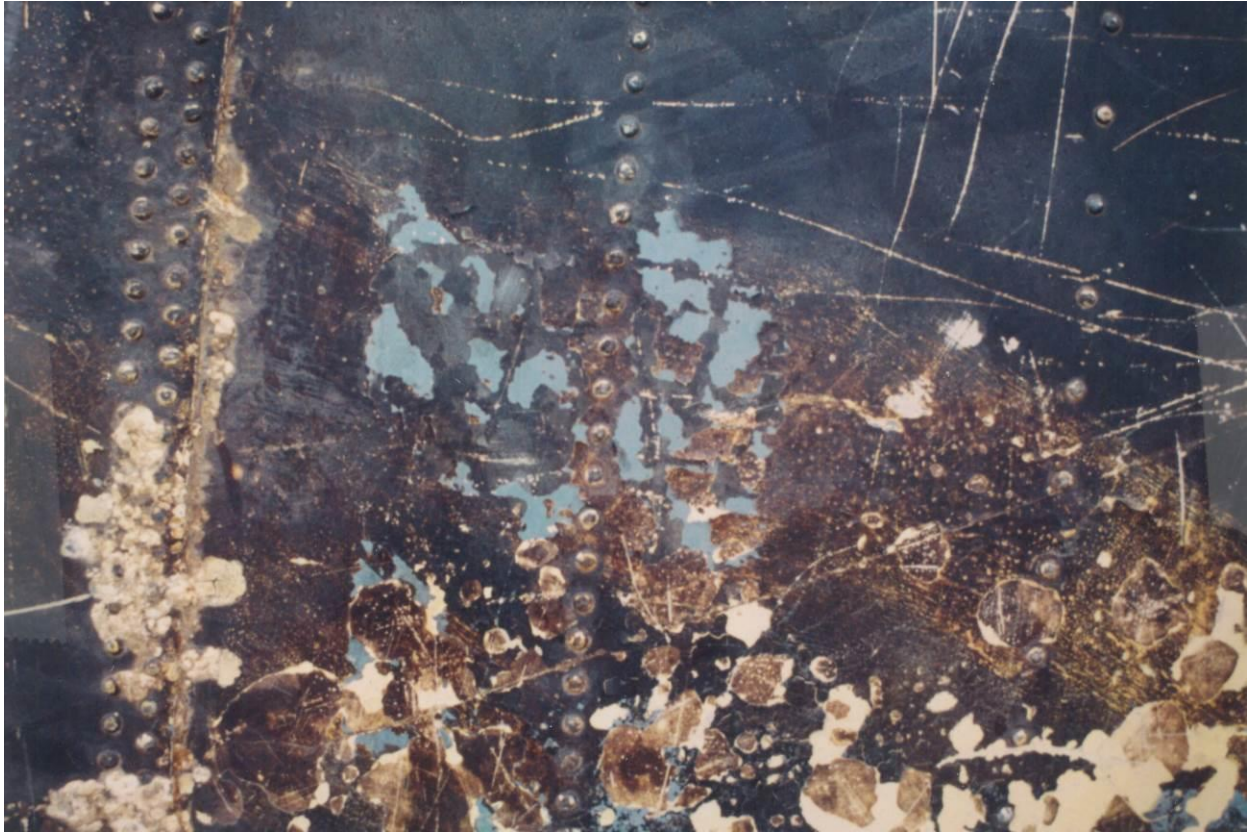
Figure 9.10- Corrosion nodules, faded dark blue paint, and an under layer of bright blue paint from an areas of fuselage recovered in the 1996 salvage. Photo courtesy of NHHC UAB.

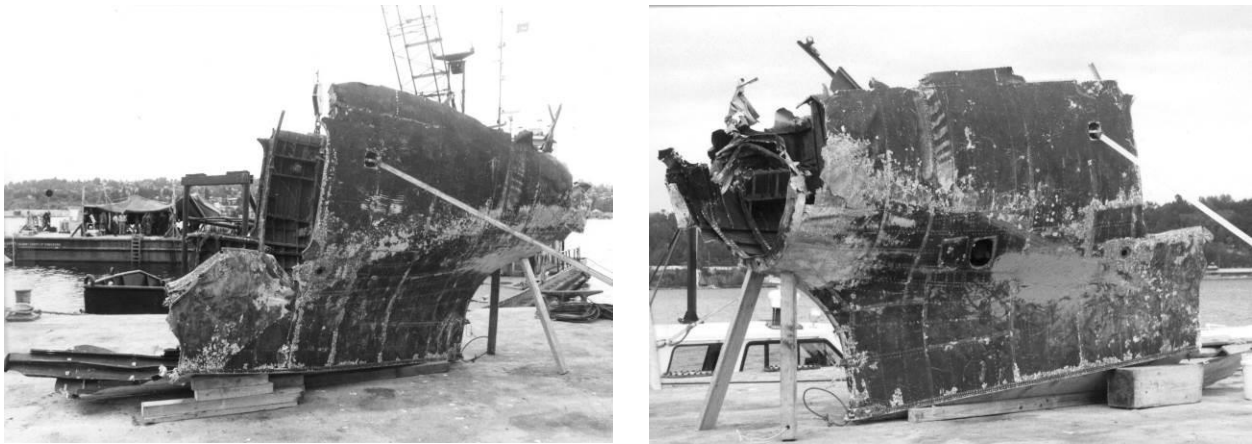
Figure 9.11- The recovered tail section of PBM-5 59172 (both side views) photographed on land in 1996 to show the areas of localized corrosion. The bottom part of the aircraft in the photo would have been exposed and the top part buried. The corrosion pattern shows the sediment line. Photos courtesy of NHHC UAB.

The salvage team recovered several metal objects in varying states of decay, and found several small shreds of doped fabric from the flight control surfaces around the site. In the photographs (unfortunately none appear of the recovered fabric) one can clearly see the dark blue color of the paint, as well as a medium blue color underneath in areas where the over layer had worn away (Figure 9.10). Wills concludes that, overall, the wreck was decaying at a slow rate, with accelerated rates seen around areas with magnesium, around areas which are joined or fastened together, in areas which experienced mechanical stress, or around metals not treated with anti-corrosive processes during manufacture.²⁸⁷ In his report, he also notes that “exposed portions of the wreck may have suffered greater corrosion than portions which have remained buried in the sediment layer” (Figure 9.11).²⁸⁸

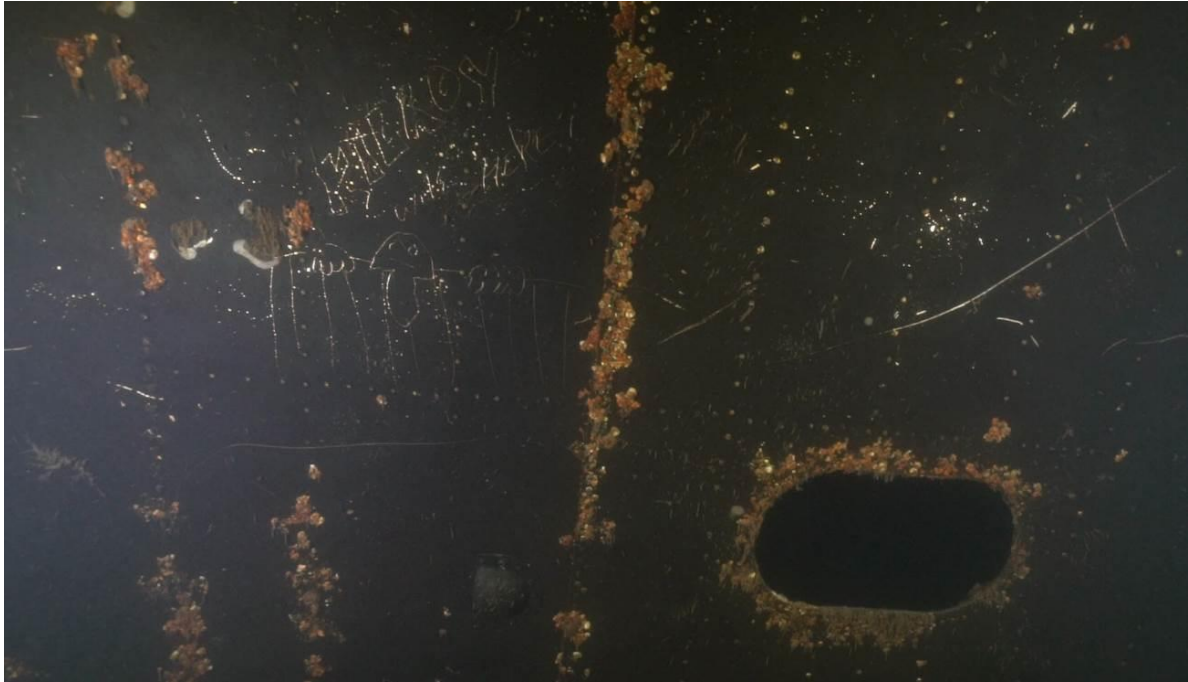
Figure 9.13- Corrosion patterns following rivet seams and the outline of a window, but does not affect every rivet seam. Note the graffiti on the top left. Photo by Kees Beemster Leverentz.

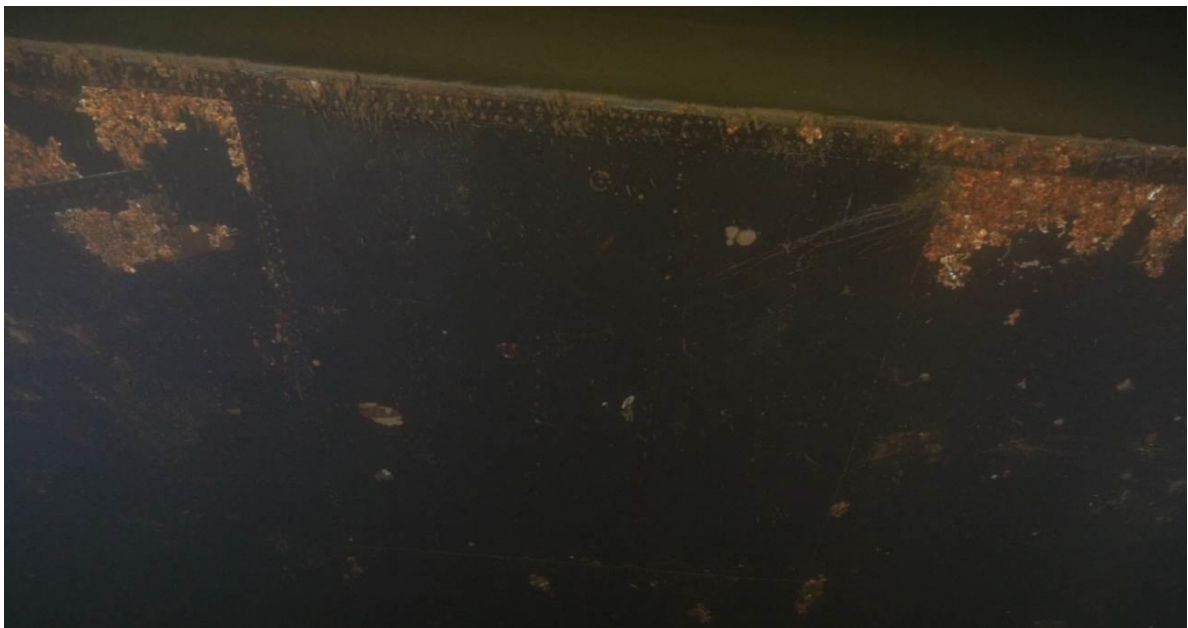
Figure 9.14- A panel with relatively no corrosion nodules in between areas with corrosion product patches. Note the straight lines following the seams. Photo by Kees Beemster Leverentz.
