AVIATION ARCHAEOLOGY: HISTORY, THEORY, PRACTICE AND DIRECTION

A Dissertation

DOCTOR OF PHILOSOPHY

August 2018

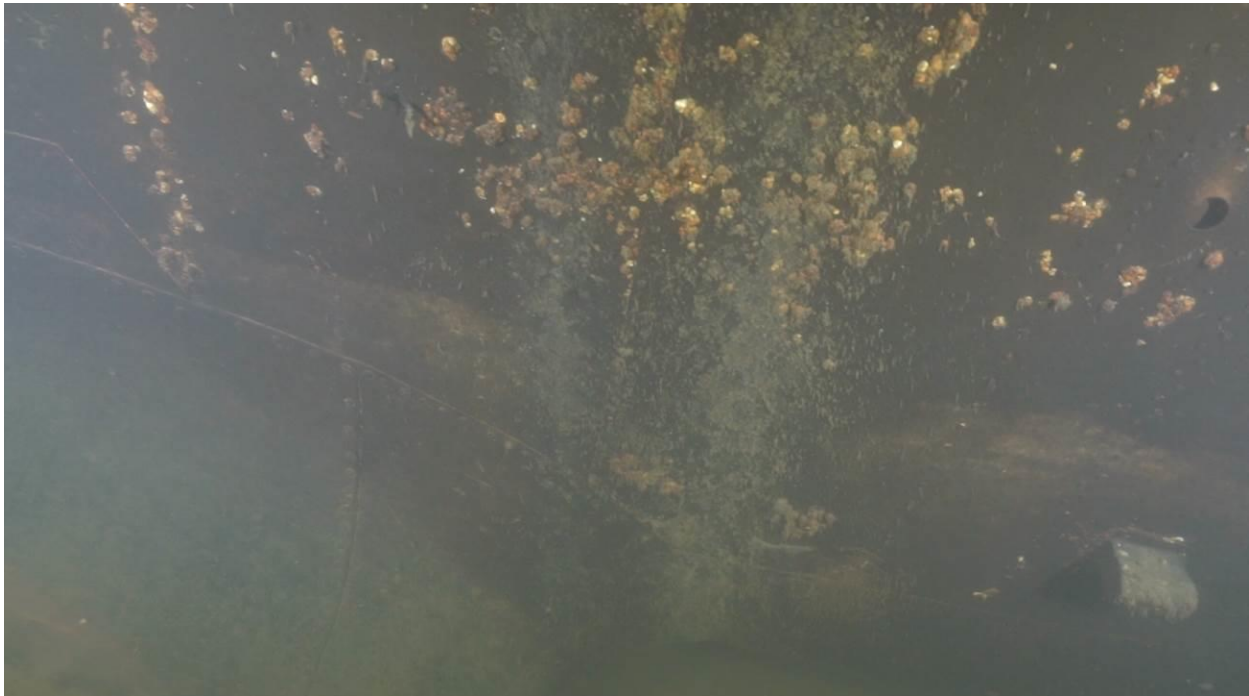
Figure 9.15- An area of algae growth on the fuselage in the path of released gas bubbles (brightness adjusted to show the growth). Photo by Kees Beemster Leverentz.

Several mollusks attach to the fuselage, mostly just below the sediment line, but a few are on the sides of the aircraft. They produce a stream of gas bubbles that float to the surface very near to the aircraft skin. In the path of the bubble stream, cellular chains of hair-like algae grow, feeding on the nutrients on the released gas (Figure 9.15). In these areas as well, corrosion appears in slightly greater amounts, although this is not necessarily correlated (Figure 9.16). This hair-like growth is most prevalent in the remains of the aft fuselage where there are more horizontal spaces to hang. The engines and propellers also appear to have nodules and the hair-like growth, as well as paint color deterioration. Stainless steel panels on both engines present as non-degraded, free from corrosion, and distinctly shiny (Figure 9.17).

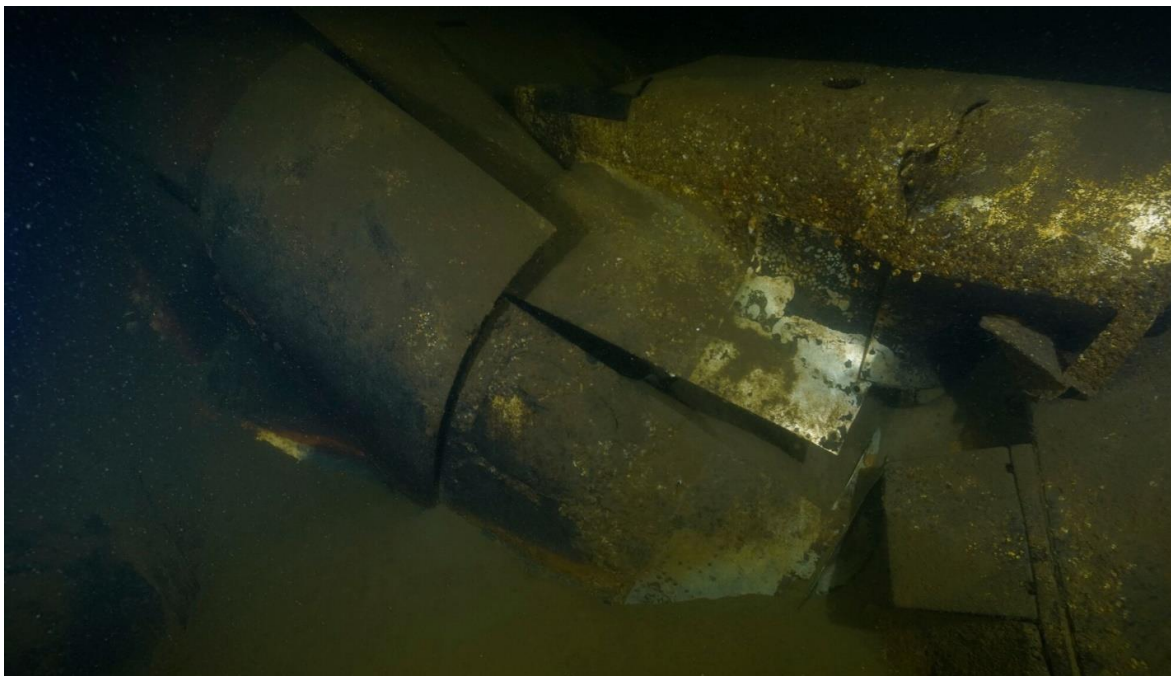
Figure 9.17- The starboard side engine with aluminum and stainless steel panels. Photo by Kees Beemster Leverentz.

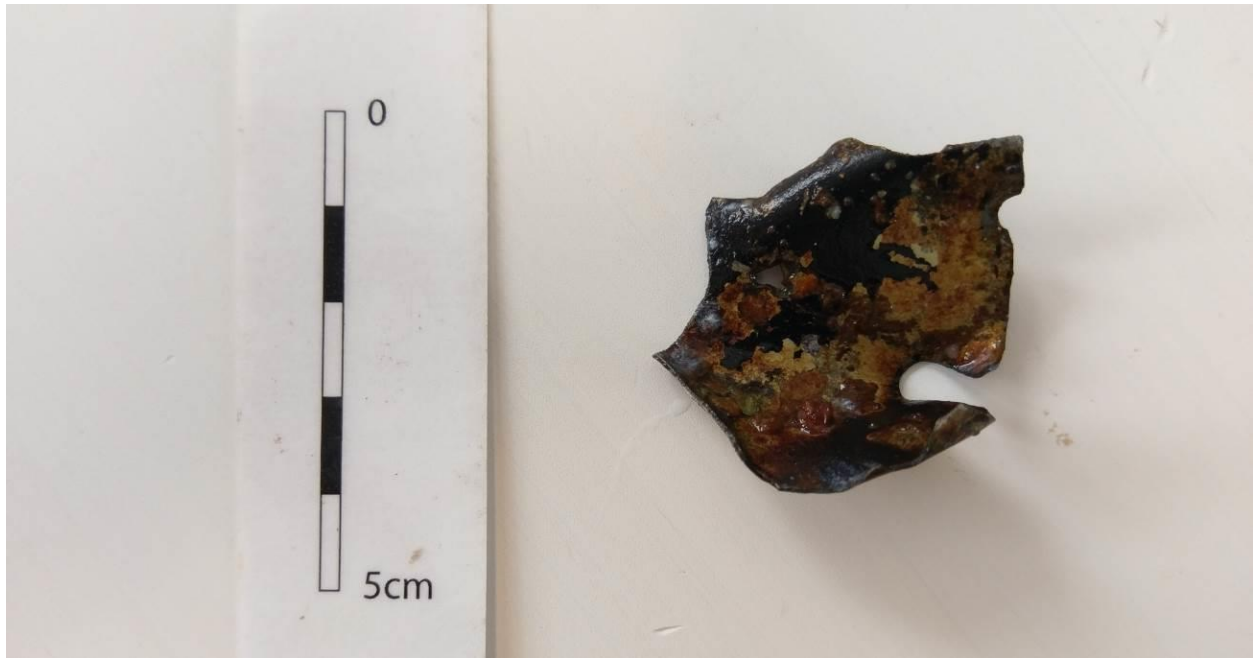
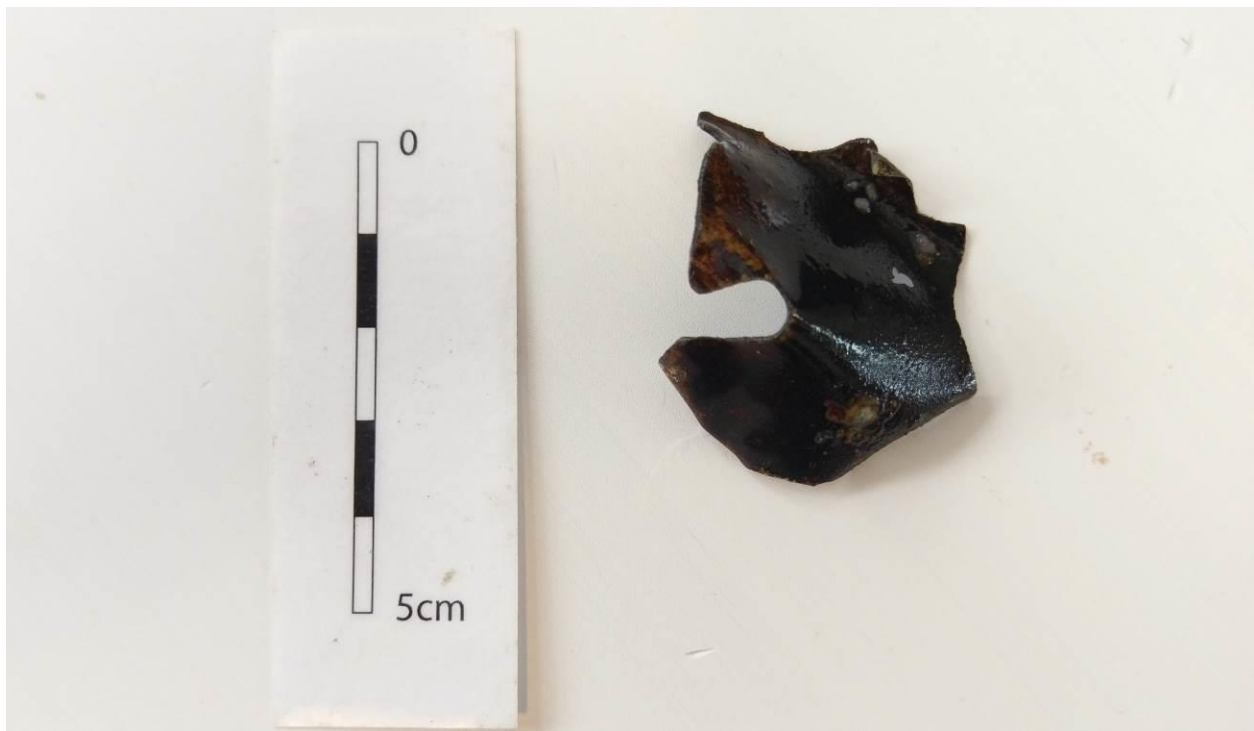
Figure 9.18- (Top) Side A of the PBM-5 sample with nodules of corrosion. Side B (bottom) shows as nearly free from corrosion. Photos by the author.

Working in partnership with the NHHC UAB Archaeology & Conservation Laboratory as co-PI on corrosion analyses, GUE divers and I acquired a sample of the PBM-5 59172 fuselage metal from the rear starboard side. GUE divers found it near to the sediment line on the starboard aft side of the aircraft where the tail was ripped from the fuselage. This metal shows both non-corroded areas and corrosion nodules (Figure 9.18). Side A is the exterior side facing the water column, side B faced the interior of the tail. I prepared the sample for initial visual analysis by scraping what appeared to be the back side of a nodule, which was the largest blemish on the less-corroded side (B). I could immediately feel that area had completely deteriorated into corrosion products and saw the telltale sign of blue gravelly substance in the pit (Figure 9.19). There is one other pitted hole in the sample. The side that displays more advanced corrosion (A) appears to have corrosion nodules in areas only where the paint has disappeared. I expect that, on this aircraft, corrosion will colonize in areas where paint loss has already occurred, and the areas which have large nodules will also have deep circular-shaped pits underneath. The prevalence of corrosion on the exposed sample may suggest that water chemistry has less effect on susceptibility to pitting as opposed to bacterial and marine life growth. More study, focused on the interior spaces of the aircraft, is needed to test this theory.

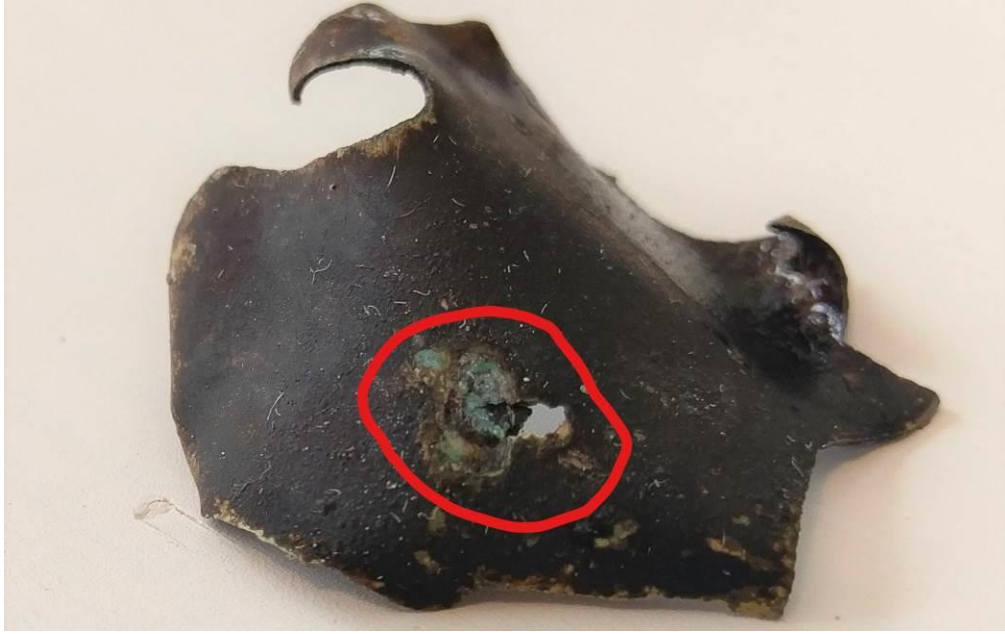
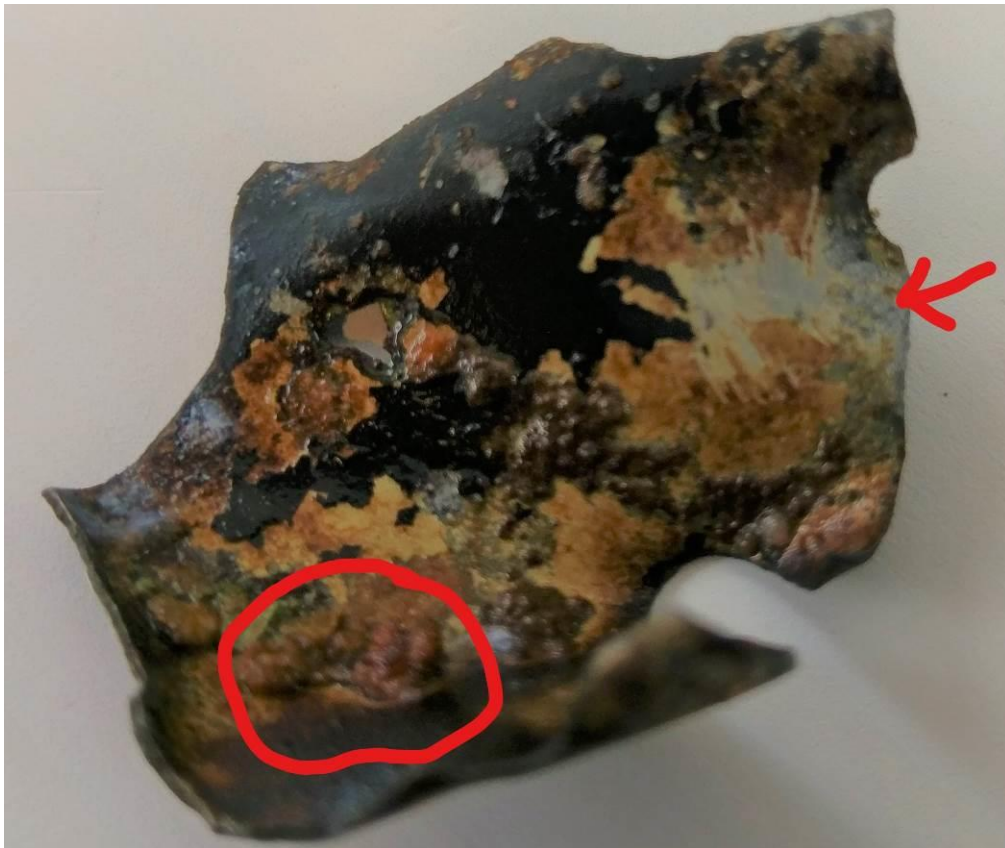
Figure 9.19- (Top) Side B of the PBM-5 sample after scraping a nodule of corrosion, which shows to be pitting through the wall of the piece from side A (bottom). The arrow on side A shows scraping of the tan color to reveal bare metal, showing loss of paint. Photos by the author.

I sent the sample to NHHC UAB Archaeology and Conservation Lab director Kate Morrand for XRF analysis on the piece for baseline information. She and Dr. Pearson at the US Naval Academy ran the XRF using a Bruker M4 Tornado micro-XRF machine. The Navy scientists tested several areas, including corrosion nodules and open pits, dark brown areas, light brown areas, and an area of bare metal. The peaks of the elements presented fairly evenly across all sample locations; the alloy is a standard 2xxx series alloy with copper, magnesium, and small iron peaks. Chromium and zinc peaks were present on painted areas, and the dark brown area presented with a slightly higher magnesium peak. Trace amounts of silicon and potassium also registered on the machine, most likely signatures of corrosion. The Navy UAB plans to run further testing on the corrosion products and nodules of the sample, as well as water chemistry analysis, to discover any key mechanisms that differ from aircraft in saltwater sites.

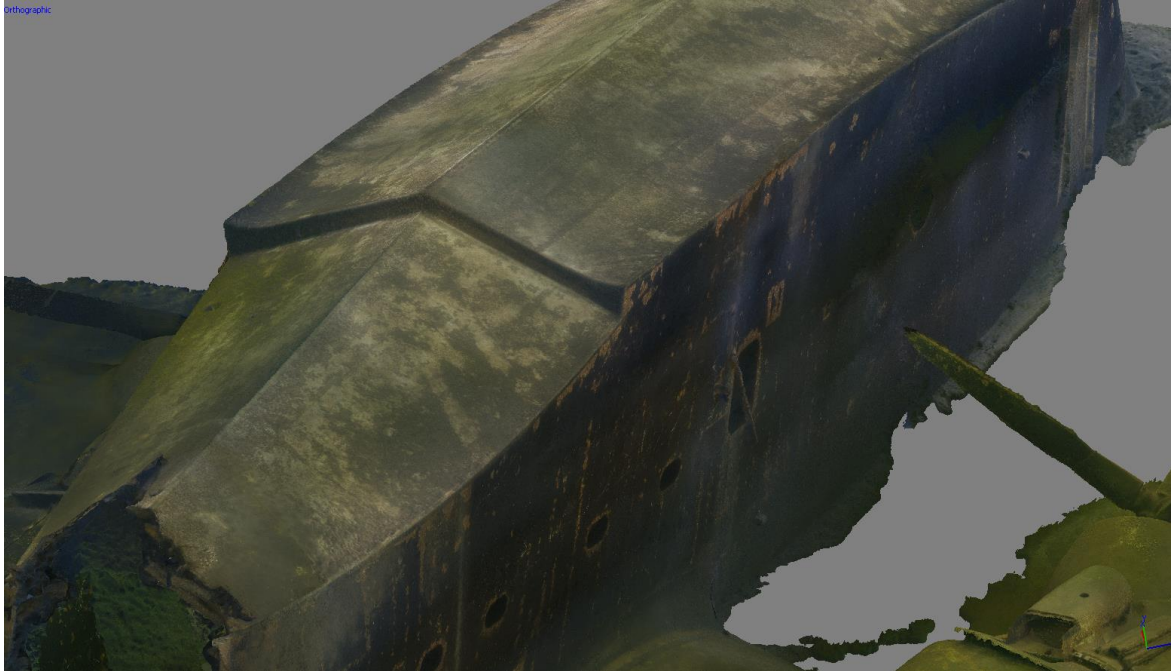
Figure 9.22- The curve of the hull and the step, beautifully rendered by Photoscan. Model by Kees Beemster Leverentz and the author.

Initial experimentation proved the superiority in photos between the Sony A7RIII and the GoPro Hero 3+. Even with the supplemental lighting, video on the Sony far surpassed the quality of the GoPro video. A contributing factor was the barrel distortion of the GoPro lens. We processed the models with Agisoft Photoscan. One unforeseen problem in the modeling process, however, was the color of the wreck, which currently presents as dark brown, against the color of the water, which is also a dark brown. We experienced difficulty with Photoscan being able to register the dark colored points against a dark colored background and rendering the object with a loss of information in those areas. Photoscan aligned the images without issue and with texture mapping produced a high quality model that showed even light scratches clearly and accurately (Figures 9.20-9.23).

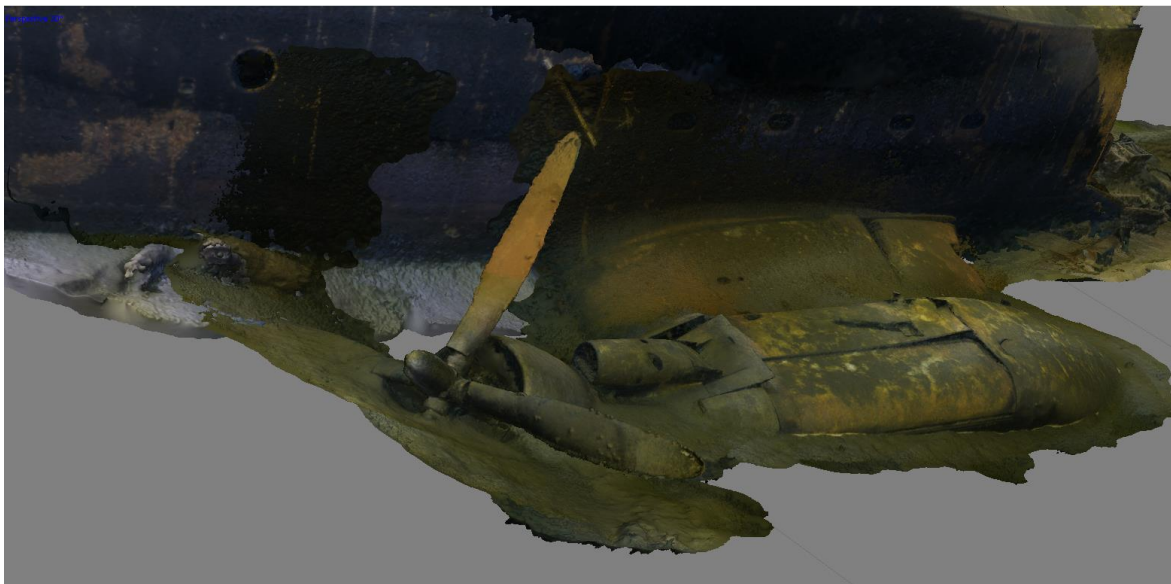
Figure 9.23- The PBM-5 rests on an incline that begins sloping down from the bow. This view shows the extent of the sediment removal and how it disrupted the incline's slope. There is a deeper hole in the sediment behind the tree limb in the left of the image. Model by Kees Beemster Leverentz and the author.

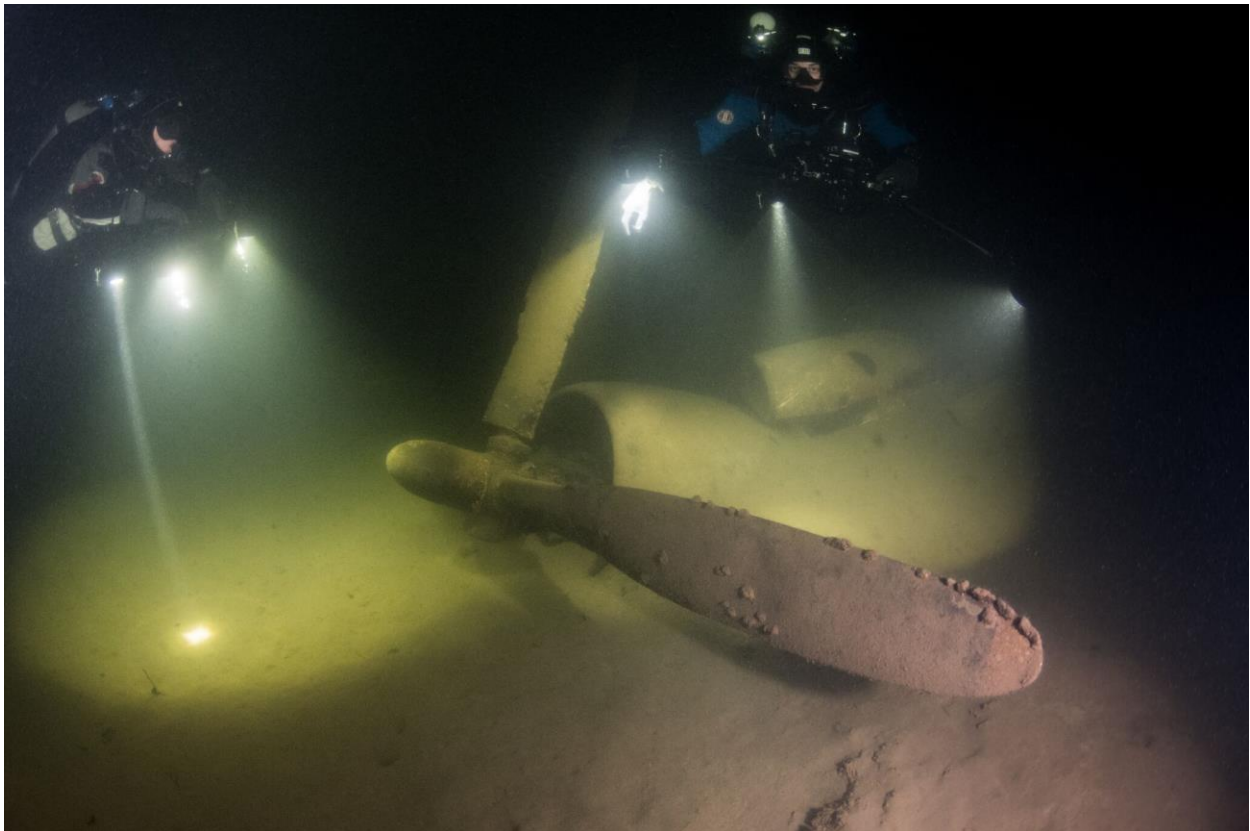
Figure 9.24- GUE divers hold lights strategically over the port engine for photogrammetry image acquisition. Photo by Kathryn Arant.

Our methodology was for divers swim a series of half-circular arcs around each third of the fuselage. Divers flew a camera over the wings and the remaining ceiling of the tail section in a mow-the-lawn pattern. Two support divers swam behind the primary diver and held supplemental 30k lumen cameras on either side, pointed to the wreck (Figure 9.24). We also experimented with one supplemental diver and the primary diver carrying a smaller lamp. The color change in the photographs was noticeable; there was a glare present in the photos with both sets of lights although this may have been due to their proximity to the diver and the diver's proximity to the wreck.

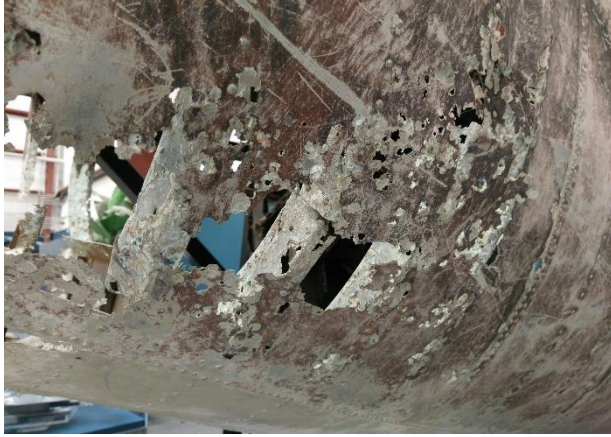
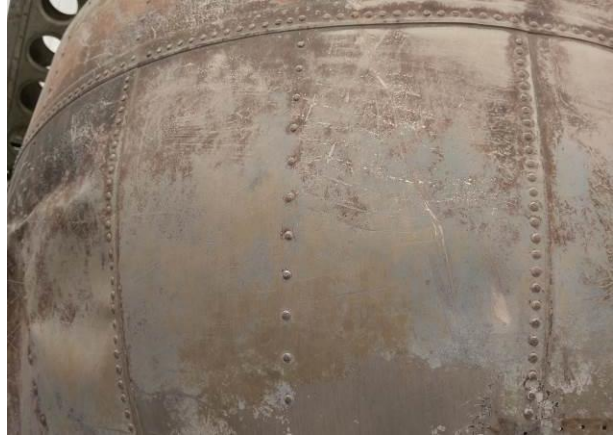
Figure 9.26- Areas of the PBM-5 59172 tail, currently on indoor display at Pima Air & Space Museum. Notice the extensive corrosion on the left photo, compared with the photo on the right, where an area shows primer and faded paint, as well as patches of bare metal. Photos by the author.

Large objects from the 1996 salvage are on display or in outdoor storage at the museum, including the aft fuselage and tail section.²⁹² These large sections of airframe present with various levels of corrosion severity, mostly from pitting on the aluminum parts and rusting on steel parts. Surprisingly, the PBM airframe artifacts stored outside do not present with different issues or more advanced corrosion than the artifacts on display, although the time difference is, at this time, 10-12 years. The displayed tail section incorporates areas of extreme pitting corrosion near areas of pristine metal (Figure 9.26). The paint on the tail has largely disappeared, although some primer and light blue areas of paint remain. Sections of the aft fuselage and vertical stabilizers, which are stored outside, display nearly the same corrosion levels and paint retention (Figure 9.27). Fabric also remains attached to some areas of the vertical stabilizers.

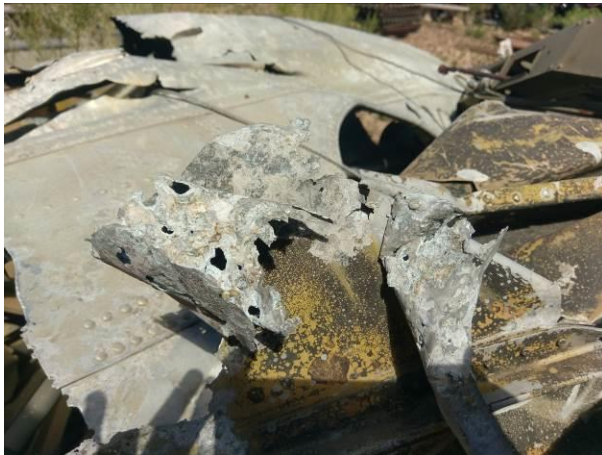
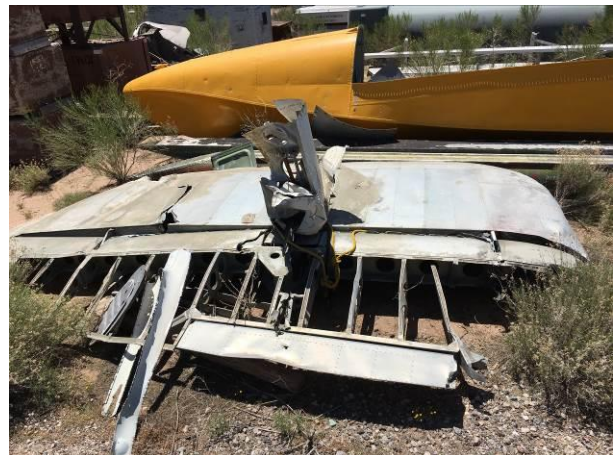
Figure 9.27- Areas of corrosion next to areas of intact and primer-covered metal on a piece of PBM-5 59172 aft fuselage (L), currently in outdoor storage at Pima Air & Space Museum. The vertical stabilizer's metal (R) is bleached but otherwise in good condition. Photo by the author (L) and Andrew Boehly (R).

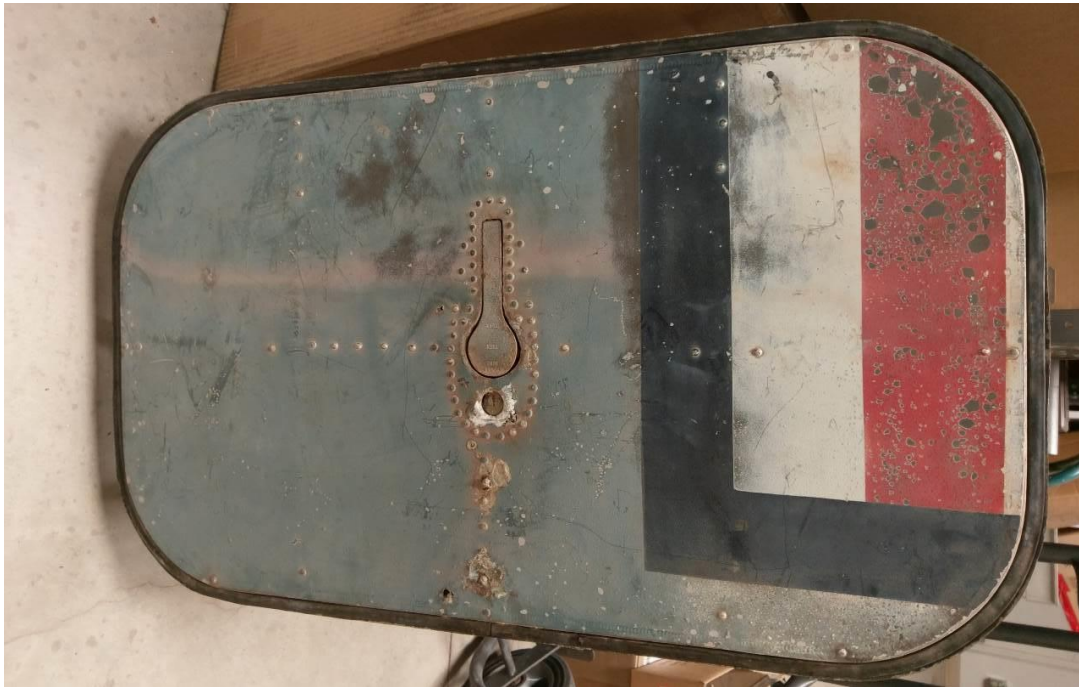
Figure 9.28- An outdoor hatch recovered from the Lake Washington PBM-5 in 1980-1981. Photo by the author.

One of the items recovered in 1980-1981 by UHRRF, given to NNAM and later loaned to Pima, is an outer door hatch. It is in good condition and has been stored in the interior archive space at Pima, protecting it from further decay (Figure 9.28). The rubber seal around the door appears intact, and the paint still shows in the original colors, although somewhat faded. Active corrosion in the form of pitting and exfoliation, probably a galvanic reaction, surrounds the key hole in the center. There is also some paint loss in small circular patches, most obviously in the red paint of the insignia. Some light pitting corrosion appears to be bubbling under the light blue paint of the door but no extreme pits mar the surface except near the keyhole. On the back of the hatch door there are a few spots of rust and more exfoliation corrosion, but only in localized areas.

The hatch artifact from Section 9.5.2, which I believe is representative of many multi-phase aircraft recovery projects, presents researchers with a fascinating study of aircraft deterioration. The PBM sank in good condition in 1949. This artifact was recovered by 1981, at most 32 years later, and given only a cursory desalination treatment. In 1996, at least 15 years after the hatch recovery and 47 years after deposition, Wills described the recovered tail section as appearing dark blue and light blue, with an overall lighter color underneath, and visible markings on the vertical stabilizer. He also reported corrosion nodules on the metal surfaces of the PBM, and noted a newly recovered, similar hatch as having extensive corrosion growth.²⁹⁵ The items recovered in 1996 and kept in museum storage are noticeably more deteriorated than the hatch, and retain less paint. It is possible that this is also due to storage conditions prior to their display. Today, 22 years after the most recent recoveries, 37 years after the first recoveries, and 69 years after the PBM sank, its paint now appears dark brown, with no indication of naval insignia or other markings.

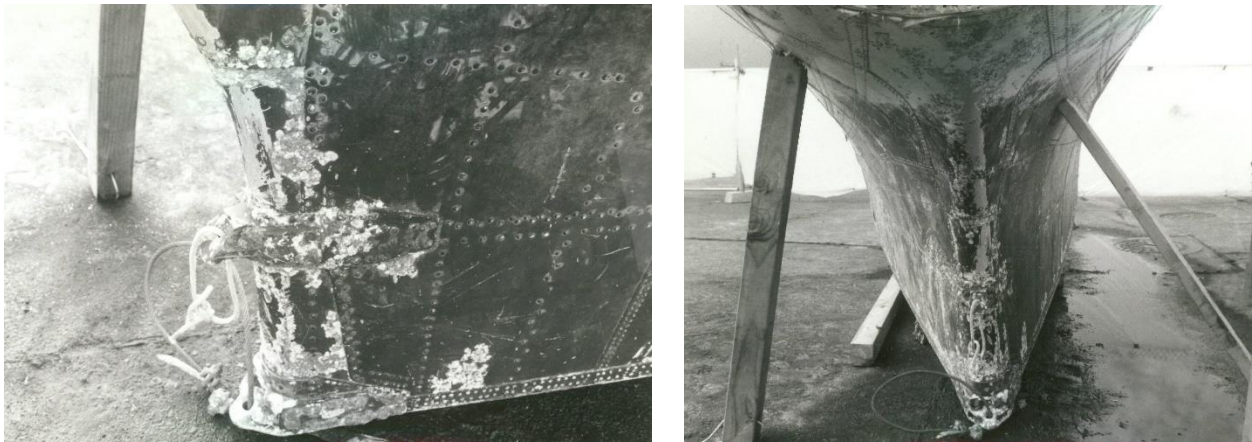
Figure 9.34- Corrosion nodules on the rear afterbody of the PBM-5 hull the day of recovery in 1996. Photos courtesy of NHHC UAB.

Another artifact studied at Pima shows a different set of insights into the corrosion process. The 1996 salvage report shows a number of images of the rear afterbody area of the recovered fuselage section, and comments from Wills suggest that it contained more corrosion nodules than nearby areas (Figure 9.34).²⁹⁶ This piece of PBM-5 material was rinsed several

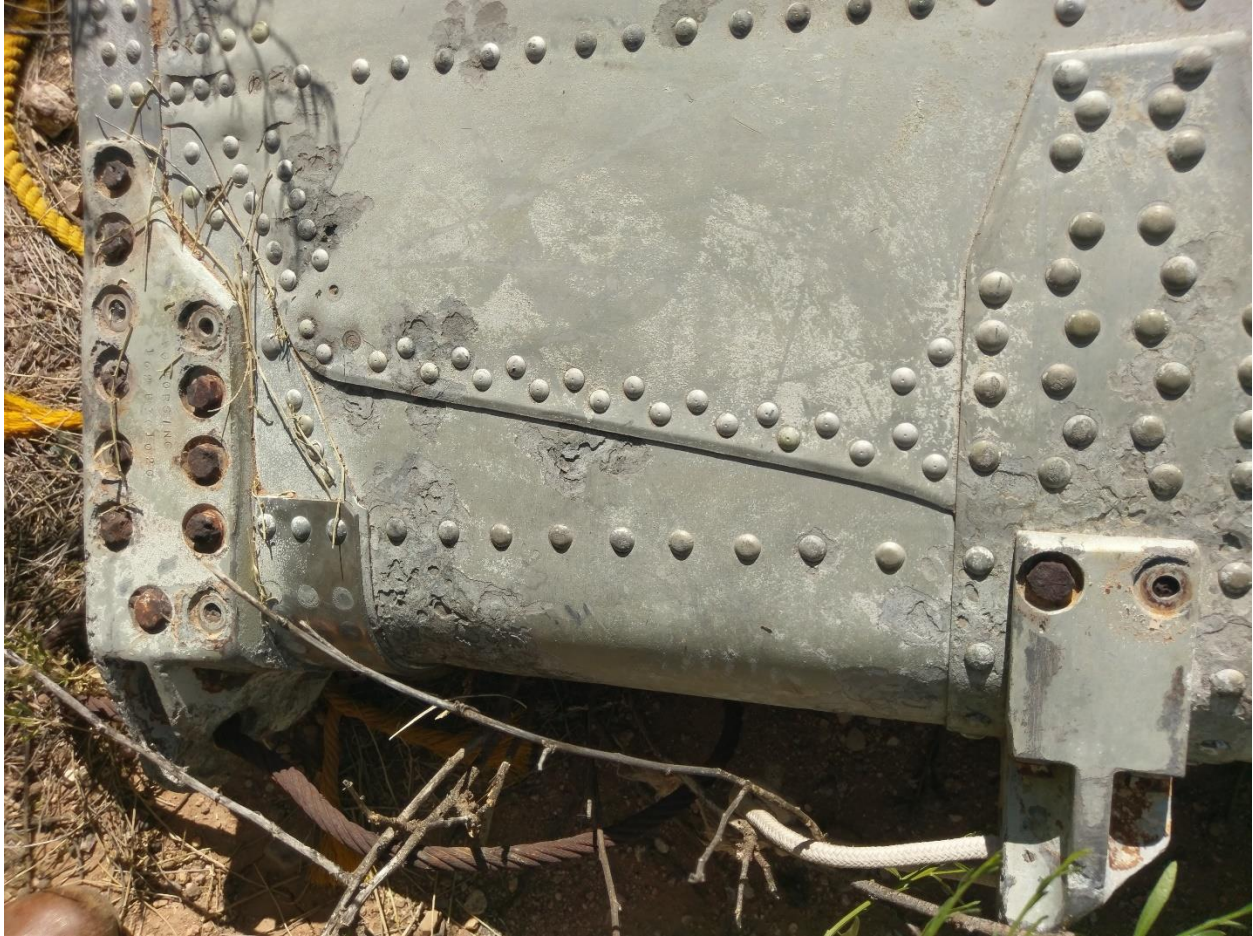
Figure 9.35- Corrosion pitting damage to the rear afterbody as seen in 2018. Note the bare metal has a slight hint of green primer and the pits do not appear to go all the way through the reinforced aluminum in this area. Photo by the author.

times before being transferred to Pima, but has been in outdoor storage since the recovery. Consequently the paint has largely disappeared from the exterior skin, but so have the nodules of corrosion product. The bare metal today appears only slightly marred by light pitting corrosion in the same area, suggesting that, at least in 1996, the nodules were not advanced enough to eat all the way through the metal (Figure 9.35).

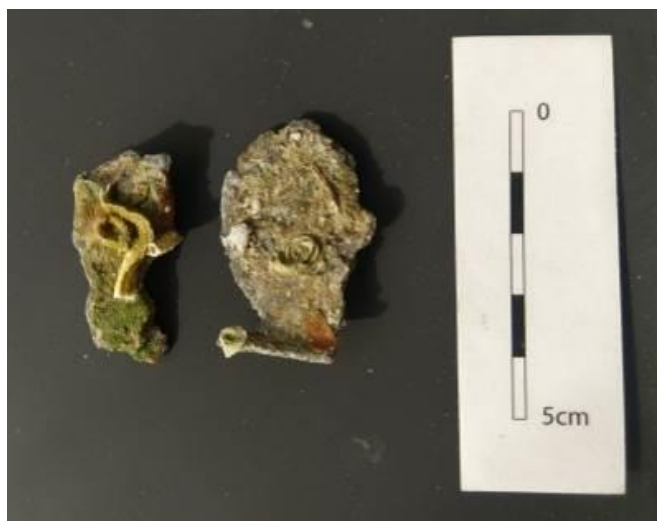
Figure A.1 - There are multiple aircraft wrecks around Vis island, off the coast of Croatia. Along with fieldwork on *The Tulsamerican* site, I visited dump sites for aircraft debris in local harbors. I took sediment, water chemistry, and corrosion potential readings from two of the dumped B-24 wings in 2015. I discovered small metal fragments in one of the sediment samples, VISB-2401 and VISB-2402, and decided to analyze these fragments with XRF. VISB-2401 (R) and VISB-2402 (L) are possible aluminum samples. Both present with a large amount of biofilm, some calcareous encrustation, and other marine growth. Upon scraping, VISB-2401 clearly is shiny bright metal, while VISB-2402 remains a dark color and resembles lead. Photo by the author.

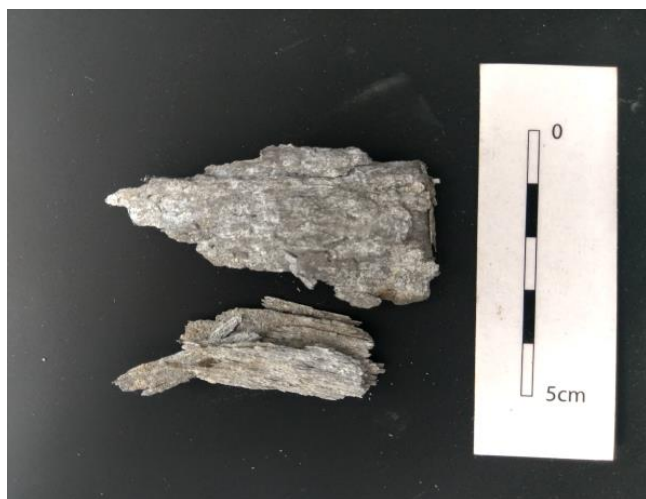
Figure A.2- RAFMDeH01 is a sample of propeller blade material from Handley Page Hampden that crashed in a terrestrial site in Russia in 1942 and was exposed to the elements until 1991. The sample was from the root of a propeller blade and had delaminated into thin slivers from exfoliation or intergranular corrosion. Photo by the author.

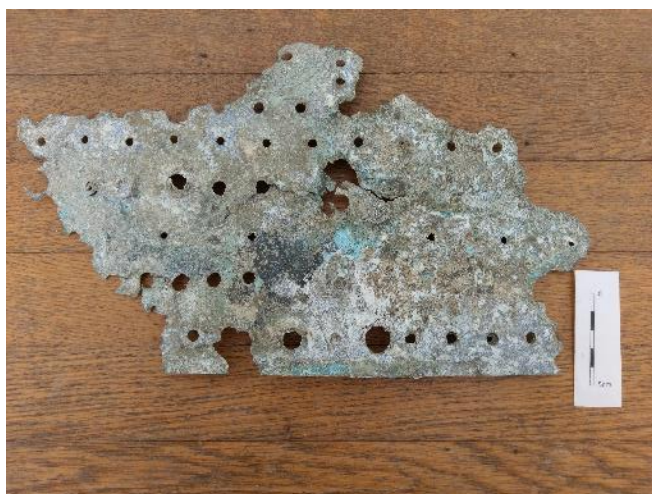
Figure A.4- A sample from the Norsk Luftfartsmuseum from a Focke Wulf 190 aircraft, WWII-era. This sample NLMFW-19001 was recovered from the ocean surrounding Norway and left exposed to the environment. Photo by the author.

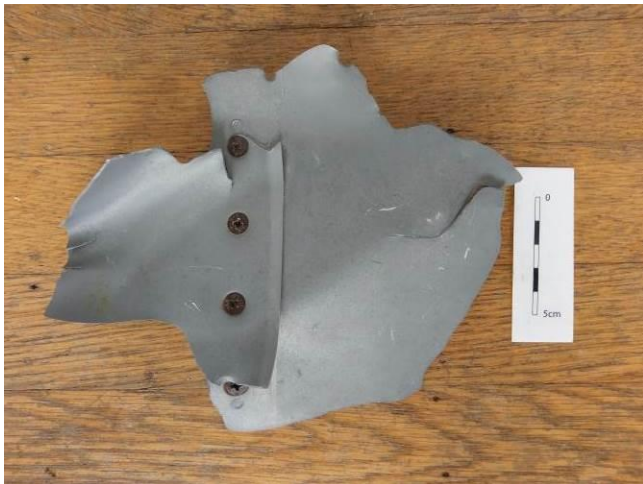
Figure A.6- A recovered piece of T-33 aircraft skin from a terrestrial crash site in Greenland. T-33 is post-WWII era, one of the first jet aircraft. Photo by the author.

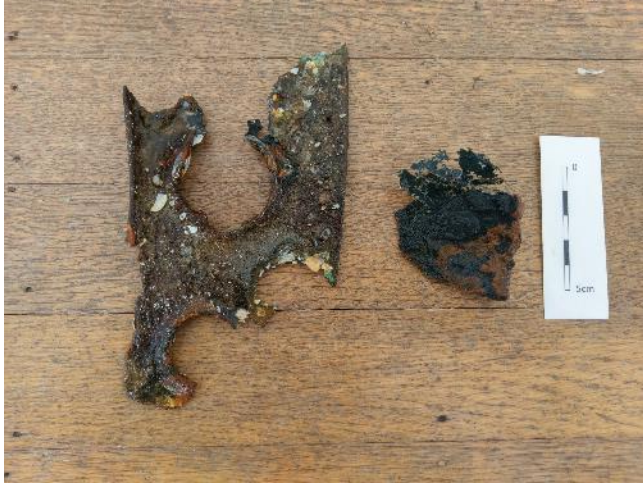
Figure A.7- Two samples from a WWII P-38 aircraft, submerged on a beach in Wales, UK. MoHP-3801 (L) is structural aluminum with a zinc-chromate primer, and MoHP-3802 (R) is, I believe, aluminum covered with corroded and concreted ferrous alloy metal from the engine. Photo by the author.

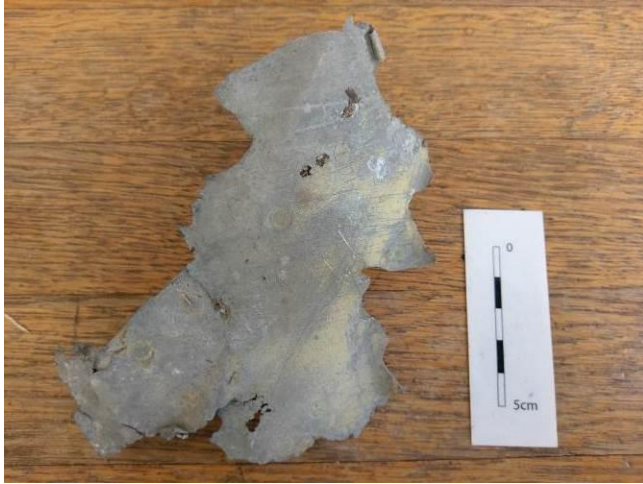
Figure A.9- CAMP-4701 is a piece of skin from a WWII P-47 aircraft found on a beach in North Carolina, recovered, then stored outside. Photo by the author.

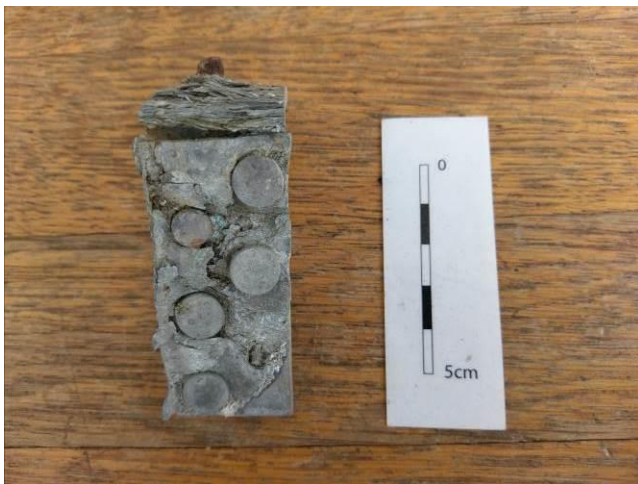
Figure A.10- CAMP-4702 is a piece of cast aluminum and rivets suffering from exfoliation corrosion. Photo by the author.

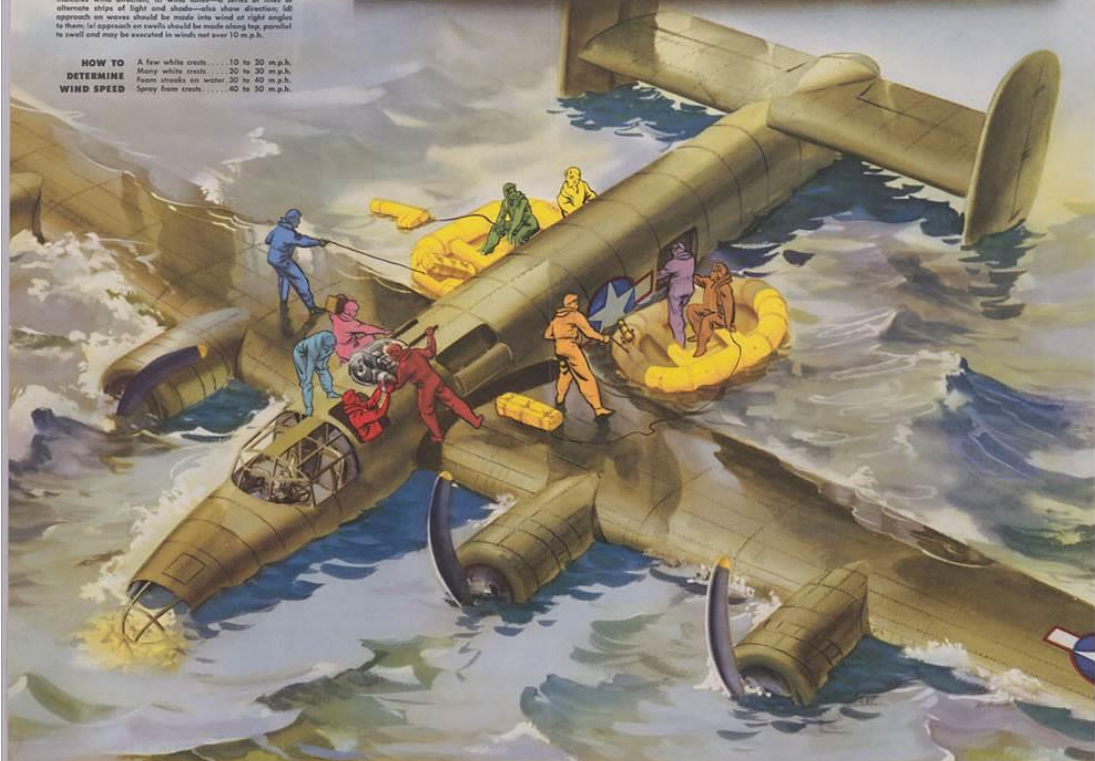
KNOW YOUR DITCHING DUTIES! PRACTICE THEM! DRILL IS IMPORTANT!

Each crewman's duty is briefly and clearly indicated at the right. These duties should be studied, altered if necessary to agree with any modifications, memorized, and practiced until each member of the crew performs them mechanically. Drill is the responsibility of the pilot.

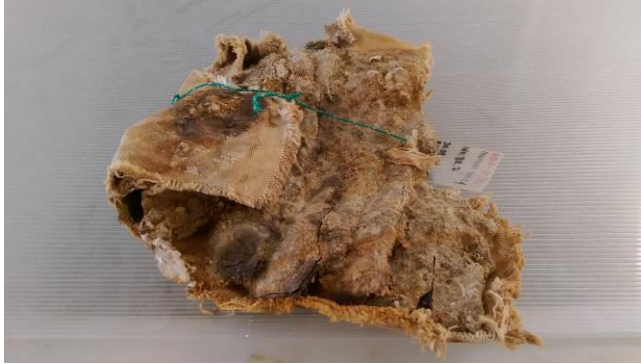
Figure F.1- A flak jacket, partially folded. The iron inserts are corroded and exfoliating but the canvas remains in good shape. There are also some snaps and a rubber hose attached to the canvas. Photo by the author.

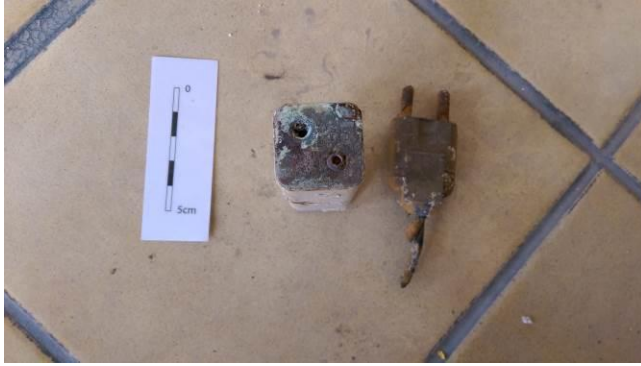
Figure F.3- A plug and socket, possibly from a headpiece. Photo by the author.

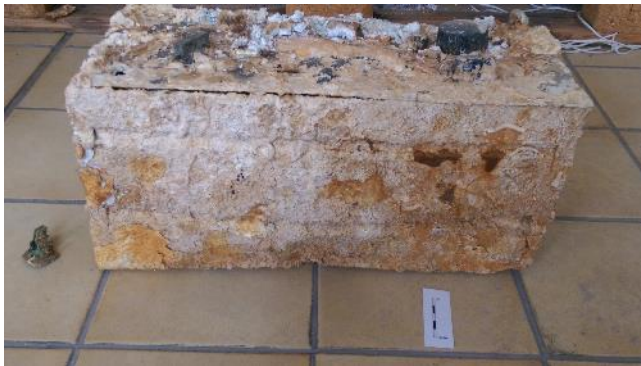
Figure F.4- Aluminum radio box. Photo by the author.

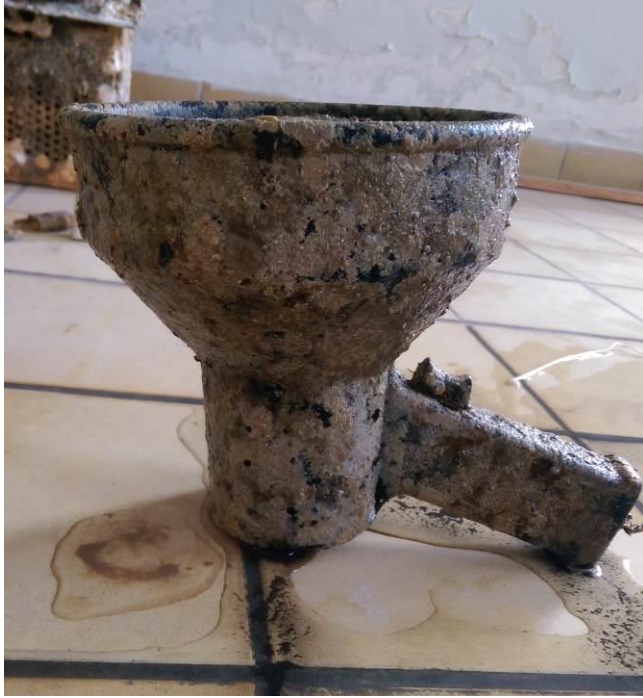
Figure F.5- A signal torch, used in the tail section of the aircraft. This one says GRIMES MI 6.00, Model K-3, Urbana Ohio, on the handle. It is an early plastic material. The lens is intact. This is the only artifact kept in wet storage in Split. Photo by the author.

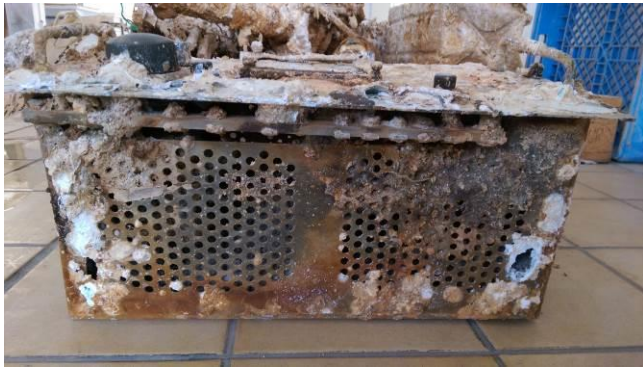
Figure F.6- Another aluminum radio box. Photo by the author.

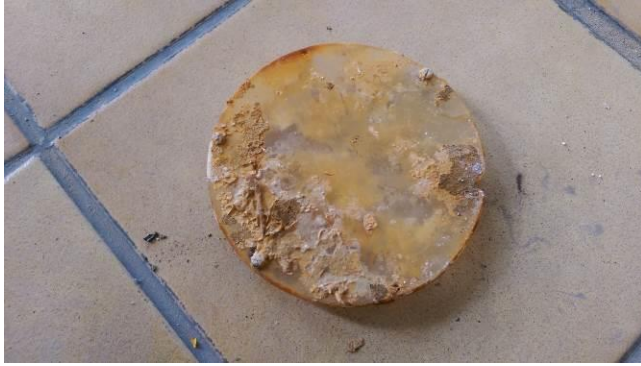
Figure F.7- A lens cover for the signal torch. Photo by the author.

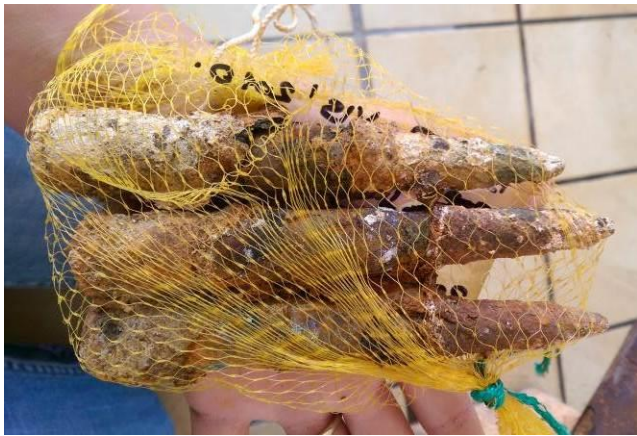
Figure F.8- .50 caliber bullets for the machine guns. Photo by the author.

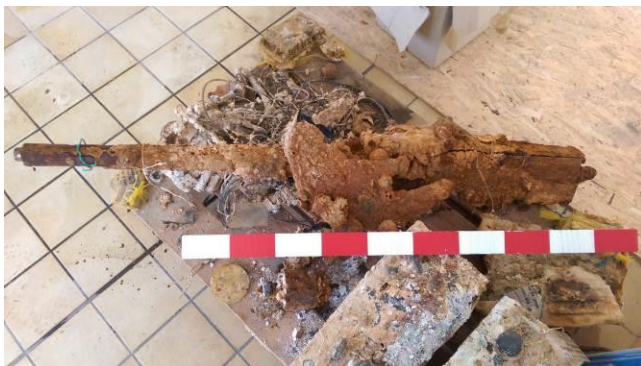
Figure F.9- The nose turret gun, a M2 Browning machine gun. There were 10 aboard the B-24 in the turrets and waist guns. Photo by the author.

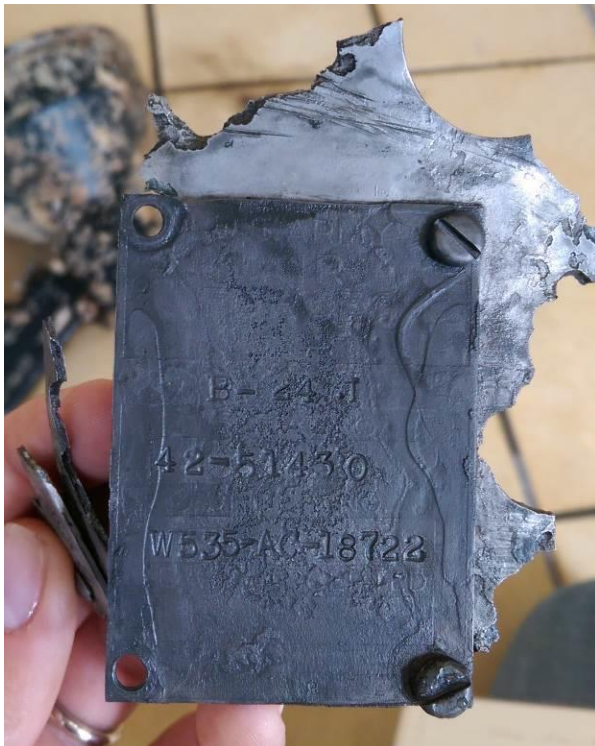
Figure F.11- B-24 42-51430 data plate, conserved and sealed by the Croatian Conservation Institute in 2010. Photo by the author. Photo by the author.

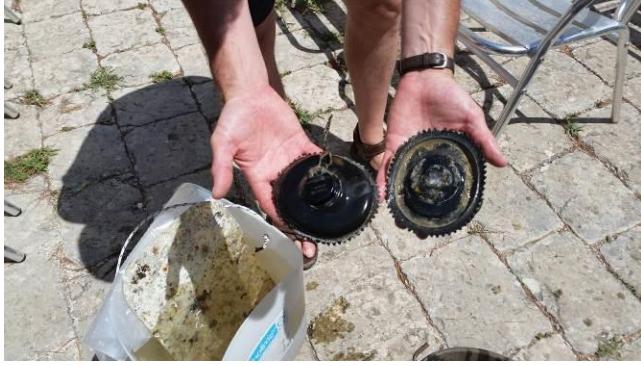
Figure F.12- Earphones for a headset, excavated by DPAA in 2017. This artifact is kept in wet storage in Vis Museum. Photo by the Niall Brannigan, DPAA.

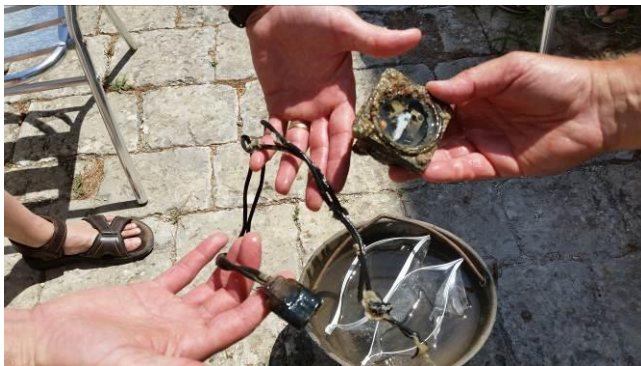
Figure F.13- A cockpit panel instrument and some wiring for a headset. This artifact is kept in wet storage in Vis Museum. Photo by the Niall Brannigan, DPAA.

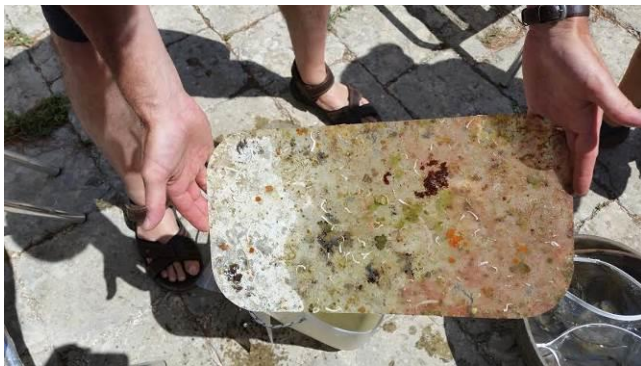
Figure F.14- A small piece of cockpit plexiglass. This artifact is kept in wet storage in Vis Museum. Photo by the Niall Brannigan, DPAA.

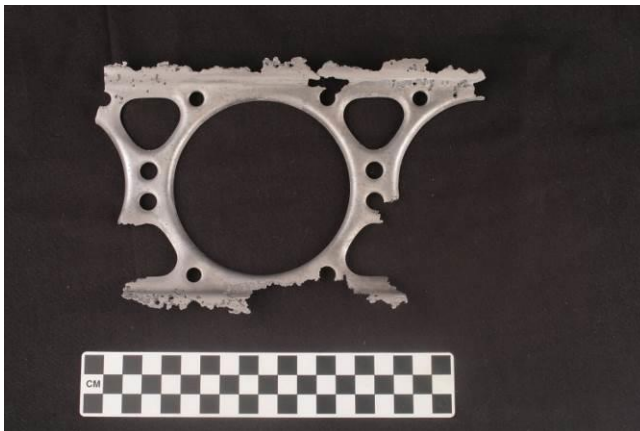
Figure J.2- A piece of girder frame recovered in 1992. This artifact is in private collection. Photo by the author.

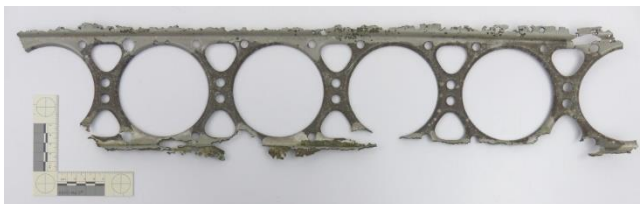
Figure J.3- A piece of conserved girder frame, recovered in 1992. This artifact is at the National Naval Aviation Museum. Photo by the author.

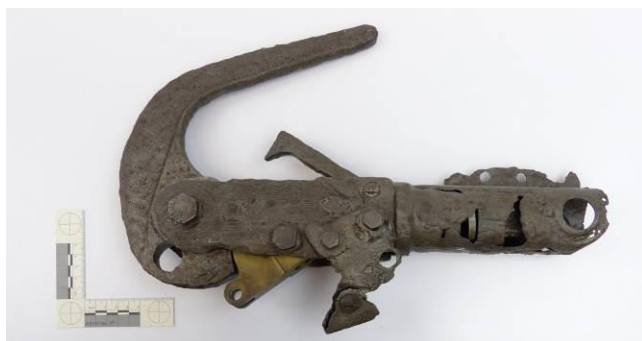
Figure J.6- A 'skyhook' recovered from Biplane 3 in Field A. It was conserved at ECU soon after recovery. This artifact is at the National Naval Aviation Museum. Photo by the author.

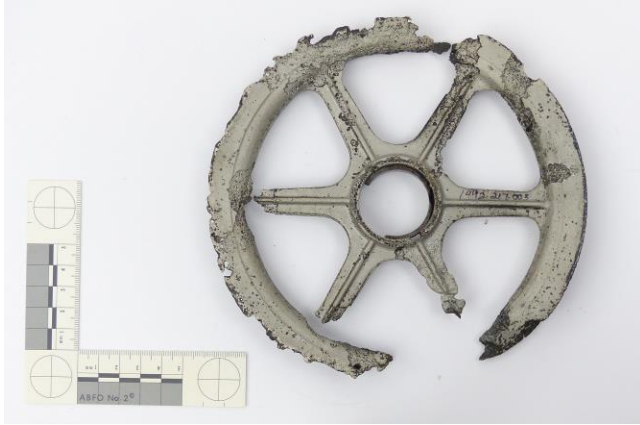
Figure J.7- A pulley wheel, possibly associated with the hangar area. It was conserved at ECU soon after recovery. This artifact is at the National Naval Aviation Museum. Photo by the author.

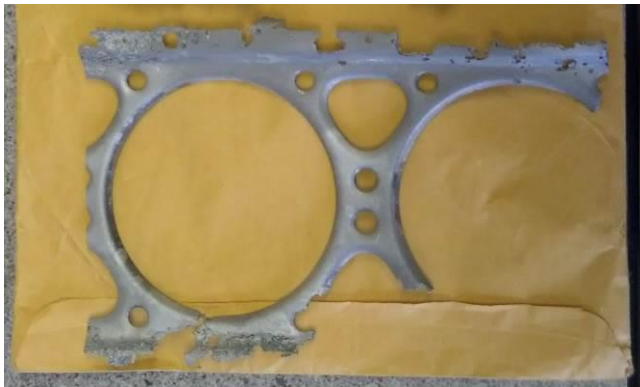
Figure J.8- A piece of girder frame recovered in 1992. This artifact is in private collection. Photo courtesy of Chris Grech.
