AVIATION ARCHAEOLOGY: HISTORY, THEORY, PRACTICE AND DIRECTION

A Dissertation

DOCTOR OF PHILOSOPHY

August 2018

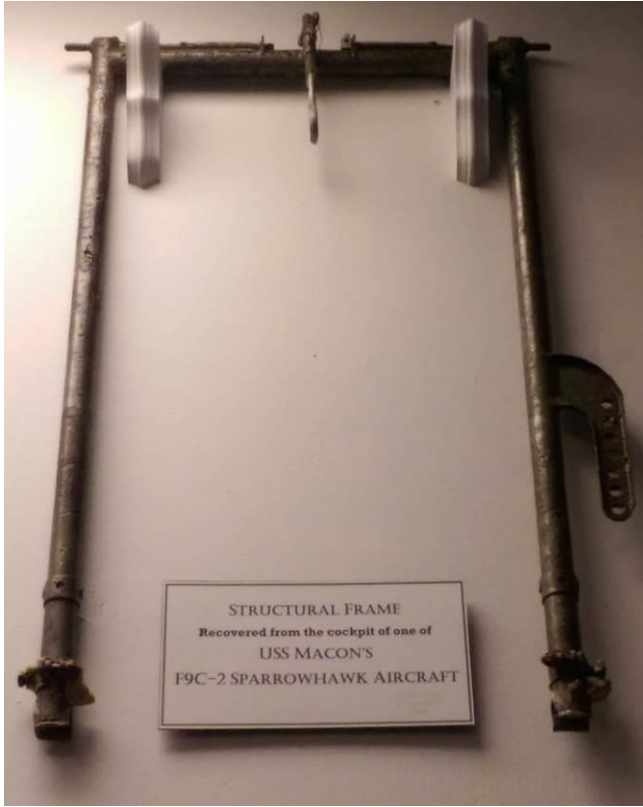
Figure J.9- Structural frame from the cockpit of Biplane 3, recovered in 1992. This artifact did not undergo conservation and is on loan for display at Moffett Field Historical Museum. Photo courtesy of Moffett Field Historical Society.

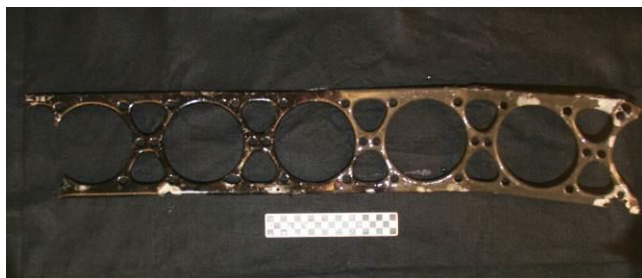
Figure J.11- A piece of girder frame, recovered in 2015. This piece has undergone conservation and is currently at the NHHC UAB lab. Photo by the author.

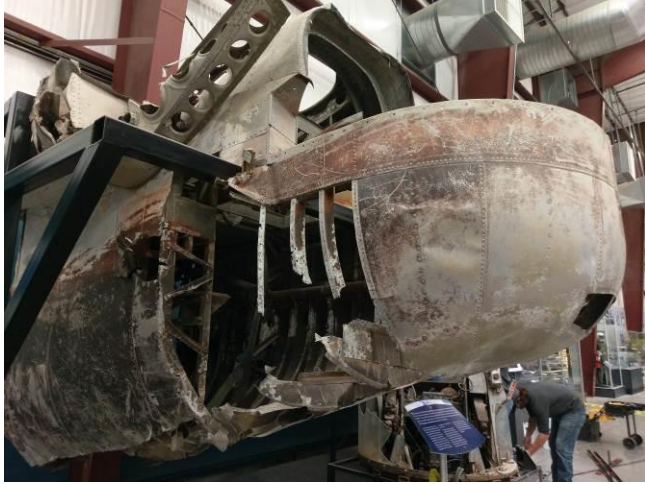
Figure N.1 – PBM-5 recovered tail section showing areas of damage and corrosion. Likely the loss of the panel was due in part to the corrosion of the stringers underneath. Photo by the author.

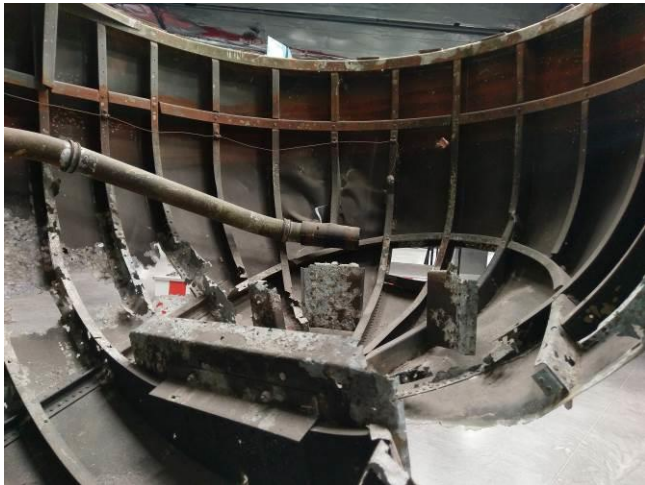
Figure N.2- The inside of the tail section, showing areas that are free of any corrosion. Photo by the author.

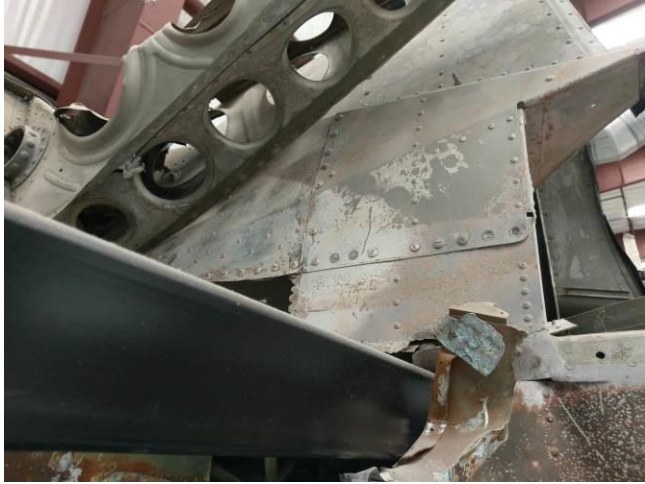
Figure N.3- An exterior view of the tail section showing some faded paint lines. Bare metal interior structure pieces show little corrosion. Photo by the author.

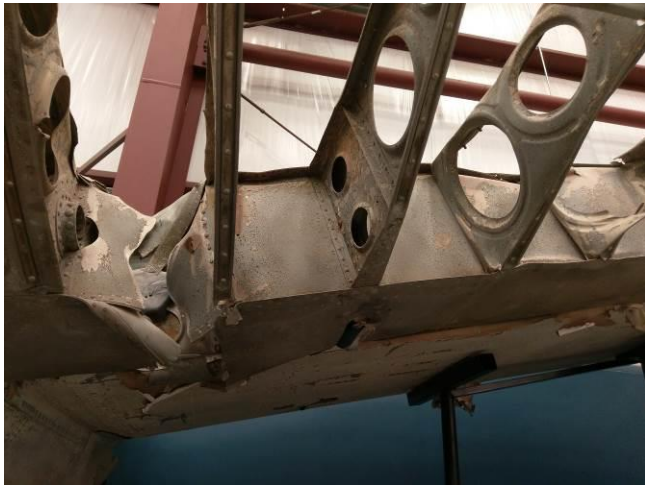
Figure N.4- Some chipping paint is still visible on the elevator structure. Photo by the author.

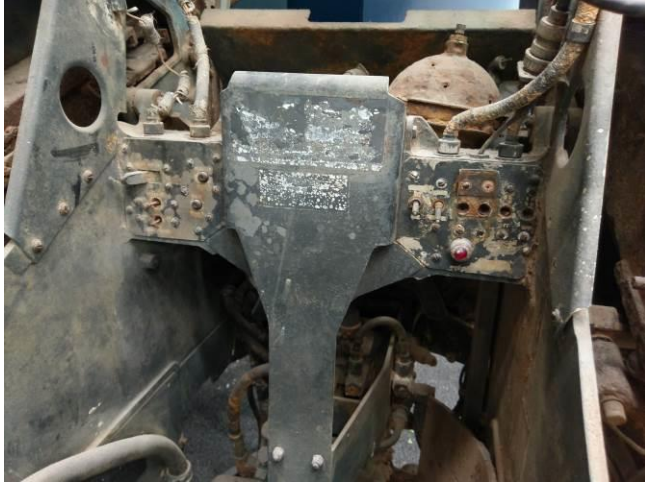
Figure N.5- The interior central control panel of the Martin 250CH-2B tail turret, recovered in 1996. Active corrosion presents in the middle of the panel. Photo by the author.

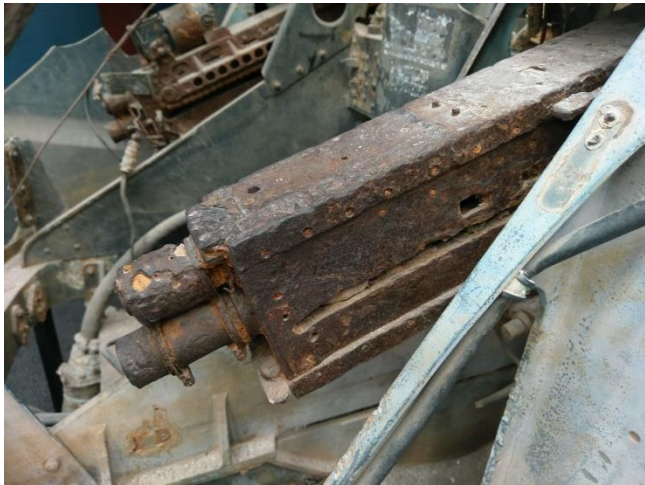
Figure N.6- One of the two M2 Browning machine guns inside the tail turret. Both display the same level of rusting and light pitting. Photo by the author.

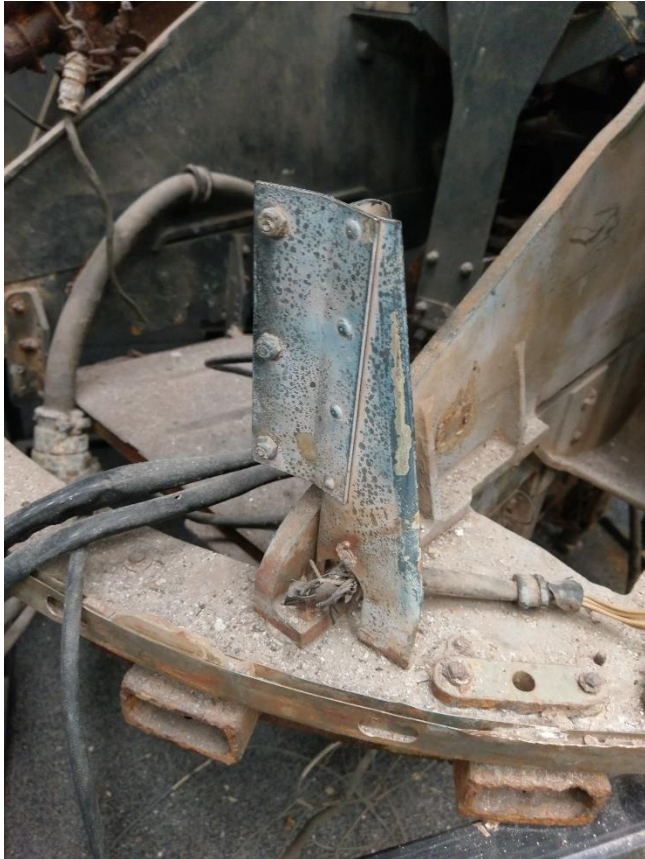
Figure N.7- Light blue paint is peeling, but obvious on a section of the tail turret. Little corrosion appears on these cast aluminum and steel parts, although the steel parts have faint rust marks in some areas. Photo by the author.

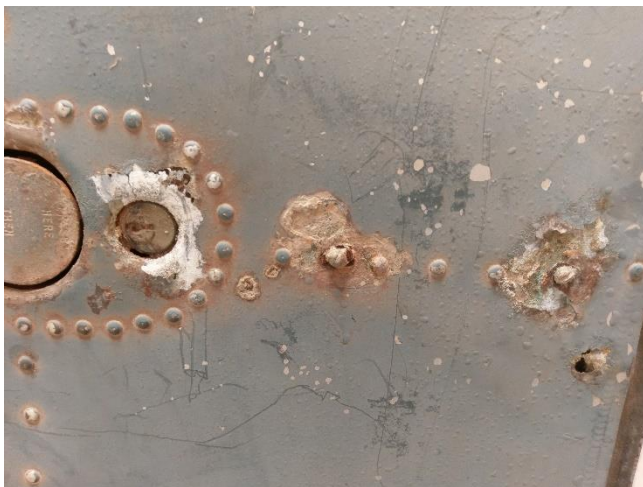
Figure N.8- A close-up of the pitting and exfoliation corrosion on the hatch door artifact recovered in 1980-1981. Blue paint still appears mostly intact. Photo by the author.

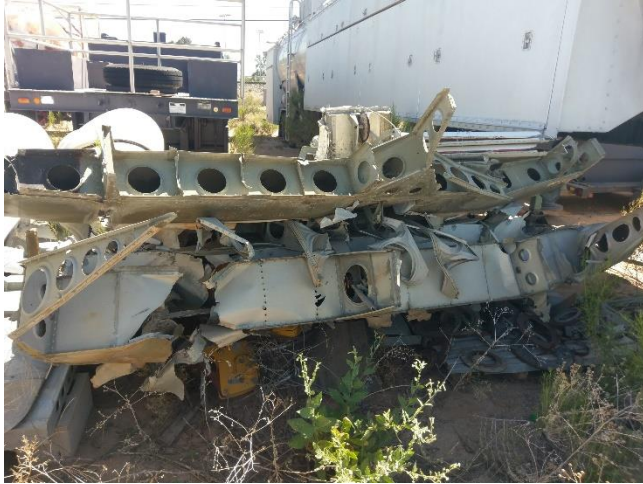
Figure N.9- Pieces of the tail and vertical stabilizer, fabric hanging at the bottom, in outdoor storage at Pima Air & Space Museum. Photo by the author.

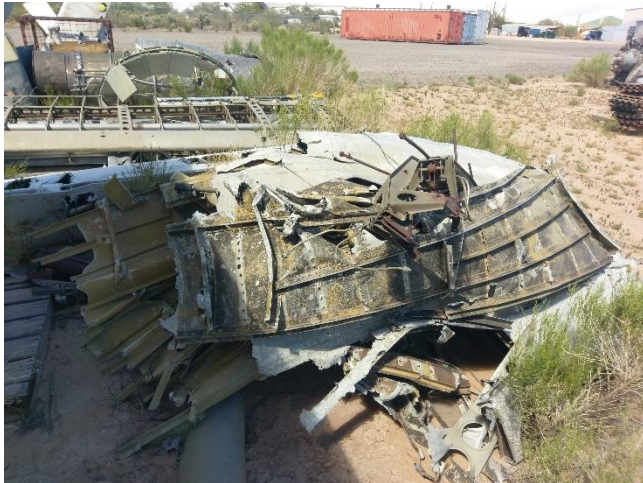
Figure N.10- Another view of pieces of the tail and vertical stabilizer in outdoor storage at Pima Air & Space Museum. Photo by the author.

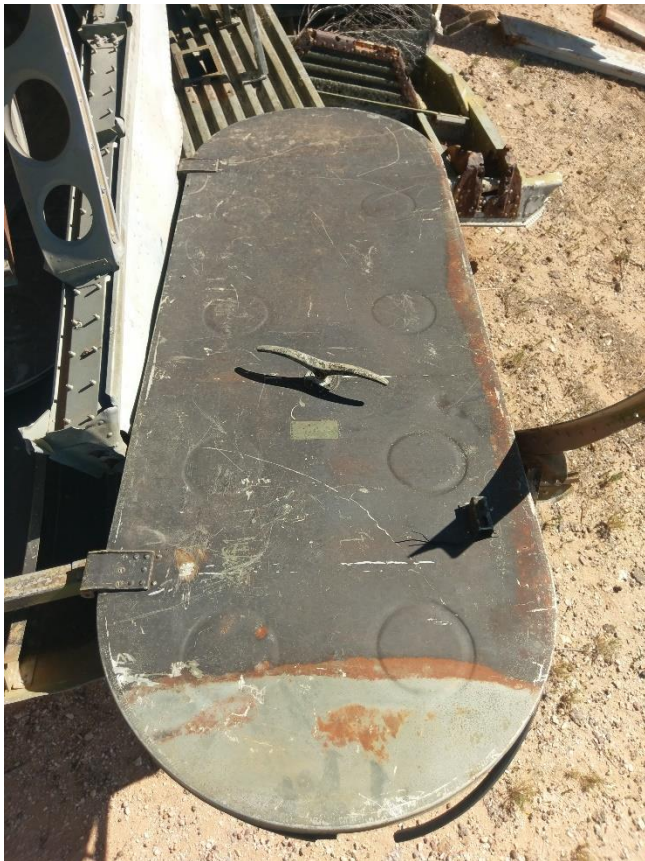
Figure N.13- An exterior tail section hatch door with mounts for jet-assisted take off (JATO) propulsion bottles, currently in outdoor storage at Pima Air & Space Museum. Photo by the author.
