Simple strengthening techniques for Non-Engineered buildings against seismic actions

Marina Traykova University of Architecture, Civil Engineering and Geodesy, Sofia, Bulgaria Christos Giarlelis Equidas Consulting Engineers, Greece Andreas Lampropoulos School of Environment and Technology, University of Brighton, UK Stephanos Dritsos Department of Civil Engineering, University of Patras, Greece Jon Moseley Consulting Engineer, Greece Contact: marina5261@abv.bg

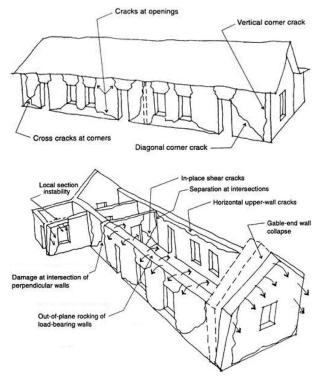
Typical types of damage to adobe construction can be summarised by the following: (a) Rocking of independent structural parts and in-plane diagonal and horizontal shear cracks, (b) Shear cracks due to pounding between orthogonal walls, (c) Pediment overturning in gable-end walls, (d) Gable-end wall overturning and possible toe crushing at their base, (e) Diagonal shear cracks in transversal walls. Gable-end wall overturning with portions of transversal walls, (f) Shear failure and sliding of peripheral bracing, (g) Diagonal tensile cracks from out-of-plane bending and diagonal shear cracks in transversal walls, (h) Separation and overturning of small wall segments, (i) Separation and overturning of large wall segments, (j) In plane shear cracks near openings

Figure 2. Typical damage in earthen (adobe) structures [2]

and masonry piers, (k) Corner dislocation and overturning and (I) Partial disintegration and loss of structural material. Figure 2 presents some of these failures.

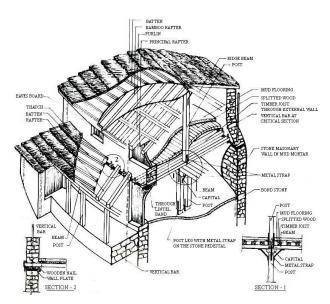
Most buildings in Nepal are made of stone and are not engineered since there is no process for Building Code enforcement in rural areas. Therefore, the damage from the 2015 Nepal earthquake was extensive. Simple strengthening techniques (Figure 6) that were suggested [6] comprise of: (a) Roof/floor retrofit with anchorage to walls thus creating diaphragms, (b) Insertion of bond stones in walls, bandages at different levels and splints at critical sections and (c) For timber frames, the creation of bracing (knee bracing, diagonal bracing) in order to strengthen beamcolumn connections and improving the anchorage of timber columns to the foundation.

Figure 6. Illustration of simple strengthening techniques in Nepal [6]
