Autonomous Systems Imaging of Aerospace Structures

Abstract. Aircraft manufacturers are constantly improving their aircraft ensuring they are more cost-efficient to do this the weight of the aircraft needs to be reduced, which results in less fuel required to power the aircraft. This has led to an increased use of composite materials within an aircraft. Carbon fibre reinforced polymer (CFRP) composite is used in industries where high strength and rigidity are required in relation to weight. e.g. in aviation – transport. The fibre-reinforced matrix systems are extremely strong (i.e. have excellent mechanical properties and high resistance to corrosion). However, because of the nature of the CFRP, it does not dent or bend, as aluminium would do when damaged, it makes it difficult to locate structural damage, especially subsurface. Non-Destructive Testing (NDT) is a wide group of analysis techniques used to evaluate the properties of a material, component or system without causing damage to the operator or material. Active Thermography is one of the NDT risk-free methods used successfully in the evaluation of composite materials. This approach has the ability to provide both qualitat

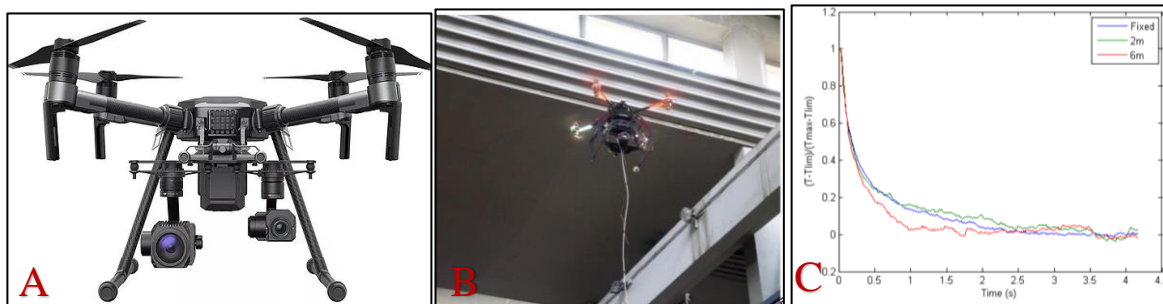
FIGURE 14 A: DJI M210 equipped with thermal camera [8]. FIGURE 14 B: UAV equipped with thermal camera [7]. FIGURE 14 C: Comparison of front face temperature responses to flash heating in the case of a large uniform irradiation with a fixed camera and a stabilized camera with UAV at two distances (2 m and 6 m) [7].

Along with the liquid penetrant NDT method, a UAV thermographic inspection was tested for civil engineering applications. The UAV is equipped with a FLIR A320, this IR camera is connected to a computer via a cable, one is a power cable and the other provides real time radiometric thermal images which will reveal heat patterns and thermal anomalies [7]. Transient thermography with flash and step heating where the methods used in this inspection. An inspection took place and gathered data on difference distances between the camera and the samples (2, and 6 metres). Along with the UAV equipped with the IR camera, there was a fixed IR camera, therefore two sets of data could be acquired and compared. A thermally uniform area of a sample is delimited, and the IR cameras captured the data [7].
