**Investigation into effectiveness of a downwire insulator
and insulated bonding wire as mitigation measures for
pole-top fires in woodpole structures**

A research report submitted to the faculty of Engineering and the Built Environment, University of the Witwatersrand, in fulfilment of the requirements for the degree of Master of Science of Engineering

Johannesburg, April, 2015

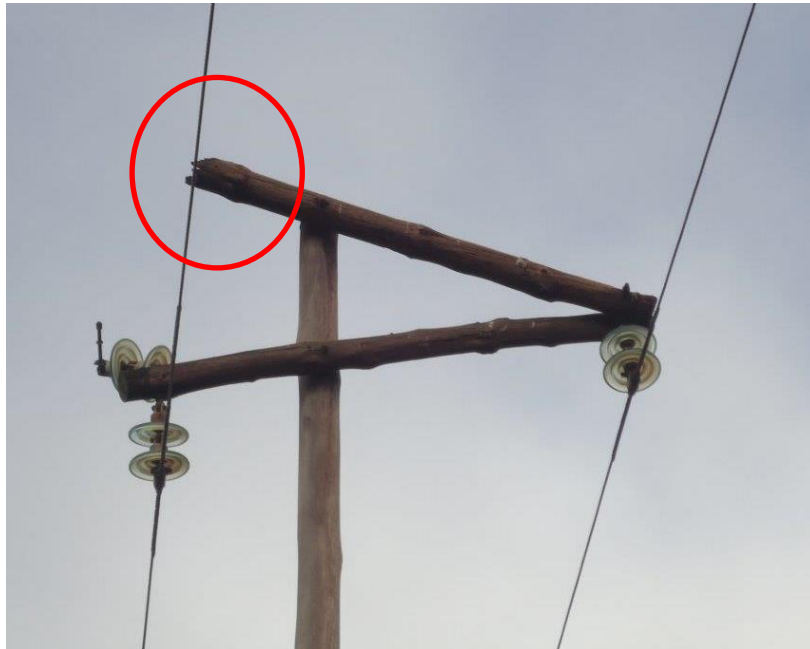
Figure 1.2: Typical example of a burnt structure in the field [4]

wood tracking to occur and consequently burning of the wood. Figure 1.2 shows a typical example of a burnt structure in the field [4].

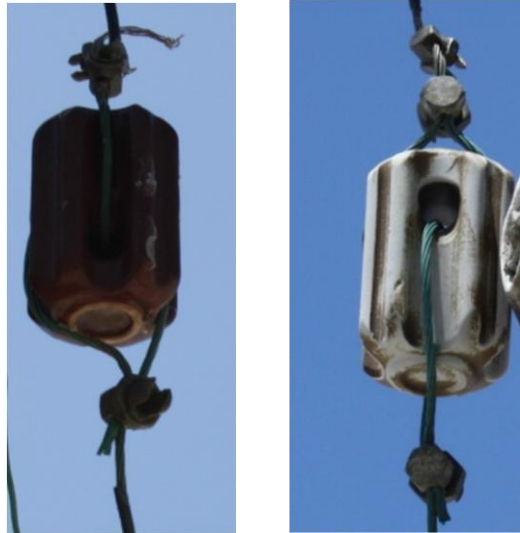
Figure 1.6: Glazed (left) and unglazed (right) downwire (stay wire) insulators [9]

An unglazed downwire insulator was also selected to investigate the effect of the downwire insulator surface material. This insulator is similar to a conventional stay wire insulator, except that the glazing was removed. It is postulated that this material may allow pollution to accumulate more easily on the unglazed insulator than on a glazed insulator, resulting in further reduction of insulator surface resistance when the insulator is wetted and polluted. Figure 1.6 shows the differences between the glazed and unglazed downwire insulators used during the investigations.

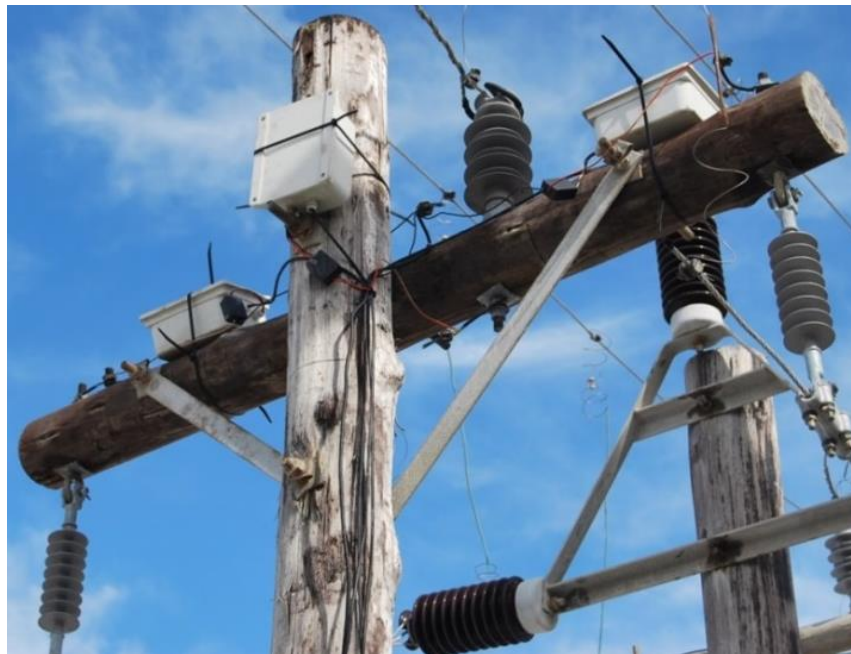
Figure 3.2: Other two structures erected at KIPTS: a) structure with unglazed downwire insulator, b) Fully bonded and earthed structure with no downwire insulator or wood gap

The other two structures are similar to this structure and are shown in Figure 3.2.

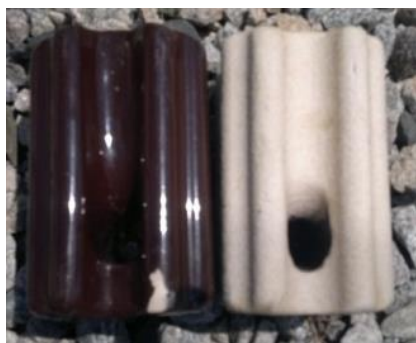
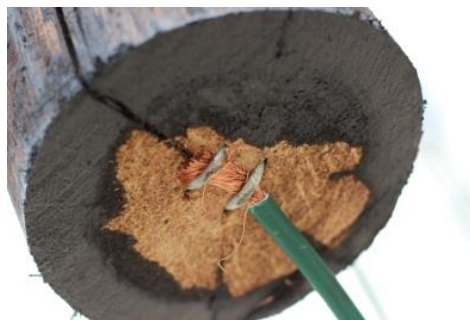
Figure 3.5: Test structure and components: a) Test structure with associated support, b) the glazed and unglazed downwire (stay wire) insulators used on the test structure, c) connection of earthed bonding wire to the woodpole

Only one structure was erected. The purpose was to compare the performance of glazed and unglazed downwire insulators effectively using the same woodpole. Modifications were made to the test structure when necessary. Figure 3.5 depicts the test structure with a glazed stay wire insulator. Two porcelain pedestals (bushings) were used to support and suspend the test structure above the ground, while providing adequate insulation from the ground. The pedestals were stayed to ground to secure the test structure for the duration of the tests. The porcelain bushings were washed with water and allowed to dry before and during testing to reduce the risk of leakage current from flowing through the stay wires to ground.

It is clear from Figure 3.5 that the key components of the test structures are woodpole, downwire insulators and the phase insulators. The wood cross-arm was effectively taken out of the circuit by correctly bonding all the phase insulators together. The key components are briefly described as follows:

- iii) The glazed and unglazed porcelain stay insulators chosen are similar to the ones used at KIPTS. The two insulators had similar dimensions (creepage, dry arc distance, profile, etc.) and were from the same manufacturer. These insulators are shown in Figure 3.5 b).

The phase insulators were directly bonded together and the bonding was connected to earth via a downwire insulator. The bonding wire used was insulated (up to 600 V AC) and u-nails were used to secure the earthed bonding wire to the woodpole – refer to Figure 3.5 c).

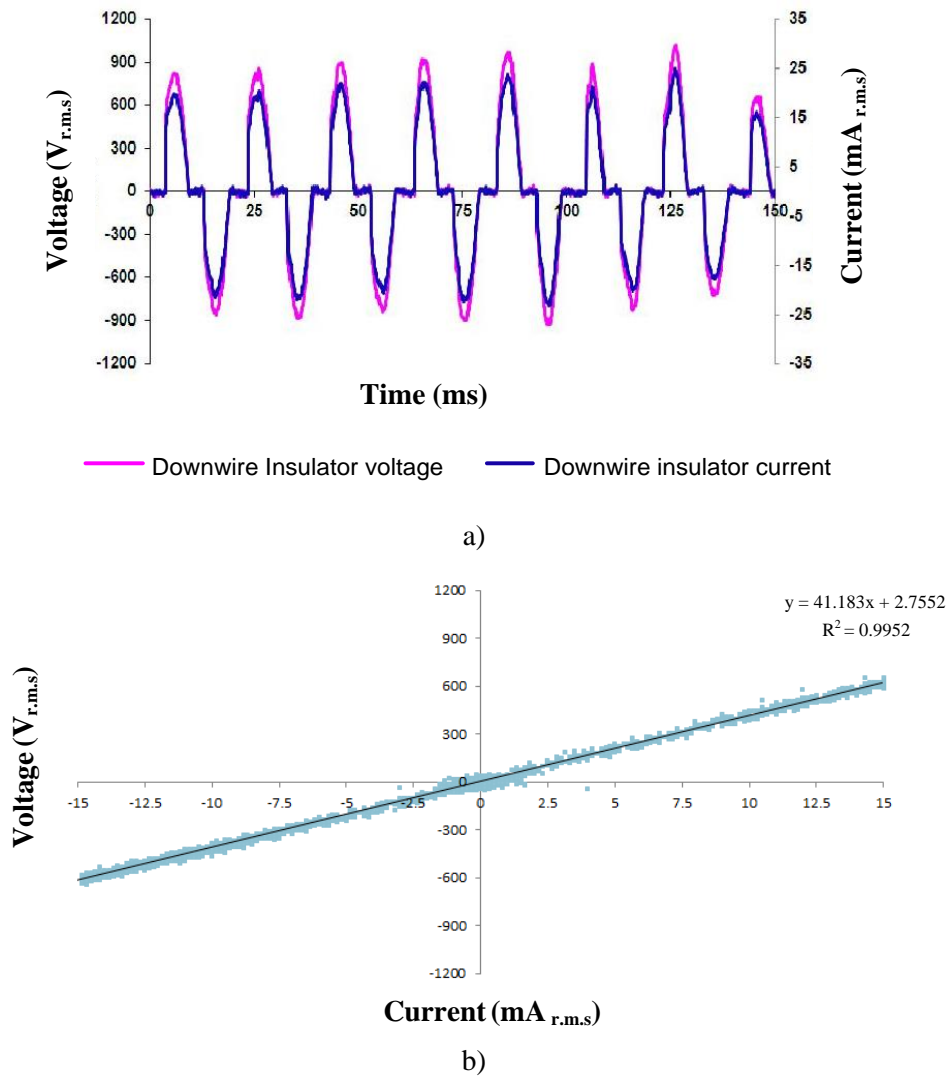
Figure 4.3: Example of measurements obtained on the structure with glazed downwire insulator

end-fittings to eliminate fires on the cross-arm or at the junction of the main pole and cross-arm. The insulator was predominantly resistive and approximately 41 kΩ. The insulator resistance was higher than the resistance of the unglazed downwire insulator estimated in Section 4.2.1.1.

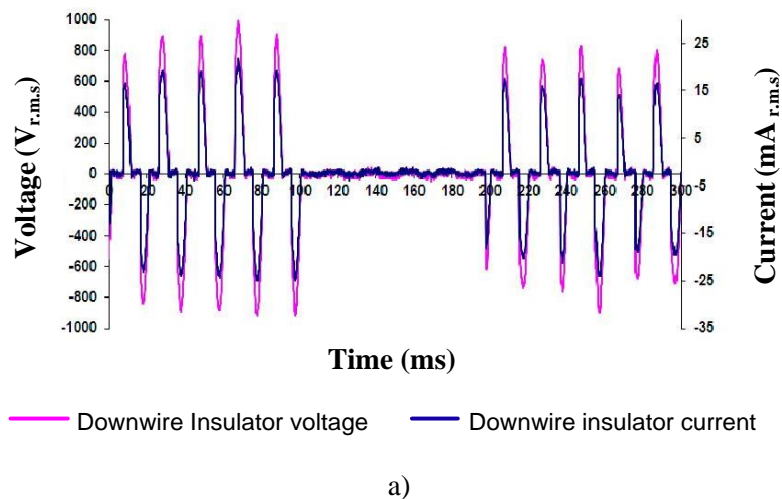
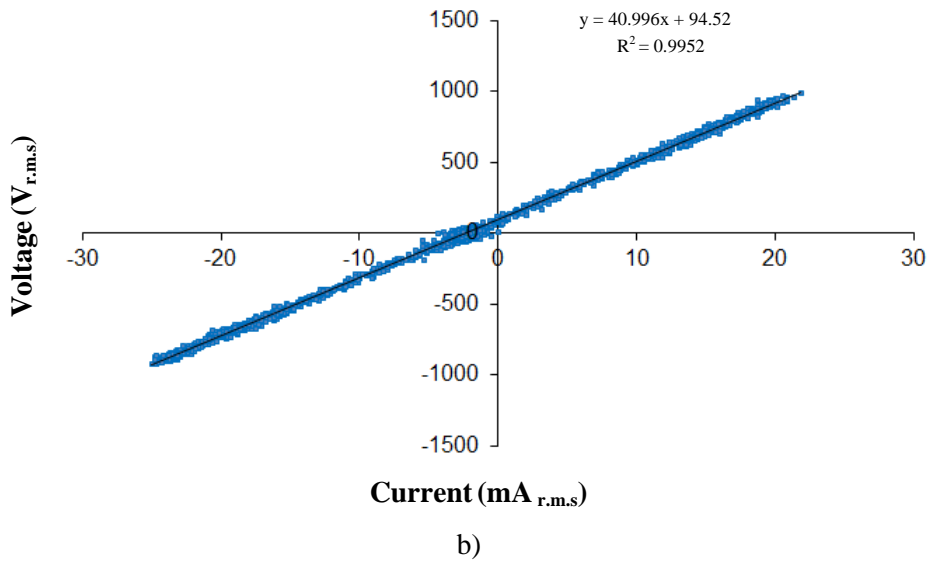
Figure 4.4: Another example of measurements obtained on the structure with a glazed downwire insulator

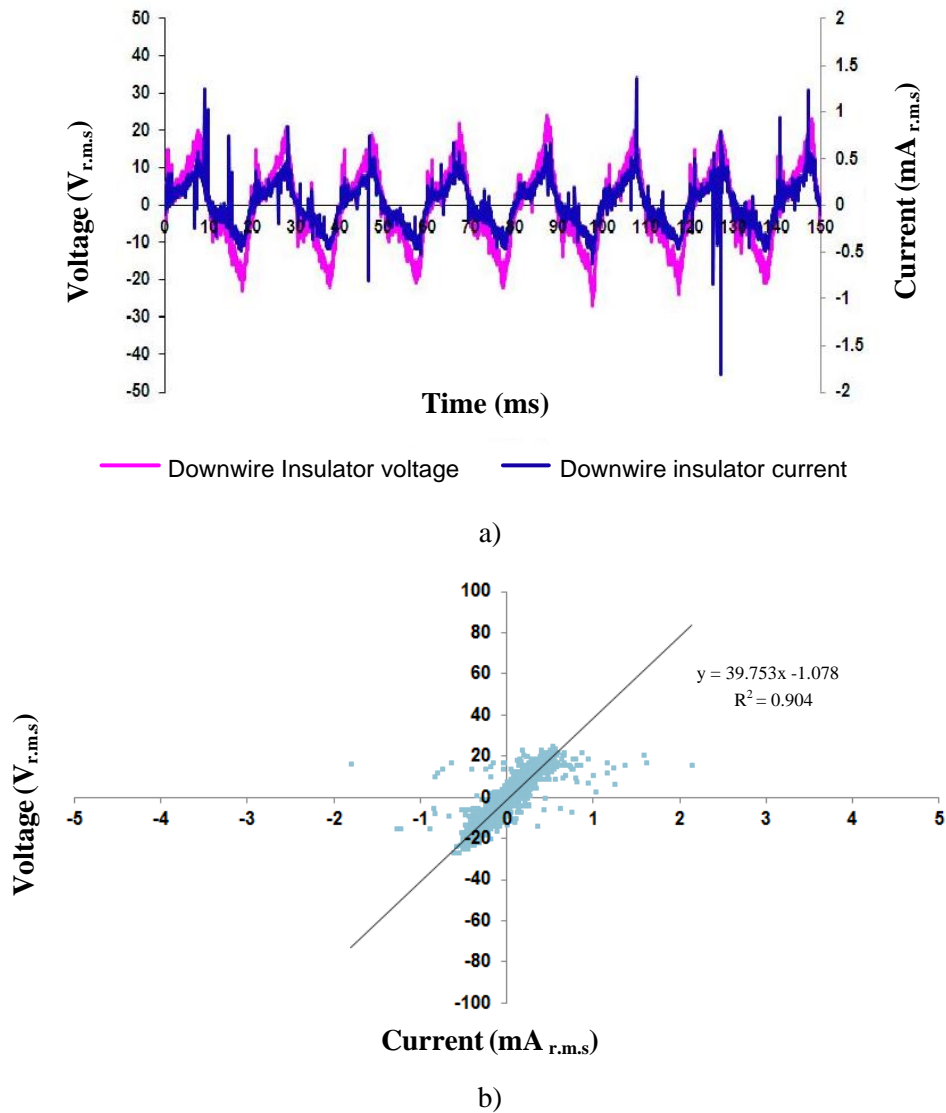
Figure 4.5: Example of measurements obtained on the structure with an unglazed downwire insulator

Figure 4.5 depicts a set of measurement results obtained. Similar results were obtained as in September, where the magnitude of the downwire insulator current and the downwire insulator voltage varied little with time and at a frequency of 50 Hz. The maximum measured insulator voltage was approximately 25 V, which is comparable to the 30 V measured in September. The magnitude of the downwire insulator current was also similar to the magnitude measured in September (approximately 1 mA). The insulator voltage and downwire current were linearly related as before. The insulator resistance was approximately 40 kΩ and is slightly higher than the 10 kΩ estimated in September.

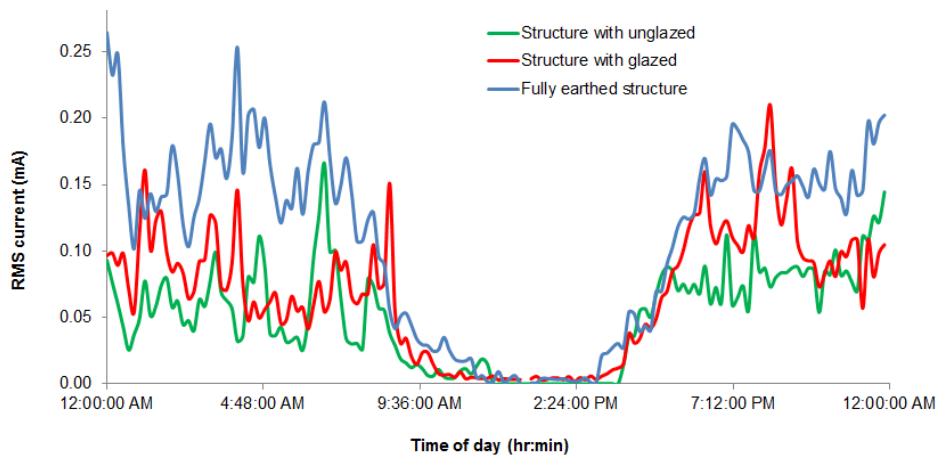
Figure 4.7: Comparison of current time trends for the three structures for the period 25 July to 31 August 2012: a) r.m.s current time trends, b) r.m.s time-of-day

Figure 4.7 shows the r.m.s current recordings of the three structures for the period 24 July to 31 August 2012. Figure 4.7 a) shows the r.m.s current time trend and Figure 4.7 b) shows the r.m.s current time-of-day trends. The time of day trends give an indication of leakage current behaviour over this period, averaged to 24 hours. In July, the fully bonded and earthed structure recorded slightly higher magnitudes of current than the other two structures with downwire insulators. This is clearly demonstrated by the time-of-day trends (Figure 4.7 b)) and is expected since fully bonding and earthing (continuous earth wire) provides a low resistance for current to flow to ground.

The magnitude of the leakage current recorded at night is higher than the values recorded during the day. This behaviour is consistent with the findings of Vosloo et al and is attributed to high relative humidity at night and early mornings of the day [11].

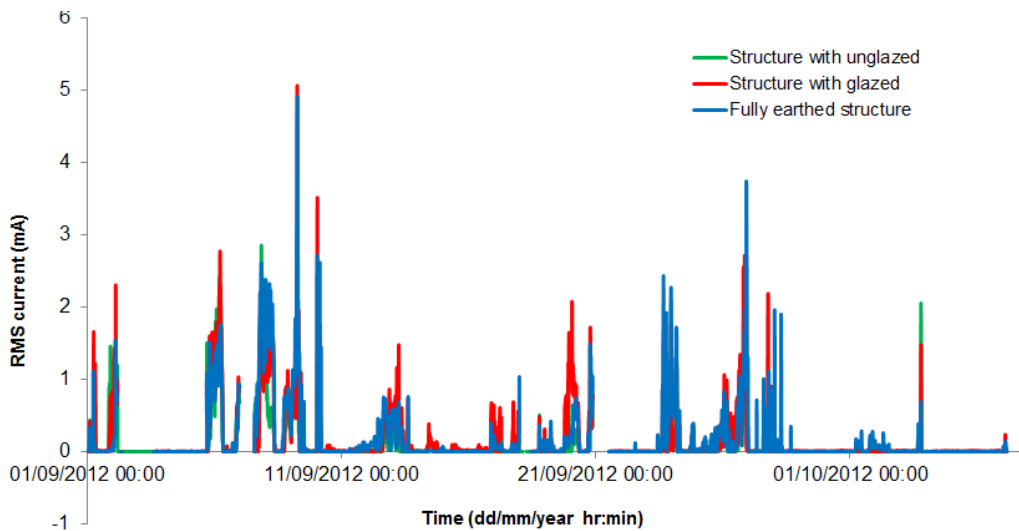
Figure 4.8: Comparison of r.m.s currents for the three structures for 4 Sep to 7 Oct 2012

Figure 4.8 depicts the r.m.s current recordings of the three structures for the above-mentioned period. Higher levels of leakage current were recorded on the three structures than in the July-August period. This may be due to the pollution building up on the phase insulators and downwire insulators throughout the time of energisation, and possibly weather conditions. Of importance is that the three structures recorded similar magnitudes of current, as shown in Figure 4.8 b). It is suspected that the high pollution and high humidity caused the impedance of the glazed and unglazed downwire to become resistive and low, thus providing low resistance paths for current to flow to earth – much similar to a fully earthed structure. These results are encouraging for pole-top fires.

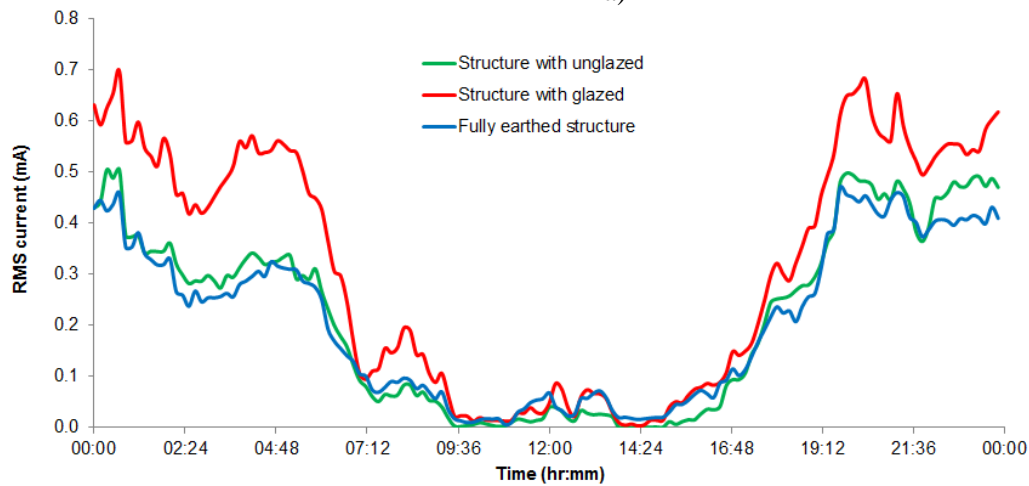
Figure 4.9: Comparison of r.m.s currents for the period 1 November to 5 December 2012

There was no data recorded in October since the site was un-energised for several days and the OLCA system was malfunctioning. The problem was resolved and the currents were logged from 1 November to 5 December. Figure 4.9 shows the r.m.s. currents of the three structures. The structure with glazed downwire insulator recorded higher levels of currents than the other two structures. Again, this is attributed to the structure position from the sea. This is consistent with the measurement of current waveforms discussed in Section 4.2, where higher levels of leakage current were recorded on this structure during the measurement performed in September and November than on the structure with unglazed downwire insulator.

The fully bonded and earth structure and the structure with unglazed downwire insulator recorded similar levels of currents. Again, the results are promising and indicate that under certain conditions, the downwire insulators conduct significant levels of leakage current to earth – similar to a fully bonded and earthed structure.

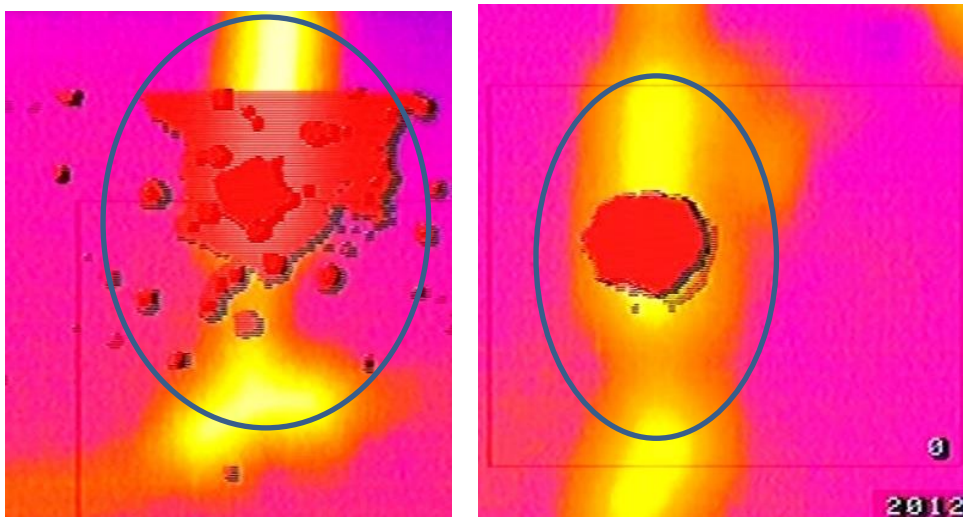
Figure 4.10: Typical examples of IR recordings: heating and activity observed on phase insulator of the structure with glazed downwire insulator (left), heating and activity observed on phase insulator of the structure with unglazed downwire insulator (right)

UV and IR measurements were conducted in September, November and December 2012, while the structures were energised. Leakage current activity and heating were observed on the phase insulators of all three structures. Figures 4.10 and 4.11 shows typical examples of the heating and leakage current activity observed on the phase insulators respectively. The IR recordings indicate that heating was detected on the phase insulators. No similar heating was detected on the woodpole and downwire insulators as shown in Figure 4.12.

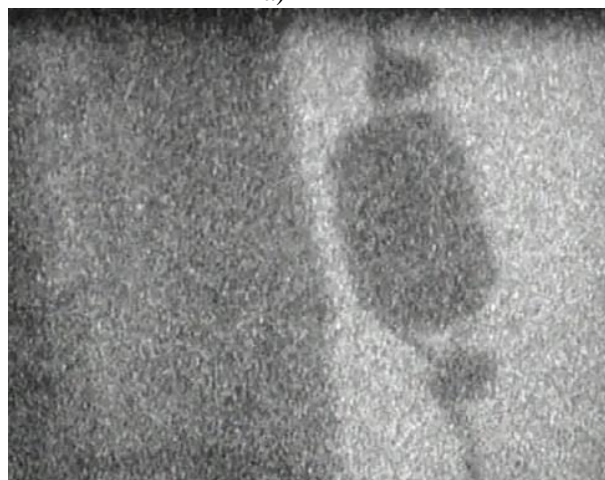
Figure 4.12: No surface discharges observed on the woodpole and downwire

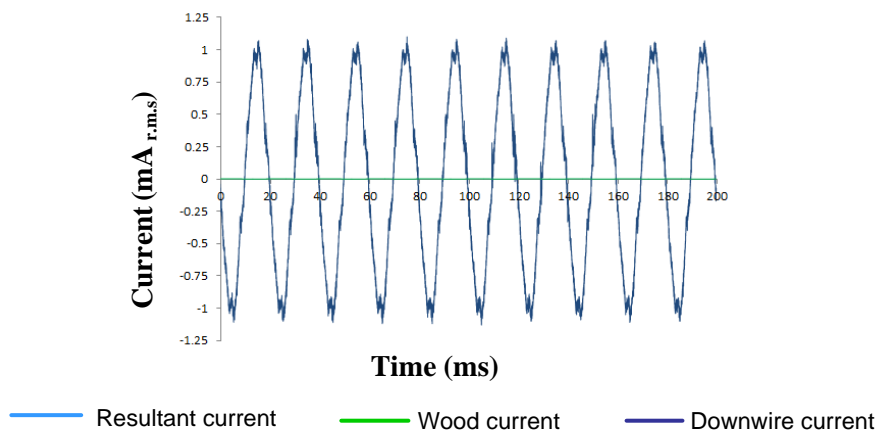
Figure 5.17 shows the measured earth downwire current, woodpole current and the voltage. Significantly more current was measured along the earthed downwire than along the woodpole path. This was also observed in section 5.2.3 and is attributed to the fact that the fully earthed downwire provides a low resistance path for current to flow to ground. No significant voltage was measured on the earthed downwire, as expected (since $V = IR$ and R is very low). This result may prove that the low voltages measured across the unglazed downwire insulator were due to the low impedance of the downwire insulator.

Figure 5.17: Measurements obtained under dry conditions

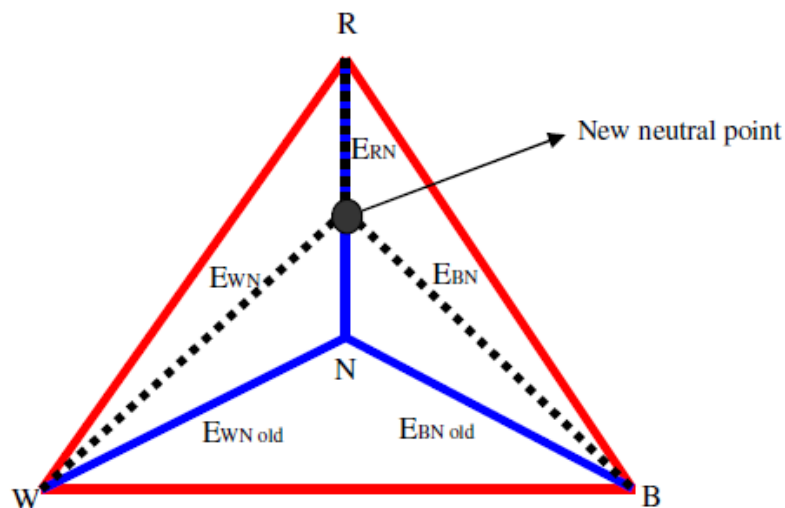
The effect of the downwire insulator voltage on the neutral shift was investigated using the phasor diagram shown in Figure 5.18 [2]. It is clear that the insulator voltage may cause considerable neutral shift to occur, where the voltage across the phase insulators E_{RN} , E_{BN} and E_{WN} are not equal (R, W and B are the red, white and blue phases of three phase system respectively). In this work, the voltages across the phase insulators were calculated as the difference between each phase supply voltage and the downwire insulator voltage.

Figure 5.18: Phasor diagram illustrating neutral shift [2]

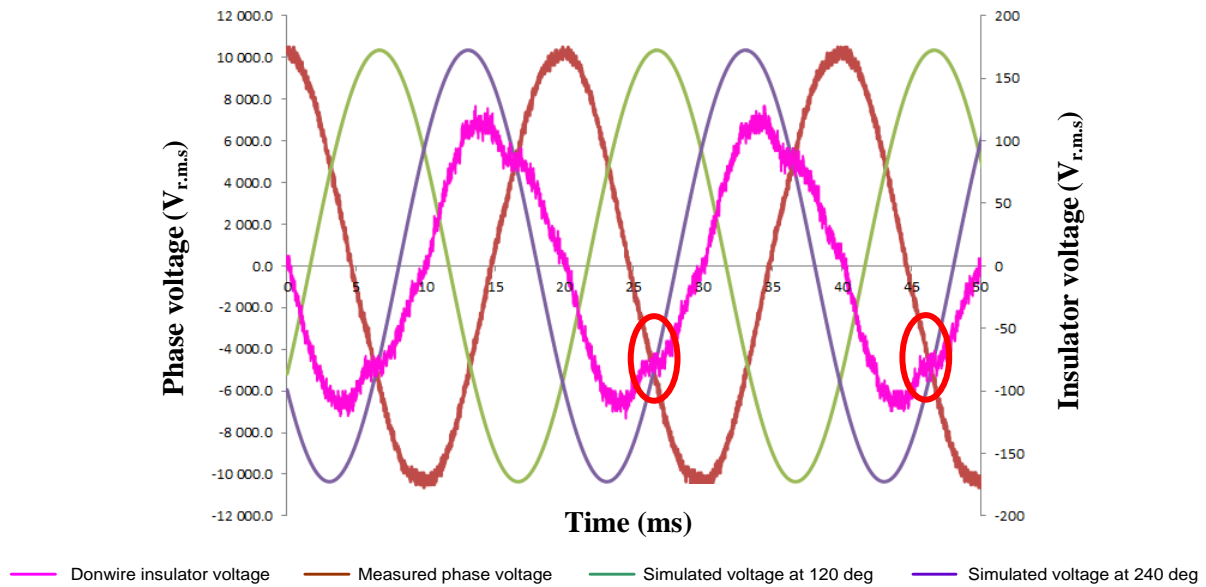
Figure 5.21 shows results for Stage 2 (when the downwire insulator was observed to have partially dried out). The same was observed as under dry conditions, where the insulator voltage was sinusoidal and led the phase voltage by 90° . However, it appears as if one of the phases was conducting some leakage current; this is shown by the distortion in downwire insulator voltage (circled in Figure 5.21). However, the downwire insulator voltage has no noticeable effect on the phase angles of the insulator voltages and the voltages across the phase insulators.

Figure 5.21: Measured and simulated voltages with unglazed insulator under wet conditions – stage 2

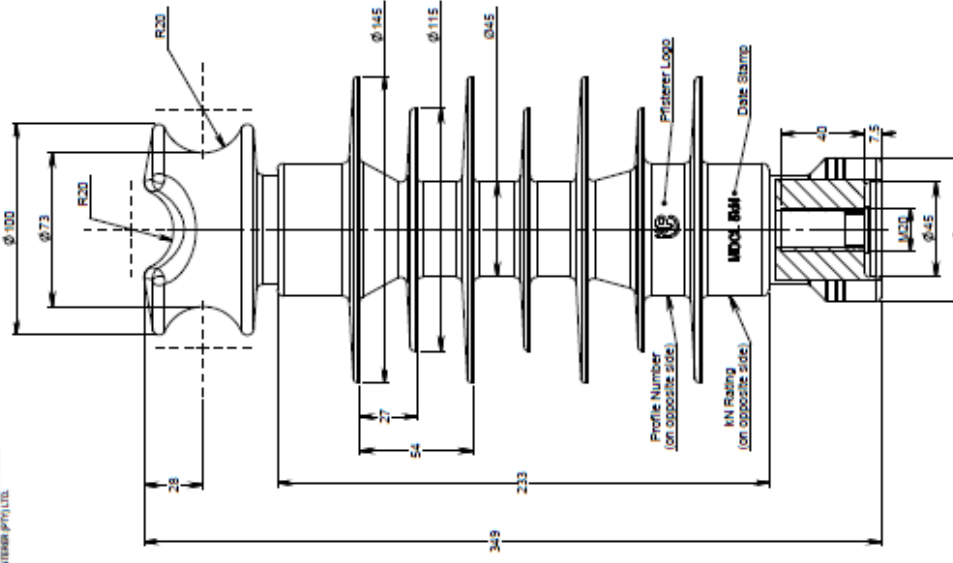
B-1: Silicone rubber post insulators as phase insulators at KIPTS

Insulator Markings:

Profile Number: 190750
 Pfisterer Logo:
