# Behavior of Concrete Columns Repaired with Polymer Mortar and Epoxy Fiber Panel

**Sungnam Hong and Sun-Kyu Park**

*Department of Civil and Environmental Engineering, Sungkyunkwan University, Suwon 440-746, Republic of Korea*

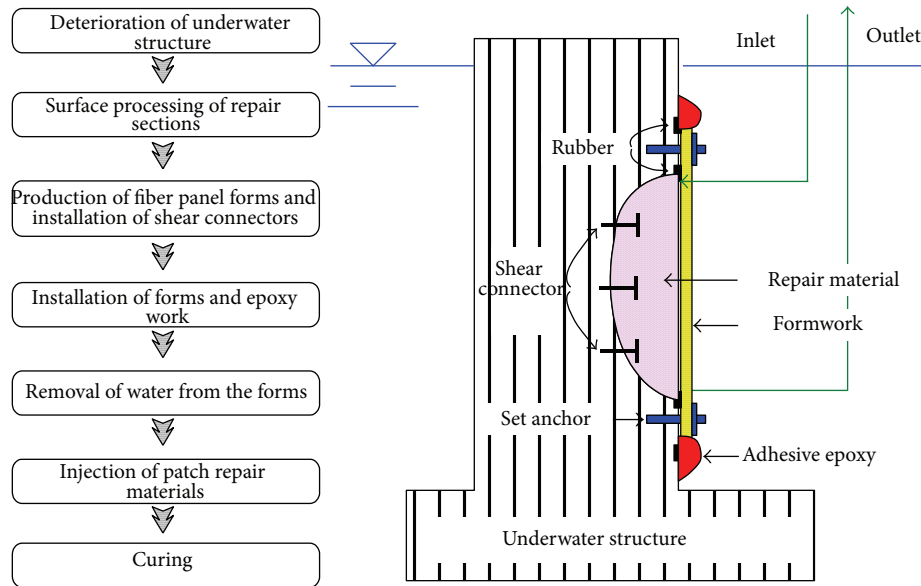
FIGURE 1: Schematic diagram of the newly proposed repair method.

repaired [18], this method maximizes the repair effects and enables economical work. Furthermore, the shear connectors installed on the repair sections give shear resistance at interfaces and prevent the elimination of repair materials; anchor bolts fix the forms, to provide binding force. The work procedure and a schematic diagram of the proposed underwater repair method are shown in Figure 1.

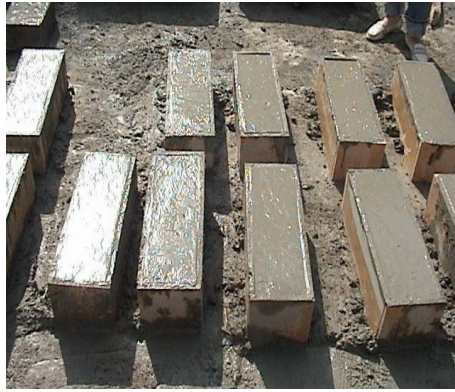
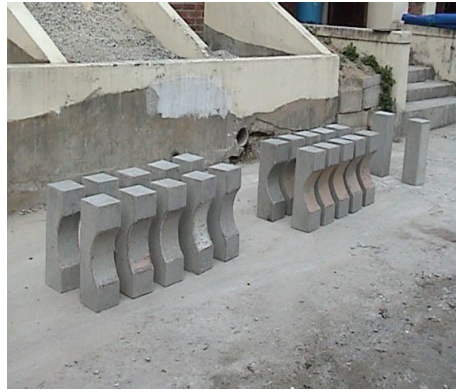
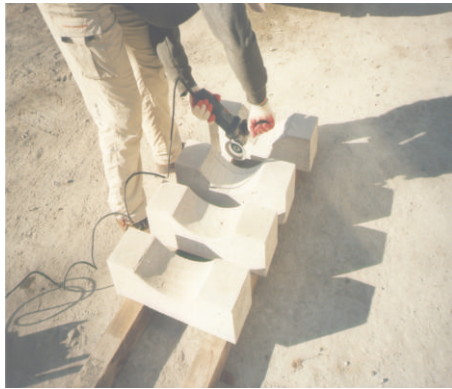
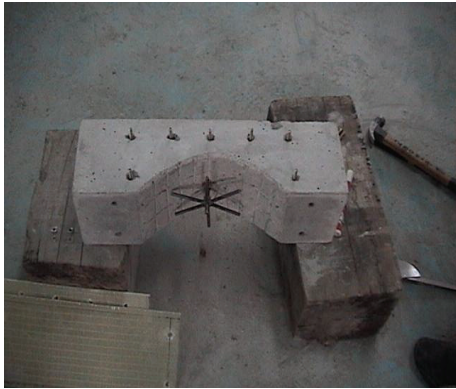
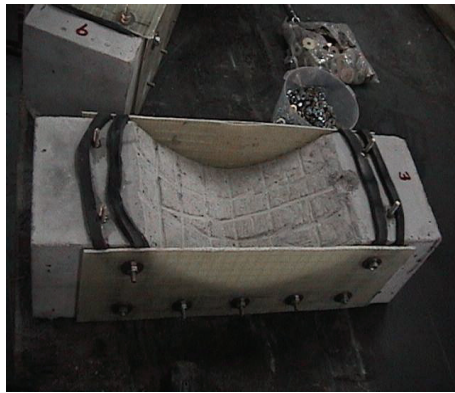
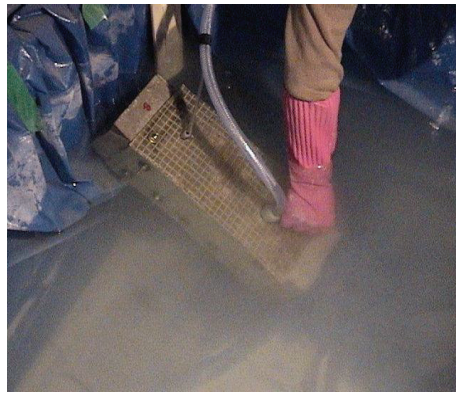
(a) Forms after pouring concrete

(b) Shape of columns

(c) Chipping of concrete

(d) Shear connectors and anchor bolts

(e) Assembly of epoxy fiber panel

(f) Injection of repair materials

FIGURE 2: Column production process.

3.3. *Production of Columns.* For columns, control and repaired columns were produced under the assumption that the concrete was damaged as shown in Figure 2. The shape and dimensions of the sections of columns are shown in Figure 3. To obtain the repaired columns, two damaged columns whose depths of damage were 5 cm and 7 cm were repaired, in accordance with the test variables.

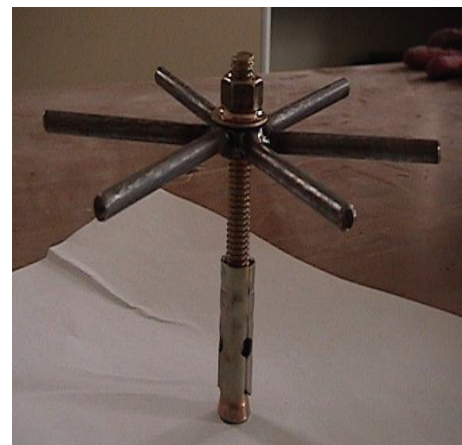
FIGURE 4: Shear connector.

wrapped up on three sides, and holes were made to insert anchor bolts underwater repair materials through them. The shear connector that was installed at the center of the repair sections to resist shear force from the repair sections, and to prevent the elimination of the repair material, is

shown in Figure 4. Also, the dimensional and mechanical characteristics of the shear connector are shown in Table 4.

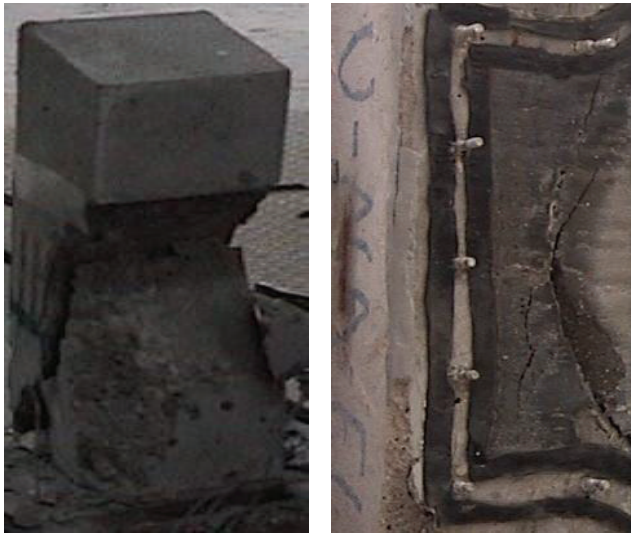
FIGURE 5: Interface failure.

**4.1. Failure Mode.** The failure modes of the columns can be largely divided into interface failure at the interface between underwater repair materials and concrete and concrete failure. Interface failure occurs suddenly, as shown in Figures 5(a) and 5(b), when the repair sections were smooth, and when water was not removed from the forms and repair sections. These are undesirable failure modes in the repair and reinforcement of structures.

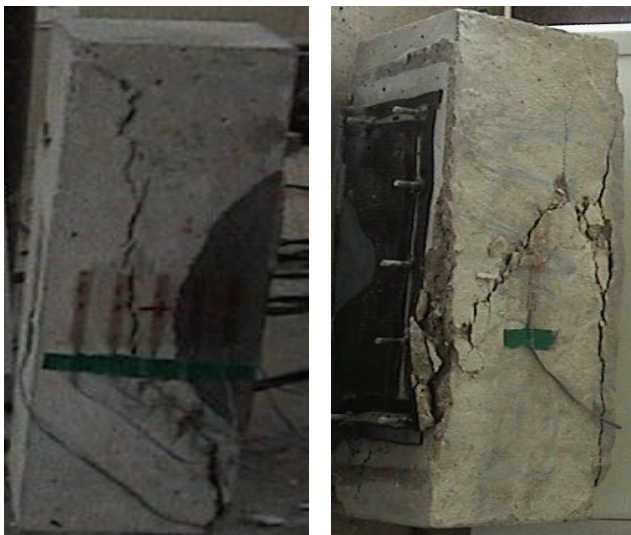
FIGURE 6: Concrete failure.

Concrete failures are illustrated in Figures 6(a) and 6(b). They occur in concrete with lower strength than repair materials, by the effect of the binding force of the forms, and the role of the shear connectors when the load shear at the interface is smooth. However, concrete failure would not occur in actual structures, because the repair sections are larger than the existing concrete sections.

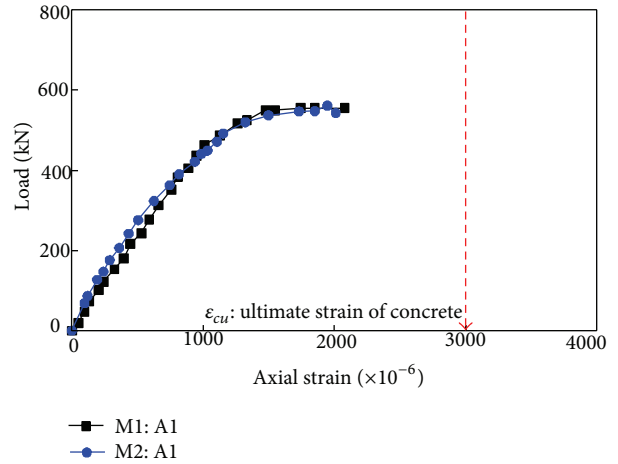
FIGURE 7: Load-axial strain curve: M1 and M2.

4.2. *Control Columns.* The maximum loads of control columns M1 and M2 were 555.1 kN and 560.9 kN. The mean strains at maximum load measured at A1 and A2 of the columns were  $2079 \mu\epsilon$  and  $1947 \mu\epsilon$ . These results are shown in Figure 7. Figure 8 shows the strains of M1 at S1 to S5. As the load increased, the strains were constant at various points on the side, and stress was evenly distributed on the shear surface of the concrete.

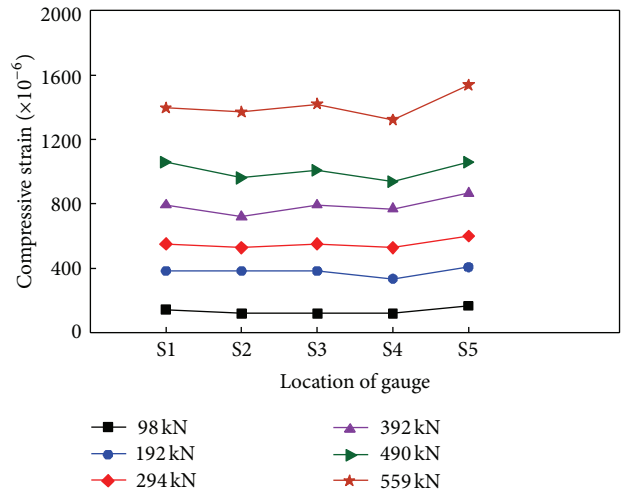
FIGURE 8: Strain distribution: M1.

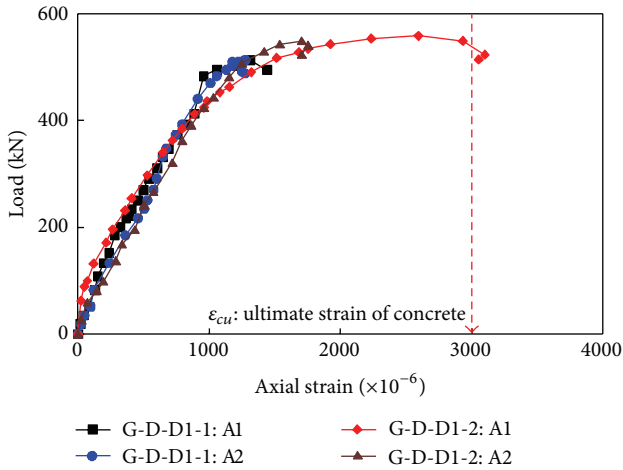
FIGURE 9: Load-axial strain curve: G-D-D1 columns.

4.3.1. *G-D-D Series.* The results of the loading experiment on the repaired columns G-D-D series are shown in Figures 9 and 10. The axial strains of concrete at maximum load A1 and A2 of the columns G-D-D1-1 and G-D-D2-1 with smooth repair sections were  $1312 \mu\epsilon$  and  $1466 \mu\epsilon$ , respectively, which were lower than the strain at maximum load of the control columns. The reason for this result is that the columns did not fail by the failure of the concrete or repair material, but by sudden interface failure, due to decreased bond strength at the interface.

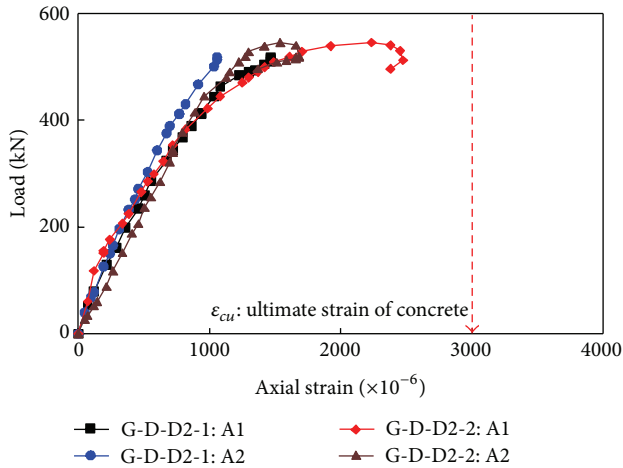
FIGURE 10: Load-axial strain curve: G-D-D2 columns.

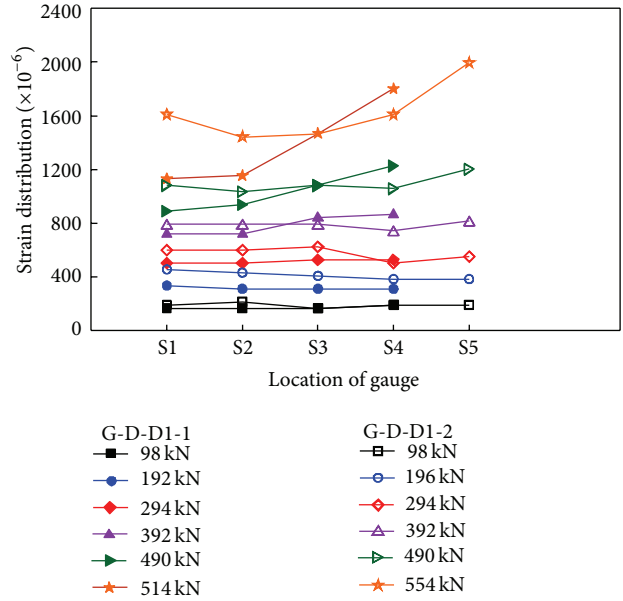
FIGURE 11: Strain distribution: G-D-D1 columns.

Figure 11 shows the strains of the column with smooth surface of repair sections and the chipped column. For the smooth surface column, the strain steadily increased up to 392 kN at various locations but rapidly increased in weak concrete from 490 kN until failure. However, for the chipped column, strain steadily increased to 490 kN and then rapidly increased in concrete at failure. The reason for this is that the bond strength between concrete and repair material increased by the surface treatment of the repair sections, and the load was smoothly transmitted through the interface. As

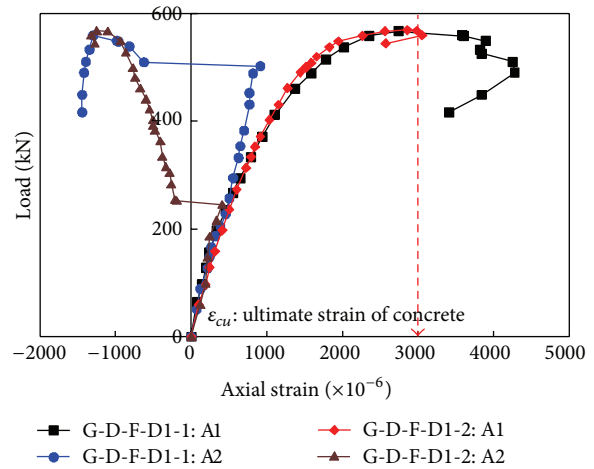
FIGURE 12: Load-axial strain curve: G-D-F-D1 columns.

4.3.2. *G-D-F-D Series.* As shown in Figure 12, the maximum load of the column G-D-F-D1-1 was 567.8 kN, and the strains of the fiber panel form of the repaired surface and the concrete surface showed similar behaviors until 294.2 kN. At

500.1 kN, the strain changed to the tensile region simultaneously with the failure of the epoxy finishing at the joint of the forms, and binding force was exhibited until the column reached the maximum load. For the column G-D-F-D1-2, as shown in Figure 12, the strain of the form changes to the tensile region at 245.2 kN. This difference between columns in the load at which the strain of the form changes to the tensile region seems to be due to work errors of the epoxy.

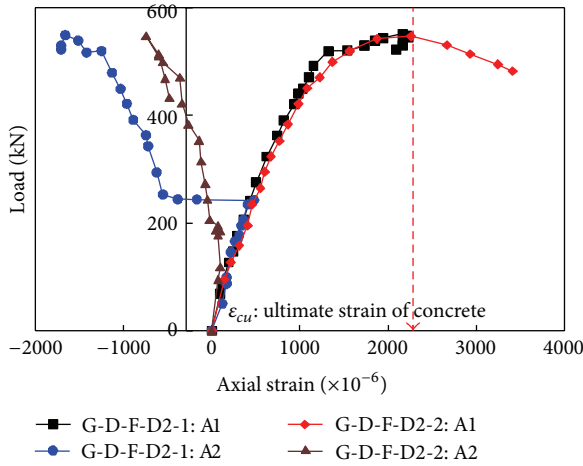
FIGURE 13: Load-axial strain curve: G-D-F-D2 columns.

Figure 13 shows the results of the columns G-D-F-D2-1 and G-D-F-D2-2. It can be seen that the epoxy fiber panel form is changed from compressed condition to tensile condition at 242.2 kN and 196.1 kN, and the binding force is exhibited until the columns reach the maximum load.

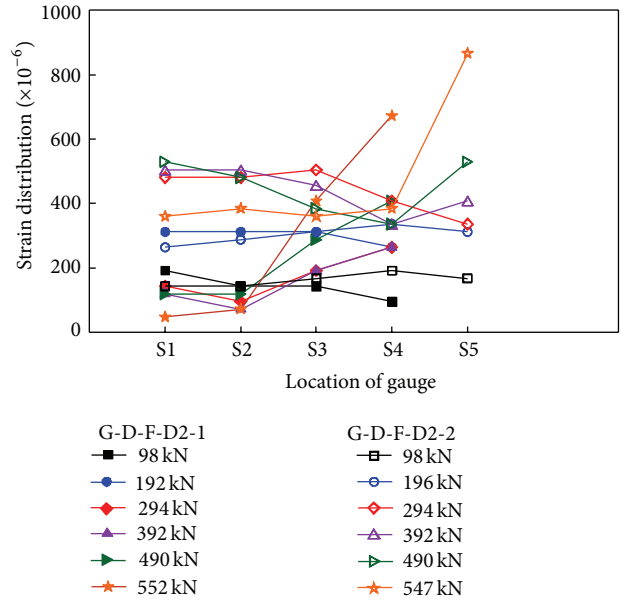
FIGURE 15: Strain distribution: G-D-F-D2 columns.

Figures 14 and 15 show the strains S1 to S5 by loading steps at different locations of the columns that were repaired

using fiber panel forms on the ground. No interface failure occurred due to the increased bond strength at the interface by chipping and the binding force of the fiber panel forms and anchor bolts. However, when the load increased over 490.3 kN, the strain of concrete rapidly increased, and failure occurred at the load of 539.4 kN or higher. The reason for this result seems to be that the bond strength at the interface increased by chipping, and the binding force of the forms and anchors inhibited expansion and failure, thus improving the repair effects.

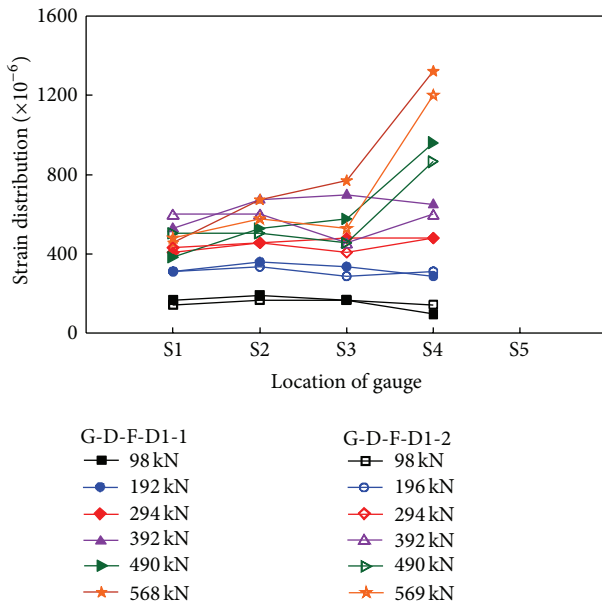
FIGURE 14: Strain distribution: G-D-F-D1 columns.

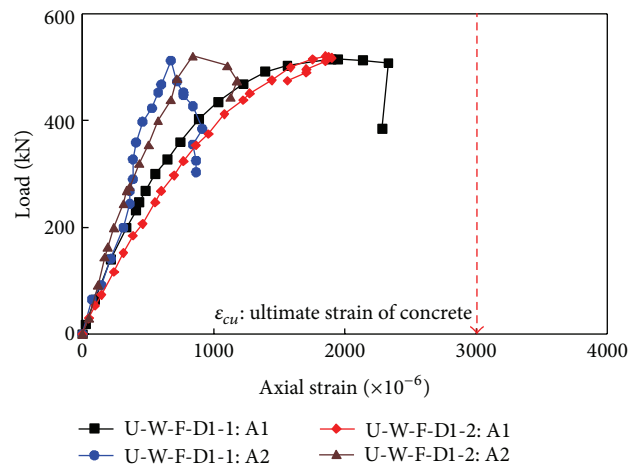
FIGURE 16: Load-axial strain curve: U-W-F-D1 columns.

4.3.3. *U-W-F-D Series.* The loading experiment results for the columns U-W-F-D series are shown in Figures 16 and 17. The

columns failed at the maximum load of 509.9 to 529.6 kN, and the axial strain A1 at maximum load was 1850  $\mu\epsilon$  to 1899  $\mu\epsilon$ , smaller than that of the control column.

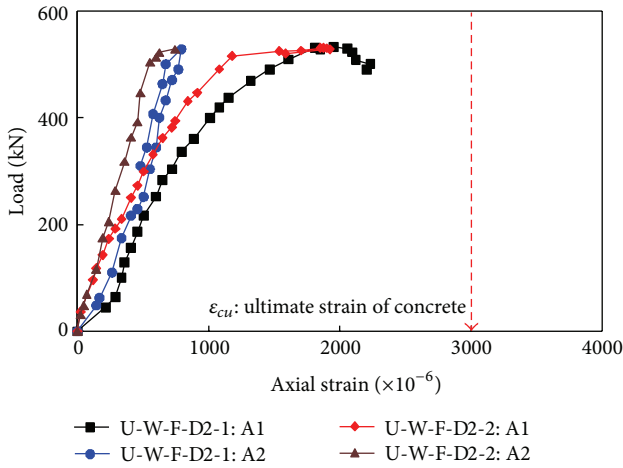
FIGURE 17: Load-axial strain curve: U-W-F-D2 columns.

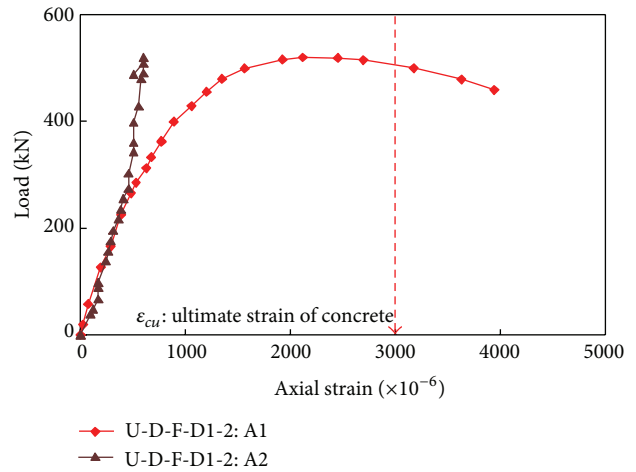
FIGURE 19: Load-axial strain curve: U-D-F-D1-2 column.

**4.3.4. U-D-F-D Series.** The loading experiment results for the columns U-D-F-D series are shown in Figures 19 and 20. The maximum load of the repaired columns U-D-F-D series

ranged from 500.1 to 519.8 kN, which was lower by 7–9% than that of the control column. However, the strain of concrete was 2100  $\mu\epsilon$  or higher, by the binding force between forms and anchors.

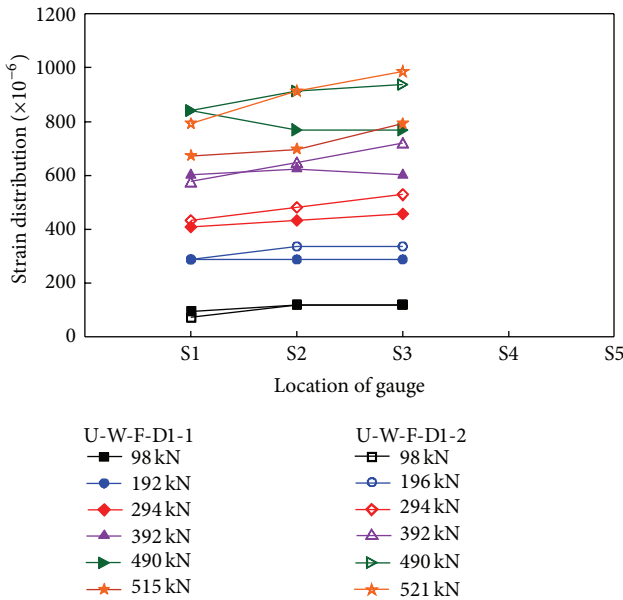
FIGURE 18: Strain distribution: U-W-F-D1 columns.

Figure 18 shows the distribution of strains at different locations on the sides of the concrete and repair materials, for the columns U-W-F-D1. The changes of strains by increasing load at different locations were not clear, and the concrete and repair materials did not fail, either. The reason for this seems to be the occurrence of interface failure, which prevented the transmission of load to the repair sections, thus decreasing maximum load and strain.

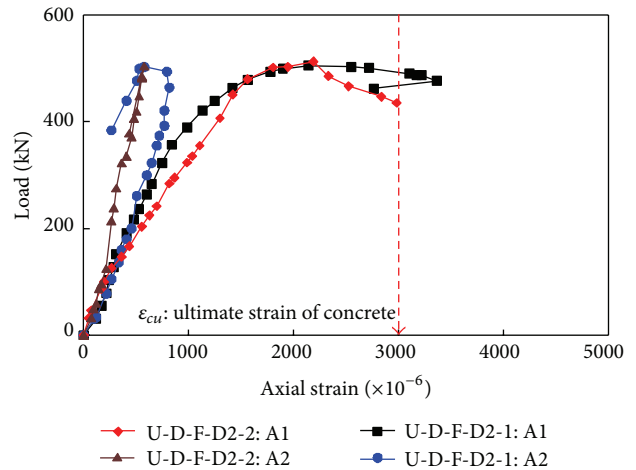
FIGURE 20: Load-axial strain curve: U-D-F-D2 columns.

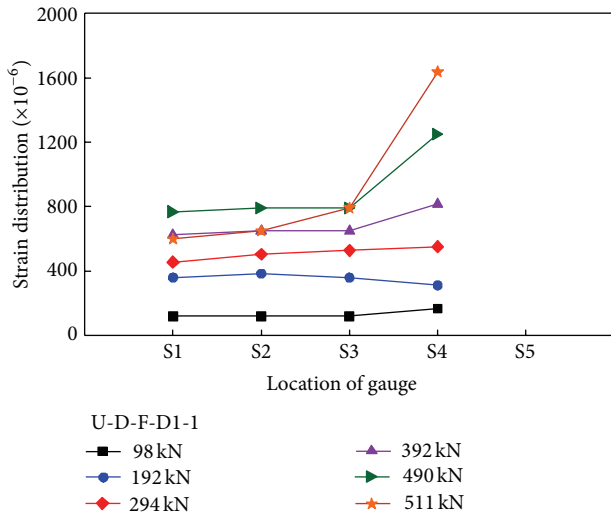
FIGURE 21: Strain distribution: U-D-F-D1-1 column.

Figure 21 shows the strains at different locations on the sides of the underwater repair materials and concrete for the column U-D-F-D1-1. Concrete failure occurred at 509.9 kN, as strain on the concrete suddenly increased. In other words, the strains of concrete sections and repaired sections also steadily changed until failure. The reason for this seems to be that the water tightness by forms increased the bond force of the repaired sections and facilitated the smooth transmission of load. Removing the water from the forms and repair sections before injecting underwater repair materials inhibited the leaking and washing of the repair materials, thus increasing the bond force at the interface. Furthermore, the water tightness and binding force by forms were effective in underwater working conditions and increased the bonding force of the repair materials and concrete sections at the interface, thus improving repair effects.

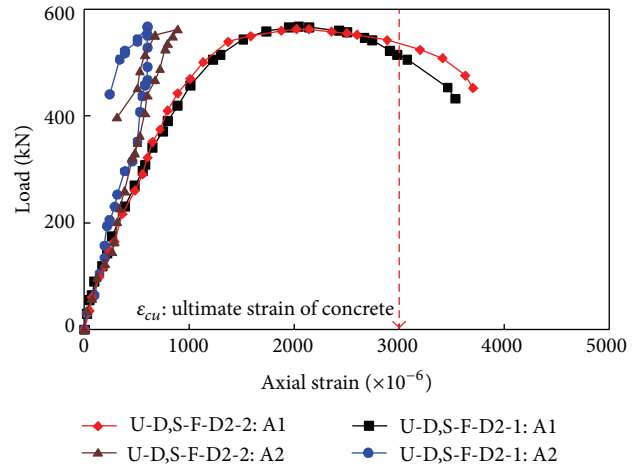
FIGURE 23: Load-axial strain curve: U-D,S-F-D2 columns.

**4.3.5. U-D,S-F-D Series.** The loading experiment results for the columns U-D,S-F-D series are shown in Figures 22 and 23. The maximum load of the columns U-D,S-F-D series was 559 kN regardless of the maximum load, which is the same strength as that of the control column.

Furthermore, for the column that did not use shear connectors, concrete suddenly failed after the maximum load, and failure occurred at the interface of concrete and underwater repair materials. However, for the columns U-D,S-F-F2-1 and U-D,S-F-F2-2, which used shear connectors, the maximum compressive strain of concrete increased to 3000  $\mu\epsilon$  or higher after the maximum load, showing a greatly improved strain capacity, and no interface failure occurred. The reason for this seems to be that the binding force of the forms and the shear connectors effectively resisted

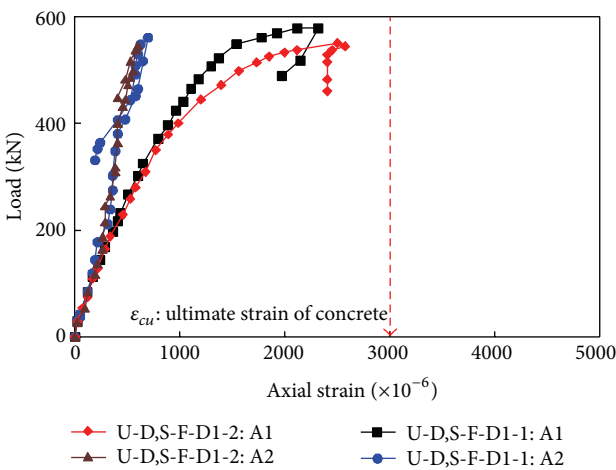
FIGURE 22: Load-axial strain curve: U-D,S-F-D1 columns.

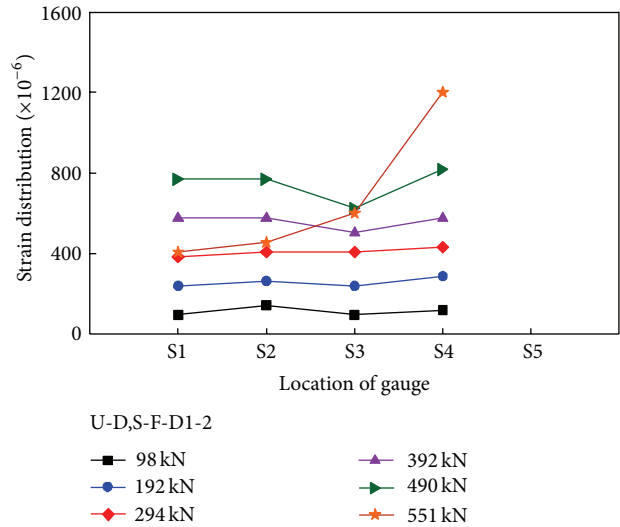
FIGURE 24: Strain distribution: U-D,S-F-D1-2 column.

Figures 24 and 25 show the strains at different locations of concrete and underwater repair materials. The vertical strain steadily increased with the increasing load, and the strain of concrete sections sharply increased at failure. The reason for this result seems to be that the binding and water tightness of the forms resisted the shear force at the interface of the underwater repair materials and concrete, thus inhibiting interface failure, and the load was evenly transmitted to the concrete sections and repaired sections, but the concrete sections that were relatively weaker failed.
