NEW ZEALAND CONTRIBUTIONS TO THE GLOBAL EARTHQUAKE MODEL'S EARTHQUAKE CONSEQUENCES DATABASE (GEMECD)

**Gian Maria Bocchini¹, Sonia Giovinazzi², Antonios Pomonis³,
Stefano Pampanin⁴, Jason M. Ingham⁵ and Andrew King⁶**

ABSTRACT

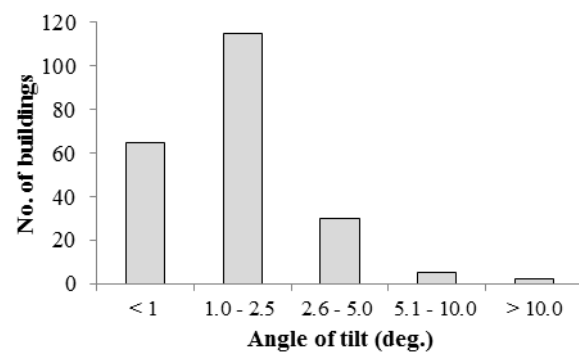
Figure 3: Degree of building tilt in liquefied areas in Dagupan City, as in GEMECD, Tier 3 (adapted from Tokimatsu *et al.* [17]). The inventory class represents 1-5 storey RC buildings.

Tokimatsu *et al.* [17] inspected approximately 300 RC buildings of 1 to 5 storeys and 250 low-rise wooden houses in both the liquefied and non-liquefied areas of Dagupan city centre. The boundaries of the damage survey are drawn as those reported in the original paper [17]. The damage statistics show the damage distribution for 217 RC buildings, 1-5 storeys (aggregated data) located in liquefied areas according to the degree of building tilt: <1, 1-2.5, 2.6-5.5, 5.6-10.0, >10.0 degrees (Figure 3); and to the extent of building settlement: <25, 25-50, 51-75, 76-100, >100 cm (Figure 4).

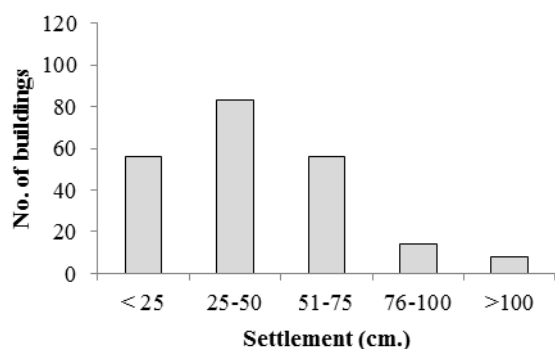
Figure 4: Extent of building settlement in Dagupan City as in GEMECD, Tier 3 (adapted from Tokimatsu *et al.* [17]). The inventory class represents 1-5 storey RC buildings.

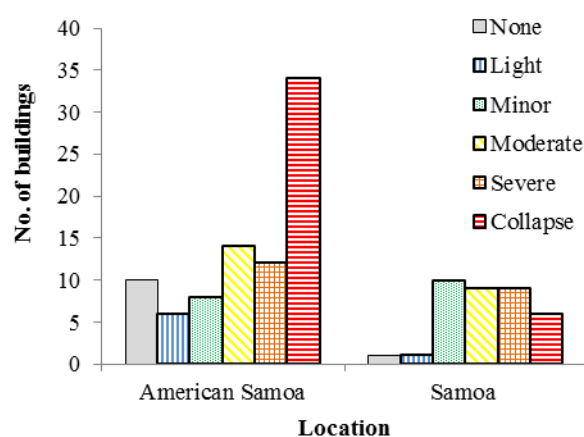
Figure 5: Damage to masonry residential buildings in Samoa and American Samoa during the 2009 Samoa tsunami as in the GEMECD, Tier 3 (adapted from Reese *et al.* [19]).

The earthquake consequence studies investigated the damage to buildings induced by the ensuing tsunami. Of the two studies available for this event, one study is based on the damage survey carried out by a reconnaissance team from New Zealand [19], which investigated, among others, 120 masonry residential buildings distributed within 12 villages (aggregated data) in Samoa (Island of Upolu, 6 villages) and American Samoa (Island of Tutuila, 6 villages). The field survey's location is represented by point coordinates in GEMECD and has been obtained from Google Earth. Six qualitative damage levels were adopted to classify the observed damage, namely: none, light, minor, moderate, severe, and collapse. The island level aggregated damage statistics are shown in Figure 5.

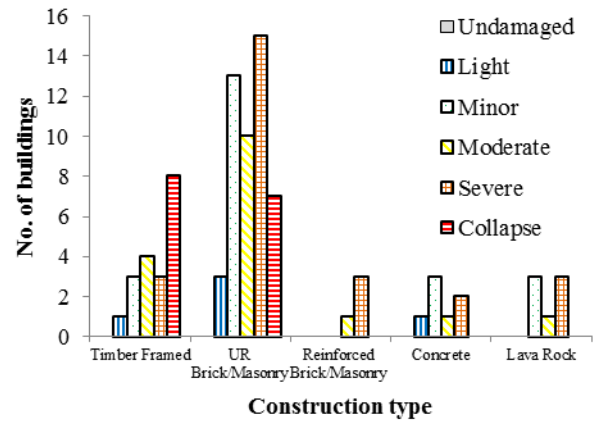
Figure 6: Damage levels observed for different building types located on the Samoan Island of Upolu, as reported in GEMECD, Tier 3 (adapted from ITST Samoa [20]).

affected villages/sites in Samoa (Island of Upolu) to explore the nature of the tsunami and its impact on the Island of Samoa [22]. During the surveys a total of 92 buildings of different construction types were inspected within 6 villages (represented as coordinate points in GEMECD). The damage survey results were presented for 85 buildings (aggregated data) belonging to five different construction types (i.e. timber framed, unreinforced brick masonry, reinforced brick masonry, concrete and lava rock). Five damage states were adopted to classify the observed damage, namely: light, minor, moderate, severe, and collapse. The damage statistics are reported in Figure 6.

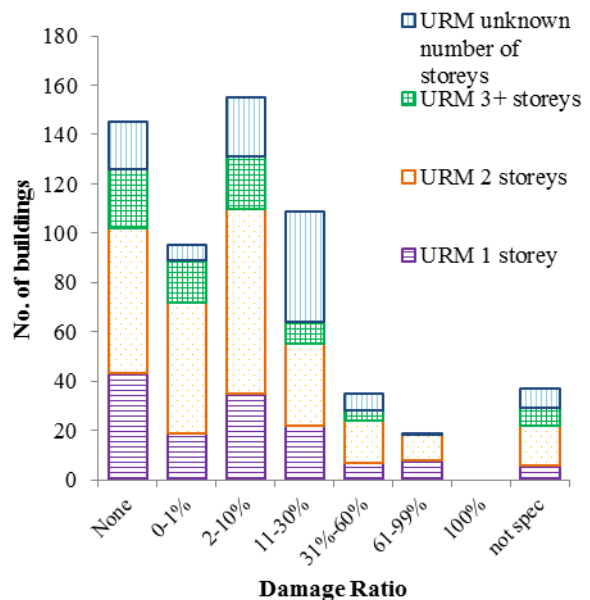
Figure 7: Damage ratios observed for URM buildings located within the CCC boundaries during the Sept 4, 2010 earthquake (adapted from Ingham and Griffith [23]).

The second study, that investigates building performance due to ground shaking, shows the damage statistics obtained for 595 URM buildings located within the CCC boundaries (aggregated data) as reported by Ingham and Griffith [23]. The damage statistics are reported according to the damage ratios collected during the BSE procedures. The damage ratios could be better interpreted as representing the extension of damage with respect to the volume of the building (% of building damage) rather than the ratio of repair cost vs. replacement cost excluding contents. It is important to note that these values are estimations of the inspecting engineers, based on a Level 1 and Level 2 (exterior and interior) assessment. The damage statistics reported in the GEMECD (Figure 7) have been extracted from the raw data provided by the authors. In Figures 8 and 9 photo examples of damage observed in URM buildings are shown.

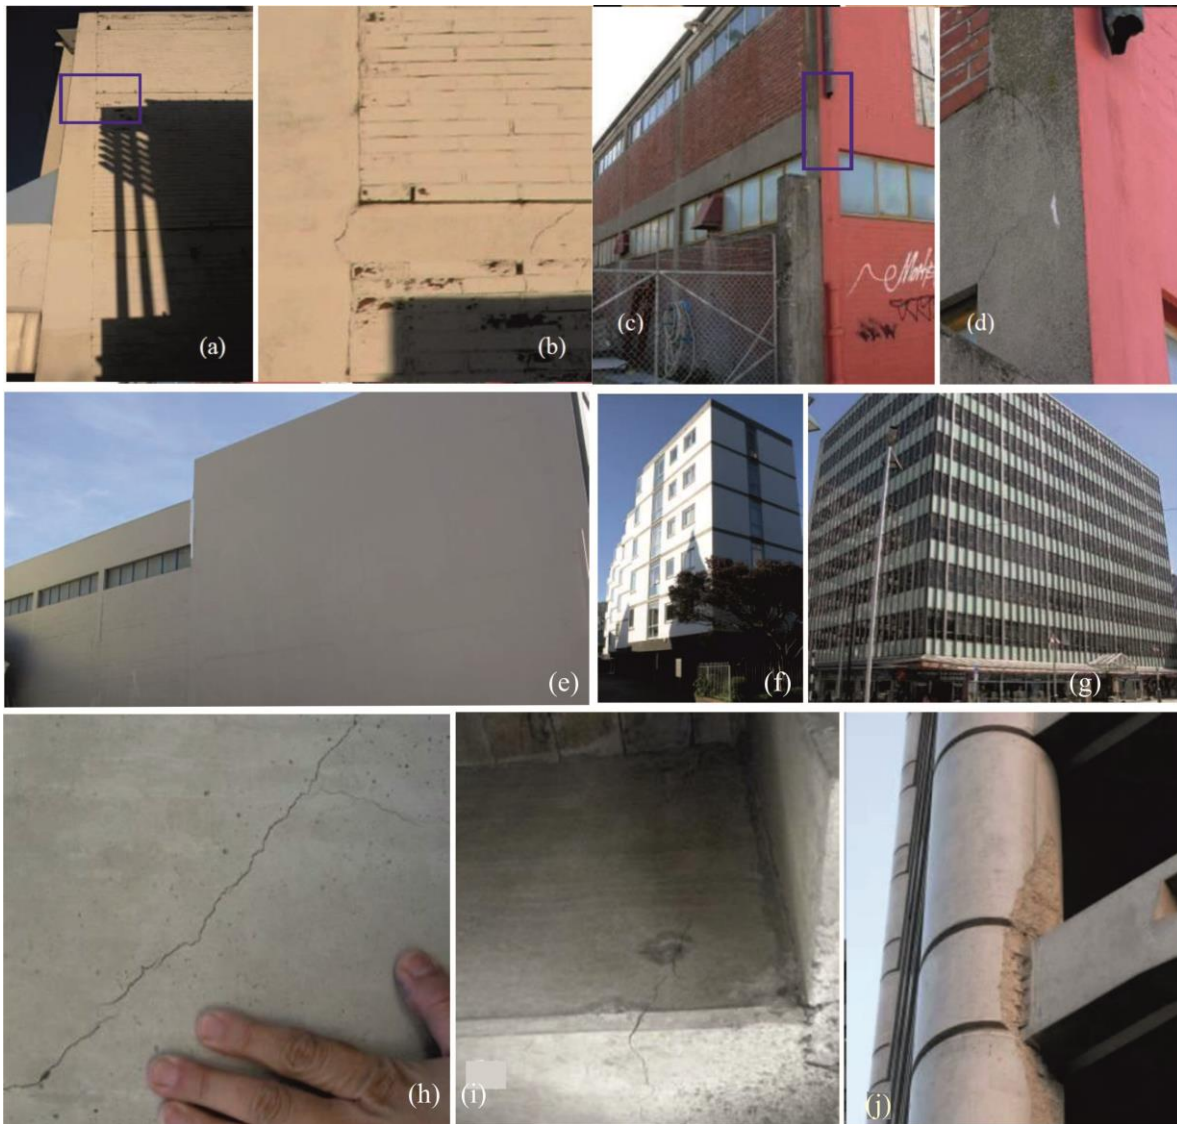
Figure 8: The damage types were observed during the Sept 4, 2010 Darfield earthquake: (a, b) Flexural cracks at the beam ends and diagonal cracks in the masonry infill observed in a three storey RC frame building with clay brick infill walls, built in the 1950s-60s; (c, d) low-rise RC frames with joint shear cracking; (e) separation cracks of the infills and RC frame observed in a low-rise pre-1970s RC frames with masonry infill walls; (f, g) mid-rise pre-1970s RC buildings with no apparent damage; (h) shear diagonal cracks on modern (post-1980) thick shear walls; (i) beam plastic hinges observed in a twelve storeys RC frame building built in 1980s and (j) damaged gravity frame observed in a fourteen storey RC core walls building with perimeter gravity frame, built in 1980s. Photos from Kam et al. [21].

One of the aforementioned studies reports the distribution of Building Safety Evaluation (BSE) tagging (green, yellow and red) for 717 RC buildings (as at Sept. 20, 2010) as shown in Kam *et al.* [21]. The 717 RC buildings belong to four different structural types (RC frame, RC shear wall, Tilt-up concrete and RC frame with masonry infill) and are located within the Christchurch City Council boundaries (aggregated data). The placard data are based on the Christchurch City Council (CCC)/Civil Defence BSE form [20]. The data are shown in Table 5. Some examples of damage that occurred to RC buildings are shown in Figure 8.

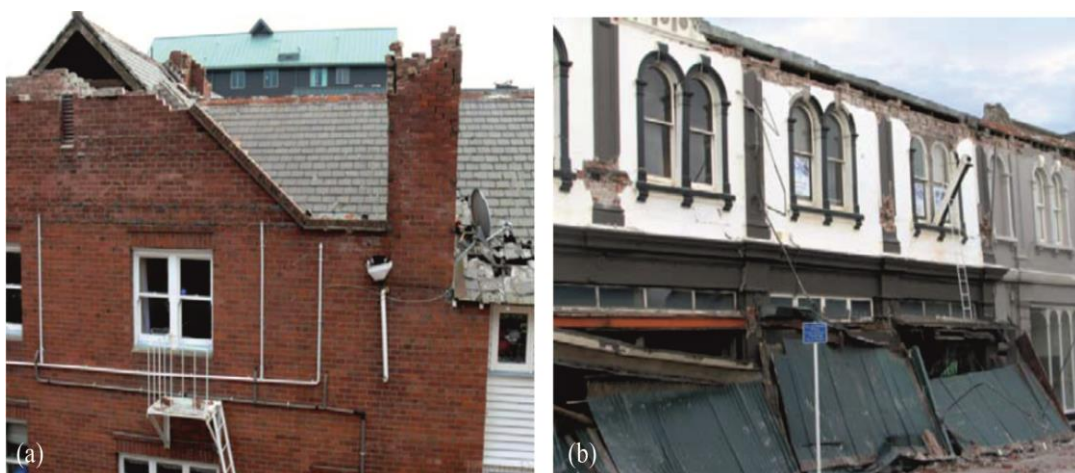
Figure 9: (a) Examples of chimneys and gable wall and (b) parapet failure observed in clay brick URM buildings during the Sept. 4, 2010 Darfield earthquake (photos from Ingham and Griffith [26]).

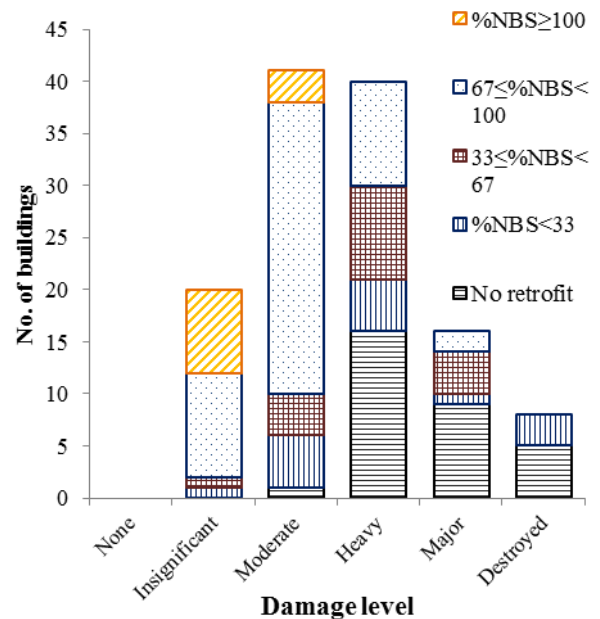
Figure 11: Damage levels (ATC 38/13) observed for 125 URM buildings during the Feb 22, 2011 Christchurch earthquake. The buildings are grouped according to the %NBS (adapted from Ingham and Griffith [27]). The data are available in GEMECD.

Ingham and Griffith [27] investigated the behaviour of strengthened and non-strengthened clay brick unreinforced masonry in the CBD of Christchurch. More specifically the two studies derived from this report show the performance of 368 URM buildings according to the type of earthquake strengthening namely: Type A, Type A&B, No retrofitted, and Unknown (Type A retrofits include gable restraints, wall-to-diaphragm anchorage, and roof and floor diaphragm improvement; Type B retrofits include strengthening techniques that sought to strengthen masonry walls and/or introduce added structure to supplement or replace the earthquake strength provided by the original unreinforced masonry structure among which the most common are steel moment frames and steel brace frames; No retrofitted refers to building that are non retrofitted and Unknown refers to building for which the earthquake retrofitting is unknown or absent), and the performance of 125 clay brick URM buildings according to the percentage of the New Building Standard (%NBS, as per NZSEE2006 guidelines on assessment of existing buildings) evaluated using the Initial Evaluation Procedure, IEP [22] (Figure 11). In both studies the damage level observed is classified according to the ATC38/13 damage scale.

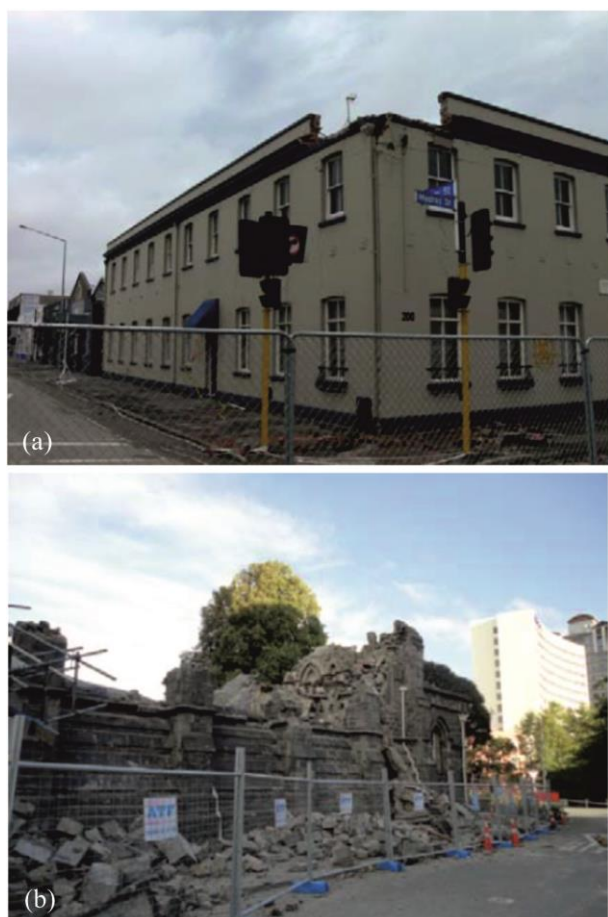
Figure 12: (a) External view of failed parapet at corner; (b) collapse of the Stone Chamber of the Canterbury Provisional Chambers building. Photos from Ingham and Griffith [26].

In Figure 12 examples of damage sustained by URM buildings are shown.

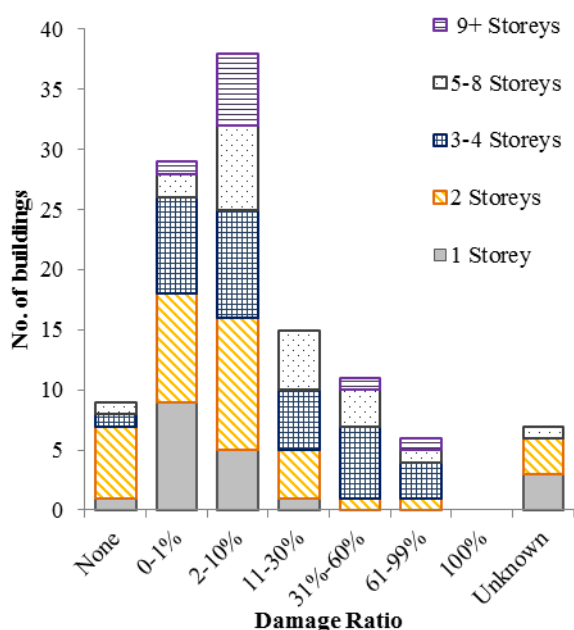
Figure 13: Damage ratios observed for RC buildings built before 1979 during the Feb. 22, 2011 earthquake (adjusted from Kam and Pampanin [28]). The data are available in GEMECD, Tier 3. The damage ratios were adapted from the Christchurch City Council (CCC) database, Civil Defence Building Safety Evaluation (BSE) data and authors field inspection (as at June 12, 2011).

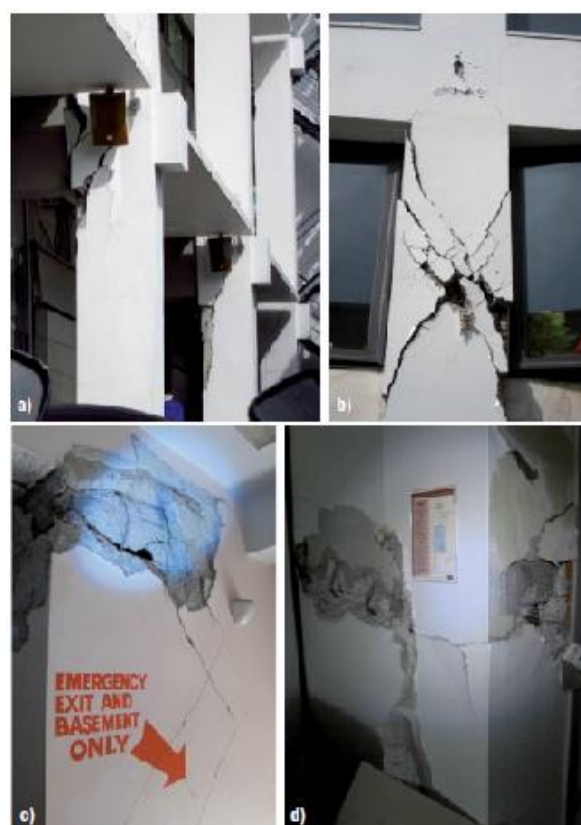
Figure 14: Pre-1970s RC building brittle failure mechanism: a) near collapse of a frame/wall building with beam-column joint failure; b) short column shear and beam-column shear damage; c) lightly reinforced 1950 RC wall compression failure; d) shear/axial failure of composite RC wall/steel columns system (photos from Kam and Pampanin [29]).

Kam and Pampanin [28] provide an overview on the seismic performance of the main building types in the Christchurch CBD with emphasis on the RC buildings (also analysed in more detail in Kam and Pampanin [29] and Kam *et al.* [30]) namely: RC frame, RC shear wall, tilt-up concrete and RC frame with masonry infills. Damage statistics are also available for timber framed, reinforced masonry, URM and steel frame buildings. The damage statistics imported in GEMECD report the damage ratios (see previous section for its definition and limitations) adapted from the Christchurch City Council (CCC) database, Civil Defence Building Safety Evaluation (BSE) data and authors' field inspection (as at June 12, 2011). The damage statistics have been extracted from the raw data provided by the authors and are presented according to the period of construction (i.e. pre-1970s, 1980s, 1990-2010, unknown) and number of storeys (i.e. 1, 2, 3-4, 5-8, 9 or more, unknown). The period of construction of RC buildings was defined on the basis of the issuing of key versions of the NZ seismic loading and material design standard. Figure 13 shows the damage ratios - RC buildings built before 1979. In the original paper the damage statistics are reported according to the placard colour. Figures 14 and 15 show some photos on the type of damage observed in RC buildings.

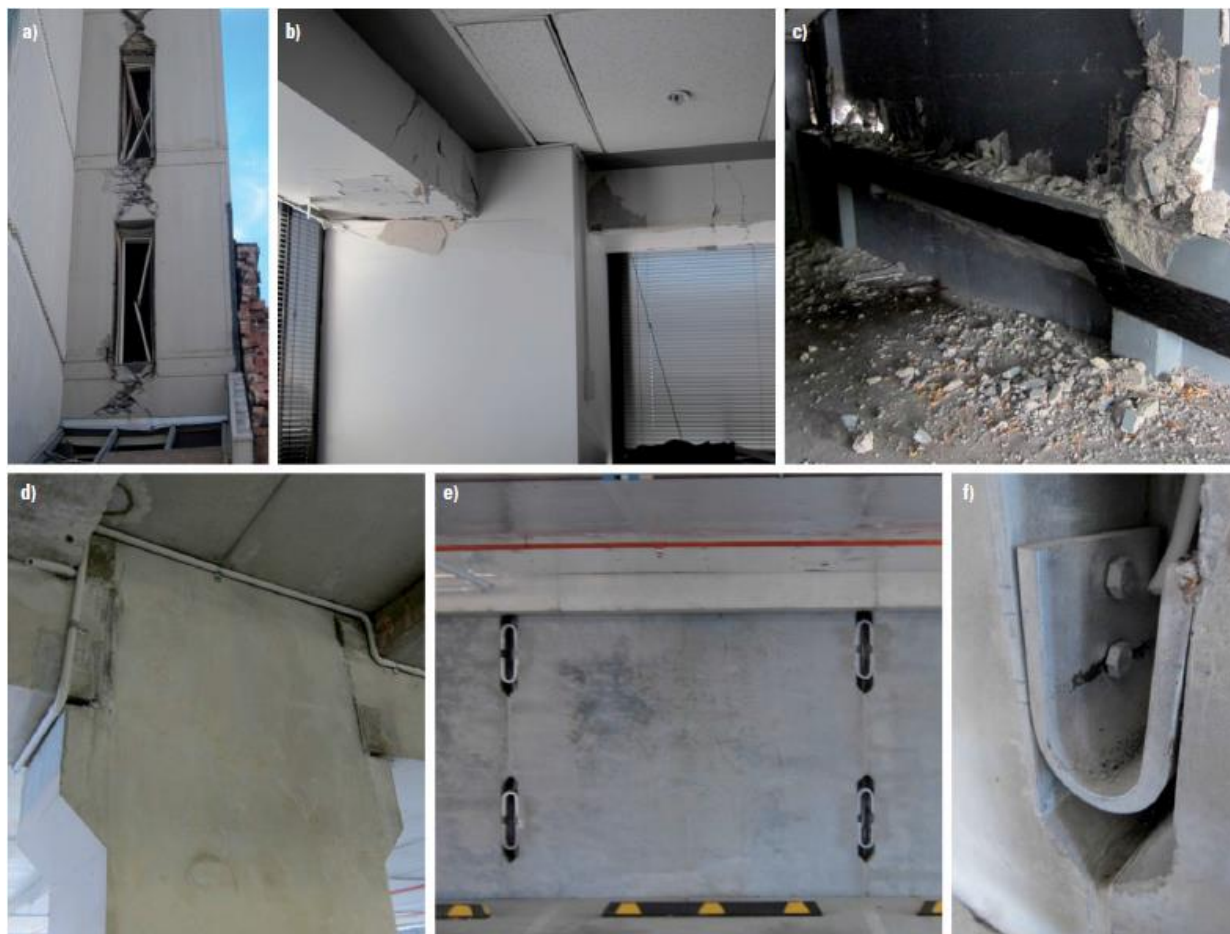
Figure 15: Ductile-response RC systems: a) coupling beams of 1960s coupled-walls building; b) beam plastic hinges on 1980s perimeter RC frames building; c) ductile behaviour of 1980s RC walls building and d–f) “low-damage” PRESSS post-tensioned frames building built in 2010 (photos from Kam and Pampanin [29]).

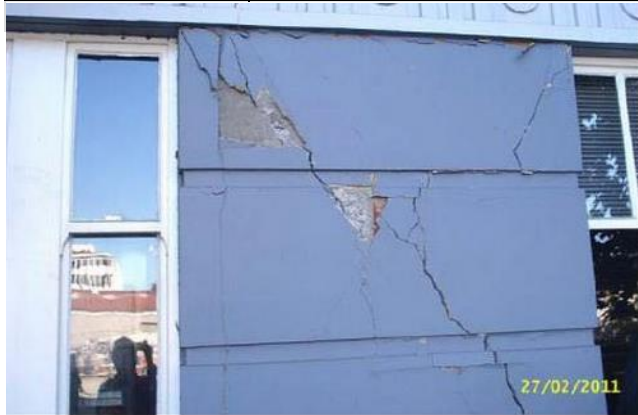
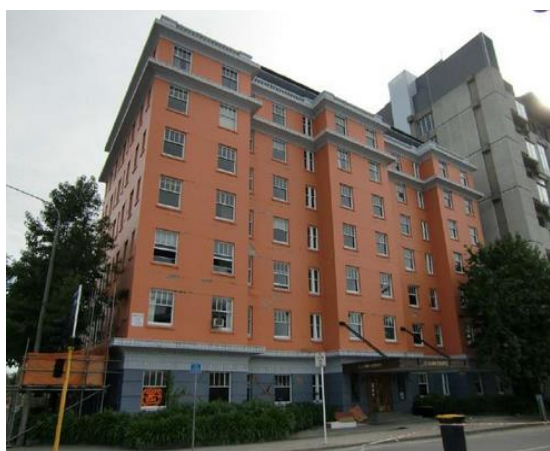
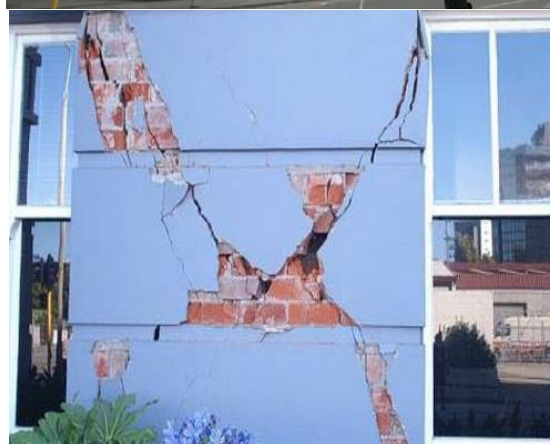
Location name	St Elmo Courts
Address or location	St Elmo Courts, 47 Hereford Street
Geometry (long/lat)	POINT(172.6309204 -43.5319099)
Damage description:	
STRUCTURAL DAMAGE:	Shear cracks in some columns at ground level; Reinforcement is exposed at certain locations.
NON STRUCTURAL DAMAGE:	Significant infill wall damage, which may further create out-of-plane instability if not fixed/repared/strengthened and may jeopardize the global stability of the whole structure.
GEOTECHNICAL DAMAGE:	Minor liquefaction at the corner next to new Christchurch City Council building.
Overall damage (EMS-98)	Heavy damage.
Comments	Yellow tagged, Demolished.

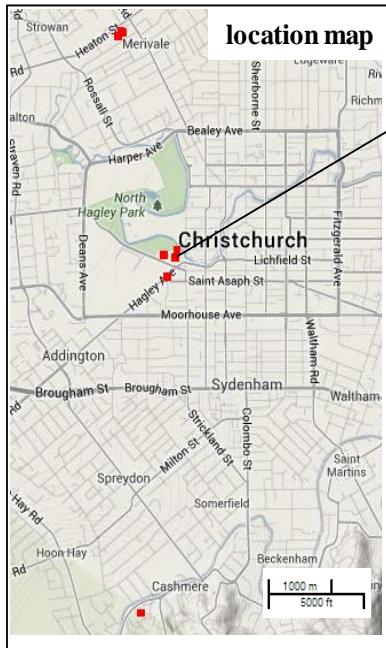
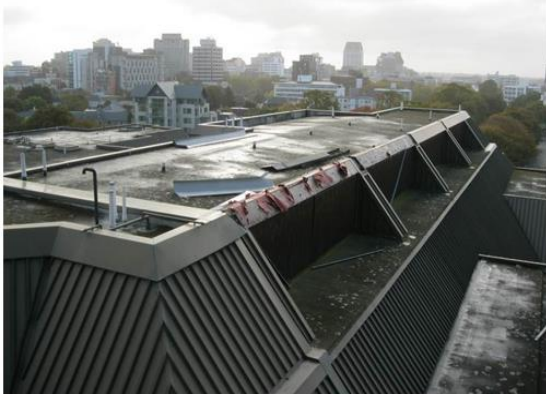
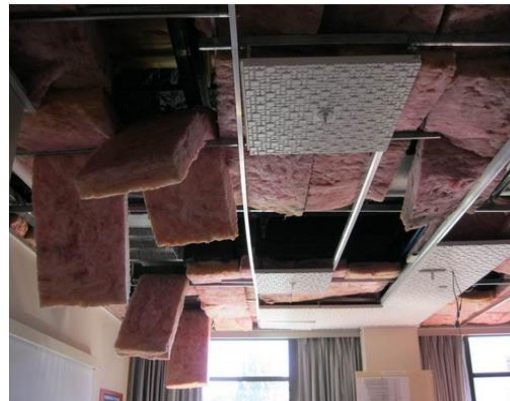
Parkside building, Christchurch Hospital, 2C Riccarton Avenue Christchurch

Damage description: Liquefaction caused severe flooding in the basement, resulting in major losses to support services. There was some minor structural cracking (though later inspections indicated that these cracks were sometimes far more severe than they appeared), as well as widespread non-structural damage to suspended ceilings, pipe- and duct-work (especially where it passed through joints and firewalls), and wiring. The building experienced damage across separation joint and firewalls and there was also significant cosmetic damage to partition walls. Parkside lost power for one and half hours. The lifts were out of action and major cracks were noted in the stairwell to the department.

Roof damage

Ceiling damage

Figure 17: Damage to critical facilities study; damage sustained by the Parkside building (Christchurch Public Hospital) during the Feb 22, 2011 earthquake. Photos and damage description are available in GEMECD.

Furthermore for the 2011 Christchurch earthquake a study of critical facilities and infrastructure is also available, which describes the damage sustained by three main hospitals/hospital complexes in Christchurch, namely: the Christchurch Public Hospital, The Princess Margaret Hospital and the St. George Private Hospital. Only the main buildings of each hospital have been considered and have been geocoded one by one in Google Earth. The study merges information from miscellaneous sources: conference papers [33-34] and reports [35], personal communication by authors of those reports, and personal communication by hospital staff. In the study a comprehensive damage description is available for all the buildings, along with a detailed characterization of the building structural types and the seismic design standard used for some of them. For each building an overall damage grade has been assigned (based on available damage descriptions and photographs) according to the EMS-98 damage scale [25] and the GEM building taxonomy. An example of the study for one of the hospital buildings is shown in Figure 17. A superior rating has been assigned to all the fields of the study reliability rating.

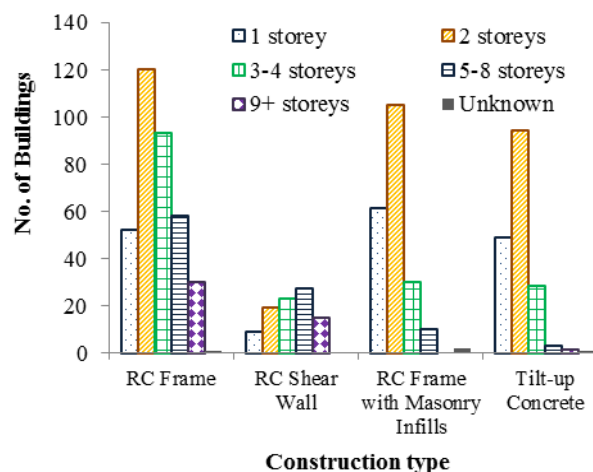
Figure 18: Distribution of Reinforced Concrete buildings within the Christchurch CBD according to the main structural type and number of storeys (adjusted from Kam and Pampanin 2011 [28]).

Figure 18 and 19 report the 4 classes of RC buildings described in Kam and Pampanin [28-29], and in Kam *et al.* [30], namely RC Frame, RC Shear Wall, RC Frame with Masonry Infill and Tilt-up concrete, according to the number of storeys and period of construction. Charts similar to those shown in Figure 18 and Figure 19 can be obtained for the other building types in the CBD by using data contained in GEMECD.

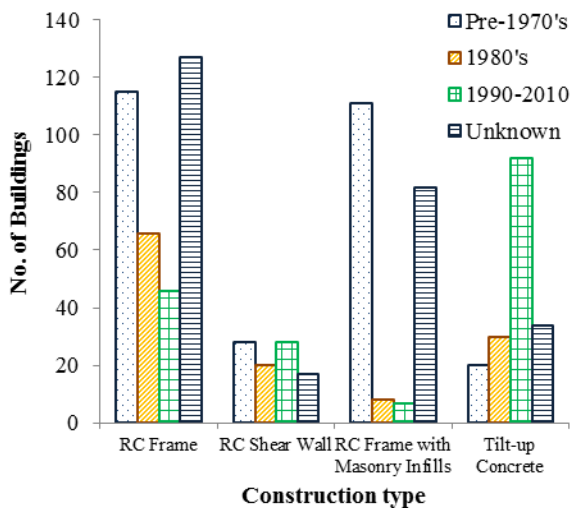
Figure 19: Distribution of Reinforced Concrete buildings within the Christchurch CBD according to the main structural type and period of construction (adjusted from Kam and Pampanin [28]).

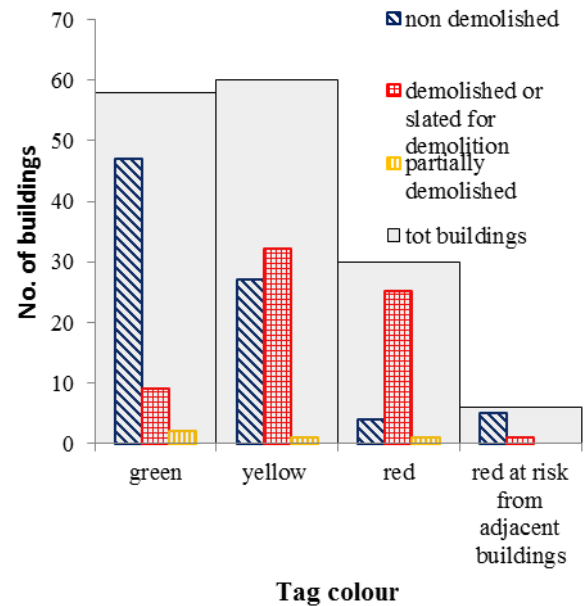
Figure 20: State of the 154 buildings inspected by Pampanin *et al.* [31-32]. The demolished or partially demolished buildings have been either observed in Google Earth or identified from the CERA demolition list, as at April 2014 [39].

Moreover from the data collected in GEMECD it is possible to consider the percentage of demolished buildings given the tag colour (herein described), the overall damage assigned to each building according to the EMS 98 [25], and the building structural type. This information is contained in the study of 154 buildings inspected by Pampanin *et al.* [31-32], that includes information about the building state as at April 2012 (the demolished or partially demolished buildings have been either observed in Google Earth or identified from the CERA demolition list, as at April 2014 [39]) in addition to a detailed damage description and building structural type at an individual level. The 154 buildings are grouped in GEMECD according to the tag colour: green tagged (58), yellow tagged (60), red tagged because at risk from adjacent buildings (6) and red tagged due to sustained damage (30). Of the 58 green tagged buildings in the study, 9 were demolished or slated for demolition (15.5%) and 2 were partially demolished (3.4%); of the 60 yellow tagged buildings 32 (53.3%) were demolished or slated for demolition, and 1 was partially demolished (1.6%); of the 30 red tagged buildings due to sustained damage, 25 (83.3%) were demolished or slated for demolition, and 1 (3.3%) was partially demolished; while of the 6 red tagged buildings at risk from adjacent buildings 1 (16.6%) was demolished or slated for demolition (Figure 20).
