Impact Damage to Composite Laminates: Effect of Impact Location

A. Malhotra · F. J. Guild

Abstract Accidental impact loading of Composite laminates during manufacture and in-service can occur in different locations including near the edge or on the edge of a composite structure. This paper describes investigation of the effect of impact to composite laminates and compares the damage arising from central, near edge and on edge impact events. The damage tolerance of impact damaged laminates using both compression and tension tests has been measured. These results reveal the different damage mechanisms arising from different locations of impact. These different damage mechanisms have been investigated using X-Ray computed tomography. Impact on the edge of composite laminates is found to lead to smaller damage area, but more fibre failure; the severity of this damage is not revealed in standard compression after impact tests.

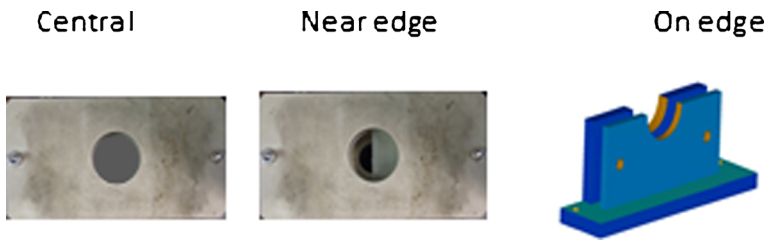
Fig. 1 Different impact locations

The composite plates were subject to low velocity impact at different locations, as indicated in Fig. 1, and at different energy levels. After the impact tests, the residual strength of the plates was measured in compression and tension. The damage has been observed using X-ray computed tomography. The effect of impact position for low velocity impact response and its correlation with residual strength is explored.

Both the impact tests and the subsequent damage tolerance tests in compression and tension have been compared for the three impact locations (see Fig. 1). The impact responses from the

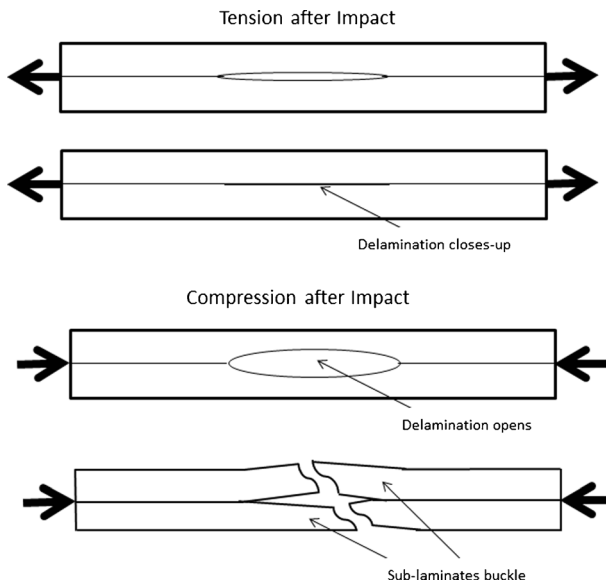
Fig. 3 Damaged composite laminate response in tension and compression

Post-impact strength measurements in compression and tension were carried out. The objective of this testing was to test the hypothesis that the different modes of testing would reveal the different failure mechanisms that had occurred for the different impact locations. This hypothesis is illustrated in Fig. 3; compression testing is expected to be more sensitive to delamination, while tension testing is expected to be more sensitive to fibre failure.

In contrast to the compression after impact test, results for the tension after impact show clear trends (see Fig. 13b). Significantly lower damage tolerance is found for the on edge impact. This must arise from the domination of fibre failure that occurs for on edge impact. Delaminations are not expected to influence damage tolerance in tension (see Fig. 3), so these results indicate that near edge impact leads to more fibre failure than central impact.

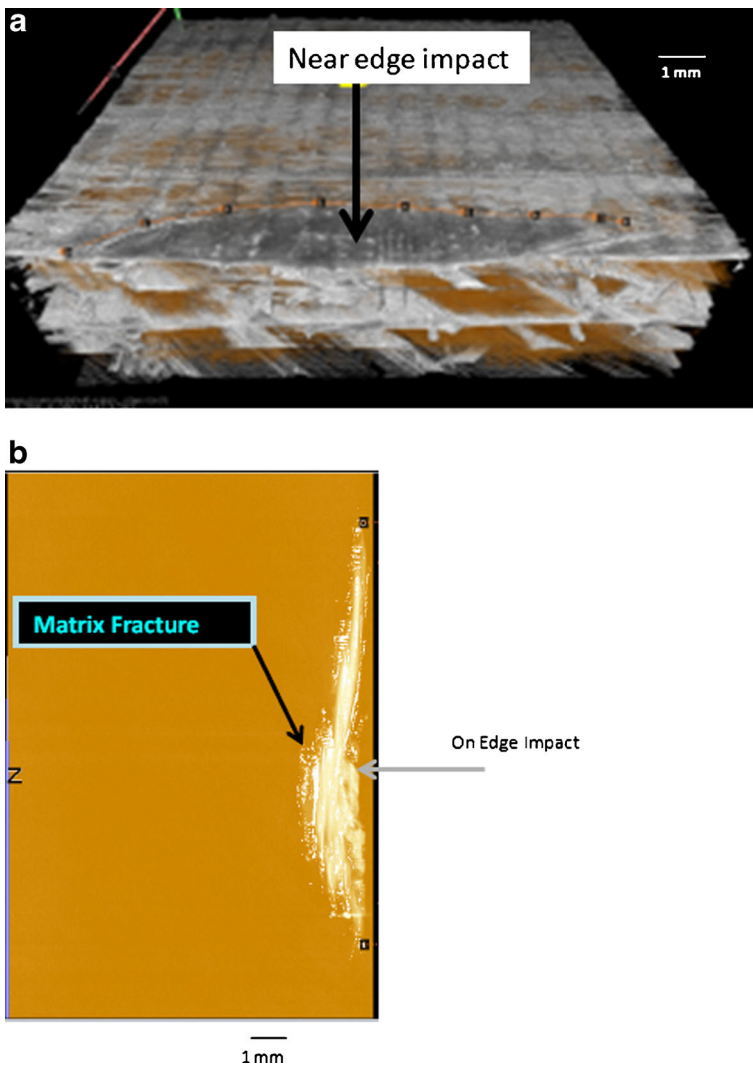
The matrix damage is compared in Fig. 6. The results for the on edge impact are for the same thickness (2 mm) and same impact energy (4 J) as shown in Fig. 5. However, the results for the near edge impact are for the thicker laminate (4 mm) and lower impact energy (2 J) since these results produced the better contrast. Matrix damage for the on edge impact is

confined to a small area around the point of impact (Fig. 6b). Matrix damage for the near edge impact is observed throughout the area of examination (Fig. 6a). This matrix damage leads to the growth of delaminations. The amount of matrix damage is far higher for the near edge impact.

Fig. 6 Matrix damage observed in X-Ray computed tomography. **a** near edge impact (4 J impact 2 mm thick) **b** on edge impact (2 J impact 4 mm thick)

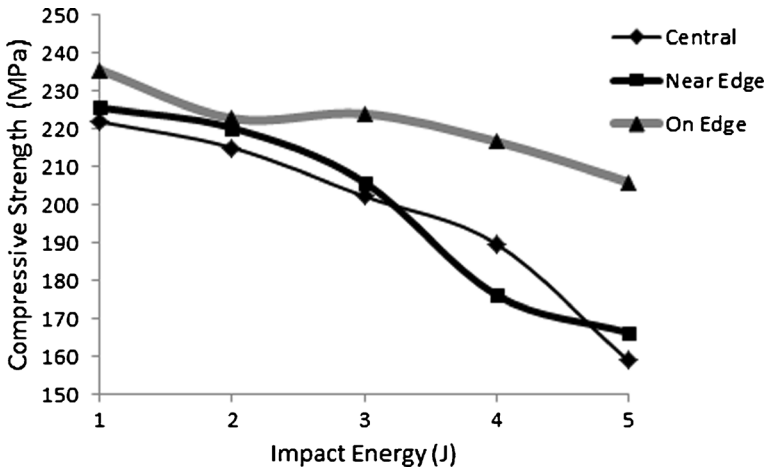
The variation of maximum compressive strength in the CAI test for the different impact positions as a function of impact energy are shown in Fig. 7. These are the results for the 4 mm thick plate; results for the 2 mm thick plate show similar trends. The compressive strength reduces for increased impact energy for all impact positions, but the decrease is much smaller for the on edge impact. At low impact energies, the compressive strength is similar for all impact positions.

Fig. 7 Variation of maximum compressive strength in the CAI test with impact energy (4 mm thick)

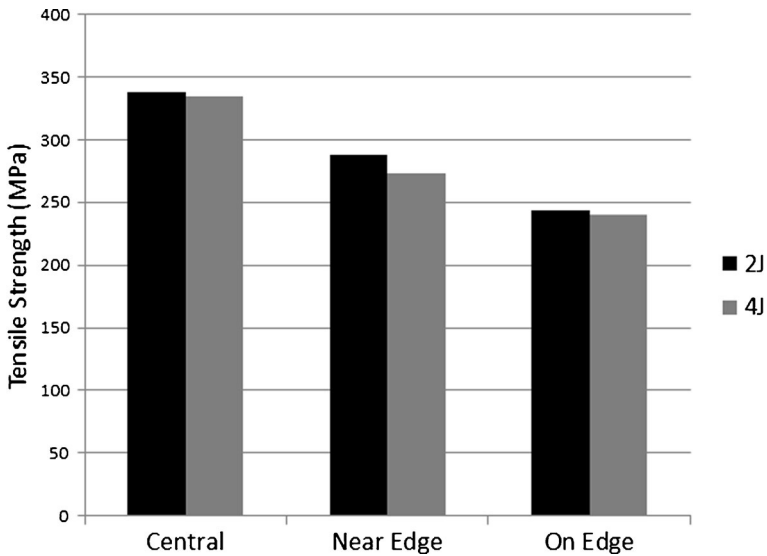
Fig. 9 Variation of maximum tensile strength measured in the TAI test with impact energy (4 mm thick)

The variation of maximum strength in the TAI tests for the different impact positions for the two values of impact energy tested are shown in Fig. 9. Some variation with energy level is found for near edge impact, but the strength for both energy levels is very similar for central and on edge impact. For both energy levels, the values of tensile strength are highest for the central impact and lowest for the on edge impact.

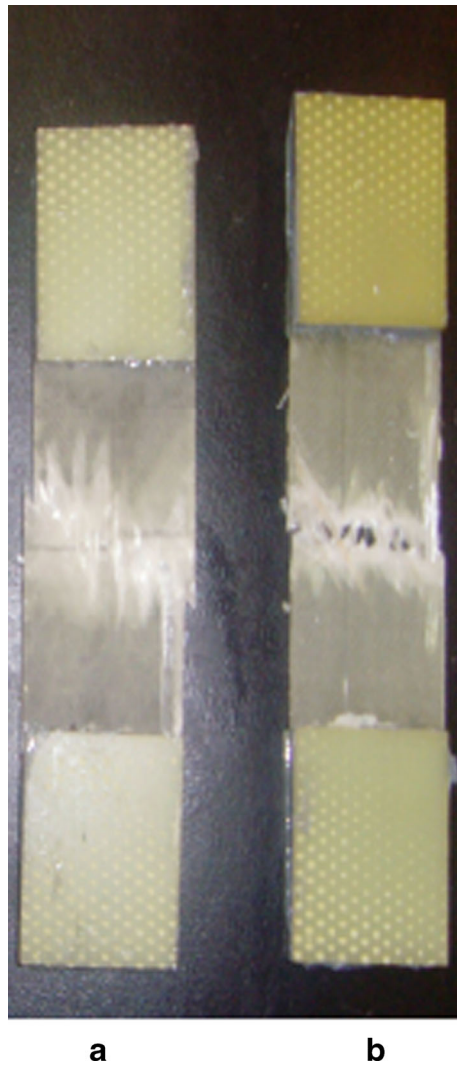
The failure processes in the TAI tests can be deduced from observation of the failed laminates shown in Fig. 10. For both near edge and on edge impact, a damage zone appears to have grown from the impact area. The area of delamination around the damage zone appears to be greater for the near edge impact.

Fig. 10 Damage zone growth in the TAI test . **a** near edge impact (4 mm thick) **b** on edge impact (4 mm thick)

The failure processes in CAI and TAI tests appear similar, with damage zone growth from the impact location for both near edge and on edge impacts. For the TAI tests, there is some evidence of more delamination around the damage zone for the near edge impacted laminate compared to the on edge impacted laminate. The strength of the laminate must be related to the stress required for the initiation of this damage zone. Comparing the values of compressive and tensile strength (Figs. 7 and 9); values for on edge impact are similar while tensile values for near edge and central impact are all higher, the difference being greater for central impact. Comparing results from the different types of impact and different tests (Figs. 13a and b), this value of initiation stress appears to be lower in compression when more delamination is present, but lower in tension when more fibre failure is present.

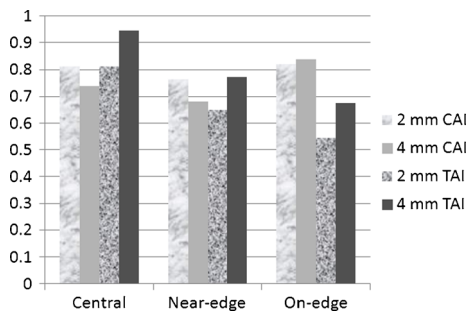
Results for CAI tests and TAI tests are compared using normalised values of maximum load, normalised with respect to the maximum load values for the undamaged laminates. The effect of thickness is summarised in Fig. 11; results are presented for the 4 J impact. Lower damage tolerance is found for the thicker laminate for the compression test, but higher damage tolerance is found for the thicker laminate for the tension test. The effect of thickness for on edge impact in the compression test is very small. The effect of impact energy is summarised in Fig. 12; results are presented for the 4 mm thick laminate. Lower damage tolerance is found for higher energy impact for the compression test for all impact positions. The damage tolerance measured in tension is similar at both energy levels for the tension test for all impact positions.

Fig. 11 Effect of thickness in the CAI and TAI tests (Values of strength normalised with respect to undamaged laminates) (4 J impact)

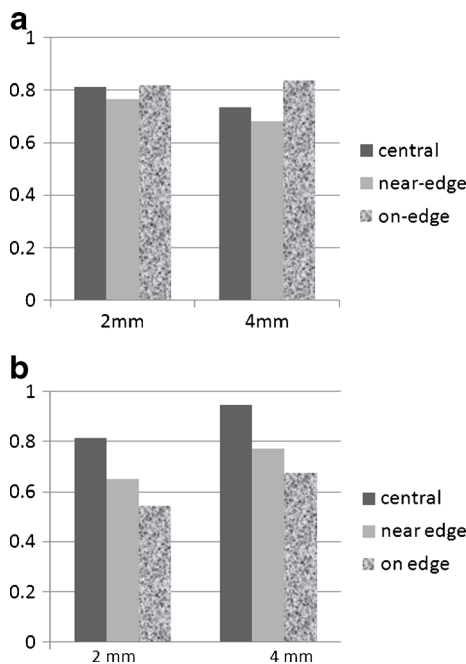
The effect of impact position is shown in Fig. 13; these are the results after 4 J impact. Similar trends are shown for both values of laminate thickness. For the compression tests, lowest damage tolerance is found for the near edge impact; higher damage tolerance is found for on edge impact, and for the thicker laminate the damage tolerance is significantly higher than for the central impact. For the tension tests, the lowest damage tolerance is found for the on edge impact and the highest

damage tolerance is found for the central impact. The trends are identical for both thicknesses of the laminate, with all values of damage tolerance being higher for the thicker laminate.

Fig. 13 Effect of impact location in the **a** CAI and **b** TAI tests (Values of strength normalised with respect to undamaged laminates) (4 J impact)

The presence of delaminations is expected to be well detected in compression after impact tests. This is confirmed in this work (see Fig. 13a) which confirms the lower damage tolerance arising from near edge impact which has been explored in previous work [6]. The damage tolerance of the on edge impact is measured as the same or higher than central impact for the compression test. These results indicate that maximum delamination length arises from near edge impact and minimum delamination length arises in on edge impact.
