# Weldability of wrought Haynes® 282® repair welded using manual gas tungsten arc welding

**Abstract** The ability of the precipitation hardening superalloy Haynes® 282® to be repaired by multi-pass gas tungsten arc welding is investigated in this study. The repair welding has been carried out on forged discs having four pre weld heat treatments, resulting in different grain sizes and precipitate structures of the base material. Another set of discs has additionally been put through a post weld heat treatment. The tendency to form cracks in the heat-affected zone and the fusion zone has been investigated metallographically. No cracks in the base metal heat-affected zone were found, whereas solidification cracks were present in the weld fusion zone of all tested conditions. While high heat input during welding increased cracking by a factor of 1.5, none of the heat treatments had a measurable influence on the cracking behaviour. Voids with solid state crack-like appearance turned out to be aluminium-rich oxides being present from the deposition of previous weld deposit layers.

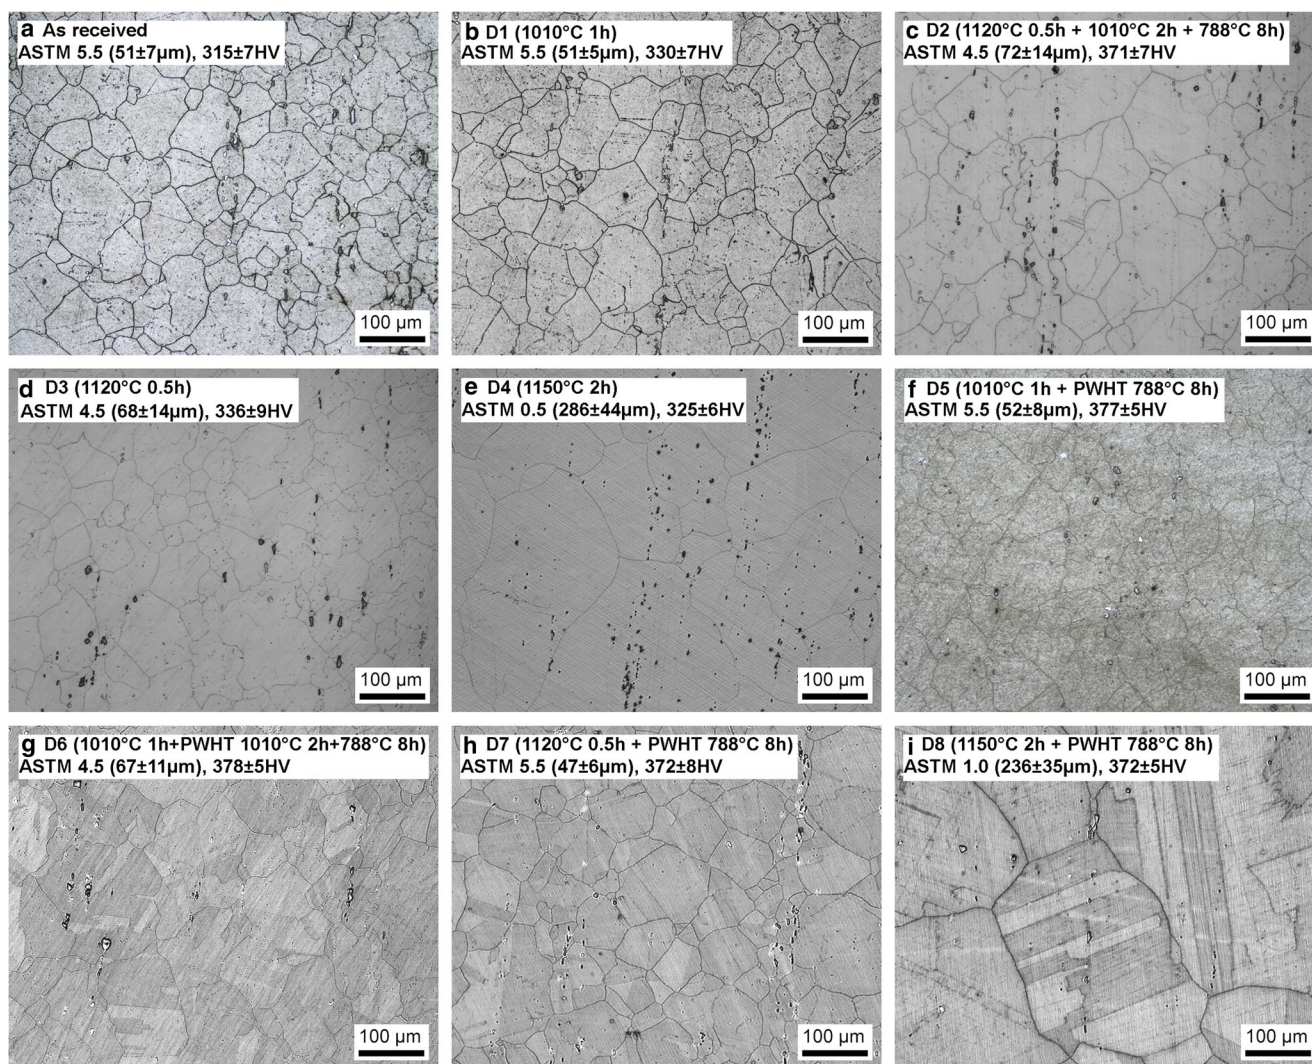
**Fig. 1** Microstructure of the base material after different heat treatments, including respective grain size and hardness values

Wrought Haynes® 282® in the form of a 100-mm-diameter forged bar has been used for this study, with the nominal chemical composition given in Table 1. The as-received, solutionised condition had a grain size of ASTM 5.5 ( $51 \pm 7 \mu\text{m}$ ) and a hardness of  $315 \pm 7 \text{HV}$  with the microstructure showing strings of primary carbides typical for the thermomechanical history of the material (cf. Fig. 1a). Grain boundary carbides were not present in this material condition.

The microstructures obtained with the different heat treatments are shown in Fig. 1b–i together with the respective grain size

and hardness values. Grain size varied within one ASTM number for the different heat treatments, except for the discs heated to 1150 °C, which is above the secondary carbide solvus temperature. This led to significant grain growth, as indicated in Fig. 1e, i. The larger grain size did not have a measurable effect on the hardness. All age-hardened samples show hardness values between 370 and 380 HV. As expected, neither heat treatment was able to change the string-like carbide alignment present from the forging process (cf. Fig. 1). Based on the microstructural evaluation, the heat treatments of disc 1 (1010 °C 1 h) and disc 3 (1120 °C 0.5 h) show no striking difference, with the amount and distribution of carbides, while not quantified, appearing to be the same. The hardness values of the base material of discs 1 and 3 however were exceeding those being expected for precipitate-free material.

the as-received condition (cf. Fig. 1) and the finding that  $\gamma'$  precipitation is rather fast in Haynes<sup>®</sup> 282<sup>®</sup> [13] led to the conclusion that the forced convection cooling as used in this study still leads to significant hardening reactions in the material. The unexpected hardness difference between weld and base metal after post weld heat treatment could be related to a difference in size and volume fraction of the  $\gamma'$  phase, caused by the different thermal history. While present in the material, this difference did not affect the cracking response since both the solidification cracks and oxide inclusions remain from the welding process and were not caused by the post weld heat treatment.

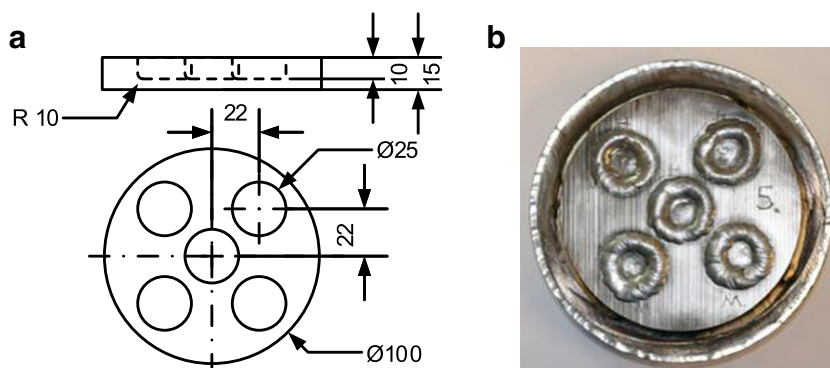
**Fig. 2** **a** Sample design. **b** Disc with filled grooves. Note the restraint maximising stainless steel disc welded onto the bottom of the Haynes® 282® disc

Five circular repair welding grooves with a diameter of 25 mm, a depth of 10 mm, and a bottom radius of 5 mm have been machined into the discs after the pre weld heat treatments, as indicated in Fig. 2a. To maximise welding restraint, the discs were fixed to 25-mm-thick stainless steel discs by a circumferential weld (cf. Fig. 2b). Repair welding has been carried out by experienced welders using manual gas tungsten arc welding (GTAW) with a tungsten-2% thorium (WT-20) electrode. Argon was used as shielding gas, with a nozzle gas flow of 8–15 l/min. Filler material in the form of 1.14-mm wire with matching chemistry has been used to fill the grooves. Two out of the five grooves have been filled using negative polarity and a welding current of 120 A, while 140 A have been used for the remaining ones. The former is typical for such a repair operation, whereas the higher weld current represents tougher conditions due to the higher heat input. The grooves have been filled with 7 to 8 layers, while the material was quenched by argon after the deposition of each layer to an inter-pass temperature of approximately 50 °C. The grooves have been filled one by one, but without specific sequence and no brushing between layer deposition.

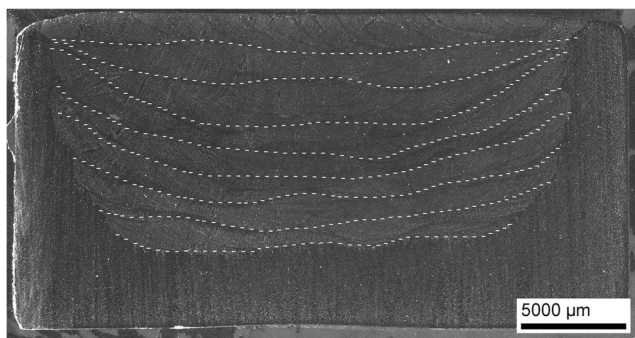
**Fig. 3** Macro image of an etched cross section with several weld deposits visible in the fusion zone (as indicated by dashed lines)

The general appearance of the repair-welded grooves is shown in Fig. 3, with the weld deposit layers being indicated by dashed lines. The groove's depth of 10 mm has been filled with seven to eight welding deposit layers, leading to an average layer thickness of  $1.5 \pm 0.3$  mm. It has to be noted that the apparent layer thickness is lower than right after depositing, since some re-melting occurs during subsequent layer deposition. The welding deposits are further referred to as fusion zone, while the term heat-affected zone describes the

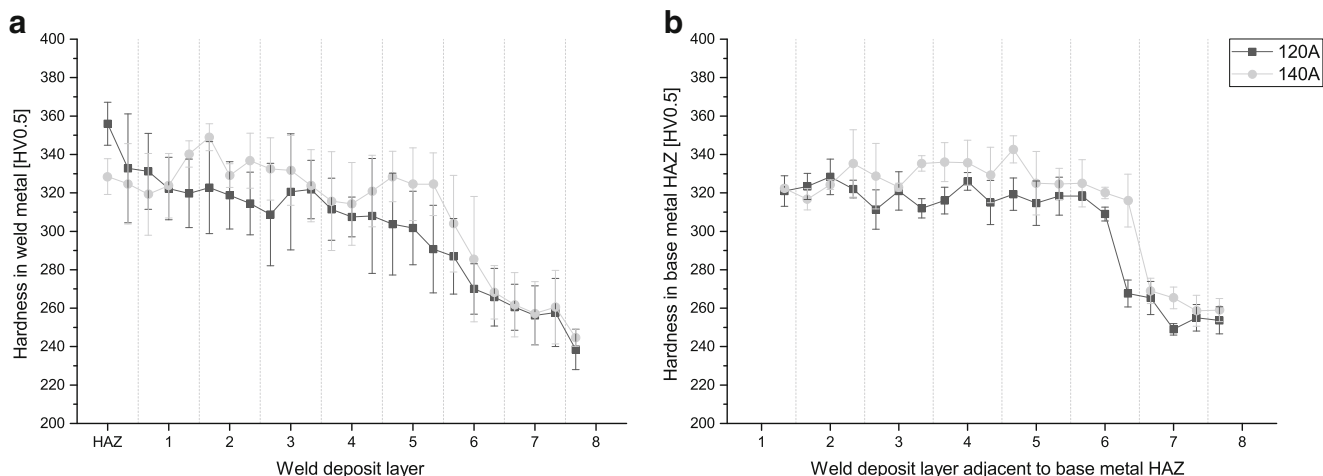
**Fig. 4** Hardness evolution as a function of weld deposit layer for 120-A and 140-A welding current. **a** Weld metal. **b** Hardness in the base metal HAZ and adjacent to the fusion zone. Indent spacing 0.5 mm

heat-affected zone of the base material. The post weld heat-treated discs show a uniform hardness distribution over the whole weld area (120 A  $402 \pm 13$  HV, 140 A  $393 \pm 15$  HV), whereas a hardness drop below 300 HV is visible for the top fusion zone layers in the discs without PWHT, as visible in Fig. 4a. While this drop in hardness occurs in both welding conditions, the higher heat input of the samples welded with 140 A welding current led to a somewhat delayed but sharper reduction in hardness. The same hardness drop also occurs in the base metal HAZ, measurable on the side walls of the grooves, cf. Fig. 4b. The hardening response is however somewhat more rapid, since values below 300 HV were only measured adjacent to the 2 to 2.5 topmost layers.

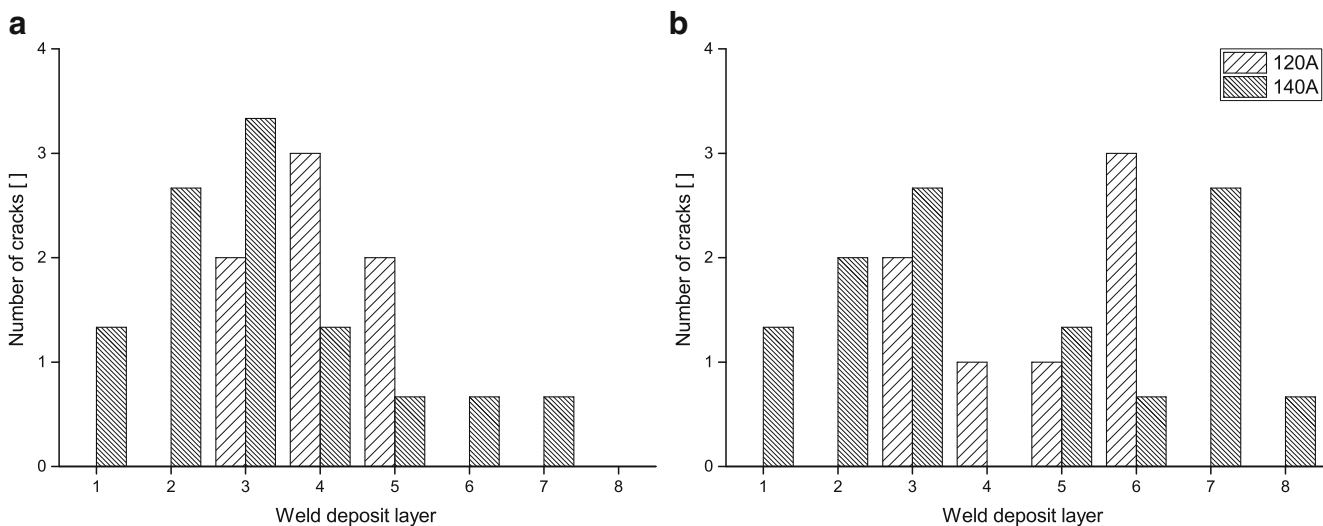
**Fig. 5** Total number of cracks per weld deposit layer. **a** Pre weld heat-treated discs (1–4). **b** Pre + post weld heat-treated discs (5–8). Results for 140-A welding condition are normalised to account for the difference in sample size between the two conditions

further. Lack of fusion has been observed in all samples, but was not further investigated. Solidification cracks had an average crack length of 375  $\mu\text{m}$ , while LoF typically ranges from 500 to 1500  $\mu\text{m}$  and the small voids around 100–200  $\mu\text{m}$ . Figure 5 shows the total number of cracks per welding deposit layer for all pre and post weld heat-treated samples. Note that only solidification cracks are shown here, since these were the only cracks present in the material. While those cracks do not form during post weld heat treatment, the grouping of samples has been kept to point out that PWHT did not lead to more cracks in the material.

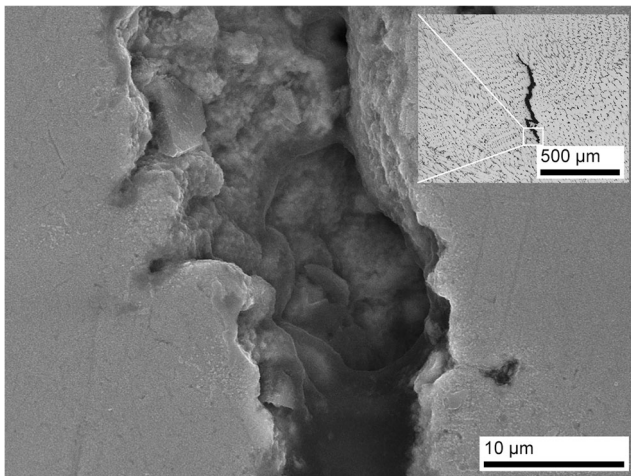
**Fig. 6** Solidification crack in disc 8, 120-A welding condition. Clear indication of a dendrite structure in the crack opening. Crack length 706 µm

cracks in the base metal HAZ would indicate that, irrespective of the material condition, wrought Haynes<sup>®</sup> 282<sup>®</sup> exhibits a generally good response to repair welding operations. This is however different for the fusion zone, where in total 47 cracks have been observed in the 40 investigated grooves. Welding with higher heat input increased cracking by a factor of 1.5, with no clear pattern being evident regarding overall crack distribution over the welding deposit layers. While stress levels have not been quantified within this study, it can be reasonably assumed that higher thermal stresses were present during welding with 140-A welding current and hence facilitating crack formation. SEM investigations of found cracks revealed the dendritic structure formed during the solidification process without signs of decohesion, as shown in Fig. 6. This further supports the assumption that those cracks are indeed solidification cracks.

The voids found in bottom regions of weld deposits appear to be cracks when viewed under an optical microscope, lying horizontally, i.e. parallel to the fusion boundary. Most of them are located at the interface between columnar grains on the bottom and equiaxed grains on top (cf. Fig. 7). No signs of liquation could be found during SEM investigation. EDS scans however revealed the presence of aluminium-rich oxide films in the voids, as indicated in Fig. 7. This finding makes it very unlikely that those voids are stain age cracks and instead support the hypothesis that these voids are caused by oxide films present during the deposition process. The large number in comparison to the amount of solidification cracks is related to the manual welding process, where more thorough surface cleaning between layer depositions would have been necessary. It should be noted though that voids caused by oxide layers are about half the size of solidification cracks and LoF (cf. Figs. 6 and 7).

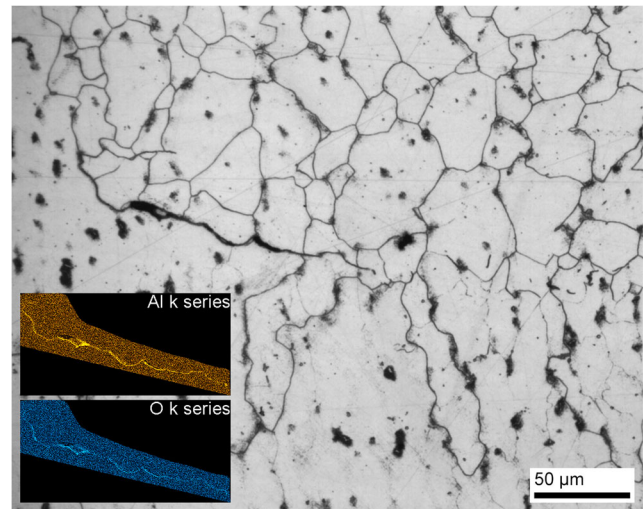
**Fig. 7** Aluminium-rich oxide layer at a presumed layer start location in disc 6, 140-A welding condition. Note the equiaxed grain structure above the oxide layer. Void size 184 µm
