SEISMIC RESISTANCE OF TRADITIONAL TIMBER-FRAME HİMİŞ STRUCTURES IN TURKEY: A BRIEF OVERVIEW

Yasemin Didem AKTAŞ*

Epicentre Research Group, Civil, Environmental and Geomatic Engineering, University College London (UCL),
London, UK
y.aktas@ucl.ac.uk

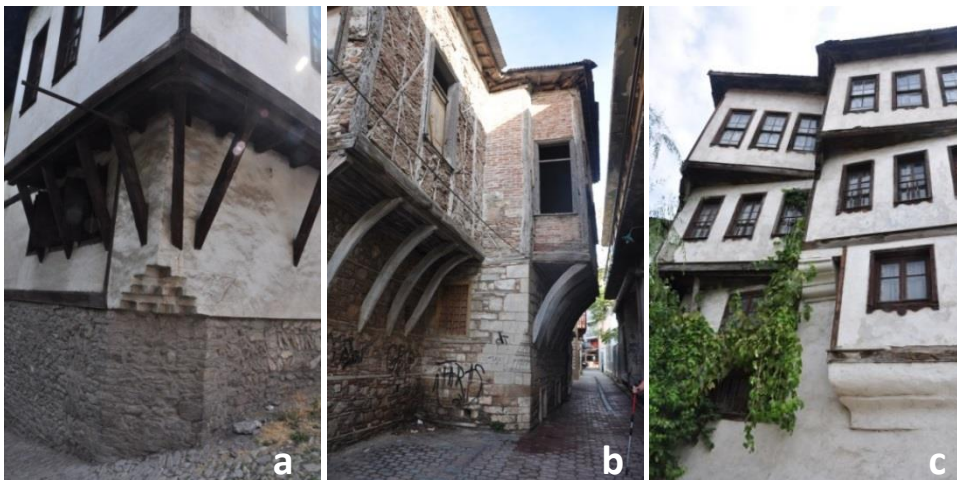
Figure 3: Braced projections from (a) Safranbolu, Turkey and (b) Chalkis, Greece (this concave variation is known as *eliböğünde*), and (c) simple cantilever projection from Safranbolu

20 Projections (jetties, *çıkma* in Turkish) are one of the most distinguishing features of *hımış* houses (Figure 3),
21 which actually did not exist till late 16th century [1]; *vakfiyes* (Turkified from Arabic *wakfiy(y)a*, meaning deed
22 documents issued for mortmain properties – *waqf*, in Turkish *vakıf* – managed under a religious, non-profit
23 charity concept) suggest that in the 15-16th centuries most houses were single-storey [45]. When the multiple
24 story housing became widespread, the projections lent themselves to making upper-storeys more spacious and
25 regular in shape in contrast to often narrow and irregular ground-floor plan geometries, as well as to have a
26 more complete view of the street via bay-windows located on the projections (*cumba* in Turkish) [46].
27
28
29

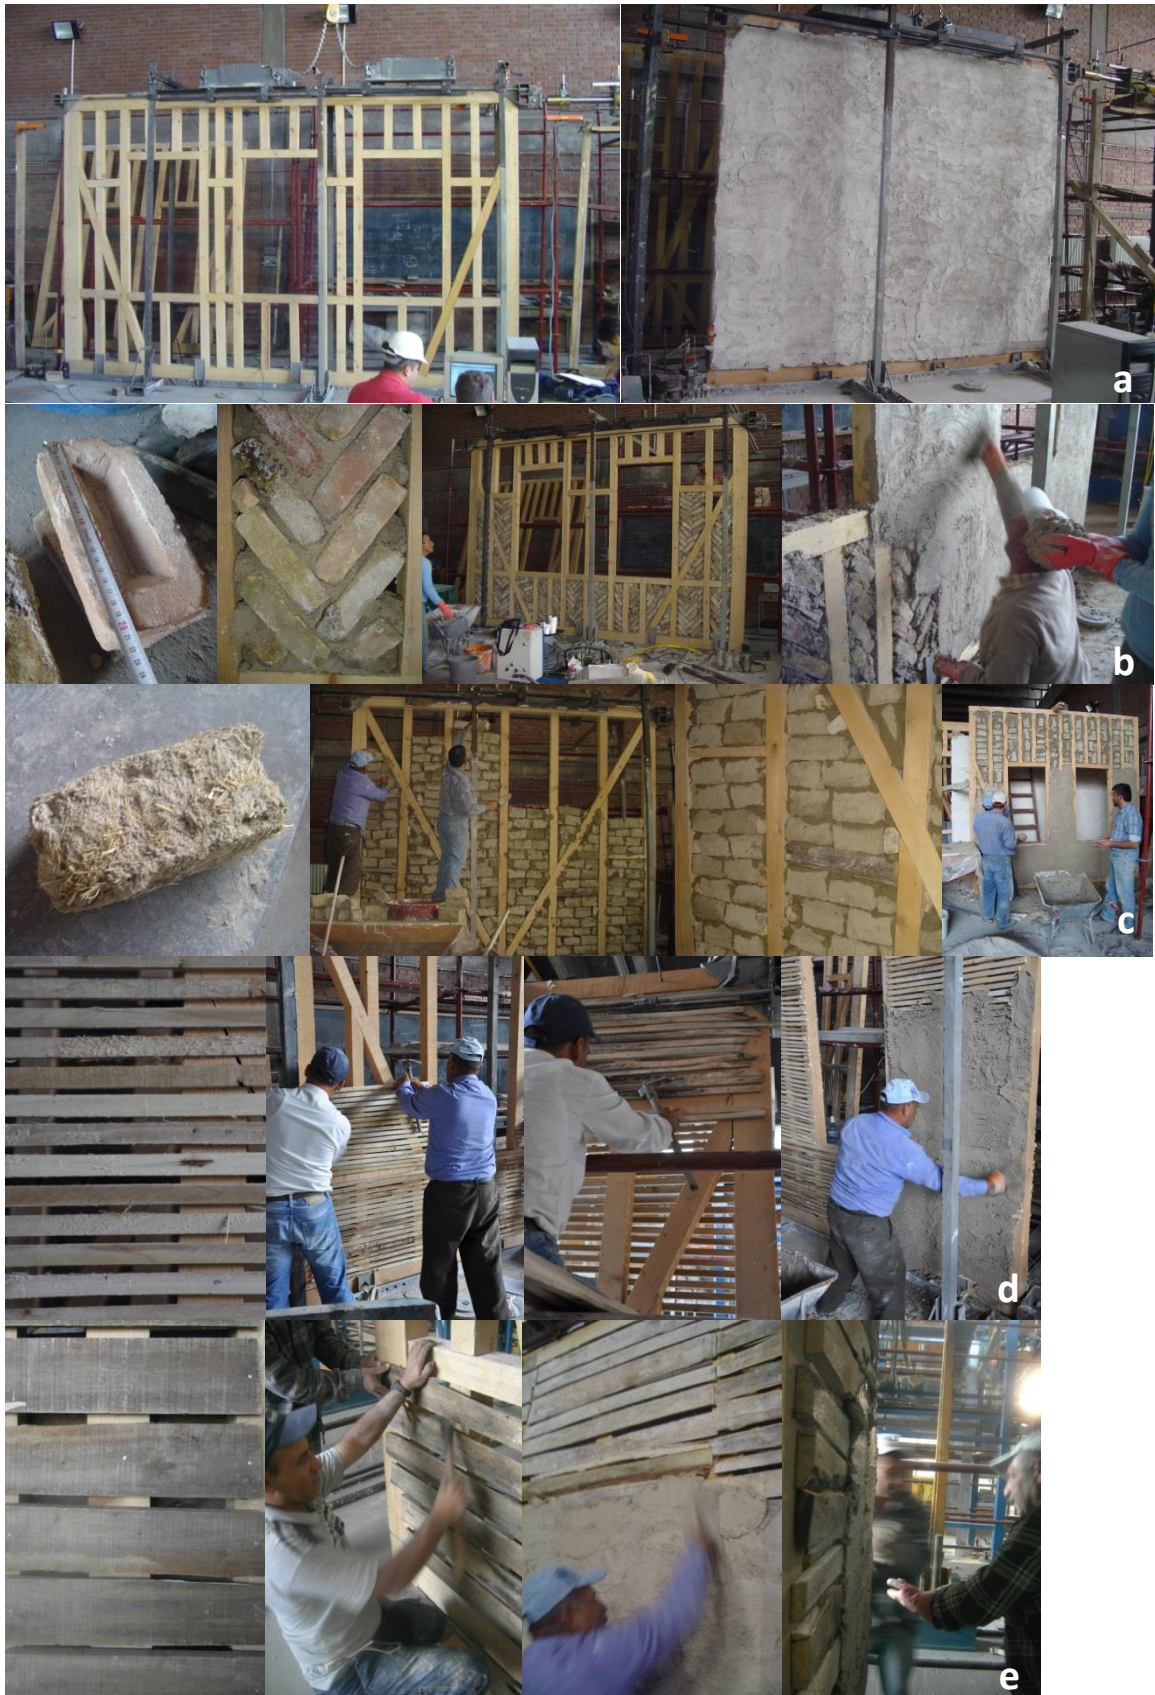
Figure 4: (a) Frame tests under reverse-cyclic lateral loading; (b) brick infill; (c) adobe infill; (d) *bağdadi* cladding; (e) *şamdolma* cladding.

38 Despite widely available information based on post-disaster observations, robust quantitative data on the
39 seismic behaviour of these structures were practically non-existent until quite recently. The experimental work
40 aiming to quantify the seismic performance of and identify the damage mechanisms at *hımış* buildings is, to best
41 of the author’s knowledge, still limited to the extensive testing scheme carried out at METU, Structural
42 Mechanics Laboratory in 2009-2011, as part of a research project titled “Seismic Assessment of Traditional
43 Ottoman Timber-Frame Houses”, funded by TUBITAK. The project included testing of 8 full-scale *hımış* frames,
44 built with different geometrical configurations selected from Safranbolu (UNESCO World Heritage Site) using
45 (unaged) pine and fir under reversed cyclic lateral loading (Figure 4a). The frames were first tested in their bare
46 state, and then repaired and re-tested with infill (brick and adobe; Figure 4b&c, respectively) and cladding

laths, see Figure 4d&e, respectively). The findings from the testing scheme were reported in detail elsewhere (see [49-52]). In the following, certain structural features of *himiş* houses are further discussed in the light of the findings of the aforementioned testing scheme and other resources.
