# A Performance Evaluation of a Notebook PC under a High Dose-Rate Gamma Ray Irradiation Test

We describe the performance of a notebook PC under a high dose-rate gamma ray irradiation test. A notebook PC, which is small and light weight, is generally used as the control unit of a robot system and loaded onto the robot body. Using TEPCO's CAMS (containment atmospheric monitoring system) data, the gamma ray dose rate before and after a hydrogen explosion in reactor units 1–3 of the Fukushima nuclear power plant was more than 150 Gy/h. To use a notebook PC as the control unit of a robot system entering a reactor building to mitigate the severe accident situation of a nuclear power plant, the performance of the notebook PC under such intense gamma-irradiation fields should be evaluated. Under a similar dose-rate (150 Gy/h) gamma ray environment, the performances of different notebook PCs were evaluated. In addition, a simple method for a performance evaluation of a notebook PC under a high dose-rate gamma ray irradiation test is proposed. Three notebook PCs were tested to verify the method proposed in this paper.

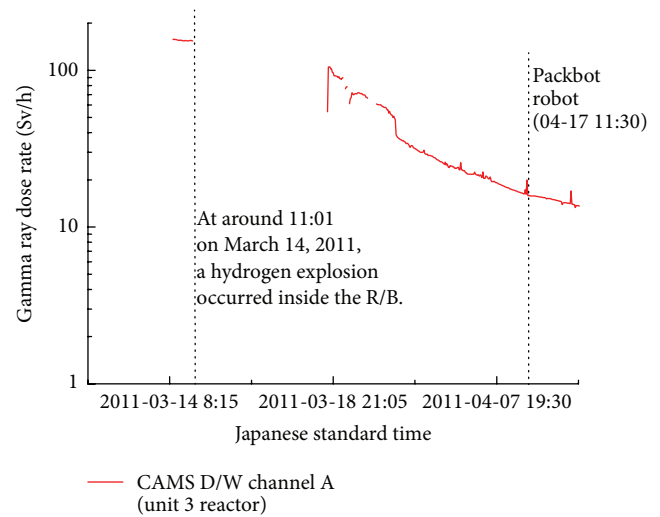
FIGURE 1: Gamma ray dose rates of the PCV D/W area in unit 3 reactor.

Figure 1 shows the gamma ray dose-rate distribution in the atmosphere between the exterior wall of the RPV (reactor pressure vessel) and the inner wall of the PCV. Since the Packbot robot system entered an area between the exterior wall of the PCV and the inner wall of the reactor building (R/B), it carried out its mission in a much lower dose-rate environment than that of the measured value in the CAMS D/W channel.

power plant lost their emergency core cooling function. In the case of unit 1 reactor, even the instrumentation system did not work owing to the inundation of the DC power source supplied by the backup batteries. According to CAMS (containment atmospheric monitoring system) data of the PCV D/W (dry well) region in unit 1 reactor, which was announced by TEPCO, the gamma ray dose rate was 164 Sv/h on March 14, 06:00, at which time more than one day had passed since the hydrogen explosion on March 12, 15:36. In the case of unit 2 reactor, the maximum dose rate was 138 Sv/h in the CAMS D/W channel at the time of the meltdown, which was followed by PCV damage. In the case of unit 3 reactor, the maximum dose rate was 167 Sv/h before the hydrogen explosion (March 14, 11:01) and 154 Sv/h after it. Figure 1 shows the gamma ray dose-rate distribution of the PCV D/W region of unit 3 reactor. The  $x$ -axis in Figure 1 represents about one month of measurement time, from before the hydrogen explosion to when the Packbot robot entered unit 3 reactor building for the first time (April 17, 11:30). The measurement time interval was one hour, on average. The  $y$ -axis represents the gamma ray dose rate. Unit 3 reactor experienced a hydrogen explosion around March 14, 2011, at 11:01, and the gamma ray dose rate in CAMS D/W channel A at the time immediately before the explosion (March 14, 10:55) was 154 Sv/h. No measurement data were provided for more than four days, owing to the impact of the hydrogen explosion. In addition, the gamma ray dose rate in CAMS D/W channel A at the time of the Packbot robot entry was 15.9 Sv/h.

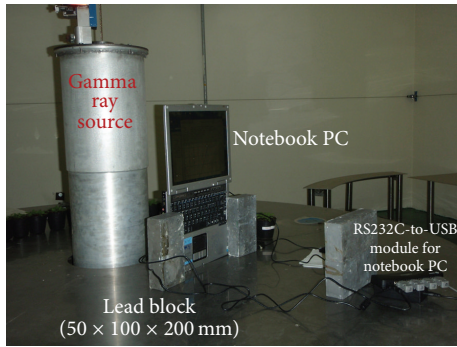
of the notebook PC under testing was periodically recorded on the hard disk of the data logger system (notebook PC), placed in the control room as shown in Figure 2. A USB-2-RS232C conversion module for the RS-232C loopback test is placed behind the lead block (50 × 100 × 200 mm), as shown in Figure 3. As the thickness of the lead block is 50 mm, the intensity of the gamma ray dose-rate irradiated at the USB-2-RS232C conversion module is reduced by less than 1/10. The TVT (tenth value thickness) of the lead material for the Co-60 gamma ray source is 40 mm [9]. The TVT is the thickness of material required to reduce the gamma radiation to one-tenth the intensity. As the cumulative gamma ray irradiation dose increases, the status of the pilot application program of the notebook PC under gamma ray irradiation test is estimated to change. When the notebook PC is under a normal status, the menu screen of the pilot application program does not change. Therefore, speckles appearing in the image of the monitoring CCD camera show a uniform distribution. When the notebook PC is over irradiated beyond the endurance limit of the cumulative gamma ray dose, a subtle change in the menu screen of the pilot application program of the notebook PC under test occurs. By detecting this, the abnormality of the notebook PC owing to a cumulative gamma ray dose beyond the endurance limit can be identified.

FIGURE 3: Experimental setup for the notebook PC under a high dose-rate gamma ray irradiation test.

Figures 2 and 3 show the experimental setup. The notebook PC under test was gamma ray irradiated at a dose rate of 150 Gy/h (19.6 cm distance from Co-60 gamma ray source) until failure. A pilot application program to check the abnormal status of the notebook PC owing to the cumulative gamma ray irradiation dose was executed. An RS-232C loopback test program was executed as the pilot application program, and the menu of the pilot application program was displayed on the LCD screen of the notebook PC under the gamma ray irradiation test. Then, using another monitoring CCD camera, installed at a 340 cm distance (2.11 Gy/h) from the radiation source (Co-60), the LCD screen of the notebook PC under test was observed online. We adjusted the field of view of the monitoring CCD camera such that the LCD screen of the notebook PC under gamma ray irradiation testing was shown fully on the image plane of the monitoring CCD camera. The distance of the monitoring CCD camera from the Co-60 source was determined to be relatively long compared to the notebook PC under test because the camera should robustly observe the status of the pilot application program until the notebook PC under the gamma ray irradiation test failed. As shown in Figures 2 and 3, the main body of the notebook PC under test is nearer to the Co-60 gamma ray source than the LCD screen of the notebook PC under test. Thus, the intensity of the gamma ray dose-rate irradiated at the main body of the notebook PC under test is greater than the LCD screen of the same notebook PC under test. Assuming that the ASIC FPGA, CPU, DSP, and electronic devices, which are generally used in the LCD driver unit and main body of the notebook PC, are made through the CMOS fabrication process, we can estimate that the main body of the notebook PC will fail to function prior to the LCD screen of the same PC as the gamma ray irradiation time elapsed. To discriminate an accurate malfunction point of the notebook PC under a gamma ray irradiation test, the time log is marked on the upper position of the image plane of the monitoring camera. In addition, the observation image of the LCD screen

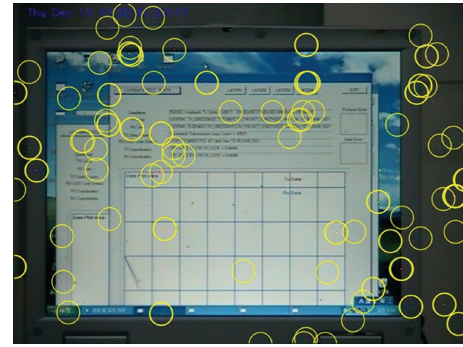
FIGURE 5: Menu image of the pilot application program, executed on a notebook PC under test (during gamma ray irradiation, about 15 min elapsed).

superimposed onto the image of the monitoring camera, as shown in Figure 5. In Figure 5, the white dots in the yellow circles are speckles.

Figure 4 shows the menu screen of the pilot application program executed in the notebook PC under test before the gamma ray irradiation. Figure 5 shows the menu screen of the pilot application program (RS-232C loopback test) of the notebook PC under test during the gamma ray irradiation. The unique difference between Figures 4 and 5 is the speckles. Before the gamma ray source (Co-60) is placed at its irradiation point, the menu of the pilot application program is only observed in the monitoring CCD camera image, as shown in Figure 4. After the source is uploaded to its irradiation position, speckles from the gamma ray are

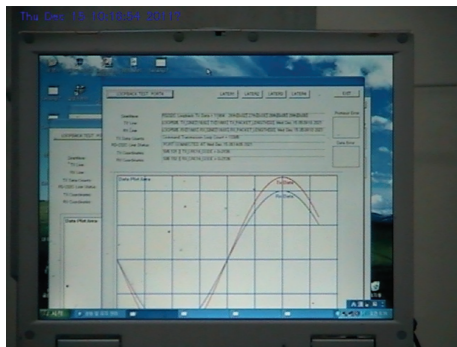
FIGURE 4: Menu image of the pilot application program, executed on a notebook PC under test (before gamma ray irradiation).

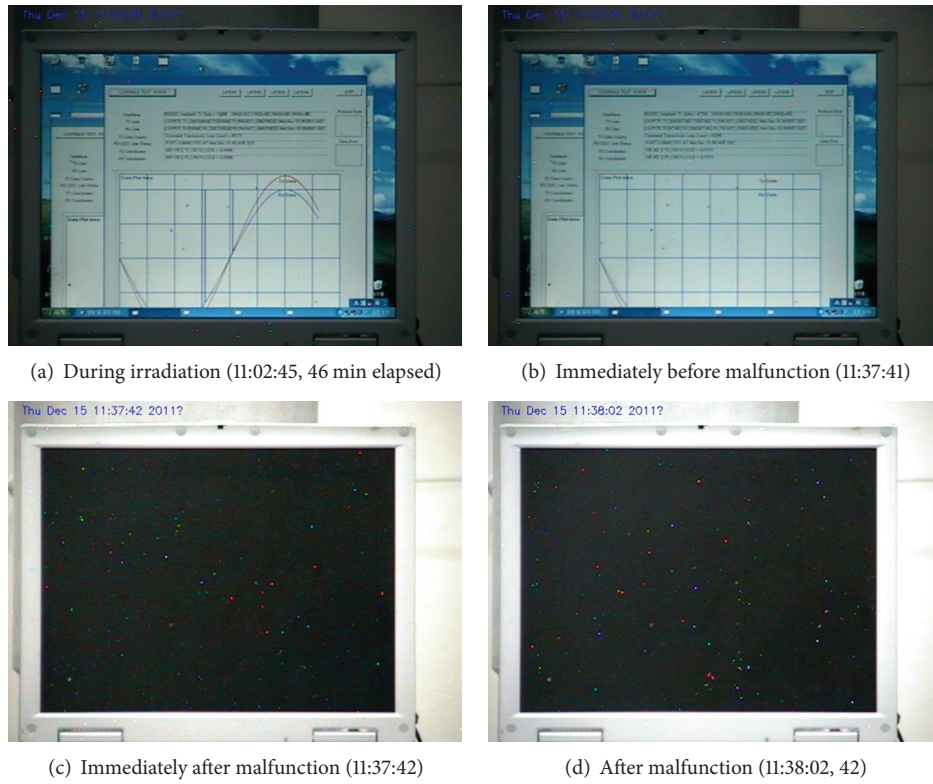
Figure 6 shows the failure of the pilot application program observed at a time when the cumulative gamma ray irradiation dose of the notebook PC under test was about 225 Gy ( $150 \text{ Gy/h} \times 1.5 \text{ h}$ ). Figure 6(a) shows the menu of the pilot application program when the notebook PC under test is in a normal state during the high dose-rate gamma ray irradiation. In Figure 6(a), the red (TX) and blue (RX) curves shown in the menu of the pilot application program (RS-232C loopback test) of the notebook PC under test represent the status of the data transmission experiment during the high dose-rate gamma ray irradiation test. If a data transmission error occurs, the peak is drawn in the received waveform (blue curve) at the time of error occurrence, as shown in Figure 6(a). This means that the notebook PC under a high dose-rate gamma ray irradiation test is operating normally. Figures 6(b) and 6(c) show images immediately before and after the malfunction of the notebook PC under test. After approximately 81 minutes elapsed, the LCD screen of the notebook PC under test was abruptly changed. As shown in Figures 6(c) and 6(d), the LCD screen of the notebook PC under test blacked out.

FIGURE 6: Menu images of the pilot application program, executed on a notebook PC under a high dose-rate gamma ray irradiation test.

Gamma ray energy is emitted through a nuclear decay reaction of Co-60. If a CCD camera is exposed to a high-energy gamma ray, white noises (speckles) are generated in the CCD camera image sensor. Since the decay of the Co-60 gamma ray source occurs randomly, speckles in the image of the CCD camera, exposed by the high-energy gamma ray source, appeared randomly frame by frame. It can be assumed that the pixel positions of the speckles in the image plane of the CCD camera, generated from the gamma ray irradiation, are also different frame by frame. Although the speckle distribution shown in the two-dimensional CCD image sensor plane is similar, the speckles appearing at certain pixel coordinates of the current image frame of the CCD camera are hardly generated at the same pixel coordinates of the next image frame of the CCD camera. The half-life of the Co-60 radiation source is approximately more than five years. A characteristic of gamma ray energy emitted from the Co-60 source does not change during an approximately two-hour irradiation period. Therefore, we can calculate the number of speckles in the image plane of the monitoring CCD camera, generated from gamma ray irradiation. Speckles from gamma rays are shown well in Figures 6(c) and 6(d). In this paper, the number of speckles generated from gamma rays was

it can be seen that the reliable performance of the notebook PC under a high dose-rate gamma ray irradiation test was degraded after the 5,878th frame, which was the time when a change in the speckle distribution occurred abruptly from the normal status, as shown in Figure 6(b), to an abnormal (blackout of menu screen) status, as shown in Figure 6(c). Since the menu screen of the pilot application program of the notebook PC under gamma ray irradiation test had a white background, as shown in Figures 6(a) and 6(b), speckles (white components) generated by the gamma rays were not unveiled well under the condition of the bright white background. The reason for the subsequent high distribution of speckles after the 5,878th frame was because the FOV background of the monitoring CCD camera was changed owing to the blackout of the menu screen of the pilot application program of the notebook PC under the gamma ray irradiation test. Since the background screen of the application program for the online test of the notebook PC was white before failure, speckles (white components) generated in the image of the monitoring CCD camera from the gamma rays were veiled in the bright white background screen and therefore showed a small distribution. Then, after failure of the notebook PC, the menu screen of the pilot application program was blacked out, and the background screen was darkened; speckles (white components) generated in the image of the monitoring CCD camera due to the gamma rays were well unveiled in the dark background screen and thereby showed a relatively high distribution. The limiting conditions (cumulative irradiation dose) for normal operation of the notebook PC under high dose-rate (150 Gy/h) gamma ray environments can be obtained, assuming that the image frame number that showed abrupt changes in the speckle distribution was 5,878, as shown below:

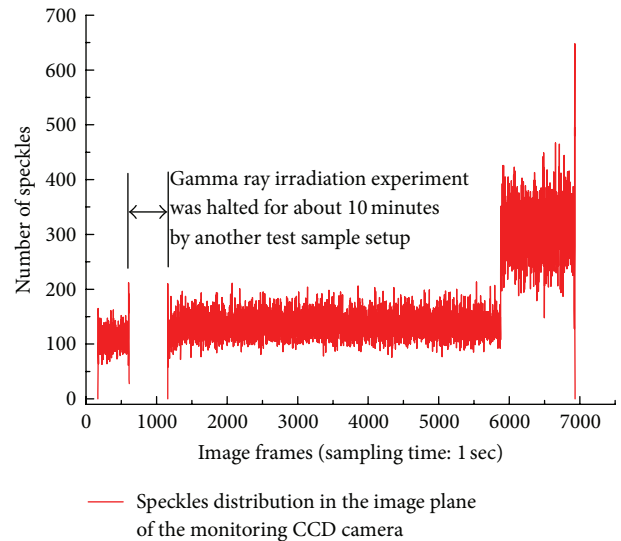
Figure 9 shows the speckle distribution calculated from the images of the monitoring CCD camera, which observed

FIGURE 9: Speckles distribution of the CCD monitoring camera images.

and recorded the LCD screen of the notebook PC under the high dose-rate gamma ray irradiation test.

In Figure 9, the numbers in the  $x$ -axis represent the numbers of image frames, stored at one-second intervals during the gamma ray irradiation period; that is, the  $x$ -axis is the irradiation time (frame numbers  $\times$  sampling time). The  $y$ -axis shows the number of speckles calculated using (1) and (2). In Figure 9, the number of speckles up to approximately the 5,878th frame was around 130 on average; the number of speckles after that frame was around 300. From this result,
