Research Article

Acceleration Characteristics of a Rock Slide Using the Particle Image Velocimetry Technique

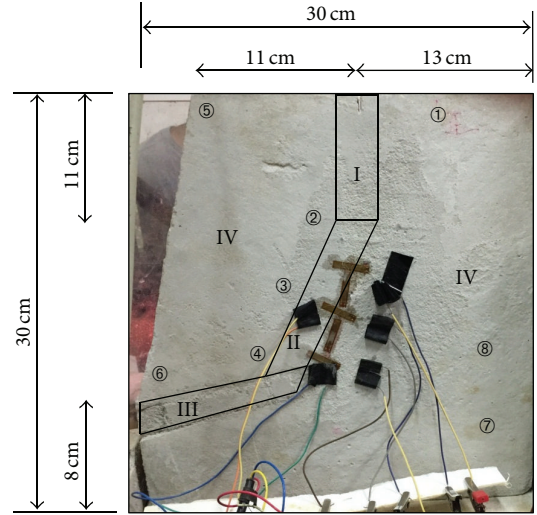
2.2. Experimental Materials and Test Principle. The test model is processed into $300 * 300 * 50 \text{ mm}^3$. The model imitates a three-step failure of sliding slope (Figure 1). Step one is creep along the horizontal soft stratum in the lower part of slope (see III in Figure 1), step two is tension at the back edge (see I in Figure 1), and step three is shearing of the locking section in the middle of the sliding surface (see II in Figure 1). Eight monitoring points were selected in the rock slide (see Figure 1). Point ① is at the top of the sliding slope, Points ②, ③, and ④ are at the potential sliding surface, Point ⑤ and Point ⑥ are at the potential sliding body, Point ⑦ is at the bottom of sliding bed, and Point ⑧ is at the middle part of sliding bed. The specifications of the sliding slope, position of the monitoring points, mechanical parameters, and material characteristics are shown in Figure 1 and Table 1. c and φ are determined from the direct shear test.

FIGURE 1: Rock slide with monitoring points and different materials (300 mm * 300 mm).

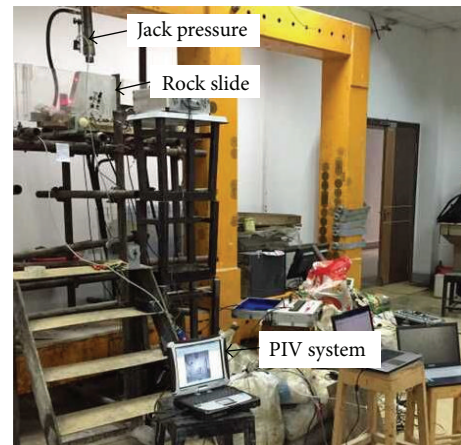
2.3. PIV Monitoring Solutions and Experiment Scheme. The acquisition frequency of the PIV system is 50 Hz and the pixel resolution of the camera is $2048 * 2048$. The slope model was fixed in a test frame and the camera was placed in front of the model (Figure 2). The jack pressure was prepared to be added after the installation of the equipment. The pressure jack was set on the preset load part of the model; then the pressure was added step by step with a constant velocity.

FIGURE 2: PIV rock slide experiment field.

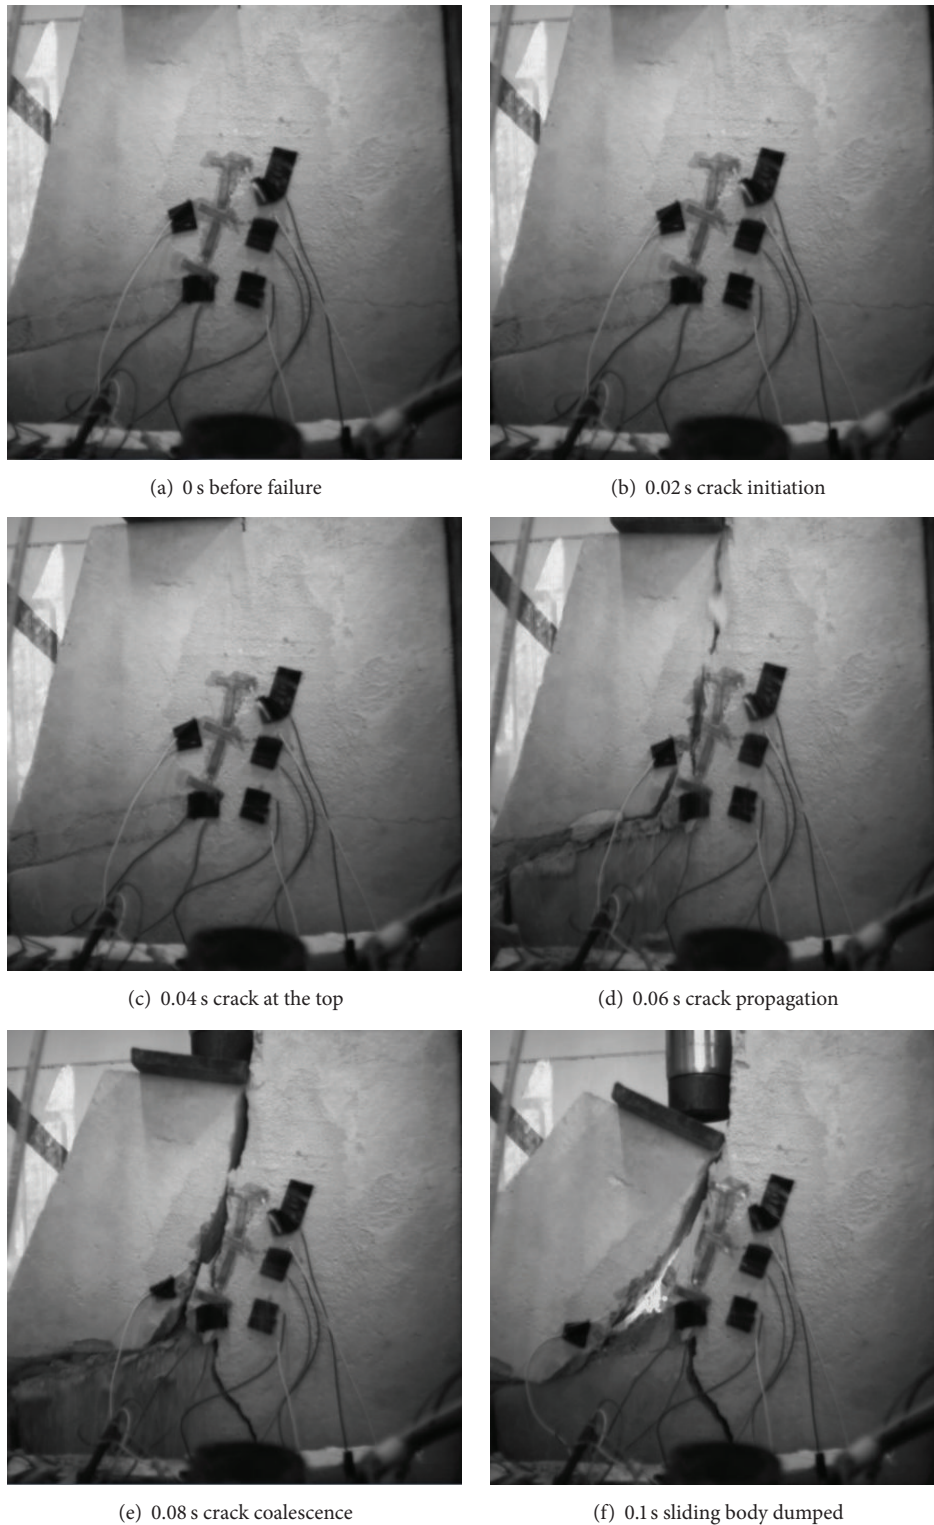
FIGURE 3: Extension of cracks during the failure process of the rock slide.

slope had failed in the experiment when the jack pressure reached 7 MPa. The temporal and spatial evolution process of failure cracks was obtained by the high-speed camera of the PIV system (Figure 3).

Figure 3 shows that the failure of the rock slope was characterized as instantaneous rotating of the sliding body. It can be seen from Figure 3 that the tension crack appeared at the top of the slope at 0.04 s; then, the crack developed at

0.06 s and the crack coalescence with the sliding body failure occurred at 0.08 s. Thereafter, the sliding body rotated along the direction of sliding bed. The rock slide was completely destroyed at 0.1 s and the whole sliding surface presented a trend of circular shape movement.

The velocity field around Point ① (Figure 4(a)) which is at the top of the slope is orientated in an upper right direction. The velocity of Point ① was almost zero at 0.04 s, but then it reached a velocity of -5.73 m/s at 0.06 s. The tension crack appeared on the top of the slope at this moment (Figure 3(c)); then, the coalescence of the failure surfaces generated the instability (Figure 3(d)). Therefore, the upward moving phenomenon at the top of the slope can be used as a warning sign for rock slide failure. Point ② moved along the sliding surface with a relatively high velocity. Point ⑦ and Point ⑧ in the sliding bed both moved in an opposite direction of the movement along the sliding surface with a relatively low velocity but Point ⑧ moved quicker than Point ⑦. Since Point ⑧ is in the middle of the sliding bed while Point ⑦ is in the bottom of the sliding bed, this phenomenon shows that different part of the sliding bed can have different failure and the deep region of the rock slope does not have a large amount of deformation.

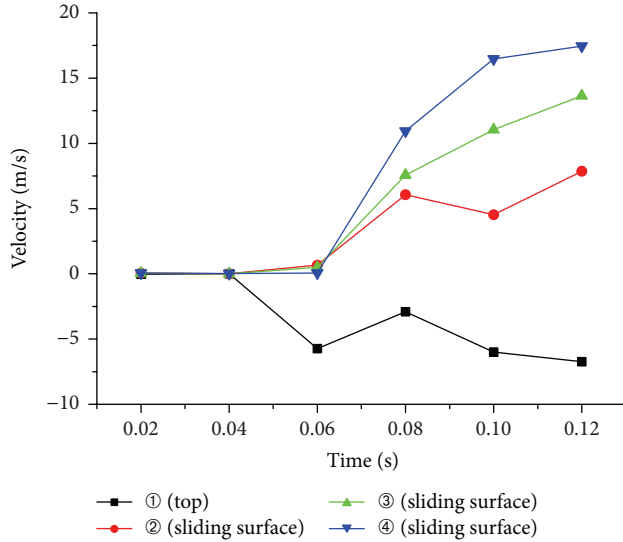
Table 2 showed that the velocity along the sliding surface is the highest (20 m/s), and the velocity of the sliding bed is relatively small. Figure 6 shows that the velocity of Point ① was -5.71 m/s at 0.06 s while the other point in the sliding surface was almost zero at that time; this was the beginning moment of rock slope failure. It can be seen from Figure 6 that the velocities of Point ⑤ and Point ⑥ are different, and the sliding bed and the sliding surface have the same phenomenon.

FIGURE 6: Change of the velocity with time of Points ①~④.

In addition to the velocity and displacement, the variation of the velocity and displacement versus time of the 8 monitoring points at the slope is summarized in Figures 6–9. The mean value of displacement and velocity (Tables 2 and 3)

is observed for the temporal and spatial evolution regularity of the sliding slope (the positive values correspond to the downside of the vectors and the negative value corresponds to the upper side in Figures 6–9).

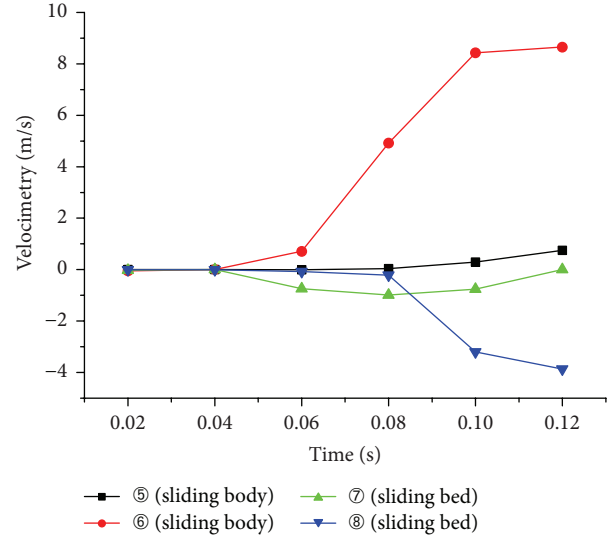
FIGURE 7: Change of the velocity with time of Points ⑤~⑧.

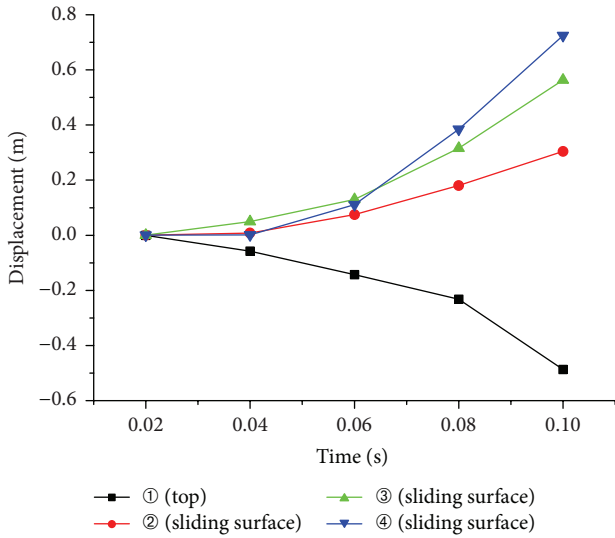
It can be seen from Figures 8 and 9 that the displacement increases with failure time. The failure happened in the sliding body first, then the sliding body start to collapsed at a uniform velocity, and finally the deformation comes into a accelerative stage until the complete failure of the slope. It can be seen from Table 3 that the average deformation on the sliding surface is the largest (0.29 m) and the average deformation on the sliding bed is relatively small (0.1 m).

FIGURE 8: Change of the displacement with time of Points ①~④.

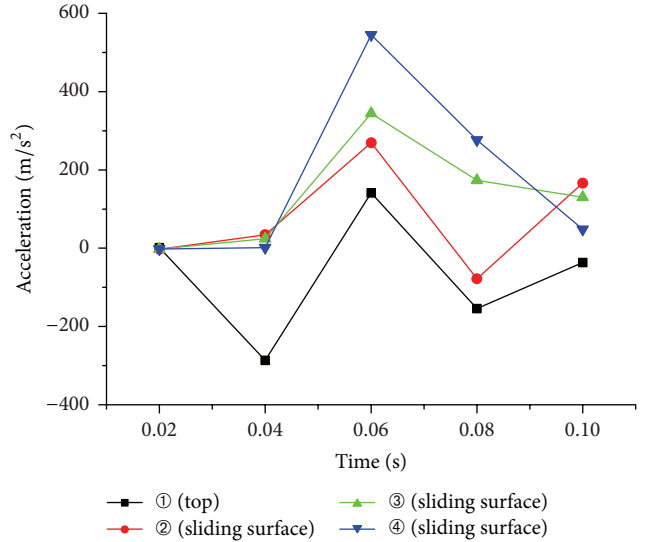
The variation of the acceleration versus time is shown in Figures 10 and 11. The sequences of the mean variation in acceleration which is taken as the mean value are shown in Table 4. It can be seen from Figure 10 that the maximum

acceleration can reach a value of 500 m/s^2 that indicates strong instantaneous forces and high energy release during rock slope failure. Figures 10 and 11 show that the acceleration of the sliding surface and the sliding body reached maximum at 0.06 s. This indicates that the sliding surface and the sliding body fail at the same time. The instantaneous force at this moment is high. In addition, the acceleration at the top of the sliding body reached peak at 0.04 s while the sliding surface reached peak at 0.06 s, which means the instantaneous force is relatively high and the sliding surface is not completely coalescing at this moment.

Acceleration indirectly reflects the magnitude of the force. The acceleration of the top of sliding bed increases significantly at 0.04 s (Figure 10), and the acceleration of sliding surface and sliding body, respectively, increases rapidly at 0.06 s (Figures 10 and 11). Table 4 indicates that the

FIGURE 10: Points ①~④ acceleration versus time.

acceleration of each particle suddenly increased when the sliding surface coalesced, and the force reached a peak at this moment. Therefore, a trend of displacement at the top of the sliding slope can be considered as the beginning of the failure for the rock slide.

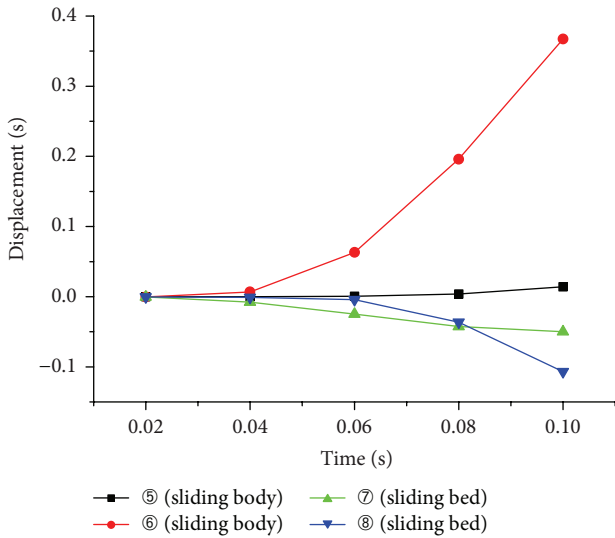
FIGURE 9: Change of the displacement with time of Points ⑤~⑧.

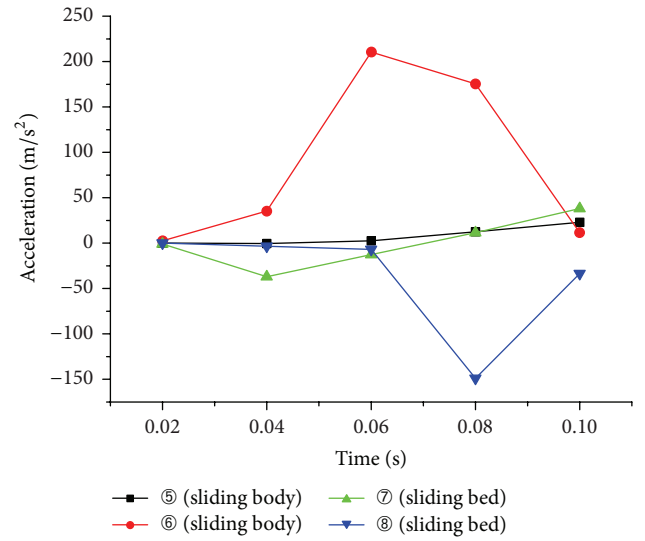
FIGURE 11: Points ⑤~⑧ acceleration versus time.
