The construction of the Cathedral of Antigua Guatemala in the 17th century from the pictorial documents

Alberto Garin¹, Osmín de la Maza² y Enrique Castaño³

In 1678, the painter Antonio Ramírez elaborated a picture explaining the condition of the works of the cathedral of Santiago de Guatemala (now La Antigua Guatemala), a picture that allows us to establish the evolution undergone by the cathedral from the second half of the XVII century to its current state.

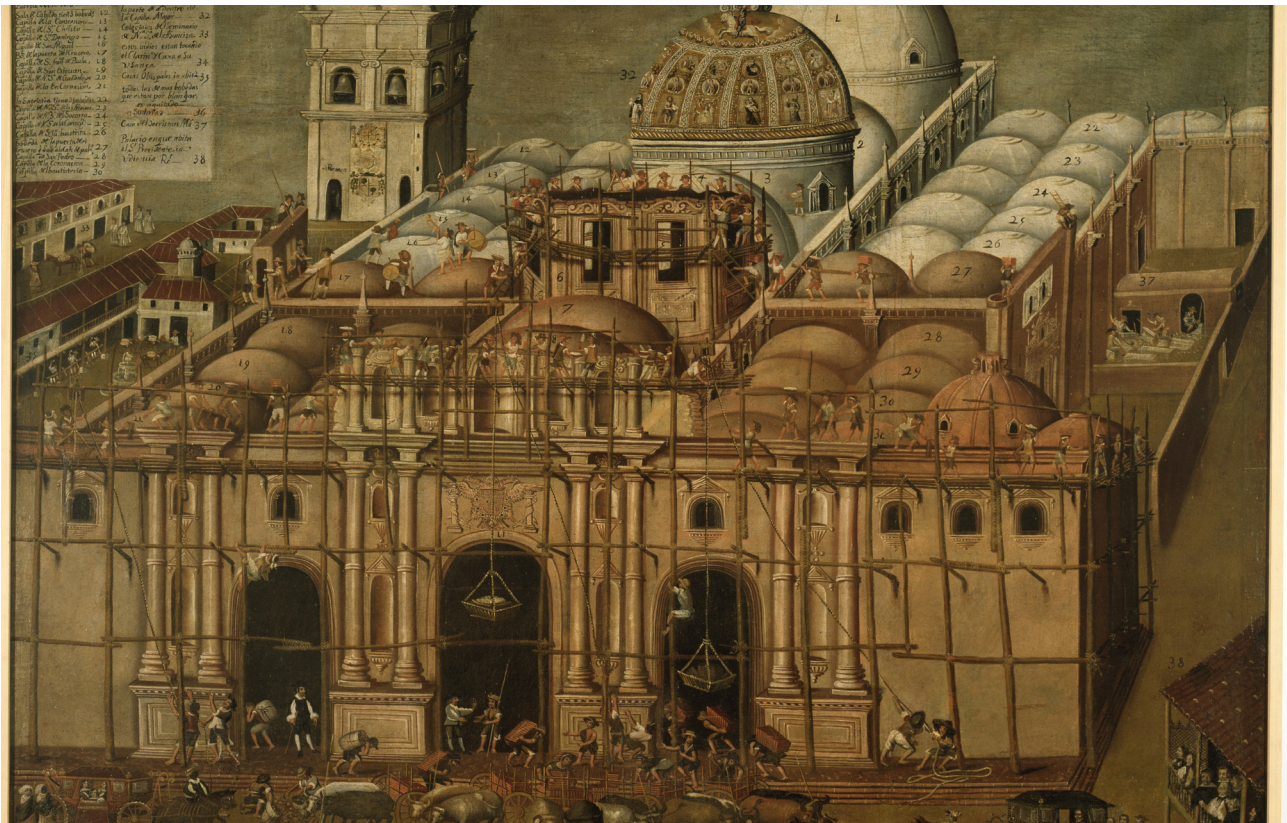
Figure 1.

The painting by Ramírez

As we have mentioned before, the painting reflects the progress made in the works of the cathedral in 1678, as well a colorful representation of society during that period of time.

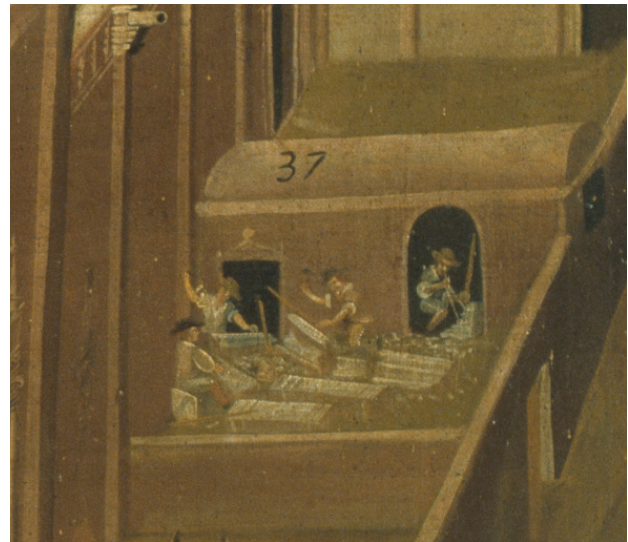
Figure 3.

The stonemasons.

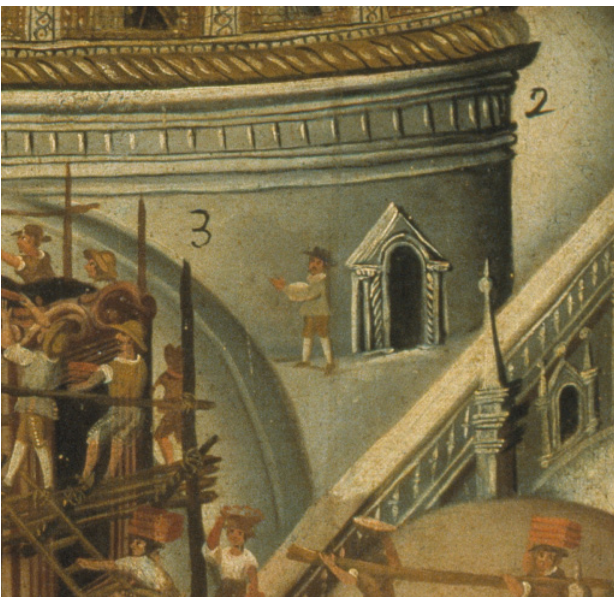
Figure 4.

A mason giving a final whitewash.

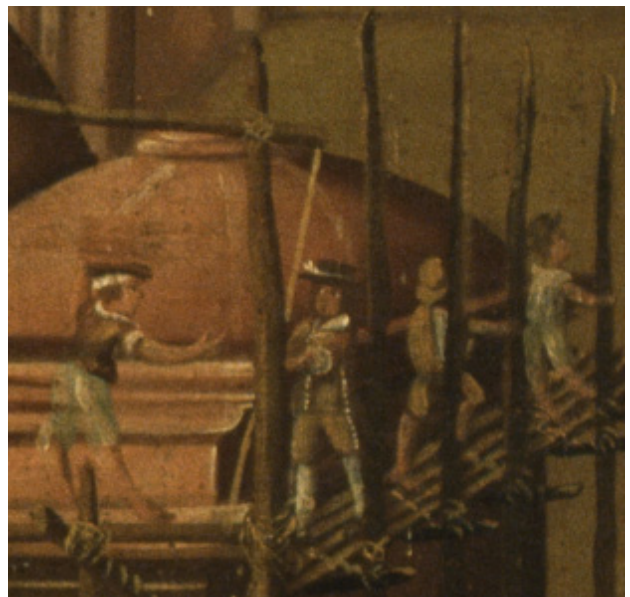
Figure 5.

A masons with a levelling rod

We consider that what they carry are levelling rods that were used to take measures and that, in this case, could be about three Castilian varas (Herrero Salas 2015). Hence, they would be assisting both the master of work and the bricklayers when measuring the different parts of the factory.

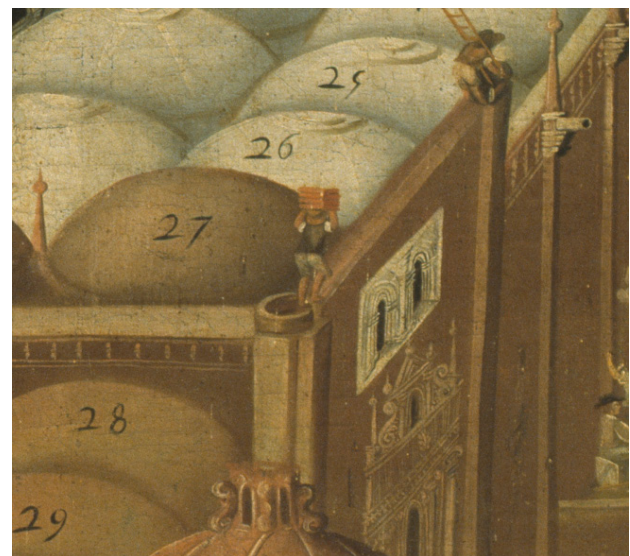
Figure 7.

Using stairs.

In order to raise the material, the labourers used pulleys that hung from the scaffolds or upon entering the cathedral climbed the stairs, seen together in domes 14 and 27. If we follow the path taken by the bricks brought in by the oxcarts, we see how the labourers, using the tumplines, introduce them inside the cathedral through the door of the epistle and then

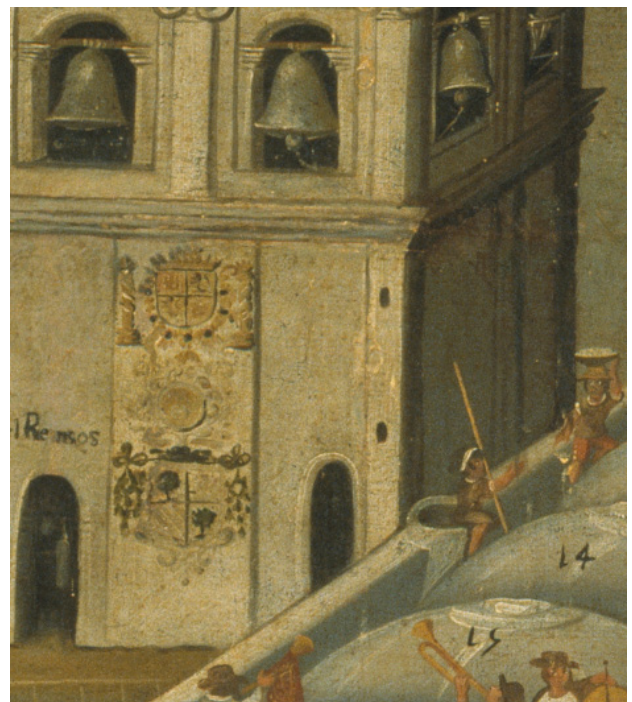
Figure 8.

The access to the belfry.

In the upper part of the picture, to the left, we can see a bell tower with a belfry under the dome that rounds off the tower. To access this belfry, we see two windows that could serve to lighten the continuing stair that we indicate next to dome 14.
