*Metals* **2015**, *5*, 891-909; doi:10.3390/met5020891

Article

## Fatigue Behavior of Ultrafine-Grained Medium Carbon Steel with Different Carbide Morphologies Processed by High Pressure Torsion

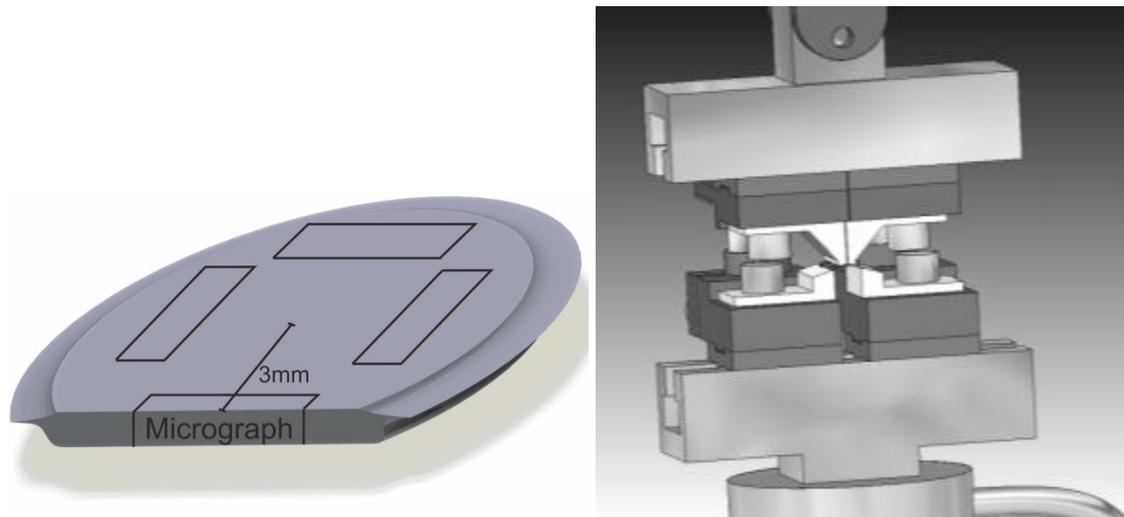
**Figure 1.** (a) HPT disc with indicated specimen extraction areas. (b) cyclic four-point-bending test fixture.

Four rectangular fatigue samples with dimensions of 4 mm  $\times$  1 mm (w)  $\times$  0.6 mm (h) were cut with their center at a distance of 3 mm from the center of every 10 mm  $\times$  0.6 mm cylindrical HPT disk as illustrated in Figure 1a. The fatigue samples were ground into the final shape and polished to 1  $\mu$ m grid size. Hardness measurements were carried out with an ASMEC UNAT 2 Nanoindenter (ASMEC GmbH, Radeberg, Germany) and a proof force of 200 mN on a surface polished with colloidal SiO<sub>2</sub>.

Cyclic four-point-bending tests were performed on a BOSE ELECTROFORCE 3230 electrodynamic testing machine at a frequency of 40 Hz under stress control. They were conducted with a load ratio of  $R = 0.1$  at room temperature. The mountings are shown in Figure 1b with a lower mounting distance of 3.2 mm and an upper one of 1.6 mm. To determine the endurance limits, the staircase method [20] was used with different step sizes, depending on the fatigue limit to be expected by a linear correlation with the hardness. Stress calculations were carried out for the controlled force  $F$  considering the specimen geometry, using Equation (2):

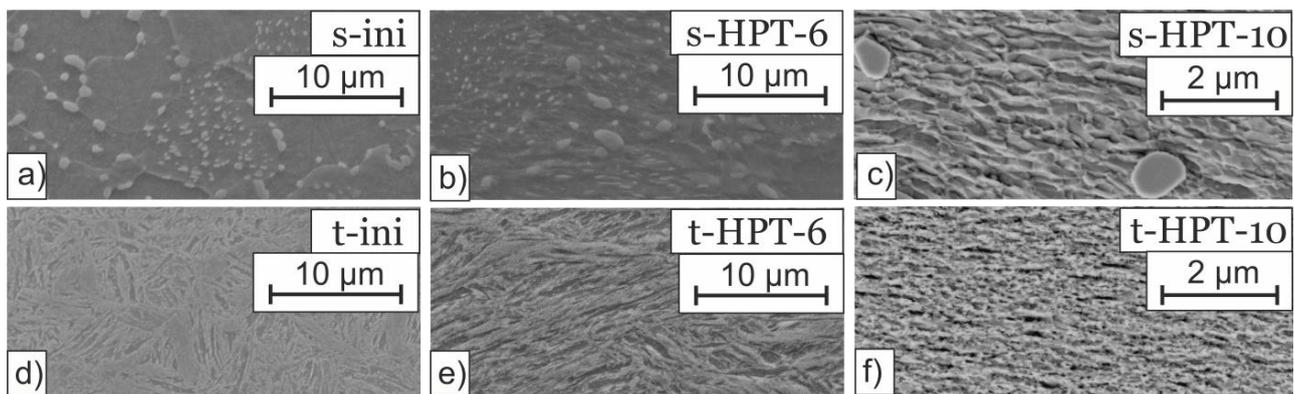
**Figure 2.** Etched surface microstructures prior to the fatigue tests (a) initial state after soft annealing containing spheroidal carbides (b) after 6 HPT rotations (c) after 10 HPT rotations (d) initial state with tempered microstructure (e) after 6 rotations (f) after 10 rotations.

The microstructure of C45 steel after spheroidizing annealing (S state) is shown in Figures 2a and 3a,b.

The soft annealed state contains spheroidal carbides distributed in a uniform coarse grained microstructure with well-defined grain boundaries (Figures 2a and 3b). The grains are micrometer sized ( $\sim 15 \mu\text{m}$ ) and initial hardness is 169 HV. This state will be referred to as s-ini. Typical images of the S state after warm HPT for six and ten rotations (these states will be referred to as s-HPT-6 and s-HPT-10) are shown in Figures 2b,c and 3c–f. After six rotations, the microstructure is refined and new grain boundaries appear (Figures 2b and 3c). The grain size shrinks to approximately  $0.8 \mu\text{m}$  and the grains show a slight elongation along the HPT shear direction (Figure 3c) with a hardness of 289 HV. After ten rotations, the ferrite grain size decreases further to approximately  $0.2 \mu\text{m}$  and the elongation is more pronounced (Figure 3e,f). Hardness rises to 511 HV. The continuous grain refinement is best visible in Figure 3a,c,e.

Needle-shaped microstructures are visible in Figures 2d and 4a,b for C45 steel after tempering (T state). Carbides are finely dispersed between the needles (Figure 4b). The samples have an initial hardness of 388 HV before HPT. This state will be referred to as t-ini. After six HPT rotations (t-HPT-6), the needles become slightly refined (Figures 2e and 4c), their long axis is oriented along the shear direction and the formation of new low and high angle grain boundaries is visible. The hardness increases to 457 HV in t-HPT-6. After ten rotations (t-HPT-10), the microstructure shows strong refinement by SEM (Figure 2f) with no visible needles anymore. ACOM-TEM reveals an ultrafine grained structure with elongated grains and the cementite is finely dispersed in the ferrite matrix. The final hardness at the fatigue samples extraction point is 758 HV. However, the microstructure and hardness show variations along the radius of the HPT disk due to the shear strain variation (compare Equation (1)). The cementite distribution is most homogeneous after 10 rotations.

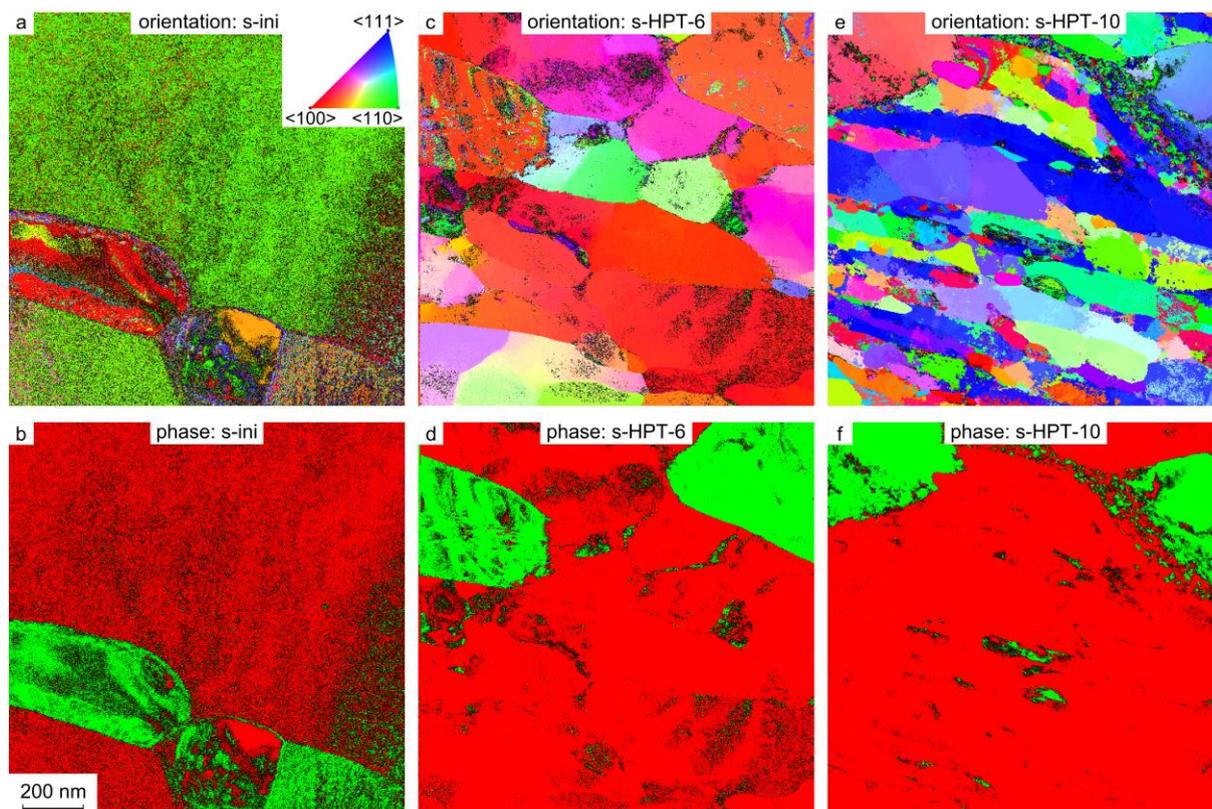
**Figure 3.** Orientation (a,c,e) and phase (b,d,f) maps (ACOM-TEM) overlaid with the reliability of the spheroidized microstructures (a,b), after 6 (c,d) and 10 HPT rotations (e,f) all prior to the fatigue tests. The color code of the orientation maps is given in (a). The projection direction is normal to the paper plane. The Fe phase is given in red and green represents the carbide phase. The reliability is given in black for both types of maps.

The spheroidal carbides are still clearly visible in s-HPT-10, but the larger ones in Figure 3e are partially fragmented and appear blurred. In addition, an increasing number of small carbides are distributed between the ferrite grains.

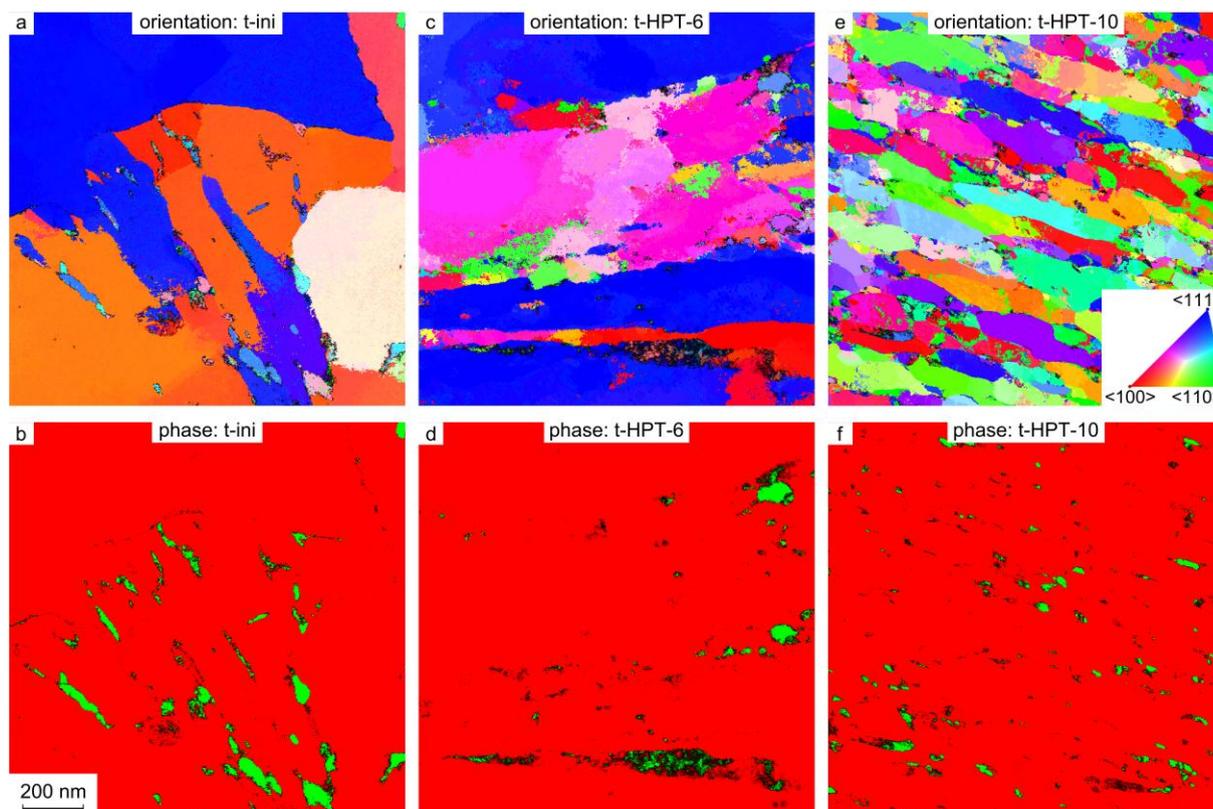
**Figure 4.** Orientation (a,c,e) and phase (b,d,f) maps (ACOM-TEM) overlaid with the reliability of the tempered microstructures (a,b), after 6 (c,d) and 10 HPT rotations (e,f) all prior to the fatigue tests. The color code of the orientation maps is given in (e). The projection direction is normal to the paper plane. The Fe phase is given in red and green represents the carbide phase. The reliability is given in black for both types of maps.

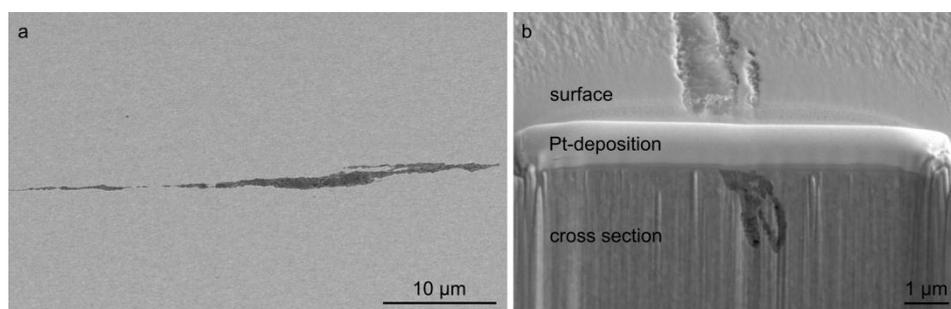
**Figure 5.** SEM images of a sheared non-metallic inclusion on the (non-etched) surface of t-HPT-10: (a) top view; (b) FIB cut through the inclusion.

After HPT, shear bands are visible by optical microscopy on the surface, fracture surface, and cross section of all specimens. Such shear bands have been reported earlier for HPT processed nanocrystalline metals such as palladium [25]. Interesting to notice is that, in the present case of the C45 steel, non-metallic inclusion were sometimes sheared by the shear bands as seen in the FIB cross-section in Figure 5.

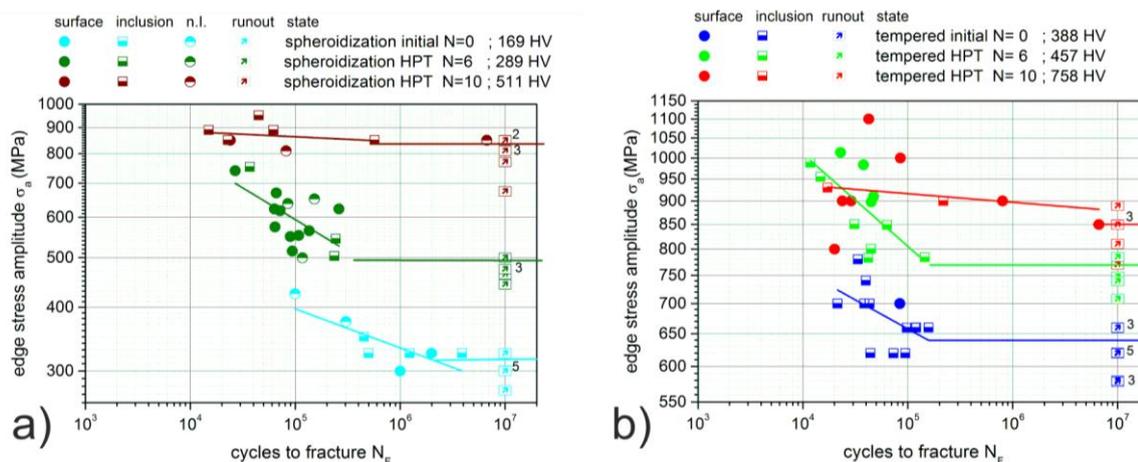
**Figure 6.** S-N curves of (a) CG and UFG spheroidized SAE 1045 revealing endurance limits of 316 MPa, 493 MPa and 837 MPa and of (b) UFG and CG tempered SAE 1045 showing endurance limits of 640 MPa, 769 MPa and 850 MPa.

Four-point-bending fatigue tests were carried out with both carbide morphologies in the initial coarse grained (CG) and the HPT deformed states (Figure 6). The edge stress amplitude was plotted against the number of cycles to fracture for both initial carbide morphologies. The arrows in the squares indicate runouts after  $10^7$  cycles. The small numbers beside the arrows show the number of overlapping runout-points. The crack initiation site type is indicated on top of the diagrams. A few specimens could not be investigated (n.I.) after fatigue, e.g., because they did not break completely.

Figure 6a shows the values for the spheroidizing annealed state in the CG (s-ini) and the UFG (s-HPT-6 and s-HPT-10) condition. For the s-ini state, a fatigue limit of 316 MPa was determined by the staircase method. Fractured specimens were observed after more than 10,000,000 cycles at stress amplitude of 325 MPa, while at stress amplitude of 300 MPa only one specimen fractured. In contrast, s-HPT-6 with a hardness of 289 HV showed fatigue fracture at lifetimes below about 400,000 cycles. The endurance limit (494 MPa) was significantly higher compared to s-ini. Crack initiation was mainly at the surface as indicated in the diagram. After 10 HPT rotations, resulting in a hardness of 511 HV, the fatigue limit further increased to 837 MPa. One specimen failed at 800,000 cycles, all other either failed within the first 80,000 cycles or ran out. Below 800 MPa, no fatigue failure was observed for s-HPT-10. The crack initiation site changed with an increasing number of HPT-rotations from the surface without non-metallic inclusions for s-HPT-6 to crack initiation at non-metallic inclusions at the surface in s-HPT-10 (see also Figure 7).

Figure 6b shows the S-N-curves for t-ini, t-HPT-6 and t-HPT-10. A fatigue limit of 640 MPa was determined for t-ini, corresponding to a hardness of 388 HV. In this case, crack initiation mostly occurred at non-metallic inclusions at the surface. With an increased hardness of 457 HV, the fatigue limit of t-HPT-6 rose to 769 MPa. For higher fatigue loads, a specific crack initiation location could not be identified. The exceptions are cyclic edge stresses between 780 MPa and 900 MPa, where all cracks initiated at non-metallic inclusions. For the t-HPT-10 specimens, offering the highest shear strain and hardness, the S-N curves and the crack behavior seem to be completely different. In contrast to the initial state and t-HPT-6, where specimens either failed before 200,000 cycles or ran out, many t-HPT-10 samples failed at a higher number of cycles. In addition, this state also revealed a number of very early cracks, which reduced the fatigue limit to a value of 850 MPa, lower than expected for a hardness of 758 HV, when considering a linear correlation between hardness and fatigue limit. Cracks were mostly initiated at the surface of the t-HPT-10 specimens.

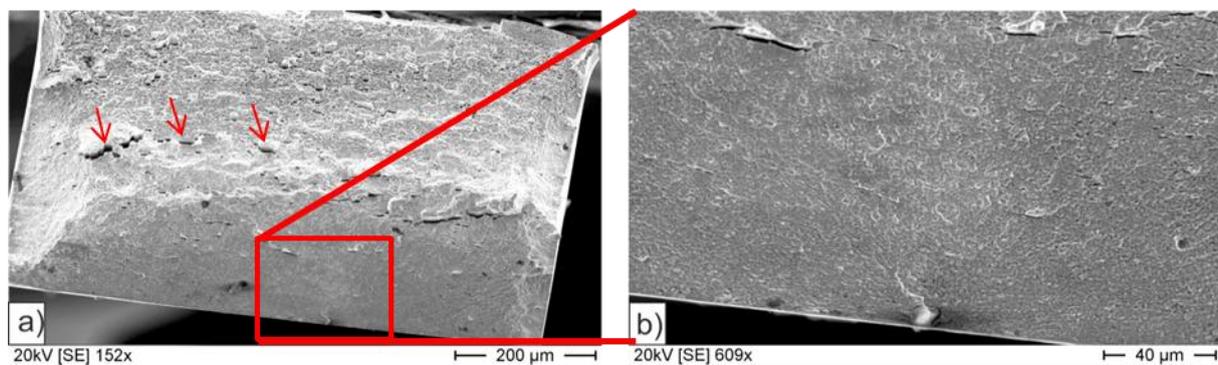
**Figure 7.** Fracture surface of s-HPT-10 (a) whole fracture surface (b) fatigue fracture surface; some shear bands resulting from HPT are shown with arrows.

Figure 7a shows the fracture surface of one of the s-HPT-10 specimens after a fatigue load of 850 MPa. A large fatigue fracture surface (Figure 7b) is visible, which is larger than typically found in conventional high strength materials. The fatigue fracture surface shown in Figure 7b is very homogeneous and appears smooth. The crack initiation occurred at a non-metallic inclusion. In the transition area between fatigue and residual fracture surface, some short cave-like shear bands are visible. Such shear bands are observed in fracture surfaces of HPT processed materials, for example in nanocrystalline palladium after HPT [25]. In this specimen, shear bands seem not to have influenced the crack initiation or early fatigue crack growth because they are observed only in the late fatigue crack growth areas well as in the residual fracture area.

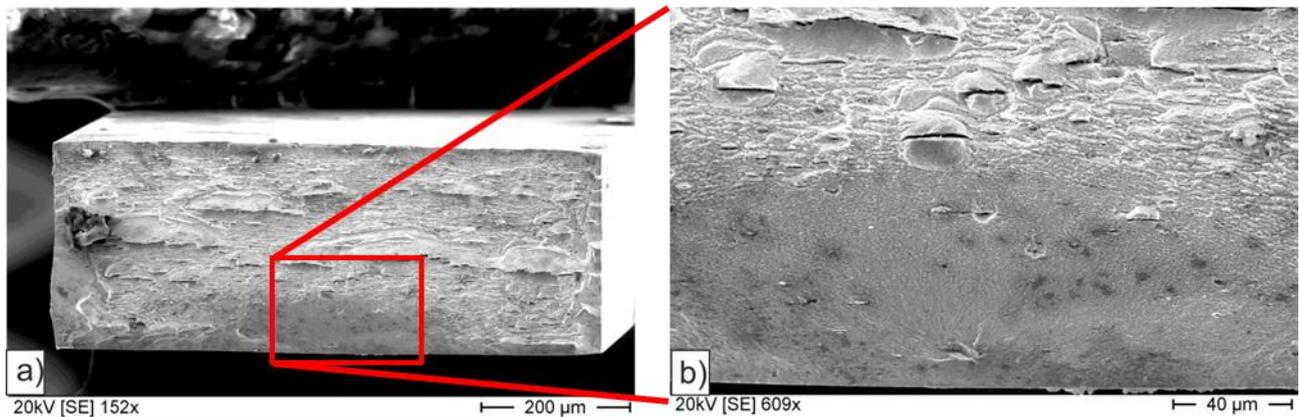
**Figure 8.** Fracture surface of t-HPT-10 (a) whole fracture surface (b) crack initiation area at the surface without nonmetallic inclusion and fatigue fracture surface.

Figure 8 illustrates the fracture surface of a t-HPT-10 sample loaded at a stress of 900 MPa. SEM investigations reveal shear bands in the fracture surface. The cave-like characteristics appear over the whole residual fracture surface. With a length of up to 200  $\mu\text{m}$ , they seem to be larger than those in the spheroidizing annealed state, which are only up to 40  $\mu\text{m}$  long. The fatigue fracture surface in Figure 8b is smaller than in the s-HPT-10 state although the sample was loaded at nearly the same stress level. We also observe crack initiation at a non-metallic inclusion. The fracture appearance is rather homogenous with a flat fatigue fracture surface. In addition, some shear bands are visible in the fatigue fracture surface but similar to the spheroidizing annealed state, they do not influence the crack initiation or propagation.

Comparing Figures 8 and 11, the fracture surfaces of t-HPT-10 do not appear as uniform as those of s-HPT-10. The main difference is that while the fatigue fracture surface in Figure 8 is not affected by

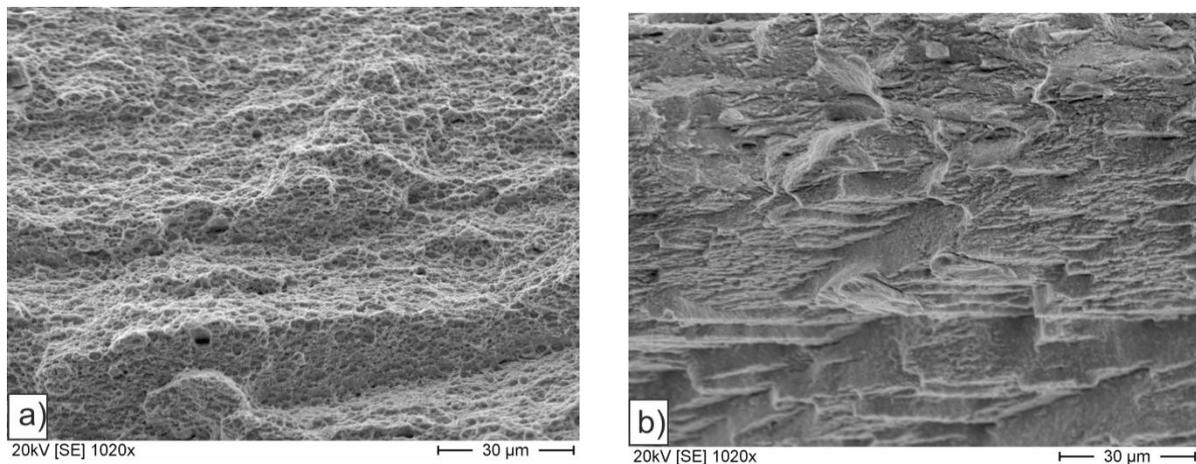
**Figure 9.** Residual fracture surface of (a) s-HPT-10 and (b) t-HPT-10.

Figure 9 shows a comparison of the residual fracture surfaces of the two states with tempered and spheroidizing annealed microstructure after HPT. There are significant differences in the morphology. In Figure 9a, s-HPT-10 shows well-defined dimples, which indicate a homogeneous ductile fracture behavior.

In contrast, Figure 9b reveals a rather rough residual fracture surface with sharp edges, which are common for this material state and indicate a brittle material behavior. Most likely, these sharp edges are shear steps from shear banding. Figure 10a,b show an FIB cross-section of the t-HPT-residual fracture surface at a characteristic cave, which was formed by a shear band. This indicates a correlation between shear bands observed at the fracture surface and the microstructure underneath. The shear band at the fracture surface is connected to a line-shaped inhomogeneity inside the microstructure. A similar line pattern is also visible in a polished and Nital-etched cross section of the HPT specimen in Figure 10c prior to fatigue loading. These lines are extended along the shear direction during HPT and become visible after etching in SEM in this case in the t-HPT-10 state. However, similar shear bands can also be seen in the micrographs of the s-HPT-10 states.

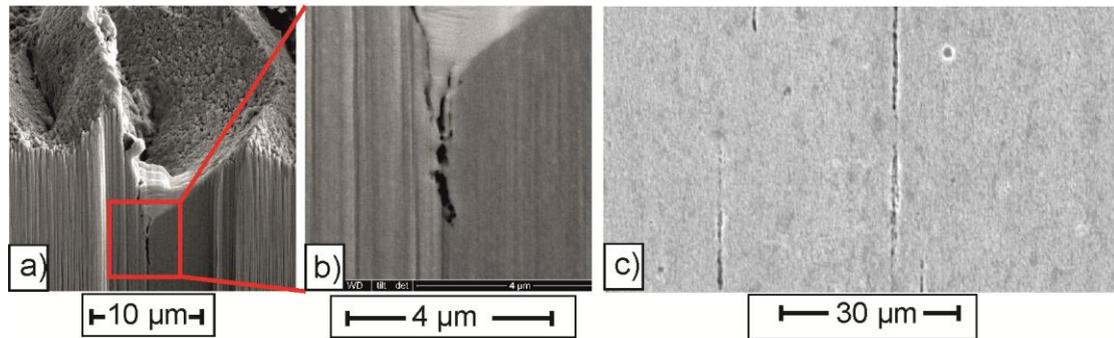
**Figure 10.** SEM images of shear bands in t-HPT-10 samples (a,b) inside the residual fracture surface and (c) on the polished and etched cross section.

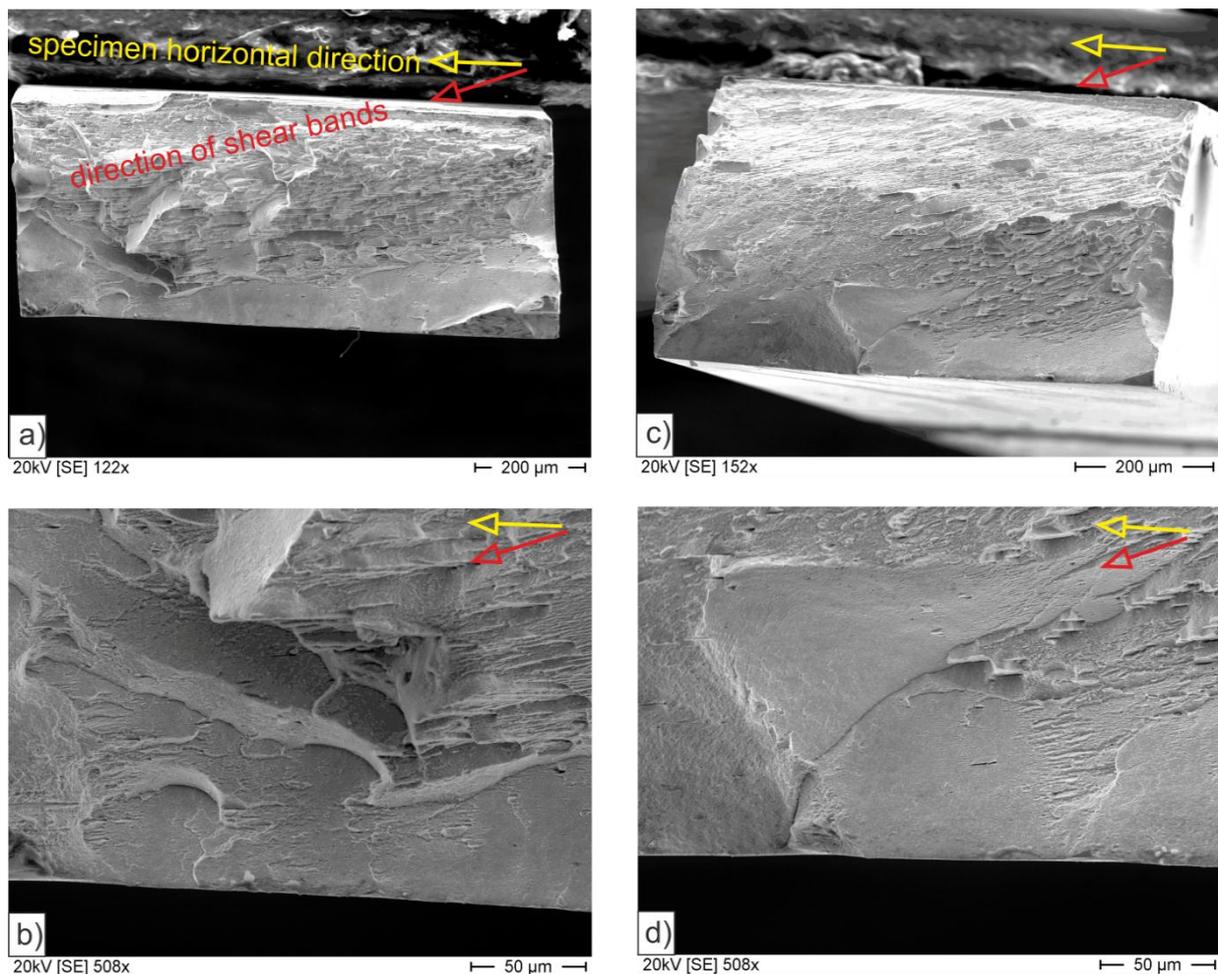
**Figure 11.** Fracture surface of t-HPT-10 state which shows shear bands (a,b) loaded at 900 MPa and (c,d) loaded at 850 MPa (red open arrows at the top indicate the direction of shear bands in correlation to the specimens surface indicated by the yellow open arrows. The crack initiation site is always at the bottom of the pictures).

The fracture surface of a tempered specimen after HPT, which failed very early at 900 MPa, is shown in Figure 11a,b. The picture shows a cliff-like fracture surface with a high topology in the residual and also in the fatigue fracture surface. The fatigue crack seems to change direction and jump between different levels. Usually, fatigue cracks grow mostly perpendicular to the tensile stress in one

defined direction, as visible in Figures 7 and 8. The fact that this is not the case here is an indication of some inhomogeneities inside the material prior to fatigue loading which affected the crack initiation site and the crack path. The whole fracture surface offers different characteristics of the shear bands compared to the fatigue samples with higher endurance limits. The shear bands seem to influence the crack growth and the lifetime of the fatigue sample because there is a link between the shear bands inside the residual fracture surface and the different levels and layers in the fatigue fracture surface.

A similar behavior is presented in Figure 11c,d, showing the fracture surface of a t-HPT-10 state sample, which cracked after 6,000,000 cycles. It is obvious that shear bands are present in the area of fatigue crack growth, especially at the crack initiation site, where an extension of a shear bands are points of multiple crack initiation. These shear bands have been produced during HPT and seem to have promoted the crack initiation during fatigue load. Further crack growth in the fatigue fracture surface is similar to that shown in Figure 11a,b, exhibiting a high topology. The fatigue crack growth is dominated by the shear bands (marked with red arrows in all pictures). The two arrows in each part of Figure 11 indicate that there is an angle of misorientation between the expected shear plane at HPT (yellow arrows) and the shear band plane in the respective specimen (red arrows). This is the case for both specimens, which both exhibited early failure during fatigue testing, and it establishes a significant difference in contrast to samples in the spheroidization annealed or tempered state, which offer a homogeneous fracture behavior in the S-N curve without early cracks (t-HPT-6). For both specimens shown in Figure 11, a complex structure of different fracture planes is visible in the fatigue fracture surface. The surface of each single plane itself seems to be very flat, as expected for fatigue failure in ultrafine grained materials, resulting in a strong topology with clustering in different spatial directions.

inhomogeneities, Figure 11 reveals a strong topology with fracture planes of different directions covering the whole surface, including the fatigue fracture surface. In both cases shown in Figure 11, the residual fracture surface has shear steps and no dimples indicating a brittle fracture behavior. In this context, Figure 10 provides an opportunity to understand the morphology of the shear bands prior to fatigue testing. Figure 10a shows an FIB cross-section of one of these cavities, which exhibits the typical fracture appearance of the shear bands [25]. There is a narrow plane-shaped inhomogeneity beneath the surface inside the microstructure. This could be a link to shear bands generated during HPT as similar stripes are present throughout the microstructure before fatigue loading, as visible in the optical micrograph in Figure 10c. This observation can be made not only in the brittle tempered state but similarly also in the ductile spheroidizing annealed microstructure with excellent fatigue properties. It follows that s-HPT-10 and t-HPT-10 do contain shear bands prior to fatigue testing but only in the tempered state they affect the fatigue properties. Therefore, the brittle behavior is the main reason for fatigue limits which are lower than expected in consideration of the hardness, because the brittle material has a more limited ability to reduce stress around process flaws owing to plastic flow. In this context, the s-HPT-10 state is an ideal material in respect of fatigue because it exhibits a high hardness and also a high ductility resulting in excellent fatigue performance with higher tolerance against crack initiation at inhomogeneities.

However, an open question is: why do early cracks or cracks at low stress amplitudes occur in some specimens of t-HPT-10? This can be explained comparing Figures 8 and 11, which both show shear bands in the fracture surface. Shear bands represent inhomogeneities, which, in combination with a brittle material, are detrimental to the fatigue performance, as shown in Figure 14. However, when comparing fracture surfaces of late and early failure, it is visible that the specimens with the worst fatigue properties exhibit a rotation of the shear bands, which is not parallel to the nominal HPT-shear planes. Unusually turbulent flows, manifesting themselves in the appearance of whirls observed at the macroscopic [30] and microscopic [31] scale in severely deformed materials, are most likely the reason for this rotation. This effect seems to increase the influence of the shear bands on fatigue failure.

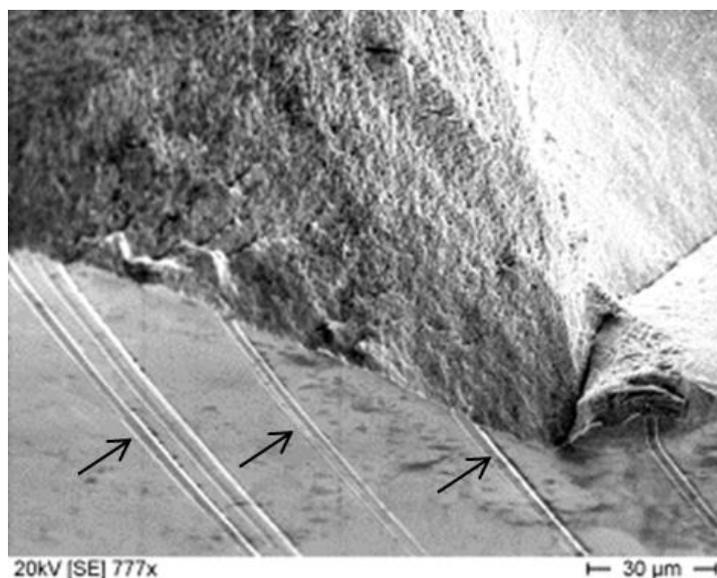
**Figure 12.** Shear bands visible at the sample's surface in the area of the crack initiation site.

Figure 12 shows the crack initiation site marked in Figure 11c,d in higher magnification after rotating the specimen by  $20^\circ$  out of plane. Some penetration lines are visible at the specimen surface where shear bands from HPT deformation seem to have been re-activated during fatigue loading. The assumed path of the shear bands inside the specimen is indicated by parallel lines, which fits the direction estimated from the overall fracture surface in Figure 11.

propagation is lower for favorably oriented shear bands [34]. Evidence for this explanation and for the crack initiation being affected by the shear bands and their orientation is presented in Figure 12, where the shear bands are visible on the fracture surface and also at the lower side of the specimen with the highest fatigue stresses. This characteristic appearance has already been reported in literature [35] and seems to be beneficial for crack initiation.

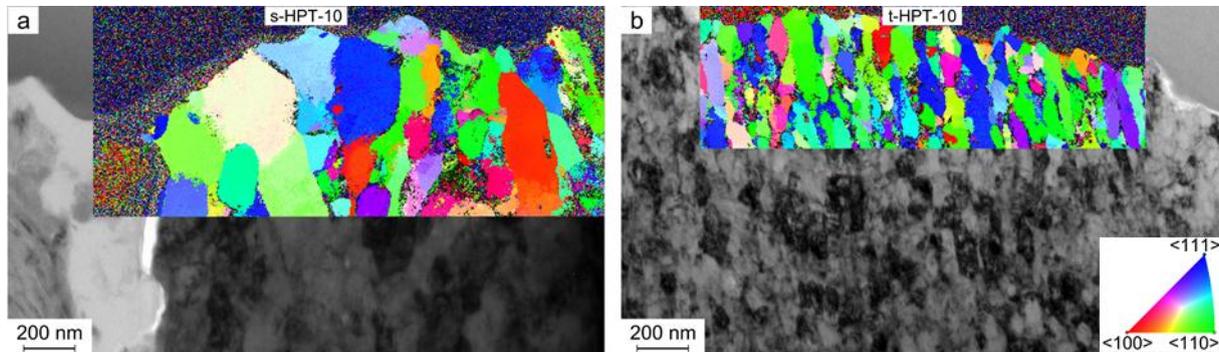
**Figure 13.** Cross section of the crack initiation (a) non-metallic inclusion for s-HPT-10 and (b) crack path near crack initiation from the surface for t-HPT-10. The overlays are orientation maps in projection direction normal to the paper plane with the reliability in black. The color code of the orientation maps is given in (Figure 3a).

Figure 13 shows cross sections of typical crack initiation sites for the HPT states after ten HPT rotations. BF-TEM and ACOM-TEM images were obtained to correlate the crack path, which is in both cases horizontal in the upper part of the images, with the microstructure underneath. In Figure 13a, a non-metallic inclusion, located on the left side of the shown area, was responsible for crack initiation in the s-HPT-10 state. Grain size and morphology close to the crack do not differ significantly from the pre-fatigue s-HPT-10 state.

Similarly, no significant grain coarsening or grain refinement has been observed for the t-HPT-10 state in Figure 12b. Nevertheless, in both cases, the crack path is influenced by the microstructure as it (partly) deviates from a straight crack front when crossing grain boundaries.

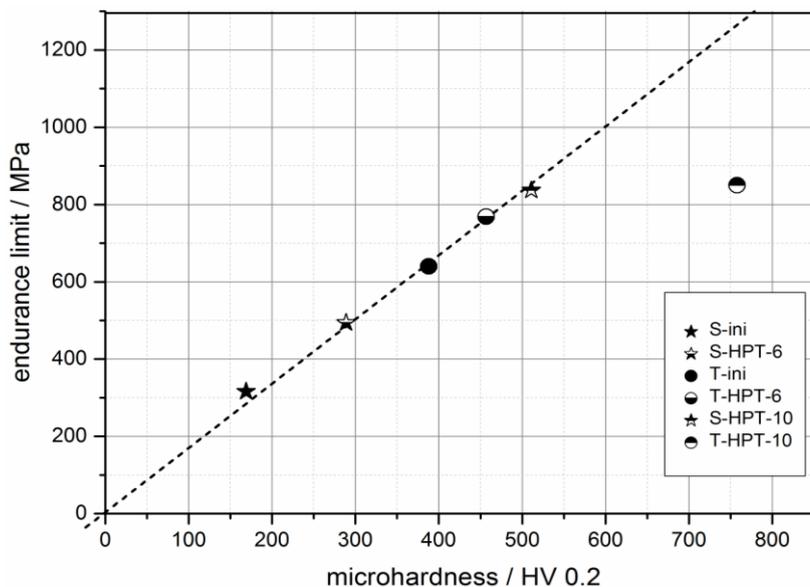
**Figure 14.** Relationship between hardness and endurance limit revealing a linear correspondence.

Figure 14 indicates the relationship between hardness and endurance limit in our investigations. It was created on the basis of the endurance limits presented in Figure 6. A linear correlation can be seen for the hardness range up to about 500 HV. The fatigue limit primarily correlates with the hardness which itself is strongly affected by the microstructure such as the carbide and grain morphologies. The initial and HPT-6 states fit this correlation very well. Following the investigation by Murakami [26], there must be a decrease of the fatigue limit with increasing hardness values over

Responsible for a deviation from the linear relationship are inherent material flaws such as non-metallic inclusions, which become more and more dominant at higher hardness. The subsequent decrease of the endurance limit, as suggested in Figure 14, depends on the material state and processing route. In high strength steels, the so-called process flaws resulting from the respective treatment are responsible for such behavior. For conventional steels, it is mostly the heat treatment which leads to process flaws. In our case, the HPT treatment replaces heat treatment for reaching a high strength. Thus, instead of the traditional process, flaws known from the literature, such as micro-cracks or weakened former austenite grain boundaries in carburized steels [28], here we are confronted with shear bands or cracks created during HPT, which act as process flaws. Other possible process flaws could not be clearly identified in the metallographic sections after the fatigue testing. Nevertheless, one result of the present investigation is that, in contrast to a material that only exhibits inherent or intrinsic flaws, here the process flaws in the material state with the highest hardness (t-HPT-10) lower the fatigue limit. The S-N curves already provide evidence for this, as contrary to our expectation, no non-metallic inclusions were responsible for crack initiation in the t-HPT-10 state, but the cracks mostly initiated from the surface. This is untypical for high strength steels and indicates that there must be something inside the microstructure that is more inhomogeneous or detrimental than the non-metallic inclusions.
