Damage Detection in a Laboratory Wind Turbine Blade using Techniques of Ultrasonic NDT and SHM

K. Yang^a, J.A. Rongong^b and K. Worden^{b1}

This paper presents a case study in the use of ultrasonic NDE/SHM techniques for detecting and locating damage in a real (but small) wind turbine blade. Two techniques are considered: (i) nonlinear acoustics, and (ii) guided-wave ‘pitch-catch’ SHM. While the nonlinear acoustics approach proved disappointingly insensitive to damage induced experimentally in the blade, the guided-wave approach not only detected the damage, but proved capable of locating it, using a ‘network of novelty detectors’ methodology. A first, slightly ill-conceived, programme of guided-wave tests actually provided valuable insight into attenuation of waves in the structure of interest and supported the idea that actuator-sensor networks of a feasible density could be used for wind turbine blade SHM.

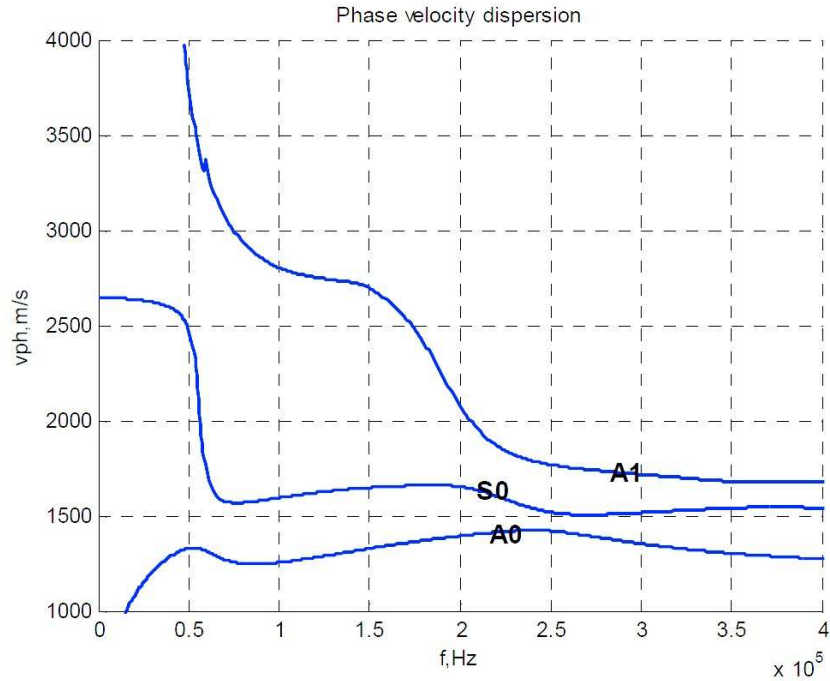
Figure 14: Dispersion curves for Glass Fibre Reinforced Plastic (GFRP) with 20 mm thickness [23].

The experiment set up was the same as that described in Section 3.1. The high-frequency excitation signals needed were generated by the two-channel TTI-TGA 1242, 40 MHz arbitrary waveform generator and signal responses were acquired using the four-channel LeCroy Waverunner LT264, 350 MHz, 1 GS/s digital oscilloscope. The guided wave input signal was chosen to be a five-cycle sine wave toneburst with frequency 165 kHz and a peak-to-peak amplitude of 20 V modulated by a Hanning window. The response signal was sampled with a frequency of 500 MHz and computed from 15 averages. The thickness of the test blade is variable, and the geometry is complex, so guided waves were not expected to be Lamb waves. However, only one side of the blade was inspected and the actuators and sensors were placed close together in the seven pairs, so it was assumed that thickness was nearly constant over the wave propagation distances and that the waves could be approximated as Lamb waves. With these assumptions, the calculation of dispersion curves was obtained by reference to [23] and is illustrated in Figure 14.

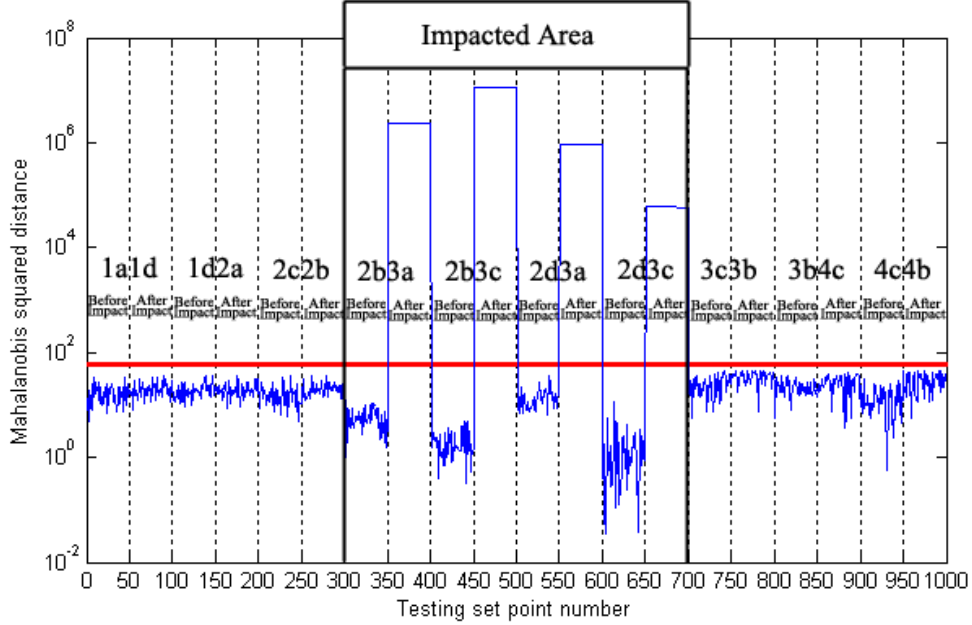
Figure 18: Outlier analysis classification results for the second impact test (‘1a1d’, ‘1d2a’, ‘2c2b’, ‘3c3b’, ‘3b4c’ and ‘4c4b’ indicate sensor groups with reference to Figure 17).

Data were acquired exactly as before with 50 averaged observations in the training, validation and test sets. The results of the outlier analysis are shown in Figure 18. This time, the procedure

shows complete success, both for detection and location. All the validation points are below threshold as required; furthermore, the MSD values for all actuator-sensor pairs which do not cover the damaged region are also below threshold. The MSD values for all actuator-sensor pairs that do cover the damage are all substantially above threshold (note the logarithmic vertical axis in Figure Figure 18). The methodology has thus detected and located the damage unambiguously. Finally, it is important to observe that the trends in the validation results, most visible in the ‘Before impact’ portions of Figure 16, are now absent. This is because the increased interval between actuation pulses is allowing the wavefield to decay between observations.
