EROSION CHARACTERISTICS OF A MEDIUM SAND BREACHED EMBANKMENT

Zainab Mohamed Yusof*, Syura Fazreen Hamzah¹ & Shahabuddin Amerudin²

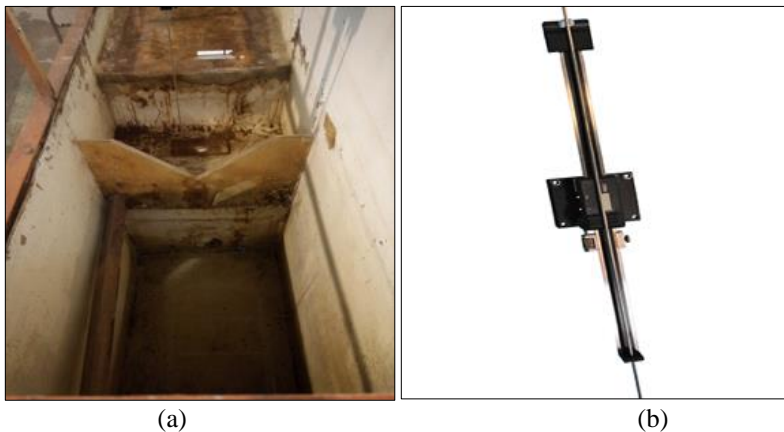
Figure 5: Flow measurement (a) a V-notch at the outlet, and (b) a point gauge to record water levels.

The flume was kept horizontally throughout the experiment. Railing was installed on both side of the channel. At the end of the flume outlet, a V-notch was installed to measure the outflow discharge after the breach process. The whole breaching process for the whole test was recorded using video recorders.

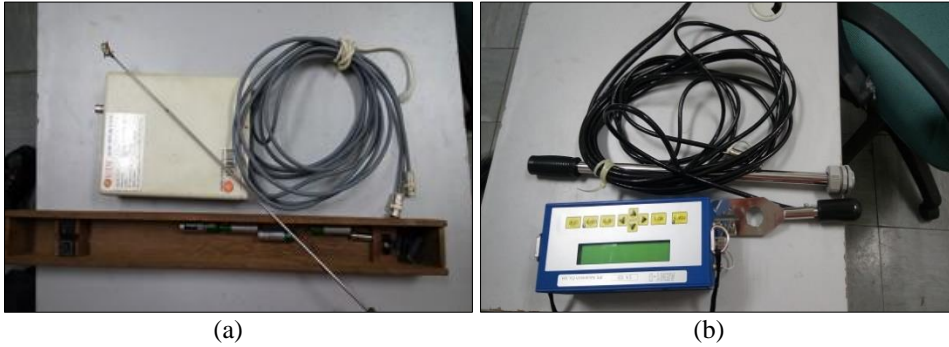
Figure 6: Flow calibration; (a) a miniature velocity, and (b) an Electromagnetic Flow Meter (EFM).

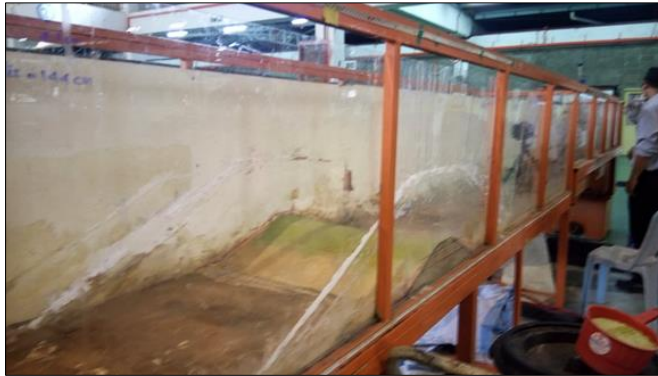
Figure 7: An embankment setup in the channel.

A sieve analysis was conducted to get the medium grain size which was in the range of 0.25 mm to 0.5 mm. The medium grain size was used as the embankment dam materials. The experimental was tested for two different inflow rates through the V-notch, which are $Q_1 = 0.8 \times 10^{-3} \text{ m}^3/\text{s}$ and $Q_2 = 1.2 \times 10^{-3} \text{ m}^3/\text{s}$ and the discharged value was calibrated by using a miniature and electromagnetic flow meter (EFM) as depicted in Figure 5 and Figure 6. A physical model was setup in the laboratory as shown in Figure 7 and Figure 8 shows the schematic diagram of the experimental setup used.
