**FIRE SAFETY AND PROTECTION MEASURES
IN HERITAGE BUILDINGS WITH SPECIAL
CONSIDERATION ON MUSEUM BUILDINGS IN
MALAYSIA**

**Thesis submitted in fulfilment of the requirements
for the degree of
Doctor of Philosophy**

July 2011

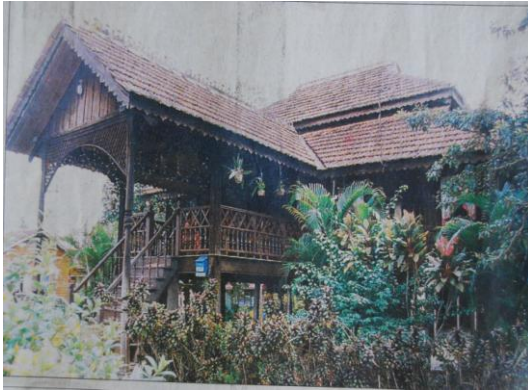
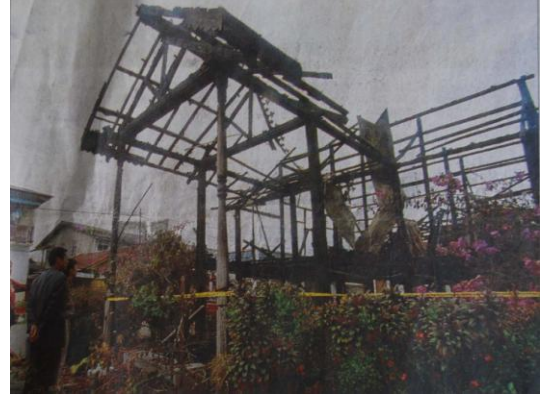
Plate 1.1: Traditional timber house 'Rumah Pak Ali' that built in 1876 was destroyed by fire in October 2003
(Source: Surainie Mohd Hanif)

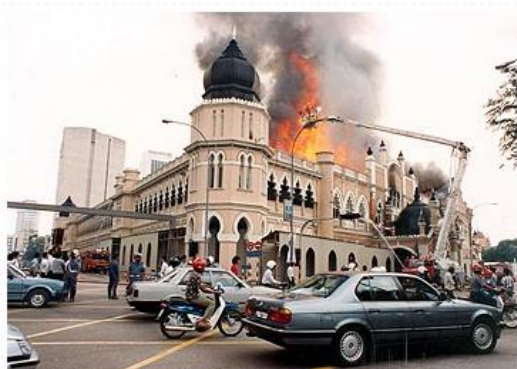
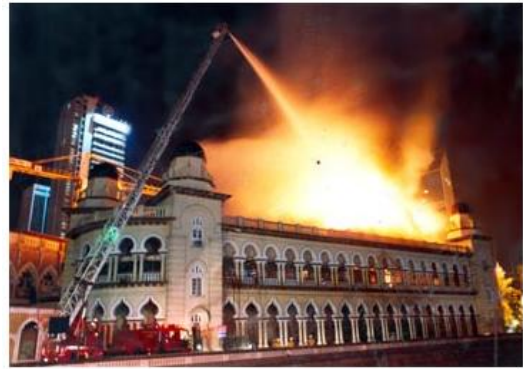
Plate 1.2: The former High Court of Kuala Lumpur (1896) was twice destroyed by fire in 1992. The first fire occurred in 16 March 1992 when the building was undergoing renovation works (left) and later in December (right)
(Source: <http://www.beritaharian.com.my> , 23 March 2008)

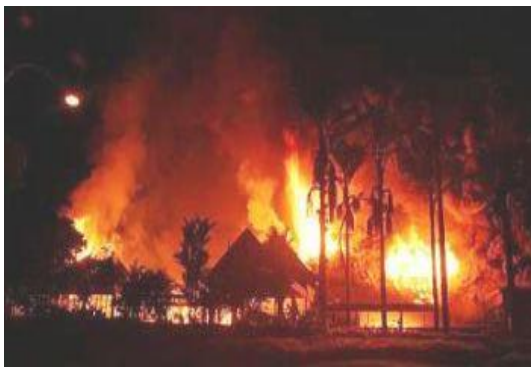
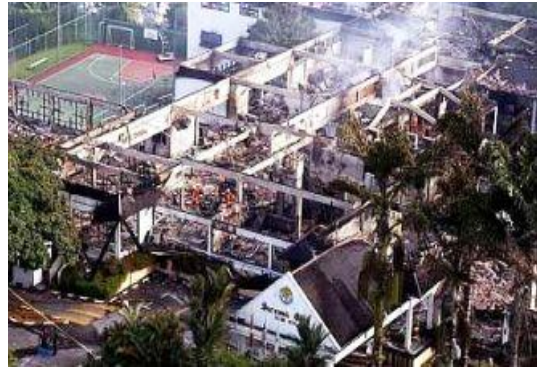
Plate 1.3: The Sarawak's oldest club that known as the Sarawak Club (1876), was razed in an early morning fire on 27 July 2006
(Source: <http://thestar.com.my/news> , 28 July 2006)

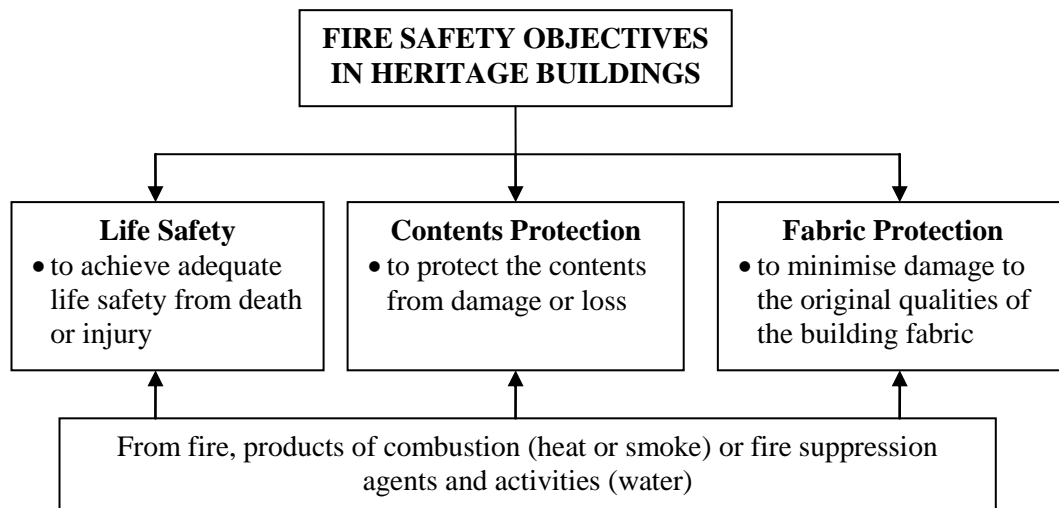
Figure 2.1: Fire safety objectives in heritage buildings

which, a reasonable level of protection against damage or loss to collections from fire, products of combustion, and fire suppression agents and activities shall be provided. Fire safety and fire protection features shall be designed, approved, implemented, and maintained to preserve the original qualities or character of the collection or a heritage building, structure, site, or environment (NFPA, 2005). The recommendations of fire safety design in heritage buildings are further explained in this chapter.
