Thattaliyath Kadumberi, Arjun Prakash and O'Leary, Richard and Gachagan, Anthony (2012) *Ultrasonic imaging of electrofusion welded polythene pipes employed in utilities industry*. In: 51st Annual Conference of the British Institute of Non-Destructive Testing 2012 (NDT 2012). British Institute of Non-Destructive Testing, Northampton, pp. 129-139. ISBN 9781622764372

Ultrasonic Imaging of Electrofusion Welded Polyethylene Pipes Employed in Utilities Industry

Electrofusion welding (EFW) is a widely used technique for joining polyethylene pipes in the oil, gas and water industry. Like many welding and joining methods, the joints created by EFW can exhibit a range of flaw types that can be attributed to process variables such as: poor preparation of the parent material, contamination of the weld surfaces prior to welding and operator and/or equipment failure during the welding process. This paper describes ultrasonic testing using 128-channel linear array with a DYNARAY system to acquire data from a range of joints created using EFW. The samples were created in the laboratory with a range of defects that represent those commonly observed in the field. The samples were subsequently des

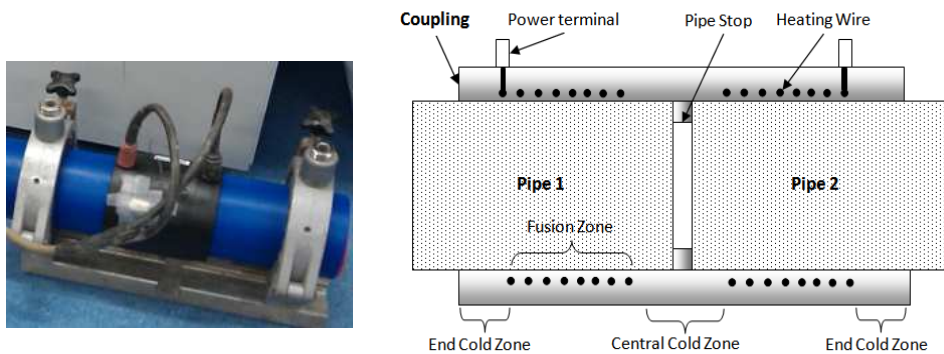
Figure 1: (Left) Pipe coupling assembly (Right) Cross-sectional schematic

The most common methods of joining Polyethylene pipes are the butt fusion welding and electrofusion welding (EFW). The current discussion will be limited to the EFW technique where pipes are inserted into a polyethylene coupling which has an embedded wire for resistance heating (See Figure 1). A voltage is applied across the input terminals for duration equal to the Specified Fusion Time (SFT) and then allowed to cool. The duration may vary depending on coupling type and will be specified by the manufacturer. The procedure for EFW (based on the Water Industry Standards⁽³⁾, 2002) can be summarised as: pre-joint checks, preparation of the pipe surface, joint assembly and clamping, fusion cycle and visual joint checks on completion of the fusion cycle.

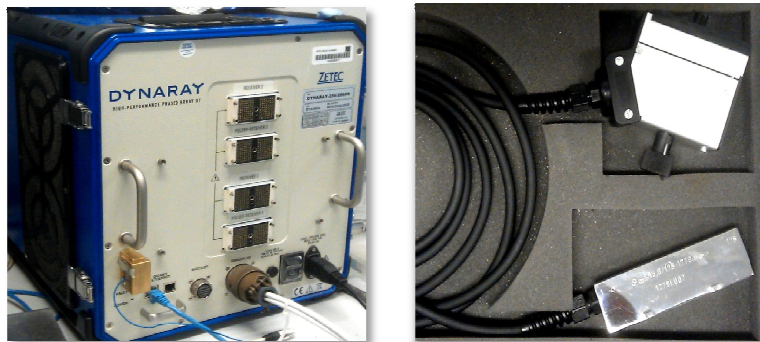
Figure 3: (Left) Zetec *Dynaray* phased array controller and (Right) Vermon 5MHz, 128 element probe

For the 110 mm coupling, the embedded heating wire has a diameter of 0.6 mm with a pitch 2 mm. An inspection wavelength that is less than the wire diameter would be expected to resolve the wires and any defects that appear between them. The velocity obtained in the ultrasonic characterisation experiment presented in Section 2.2 was used to calculate the inspection wavelengths for different frequencies. A 5MHz probe which would result in a wavelength of approximately 0.4 mm in the sample at room temperature was considered a good trade-off between resolution and wave attenuation. The final inspection setup involved a 5MHz linear array with 128 elements, Zetec *Dynaray* Phased array controller (Shown in Figure 3) and a PC running the Zetec *Ultravision* software.

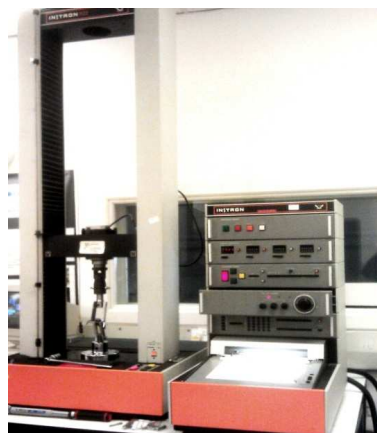
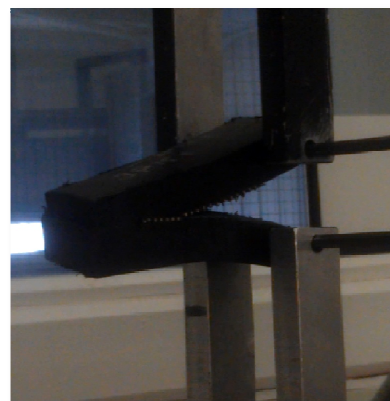
Figure 12: (Left) Instron tensile testing device (Right) Weld being pulled apart during destructive testing

Once the samples were ultrasonically inspected, they were destructively tested by the double cantilever cleavage test. Six rectangular sections of diameter approximately 20 mm were cut from each weld using a band saw, ensuring the pipe and coupling surfaces remained parallel to the axis formed by the weld interface. Two holes were drilled at the cold zone end – one through the coupling and the other through the pipe, to fit metal pins. The *Instron* tensile testing machine was used to pull the joint apart at a constant rate (See Figure 12), with data being logged for the *Force/Displacement* value. From this data, the mean value for a weld is noted and used to determine weld strength.
