Rock Mech Rock Eng (2014) 47:57–70
DOI 10.1007/s00603-013-0389-4

Laboratory and In Situ Simulation Tests of the Excavation Damaged Zone Around Galleries in Opalinus Clay

Abstract In the context of nuclear waste disposal in clay formations, laboratory and in situ simulation experiments were performed to study at reduced scale the excavation damaged zone (EDZ) around tunnels in the indurated Opalinus Clay at Mont Terri, Switzerland. In the laboratory, thick-walled hollow cylindrical specimens were subjected to a mechanical unloading mimicking a gallery excavation. In samples cored parallel to bedding, cracks sub-parallel to the bedding planes open and lead to a buckling failure in two regions that extend from the borehole in the direction normal to bedding. The behaviour is clearly anisotropic. On the other hand, in experiments performed on specimens cored perpendicular to bedding, there is no indication of failure around the hole and the response of the hollow cylinder sample is mainly isotropic. The in situ experiment at Mont Terri which consisted in the overcoring of a resin-injected borehole that follows the bedding strike of the Opalinus Clay showed a striking similarity betwe

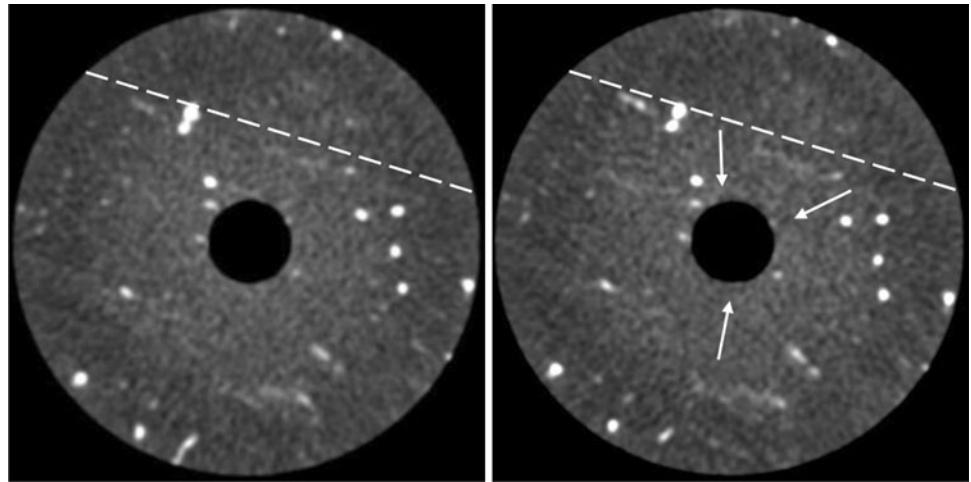
Fig. 4 Medium resolution XRCT scans of the Opalinus Clay sample N°2/5 cored parallel to the bedding planes, before (*left*) and after (*right*) mechanical unloading. When looking carefully (*arrows*), slightly darker (i.e. less dense) zones can be noticed close to the hole wall in the direction normal to the bedding (*white dashed lines*). Images courtesy of Lausanne Cantonal Hospital (CHUV)

The resolution of the X-ray tomography scans performed at Lausanne Cantonal Hospital is unfortunately too low to reveal fractures. Only a slight change in density can be noted when carefully comparing the images. Figure 4 illustrates for example the same CT slice of the N°2/5 sample before and after mechanical unloading. Less dense zones (i.e. the slightly darker grey zones pointed by the arrows in Fig. 4) are barely discernible near the hole wall in the direction perpendicular to the bedding planes. A visual inspection of the sample after the test allowed distinguishing some early stage features of the fracture pattern observed in the first experiment, but with a much less-developed failure mechanism (Fig. 5).

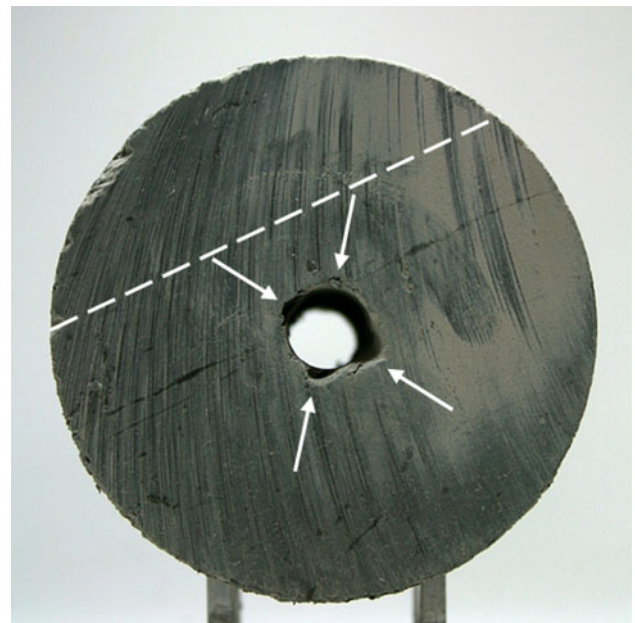
Fig. 5 Picture of the Opalinus Clay sample N°2/5 cored parallel to the bedding planes (*white dashed line*) after its removal from the testing cell and saw cutting. Early stage features of failure indicated by the *arrows*

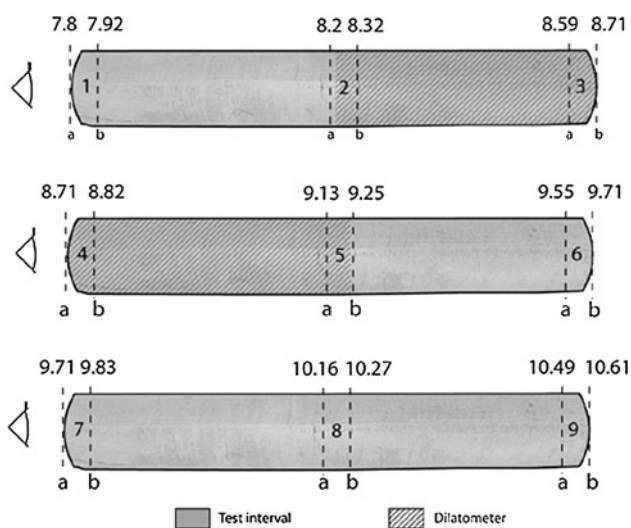
Fig. 8 Location of the sections in the overcore retrieved from the borehole BSE-3. The previous position of the loading element (dilatometer) is marked

from the wall of the adjacent gallery. During the test, the dilatometer pressure had been increased stepwise to 5.0 MPa. After the test completion, the packer system was removed in May 2007. After injection of dyed resin 3 weeks later, the borehole was then overcored in October 2007. The cores retrieved from the tested sections between 7.8 and 10.8 m were cut at 9 locations perpendicular to the overcore axis. Figure 8 shows the location of the slices along the overcore. The overcoring successfully maintained the orientation of the original borehole leading to an almost perfectly centralized position of the original borehole in the overcore up to the maximum depth. The mapping of geological structure on the core material of the original borehole and the overcore was done on photographs taken under UV light. The mapping revealed no abnormal tectonic features e.g. faults or fracture zones.
