Fit-in GFRP Liner for Retrofitting Corroded Metal Culverts

Abstract. Corrugated metal pipes (CMPs) have been used as culverts in North America since the 1950s. Today, corrosion of CMPs is a major problem that requires an urgent and efficient solution to retrofit thousands of corroded CMPs across the country. One potential solution gaining wide acceptance is to use a fit-in Glass Fiber Reinforced Polymer (GFRP) liner inside the old CMPs and to connect them using polymer grout. In this paper, a methodology to retrofit corrugated metal culvert using a fit-in GFRP profile liner was developed and implemented. First, material characterization of the GFRP material and the epoxy grout were carried out for proper design of the retrofit system. Second, full-scale CMP-GFRP composite section was tested under three-point bending configuration to observe the retrofitted culvert behavior to failure. The new CMP-GFRP section develops full composite action and shows failure capacity of 75 kip with a deflection of 3.52 in at the end of the test. Post failure of the polymeric grout, GFRP pipe failure was observed at mid-span location starting on the tension side. A finite element model was developed

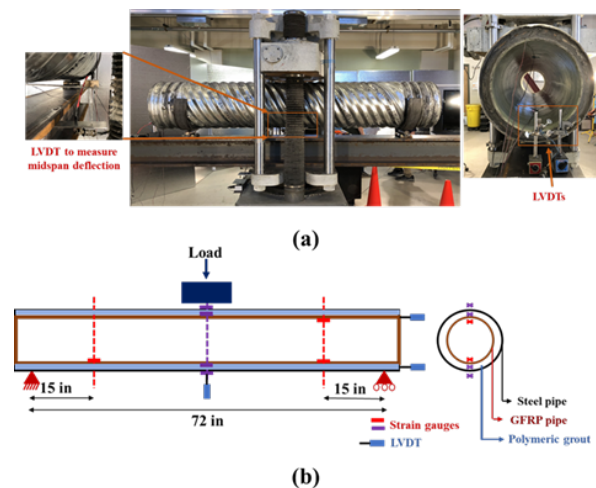
Fig. 1. (a) Experimental set-up for testing CMP retrofitted with GFRP profile liner under three-point bending; (b) Experimental instrumentation.

The test setup was designed with semicircular striped loading and reaction points to allow having one hinge support and one roller support. A 400-kip Instron loading frame with cross head displacement rate of 0.012 in./min was used to perform the test of the composite section. Linear Variable Displacement Transducers (LVDTs) were placed at mid span section to measure the deflection of the composite beam and at the end to observe any debonding and to measure the end slip between GFRP, grout material and CMP. The data was recorded at 10 Hz time period and the test continued for 5 hours and 6 minutes.

A 3-point bending test was conducted on the CMP section retrofitted with GFRP profile liner. The experimental setup is presented in Figure 1.

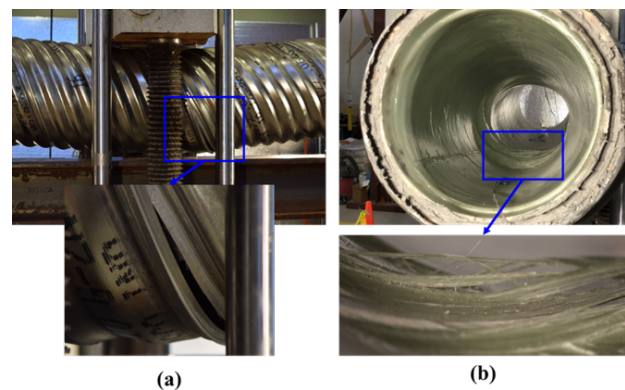
Fig. 3. (a) Corrugated steel pipe joint complete separation at the end of the test; (b) GFRP failure.

GFRP material, and the superior bond between both GFRP and steel to the polymer grout material. The modes of failure of the CMP-GFRP section to the corresponding peak loads were identified and are shown in Figure 2. First, the point at which the steel yielded is shown. Second, failure mode at the peak load is shown. Failure at the peak load occurred because of separation of the CMP joint located exactly at the mid span section of the beam as shown in Figure 2(a). At the peak load of 75 kips, compression existed on top of the beam and maximum tension existed below the neutral axis at the bottom farthest location. At that load, the strains in GFRP reached -0.00113 the corresponding strain reading in GFRP in tension has been recorded as 0.0023 and post peak after the load drop, the strain in tension GFRP increased to 0.0072, indicating a sudden increase in strain of GFRP under tension. No change in the compression strain maintaining at -0.00113. This can be attributed to steel separation and tension failure of grout itself as the failure strain of grout in tension was 0.005 as shown in Figure 2(b). Beyond this point, the strains in GFRP increased significantly. At point (iii) shown in Figure 2(a) GFRP on the tension side started to fail as the strain in GFRP reached 0.036 in./in., which is very close to the typical off-axis failure strain in GFRP. Nevertheless, no signs of failure in compression were observed at this point of loading. The CMP joint separation and GFRP failure at the end of the test are shown in Figure 3.

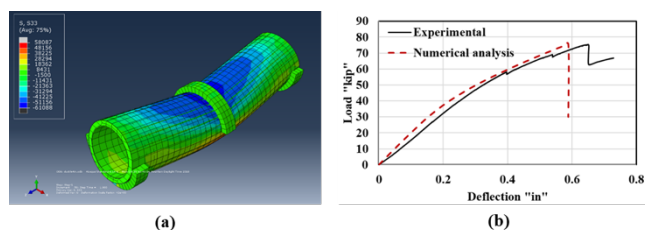
A commercial finite element software ABAQUS was used to model the CMP-GFRP composite section. The system was developed making use of the 3D geometry in ABAQUS. The model consists of steel circular pipe section, grout section and the GFRP pipe section. All the three materials were constrained with a tie constrain assuming perfect bond between GFRP-grout and steel-grout. A mesh size of approximately 2.0 in was used for the model. A C3D20R, a 20-node quadratic brick, reduced integration with quadratic geometric order was used for the analysis. Steel was modeled as elastic-plastic material with a Young's modulus of elasticity of 29,000 ksi and Poisson's ratio of 0.3. The grout material was model as isotropic material with tensile properties in Table 1. Concrete Damage Plasticity (CDP) model was

used to model damage occurrence and propagation in the grout. Stress-strain of the grout material extracted from the material characterization stage were used in the FE model. A semicircular ring was used to represent the supports and loading head with boundary conditions similar to those used in testing. The model is shown below in Figure. 4(a). The load versus displacement behavior comparing experimental to the numerical analysis is presented in Figure 4(b). The behavior from numerical analysis agrees well with the experimental observations. Further work is underway to improve the finite element model and to use it for future design of the culvert retrofitting system.

Fig. 4. (a) CMP-GFRP composite pipe numerical model; (b) Load versus deflection behavior of numerical model compared with that observed experimentally.
