HCF Failure Modes and Mechanisms of Dissimilar Welds of Martensite/Austenite Metals at Elevated Temperature

Abstract. In this paper, the high cycle fatigue (HCF) behavior and failure mechanism of welded joint for martensite/austenite dissimilar metals were systematically investigated at elevated temperature. The HCF tests were performed at different elevated temperatures of 550, 600 and 630 °C with stress ratio of -1. Most tested specimens failed in the heat affected zone (HAZ) of martensite metal, while minor failure occurred on the weld metal (WM) with comparatively more scattered fatigue life. Fatigue crack in the WM initiated from welding defects like porosities and non-metallic inclusions. For failures in the 10Cr-HAZ, fatigue cracks nucleated from the interior matrix of HAZ, which possessed lower hardness. The initiation of cracks was divided into facet type crack origin (FTCO) and rough type crack origin (RTCO). FTCO was observed for specimens tested at high stress amplitude with fatigue life below 10^7 cycles. Micro-cracks were observed at prior austenite grain boundaries (PAGBs) at high stress level. Micro-cracks preferred to form at martensite lath boundaries and coalesc

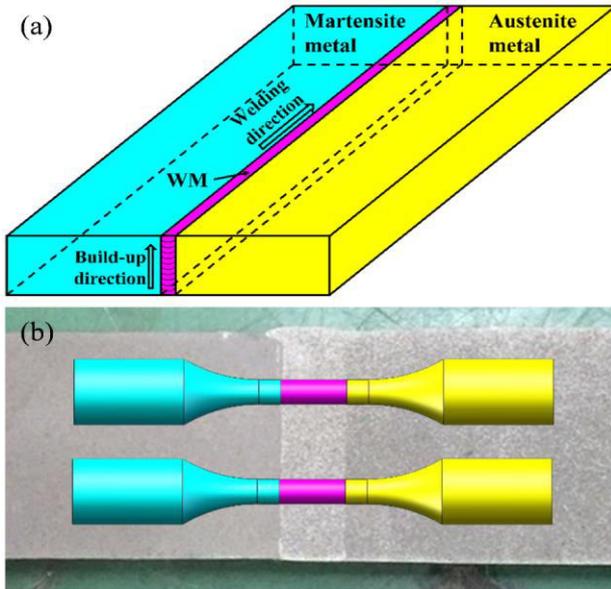
Fig. 1 (a) Schematic of the lump martensite and austenite metal welded by multi-layer GTAW, (b) sampling of high cycle fatigue testing specimens from the welded joint.

High cycle fatigue specimens schematically shown in **Fig. 1** (b) were chipped and machined from the welded joint. The specimens from upper and lower parts were marked and carefully polished. HCF tests were performed following ASTM E466-07 at 550, 600 and 630 °C. The stress ratio was -1 and the frequency was around 110 Hz. The specimens were heated in an electrical furnace with temperature being controlled within ± 1 °C. Specimens didn't fracture at 5×10^7 cycles were terminated as run-outs.

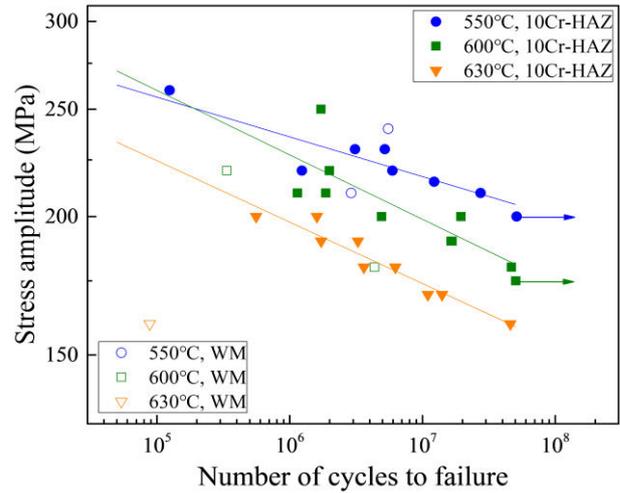
Fig. 2 *S-N* curves for the martensite/austenite dissimilarly welded joint at different temperatures.

Results of stress amplitude versus fatigue life (*S-N* curves) is presented in **Fig. 2**. Points marked with arrows represent specimens didn't fracture at 5×10^7 cycles, namely run-outs. Most specimens failed in the 10Cr-HAZ, and a few in the weld metal (WM). No failure took place in the austenite metal side. It is worth noting that fatigue data of run-outs and failures in WM were excluded when fitting the *S-N* curves of different temperatures in **Fig. 2**.

It is seen that only five specimens failed in the WM at three testing temperatures. At 550 °C, two specimens failed in WM with comparable fatigue strength with those fractured in the 10Cr-HAZ. When the temperature increased to 630 °C, fatigue life of the specimen failed in WM was much lower than that of the failures in 10Cr-HAZ. This indicates that the HCF failures in the WM is more sensitive to temperature increase in this range.

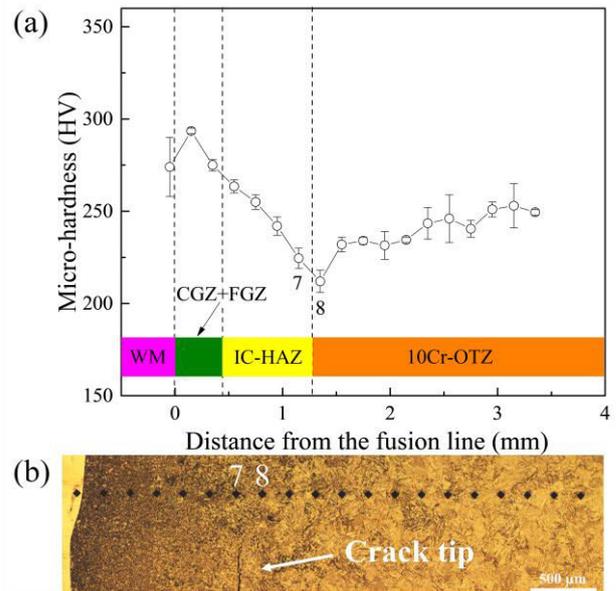
Fig. 3 (a) Micro-hardness distribution across the welded joint, (b) crack location corresponding to the micro-hardness test points.

For failures in the HAZ, the fatigue life is more logarithmically related to the applied stress amplitude and of smaller divergence. Since most failures took place in the 10Cr-HAZ, it is deemed to be the weakest part of the joint at elevated temperatures. With increasing distance from the fusion line, the 10Cr-HAZ consists of several parts, namely coarse grain zone (CGZ), fine grain zone (FGZ), IC-HAZ and over tempered zone (OTZ) as shown in **Fig. 3** (a). For the four zones, the micro-hardness is highest in the CGZ and lowest at the

boundary of the IC-HAZ and OTZ. For 10Cr material, the original microstructure is martensite lath. In the OTZ, the martensite lath was simply tempered during welding. In the IC-HAZ, the microstructure partially austenitized during welding and transformed into martensite upon cooling. During the following PWHT process, microstructure in both the OTZ and IC-HAZ was tempered. In such, the microstructure near point 8 is mostly high temperature-tempered martensite (HTTM) with comparatively low strength. In **Fig. 3** (b), the specific failure location of 10Cr-HAZ failures can be determined, as the crack locates between points 7 and 8, where the micro-hardness is lowest in the 10Cr-HAZ, namely lowest hardness zone (LHZ).

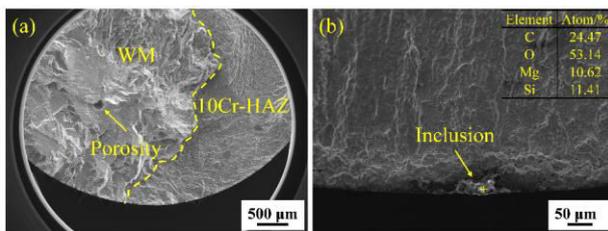
Fig. 4 Fracture surface of specimens failed in the WM, (a) crack initiation from interior porosity in the WM near fusion line of 10Cr side (550°C, 210 MPa, $N_f = 2.90 \times 10^6$), (b) crack initiation from surface defect in the WM (630°C, 160 MPa, $N_f = 8.84 \times 10^4$).

Fracture surface of the failed specimens were observed to better understand the crack initiation mechanism. In **Fig. 4** are shown two typical fracture surfaces for failures in the WM. In **Fig. 4** (a), the fatigue crack nucleated from an interior porosity in the WM near the 10Cr-fusion line, and propagated into the 10Cr-HAZ. Crack surface in the WM with austenite microstructure showed obvious crystallographic characteristics, while in the 10Cr-HAZ it is mainly transgranular propagation with coarse fatigue ratcheting marks. The specimen in **Fig. 4** (b) nucleated the crack from a surface non-metallic inclusion with short fatigue life. Combining the previous discussion, it can be concluded that the welding defects are the cause for failures in the WM.

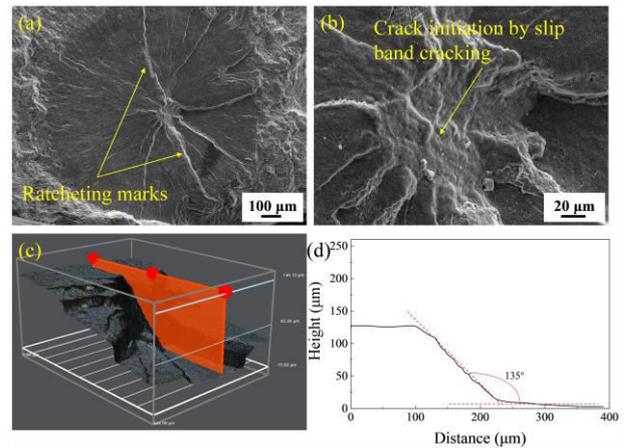
Fig. 5 Facet type crack origin in the 10Cr-LHZ (600°C, 250 MPa, $N_f = 1.72 \times 10^6$).

For failures in the 10Cr-HAZ, the fracture surface and the microstructure in the LHZ were both observed to better reveal the mechanism. In **Fig. 5** (a) and (b), fatigue crack initiated from a smooth facet at 250MPa and no defect was observed, which is named facet type crack origin (FTCO) in this study. FTCO was only observed in specimens failed with fatigue life below 10^7 cycles. In **Fig. 5** (c) and (d), the crack initiation facet is with an angle of about 45° to the loading direction. After the crack extends into a certain size, it grows perpendicularly to the loading direction in many planes and forms the ratcheting marks shown in **Fig. 5** (a). Microstructure near the fracture surface is presented in **Fig. 6**. Micro-cracks can be observed at prior austenite grain boundary (PAGB) and martensite lath boundaries

It is previously discussed that the microstructure in the LHZ is mainly HTTM. Due to the locally low strength of the microstructure, resistance property for fatigue crack nucleation is worst in this zone. Under cyclic loading at high temperature, cyclic slip may occur at some preferentially oriented PAGBs and MLBs. At high stress level, micro-cracks can form at PAGBs and extend flat into the size of a prior austenite grain, i.e, the facet in **Fig. 5** (b). Such a large shear crack is hard to be blocked by the surrounding HTTM microstructure and can easily grow into several tension cracks with short fatigue life as shown in **Fig. 5**.

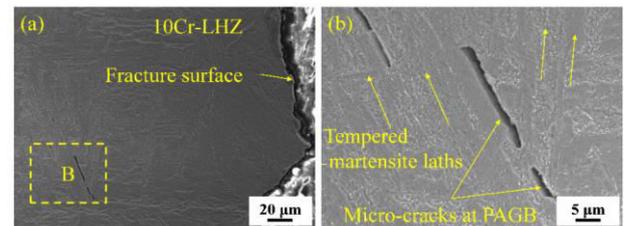
Fig. 6 Micro-cracks observed along prior austenite grain boundary near fracture surface.

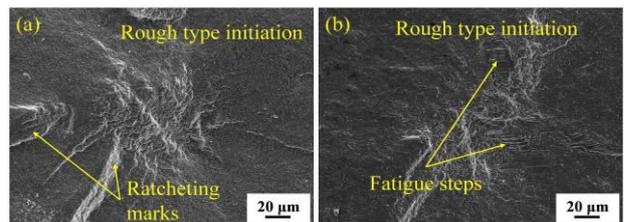
Fig. 7 Rough type crack origin in the 10Cr-LHZ: (a) 550°C, 210 MPa, $N_f = 2.74 \times 10^7$, (b) 630°C, 160 MPa, $N_f = 4.58 \times 10^7$.

For failures with longer fatigue life ($>10^7$ cycles), typical morphologies of the fracture surfaces are shown in **Fig. 7**. Instead of the smooth facet, the crack initiation site appears quite rough, and is named rough type crack origin (RTCO). Similar rough area named fine granular area (FGA), was reported on defect-induced fracture surface of high strength steels [6] and some weld metals [7]. Generally, rough area indicates extremely slow crack growth rate, and was mostly observed in the very high cycle fatigue regime (VHCF, $>10^7$ cycles). Different from the FGA, the RTCO in this investigation was not accompanied with defect, and was with an angle to the loading direction, which is similar with the FTCO. In **Fig. 8**, large number of micro-cracks and macro-cracks can be observed along the martensite lath boundaries (MLBs) near the fracture surface.

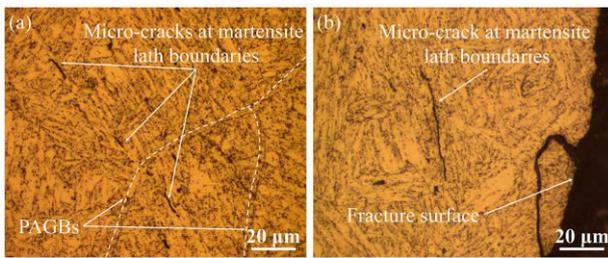
Fig. 8 (a) Micro-cracks and (b) macro-crack observed along martensite lath boundaries near fracture surface.
