Effect of insulation material on the fire performance of composite panels

McLaggan, Martyn ; Sørensen, Martin X.; Hidalgo, Juan P. ; Crewe, Robert J. ; Molyneux, Shirley ; Sønderskov, Anne; Jomaas, Grunde; Welch, Stephen ; Torero, José L. ; Stec, Anna A. ; Hull, T. Richard

McLaggan, M., Sørensen, M. X., Hidalgo, J. P., Crewe, R. J., Molyneux, S., Sønderskov, A., ... Hull, T. R. (2014). Effect of insulation material on the fire performance of composite panels. Poster session presented at 11th International Symposium on Fire Safety Science, Christchurch, New Zealand.

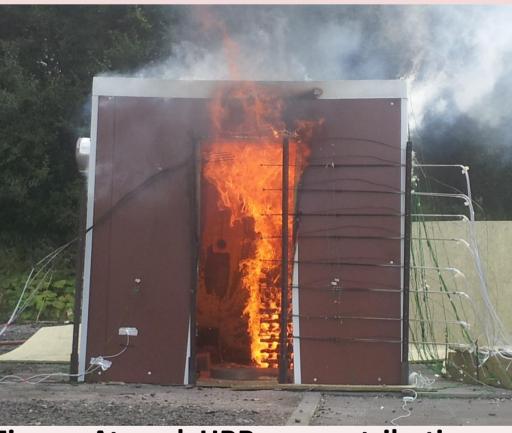
Test 4: Stone wool

Figure: At peak HRR; no contribution from SW

Test 4: A larger wooden crib weighing 297 kg was placed in the same location as test 3. This took 22 minutes to ignite (2 minutes after stepping the burner up to 600 kW), and the flames reached the bottom after 10 minutes.
