# Magnetic Field Accuracy and Trim Coils in Wendelstein 7-X

## Abstract

The super-conducting magnet system of Wendelstein 7-X (W7-X) consists of five identical field periods (modules). Magnetic field errors arise if the modules are not exactly identical. Even small deviations in the coil shapes of the same type or misalignments of coils or modules break the periodicity of the system and cause error field components.

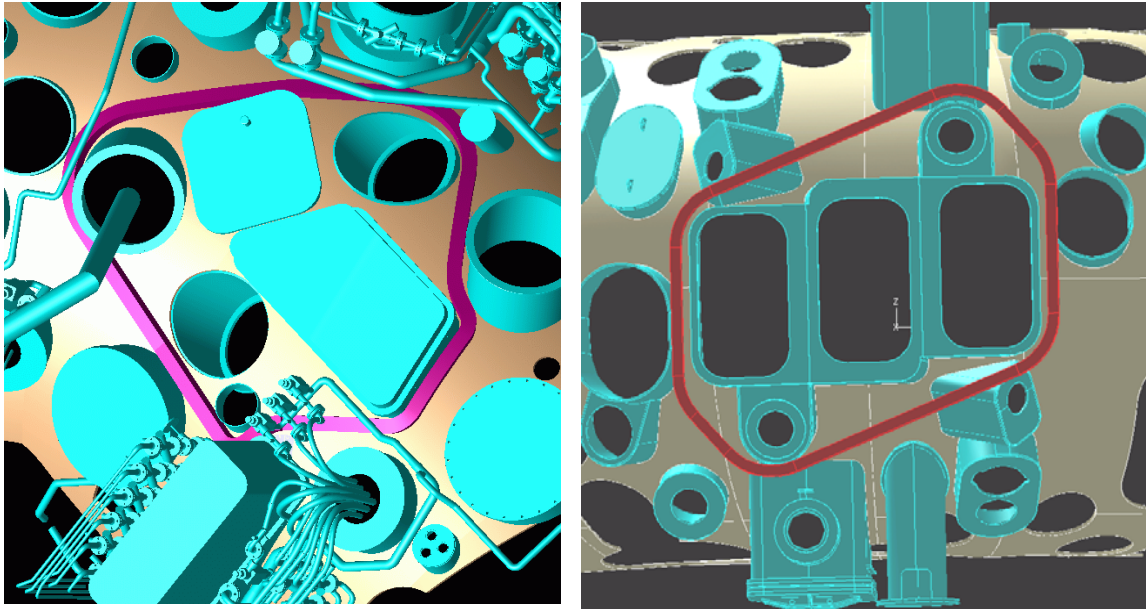
*Fig. 1 CAD plot of the trim coil type 1 on top of the outer vessel (left) and the planar coil located at the radial outside in the vicinity of the large ports (right).*

the bean shape plasma cross-section at  $\varphi = 0, Z=0$  (type 2); see Figs. 1 and 2. While the coil on top of the vessel has a saddle like 3-dimensional shape, the other one is designed as a plane coil. Both have dimensions of about 2m x 2m. Using one coil per field period, each coil should have a current capability of 100kA-turns.

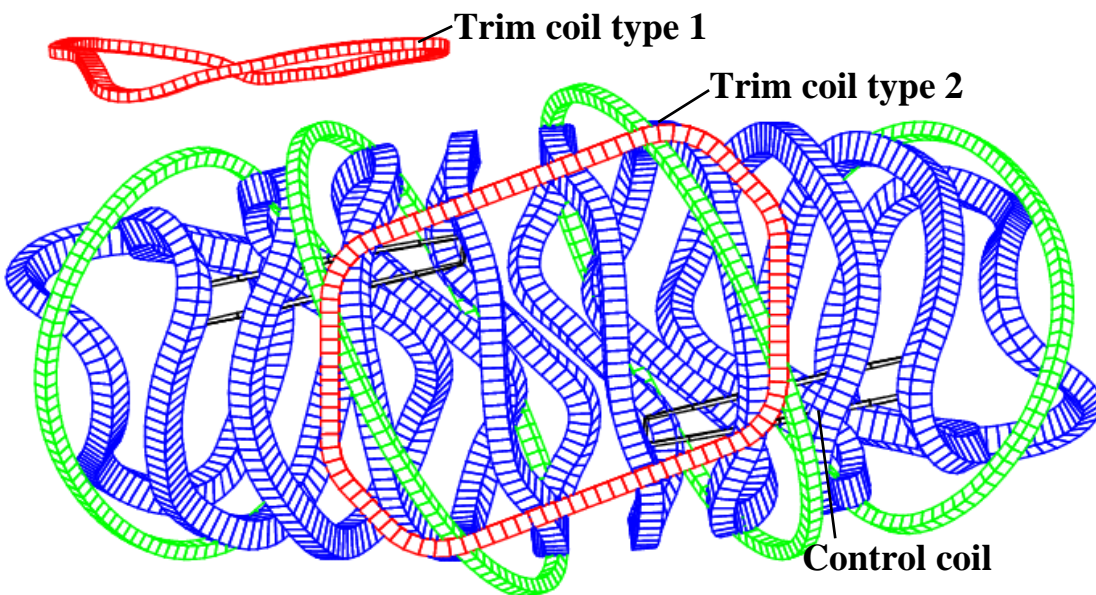
*Fig. 2 Sketch of the coil system of Wendelstein 7-X (one period) including the control coils and the two options of trim coils.*

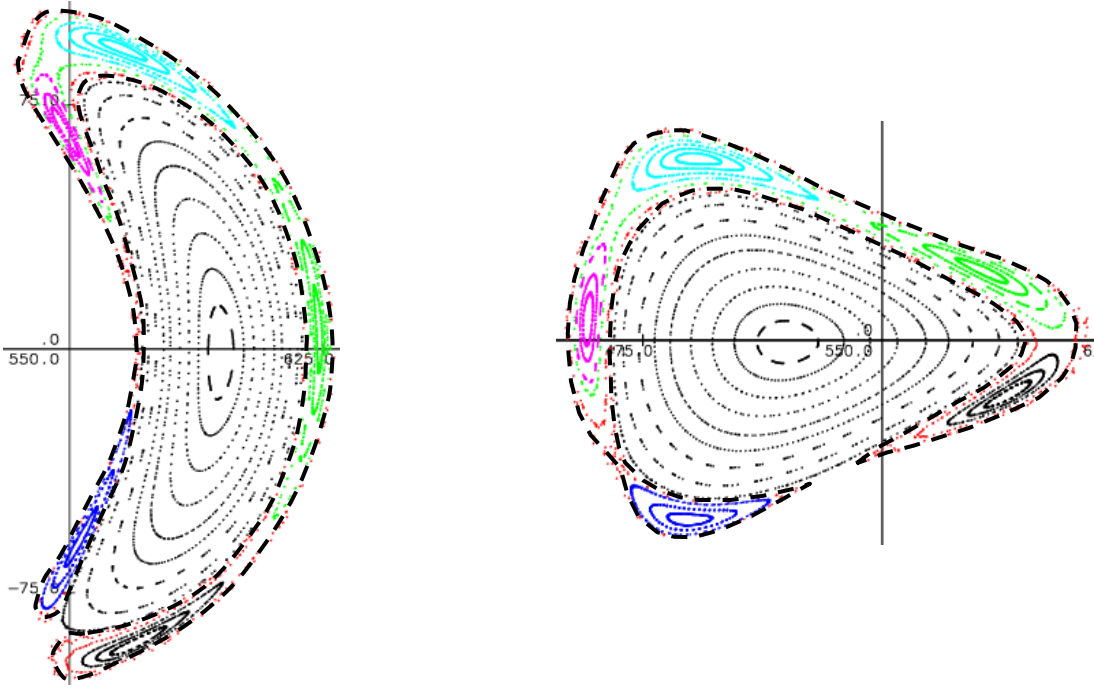
**Fig. 3** Poincaré plot of a perturbed field of W7-X standard configuration. The error field is caused by statistical inclination of the non planar coils of up to  $0.1^\circ$  with respect to the vertical and horizontal axis. The figure shows two poloidal plains at  $\varphi = 0^\circ$  (left part) and  $\varphi = 36^\circ$  (right part), which are up-down symmetric in the unperturbed case. In order to guide the eye, the 1/1 island, resulting from the error field and enclosing the remnants of the original 5/5 islands, is indicated by a dashed line.

As an example, Fig. 3 shows the Poincaré plot of a perturbed field with error field harmonics of  $\Delta B_{11}/B_{00} = 1.66 \cdot 10^{-4}$  and  $\Delta B_{22}/B_{00} = 0.31 \cdot 10^{-4}$  and Fig. 4 the Poincaré plot of the corrected field using the planar coils. Since the error field has periodicity one, the currents in the trim coils also need this periodicity.

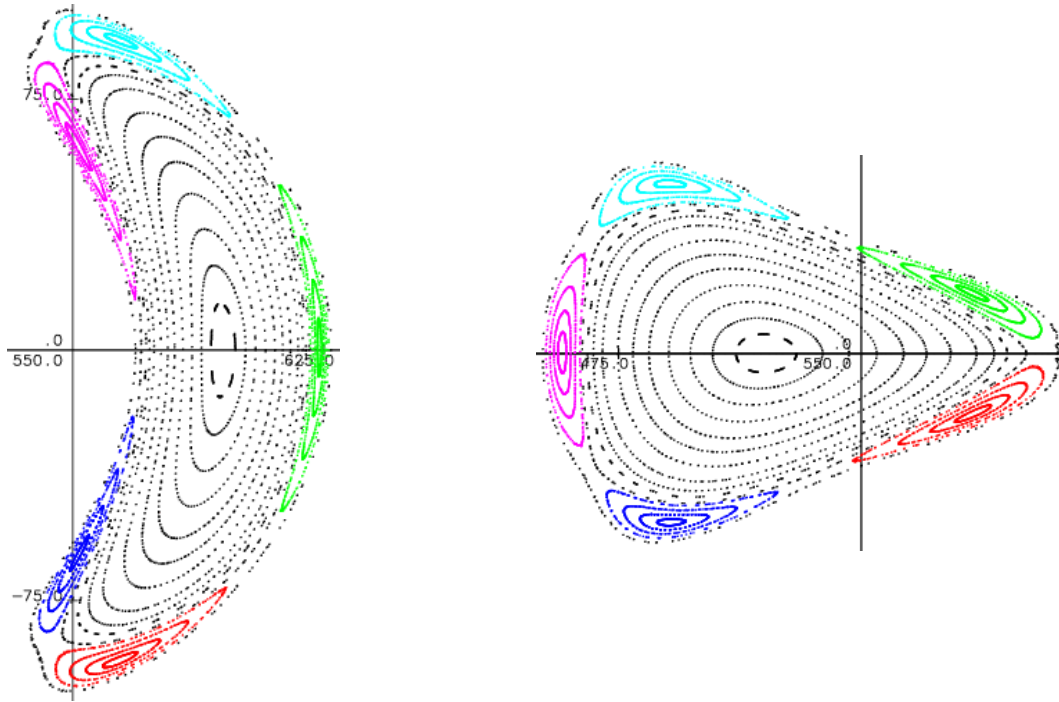
**Fig. 4** Poincaré plot of corrected field of fig. 2 using trim coil type2. The currents used in coils in the modules 1 to 5 are  $-12\text{kA}$ ,  $-29\text{kA}$ ,  $9\text{kA}$ ,  $22\text{kA}$  and  $2.5\text{kA}$ . The  $1/1$  island has vanished and the up-down symmetry is reconstructed. The symmetric  $5/5$  islands are desired and favourable for divertor action.

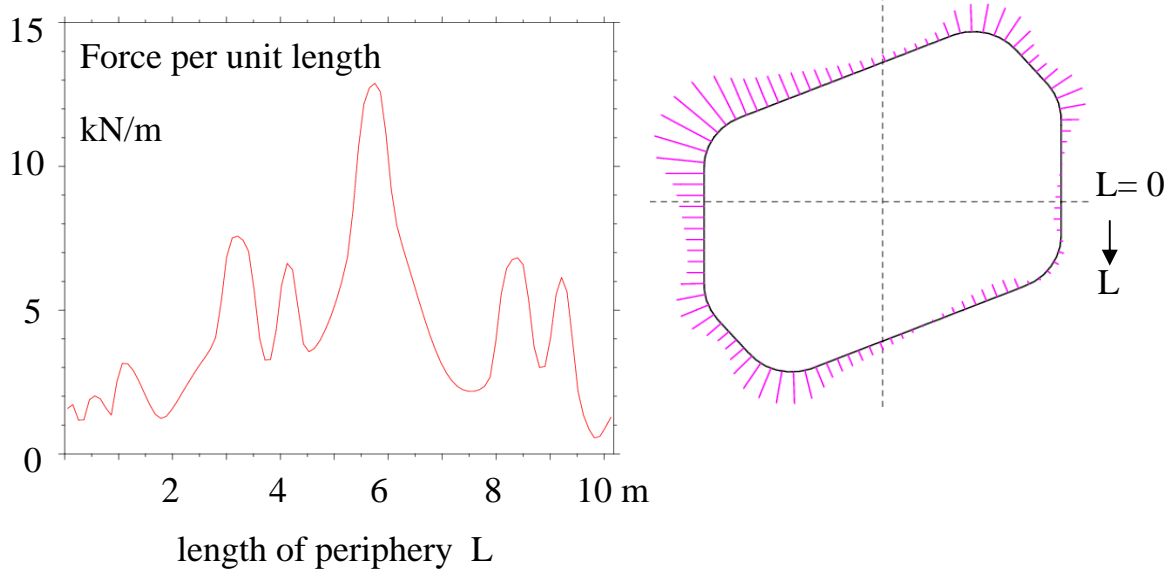
**Fig.5** Distribution of the force per unit length along the coil periphery of the planar trim coils. Coil current 100kA, high- iota configuration

The trim coils are in the stray field region of the non-planar and planar coils of the superconducting magnet system. The stray field is mainly generated by the planar coils and varies with the currents in these coils used to adjust the magnetic configuration. The maximum force per unit length reaches locally  $13\text{kN/m}$  in the high iota case with trim coil currents of  $100\text{kA}$  and a magnet field strength of  $3\text{T}$  (coil type 2). Fig. 5 shows the force distribution along the coil periphery. The forces are mainly generated by the self field and point radially outward from the trim coil centre. The asymmetry is due to the stray field of the superconducting coils and a net force results between the trim coils and the magnet system. Since the stray field comes mainly from the planar coils the net force is maximal in the configurations with large currents in these coils, e.g. low-shear, high-iota case. In the high-iota configuration a toroidal component of  $14\text{kN}$  and a vertical component of  $10\text{kN}$  result. Taking into account the forces of the trim coils in all five modules the net forces can either result in a horizontal force of up to  $40\text{kN}$  or in a moment of up to  $500\text{kNm}$  (with respect to

the vertical axis of the device) depending on the current distribution in the coils. The net force must be balanced through the thermal isolation of the cryostat as in the case of the gravitational force.
