The Use of Image Analysis for Determination of Surface Deterioration Level of Improved Alumina Based Materials Subjected to Cavitation

M. M. Dimitrijević^{1*)}, M. Dojčinović¹, A. Devečerski²,
R. Jančić-Heinemann¹, T. Volkov-Husović¹

Abstract:

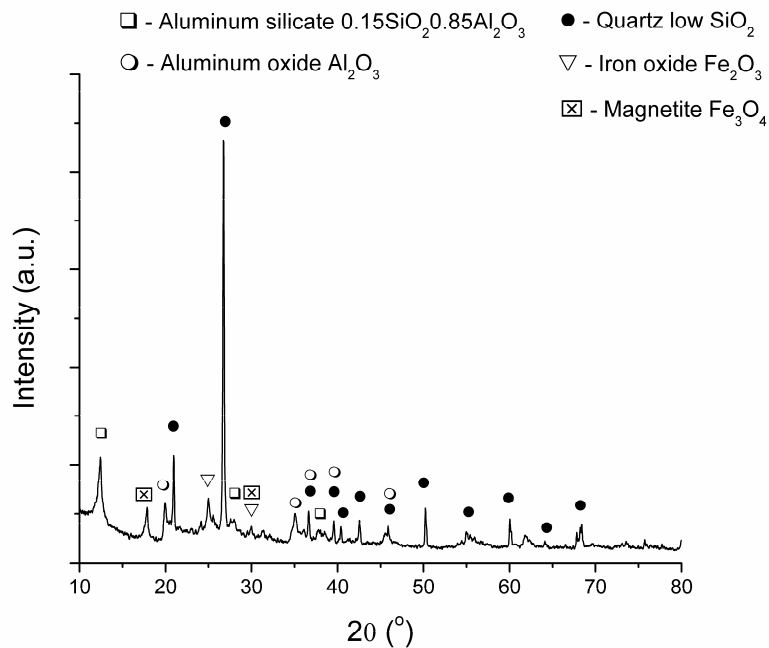
Fig. 3. Mineralogical composition of clay powder used for sample preparation. Phases identified in the specimen are: quartz, aluminum oxide, iron oxide and magnetite.

Microstructure of sintered samples was studied using X-ray analysis. The diffraction patterns were obtained for raw materials such as clay, bauxite and chamotte. Clay was composed of quartz (SiO_2), aluminum oxide (Al_2O_3), iron oxide (Fe_2O_3) and magnetite (Fe_3O_4), as seen in Fig. 3., while for chamotte powder quartz (SiO_2 , JCPDS number 05-0+50), silicon oxide (SiO_2 , JCPDS number 27-0605) and mullite ($\text{Al}_6\text{Si}_2\text{O}_{13}$, JCPDS number 15-0776) were identified, Fig. 4.

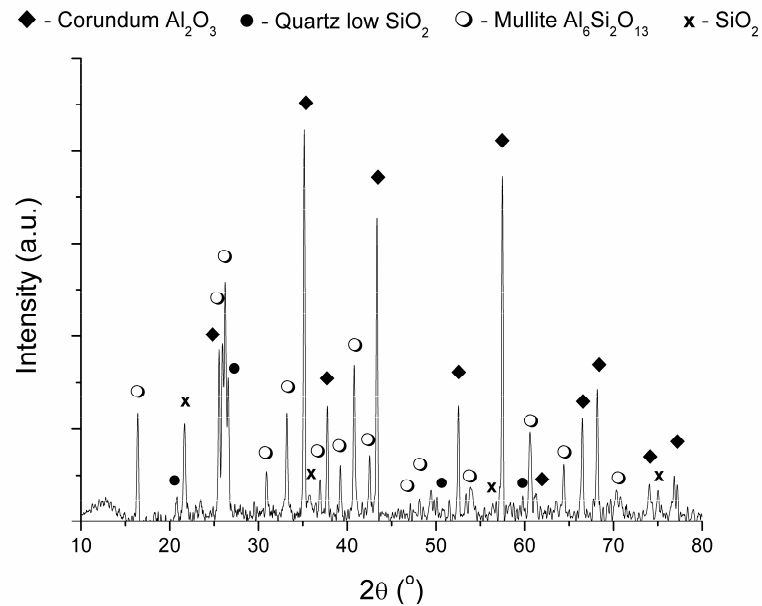
Fig. 6. Mineralogical composition of sintered sample. Phases identified in the specimen are: corundum, quartz, silicon oxide and mullite cavitation.

Bauxite powder consisted of minerals mullite ($\text{Al}_6\text{Si}_2\text{O}_{13}$, JCPDS number 15-0776) and corundum (Al_2O_3 , JCPDS number 10-0173), Fig. 5. The sintered sample consisted of corundum (Al_2O_3 , JCPDS number 10-0173), quartz (SiO_2 , JCPDS number 33-1161), silicon oxide (SiO_2 , JCPDS number 27-0605) and mullite ($\text{Al}_6\text{Si}_2\text{O}_{13}$, JCPDS number 15-0776), Fig. 6, and therefore the fibers inserted into this composition were chosen to be of aluminium-silicate (JCPDS number 37-1+60) nature so as to enable the good bonding between the fibers and the matrix.

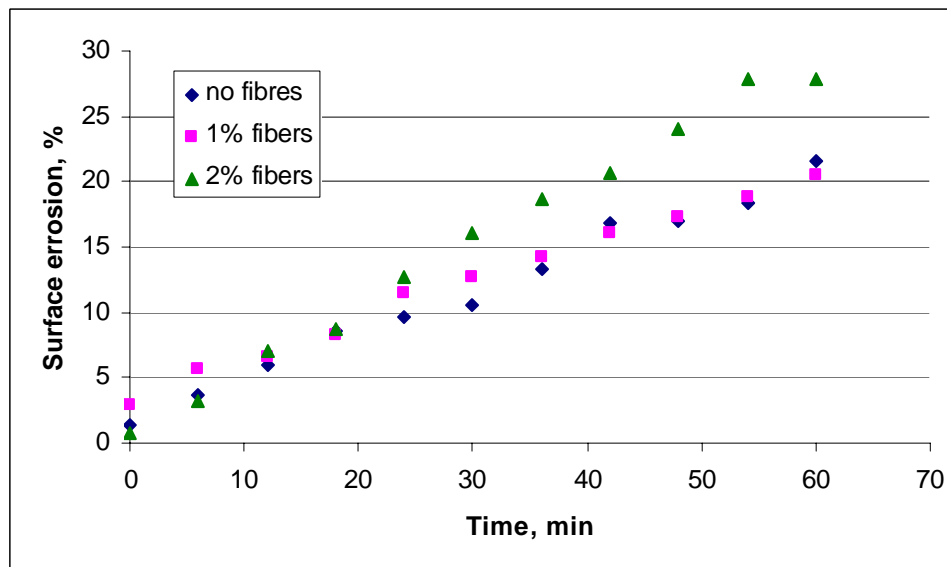
Fig. 8. Surface erosion results during cavitation determined using image analysis technique.

Image Pro Plus Program was used for determination of surface deterioration level. Results are given in Fig. 8. Erosion rates were measured as for the metallic samples. Image analysis program was applied for surface analysis during testing. Obtained results showed that surface erosion was in strong correlation with time, and erosion of the sample surface was about 25 % of the surface area before testing. Samples without fibers and those having 2 % of fibers exhibits similar results for mass loss. Mass loss of samples with 1% fibers was 40 % larger after testing for 60 minutes.

Results of surface erosion are presented in Fig. 8 and compare the destruction of surface in specimens having no fibers and having the addition of 1% volume and 2% volume fibers. The effects of fiber addition on surface preservation were not as beneficial as for mechanical properties. The mechanical properties are improved with fiber addition, but erosion rates and overall erosion levels were lower in specimens having no fibers than in
