Alaska Department of Transportation & Public Facilities
Research & Technology Transfer

Wearing Surface Testing and Screening: Yukon River Bridge

FINAL REPORT

Date: September 2015

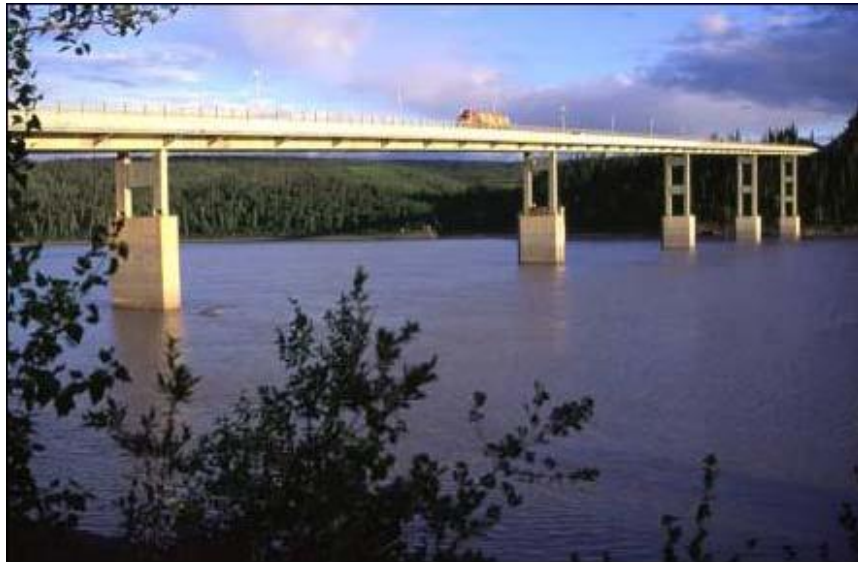
Figure 1: Yukon River Bridge.

The Yukon River Bridge, located about 50 miles north of Fairbanks, Alaska, on the Dalton Highway, is a two-lane bridge with an orthotropic steel deck structure. The bridge was designed to carry highway traffic and the oil pipeline across the Yukon River. When the bridge was built in the early 1970s, a two-layer temporary timber wearing surface was installed over the steel deck. Because the bridge is on a 6% grade, trucks typically use tire chains to provide traction. The chains tend to cause serious wear on the timber surface over time. Due to the severe climate changes of this region and intense loading from passing trucks, the timber surface deteriorates at a rapid rate.

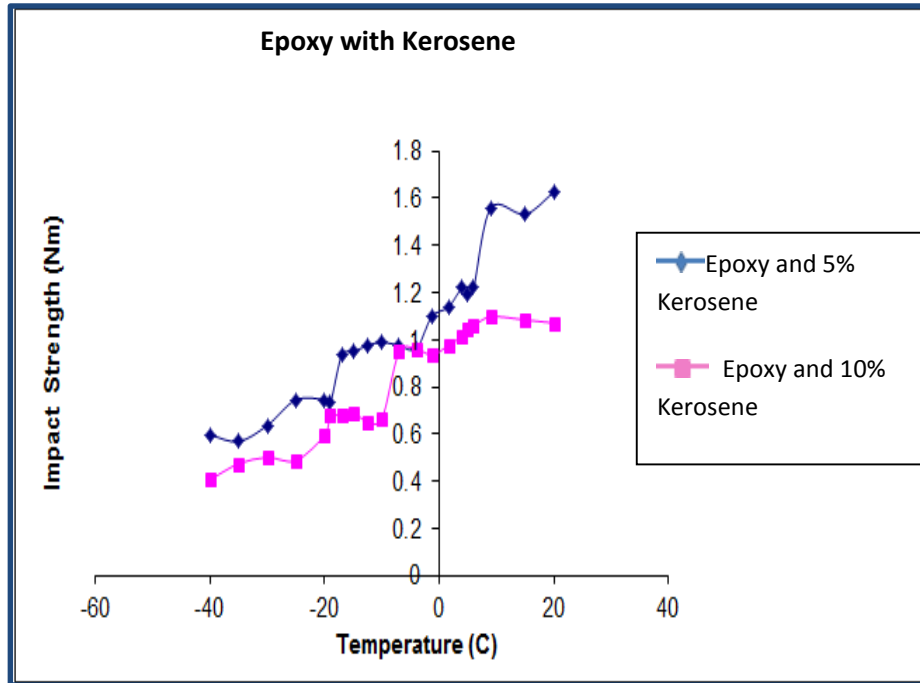
Figure 4: Epoxy with kerosene samples – temperature rise vs. impact strength.

Figures 3, 4, 5, and 6 show the Charpy impact tests calculated and graphed by impact strength vs. temperature. The tests were conducted by reducing the temperature of the Charpy samples to -40°C . By attaching a thermistor to the test samples, we conducted the impact tests to view where the brittle-to-ductile transition temperature occurred. The brittle transition temperature is clearly shown in

Figures 3–6 as a large jump that occurs around -27°C , -20°C , or 10°C . The test of 5% isopropyl alcohol has the lowest temperature occurrence as well as the highest impact strength.

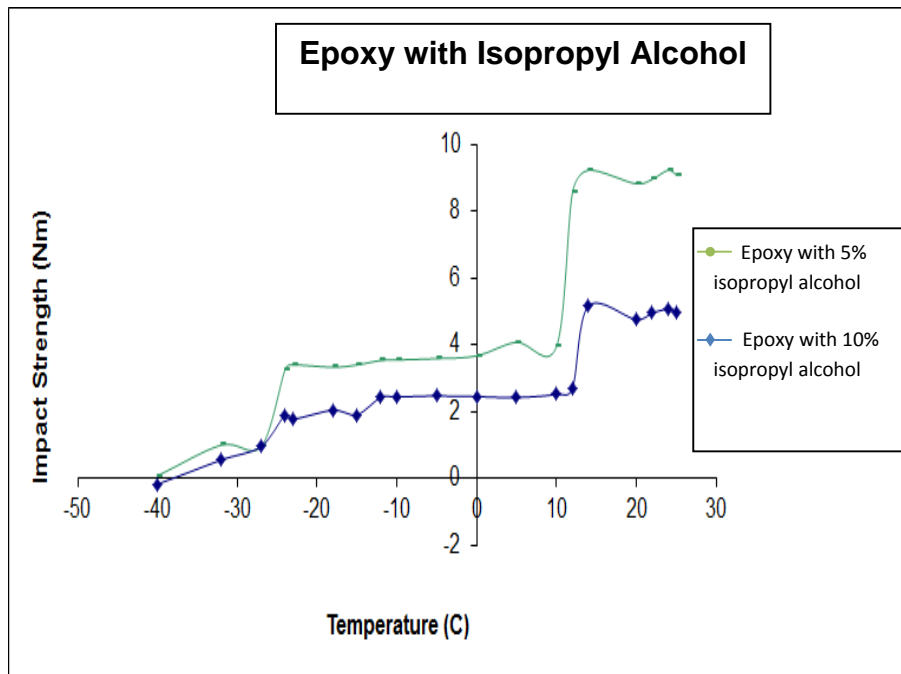
Figure 5: Epoxy with isopropyl alcohol samples – temperature rise vs. impact strength.

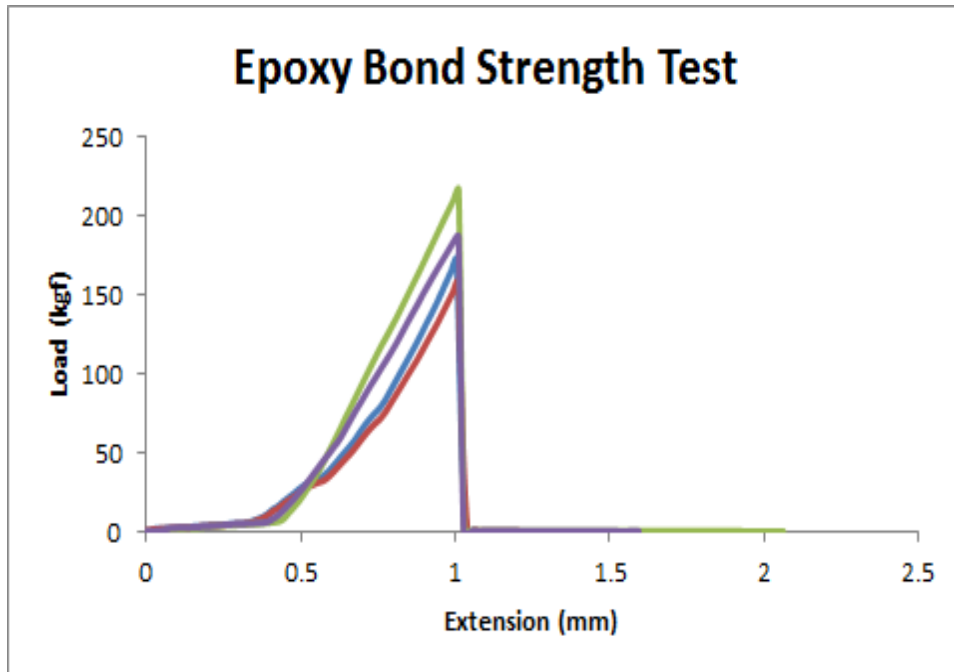
Figure 7: Epoxy samples – extension vs. load.

Shown in this section are the Instron tensile tests. We performed a bond test, in which different solutions of epoxy were applied to two halves of an ASTM dog bone metal sample, and tested how much force was required to break the material. In Figure 7, regular epoxy is shown, and in Figures 8 and 9, two solvents are shown. The 60% reduction in strength is clearly indicated.

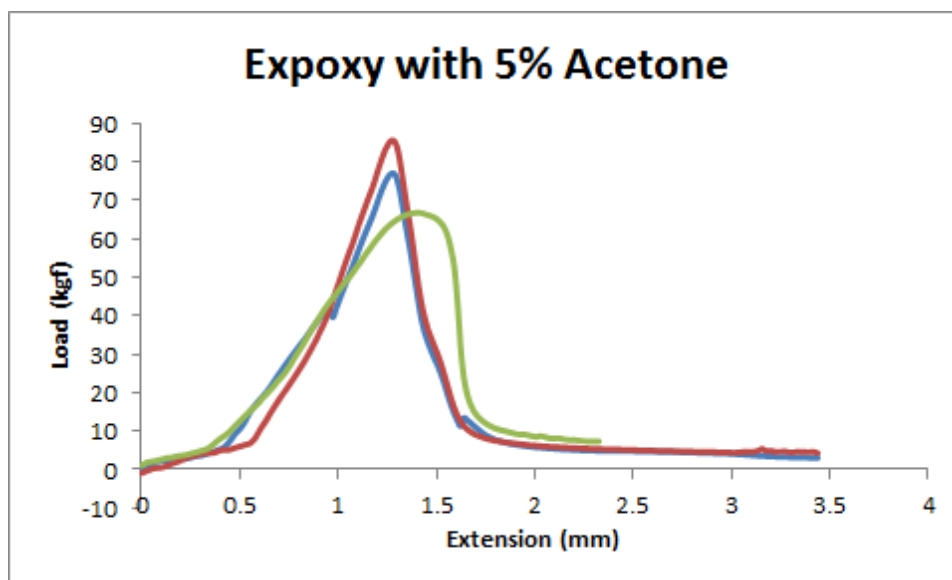
Figure 9: Epoxy with acetone samples – extension vs. load.

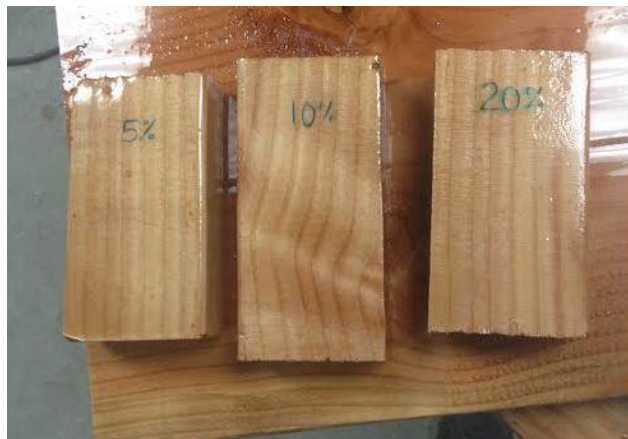
Figure 19: Test samples 3–5%, 10%, 20% isopropyl alcohol.

3.7.1 Determining percent isopropyl alcohol (Figure 19)

In order to test the resistance to moisture migration vs. percent alcohol in an epoxy mix, three different test boards were made. To determine what percent of isopropyl alcohol gave the best results, different percentages of it were added to the Type III dot epoxy. These sample board tests were conducted using the following procedure:

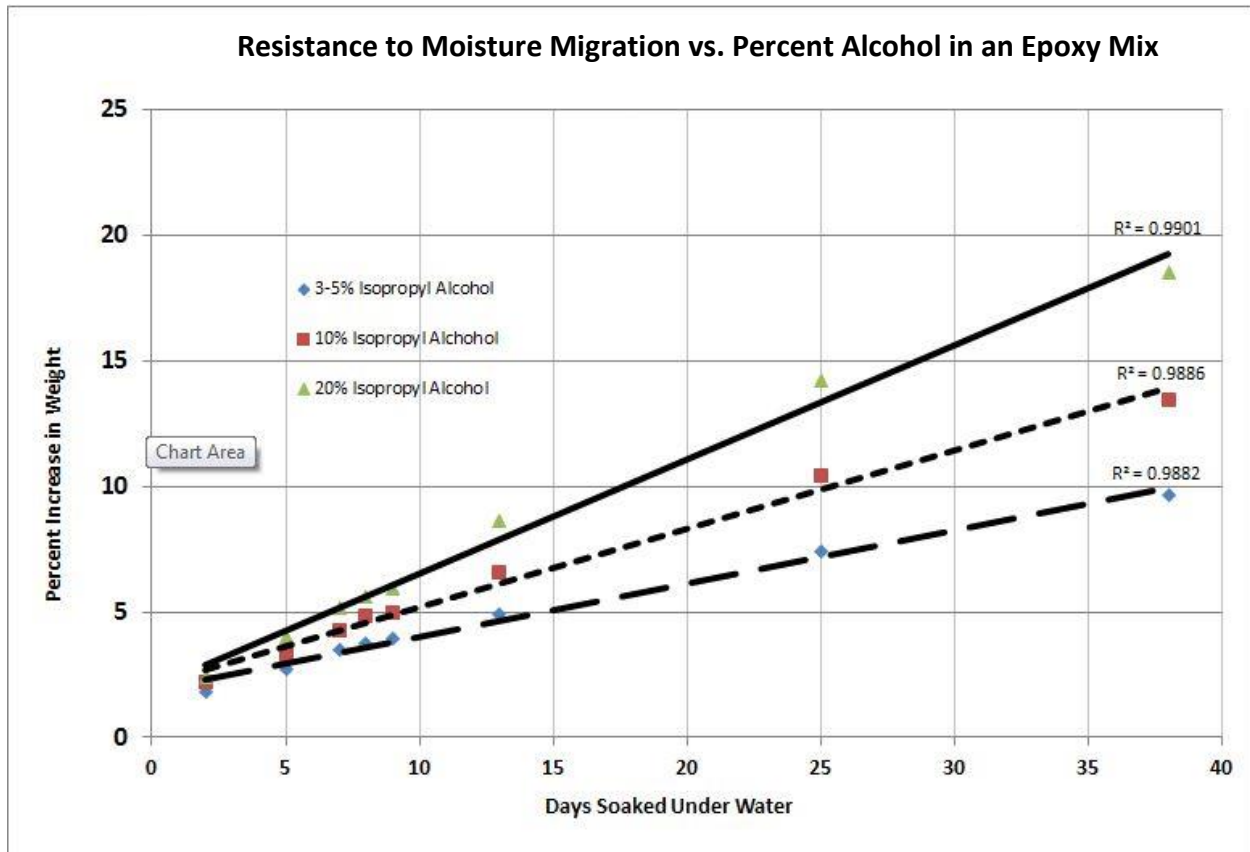
Figure 20: Resistance to moisture migration.

Graph Conclusion for Figure 20: These results gave clear data indicating that 3–5% isopropyl alcohol performed best while still giving the epoxy mobility and workability for application to the planks.

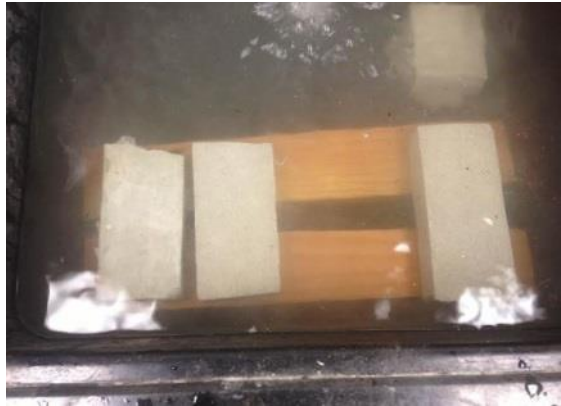
Figure 21: Test samples: no sealing, 1 sealing, 2 sealings, and 3 sealings submerged in water.

10. Boards were then placed under water in a large container.
11. On days 1, 2, 3, 7, 14, 20, 26, and 117 of being submerged in water, the weights were retaken to determine the amount of water each board absorbed. (This was done using a digital scale. Each board was weighed 3 times to ensure accurate results, and the average was then taken for each board).

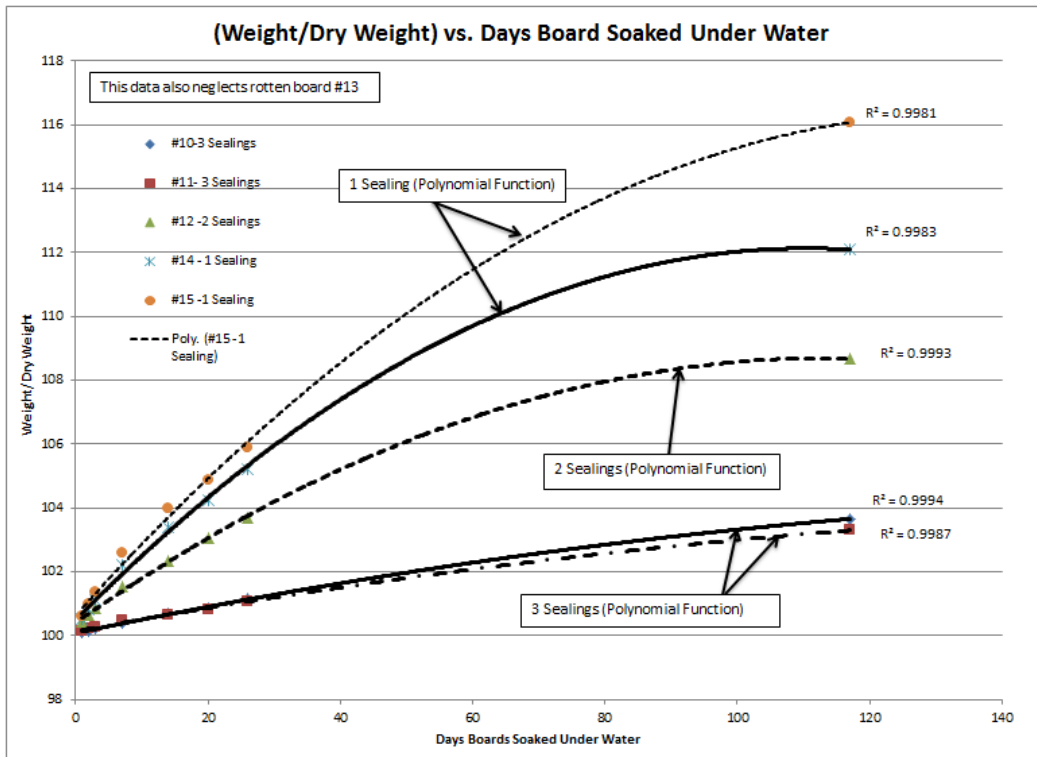
Figure 23: (Weight/dry weight) vs. days boards soaked.

Graph conclusion for Figures 22 and 23: Figure 22 displays all the test sections: 2 with no sealing, 2 with 1 sealing, 2 with 2 sealings, and 2 with 3 sealings. Figure 23 displays all the tests, neglecting the no-sealing samples and the rotten 2-sealings sample. This gave clear data on what was happening as the number of seal coatings was increased.

The results shown in Figures 22 and 23 demonstrate that as the number of seal coatings on the boards is increased, samples weighed less; thus, the samples absorbed less water with an increase in the number of coatings.

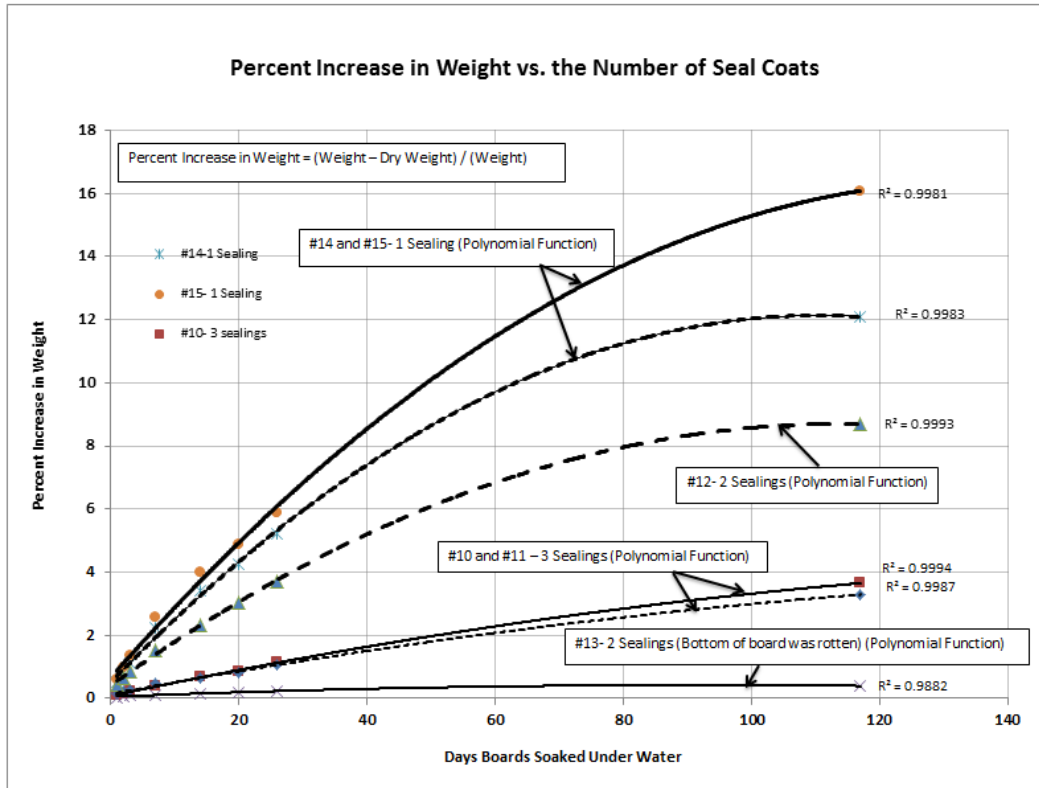
Figure 25: Percent increase in weight vs. number of seal coatings.

Graph conclusion for Figures 24 and 25: Figure 24 displays all the test sections: 2 with no sealing, 2 with 1 sealing, 2 with 2 sealings, and 2 with 3 sealings. Figure 25 displays all the tests, neglecting the no sealing. This gave clear data on what was happening as the number of seal coatings was increased.

The results shown in Figures 24 and 25 demonstrate that as the number of seal coatings on the boards is increased, samples weighed less; thus, the samples absorbed less water with an increase in the number of coatings.

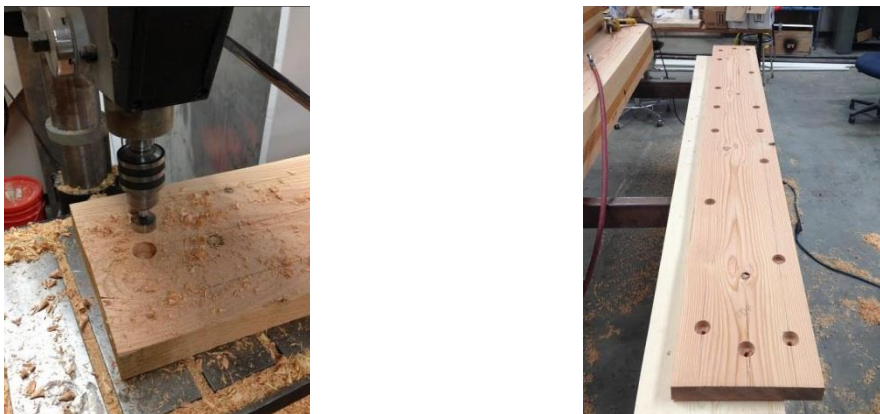
Figure 29: Drilling countersunk holes. Figure 30: Completed board though application process.

4. Countersink 1½ in. diameter hole at 1 in. depth. Be sure to use a jig or a drill press to obtain a hole that is perpendicular to the plane of the board (Figure 29).
5. Using a 3/8 in. drill bit, drill in the center of the countersunk holes (Figure 30) to bore a hole all the way through the board (this hole prevents cracking when bolts are inserted).

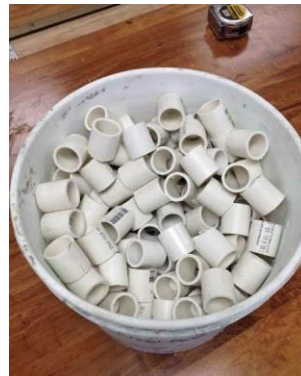
Figure 32: De-burred PVC pipe

6. Inspect the holes looking for any slivers; remove with pliers or sandpaper.
7. Sand the surface of the boards.
8. Tack the boards with tacking cloth, to get rid of the impurities and loose wood dust.
9. Cut 1½ in. PVC pipe to 1-5/8 in. lengths. This length is determined by the depth of the countersunk holes plus the thickness of the aggregate coating to meet the desired overall thickness of the planks.
10. De-bur the PVC cut pipe (Figures 31 and 32).

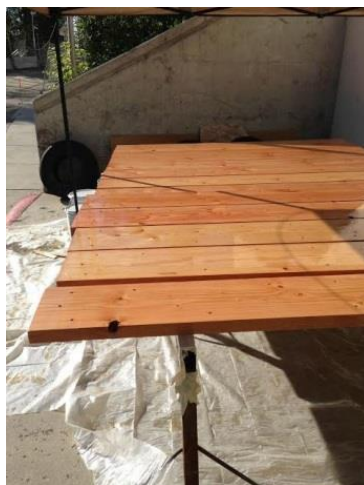
Figure 33: Planks drying after sealing

11. Set out even amounts of epoxy and hardener.
12. Set out a 3–5% by volume amount of isopropyl alcohol.
13. Mix the epoxy and hardener with a low-speed drill; be careful not to mix too fast to avoid unnecessary air formation. Mix for 1 min.
14. Add the isopropyl alcohol, and continue to mix for 2 min.
15. When mixture is well mixed, apply to the boards on 5 of the sides (not the bottom) with a 3/16 in. notched squeegee or a paintbrush. When mixture has been well applied, allow to dry for at least 5–6 hr (Figure 33). Be sure that the coating on the boards is not tacky.

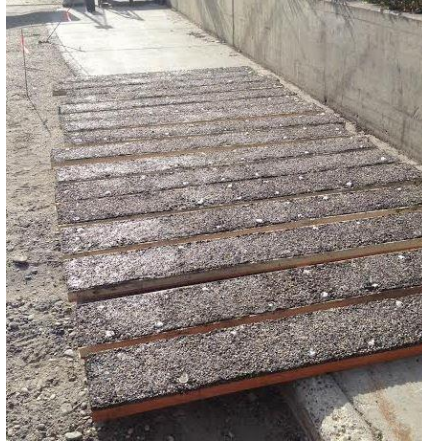
Figure 35: Planks drying.

14. Once the mixture is in place, liberally apply the local aggregate by broadcasting it across the top of the boards. The top of the boards should look like they are covered with evenly dispersed dry aggregate.
15. Allow the mixture to dry on a level surface for at least 6 hr (Figure 35).

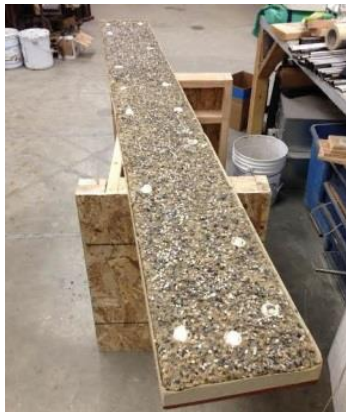
16. When the mixture has completely dried, remove the tape from the edges of the planks as well as the cotton balls inside the PVC pipe (Figure 36).

Figure 36: Removing tape and cotton balls.
