Study of plant fibre composites with damage induced by laser and mechanical impacts

Paweł H. Malinowski^{a,*}, Wiesław M. Ostachowicz^a, Fabienne Touchard^b, Michel Boustie^b, Laurence Chocinski-Arnault^b, Pedro Pascual Gonzalez^b, Laurent Berthe^c, Davi Silva de Vasconcellos^d, Luigi Sorrentino^d

Green composites
NDT
Laser shocks
Terahertz spectroscopy
Vibrometry
Impact damage

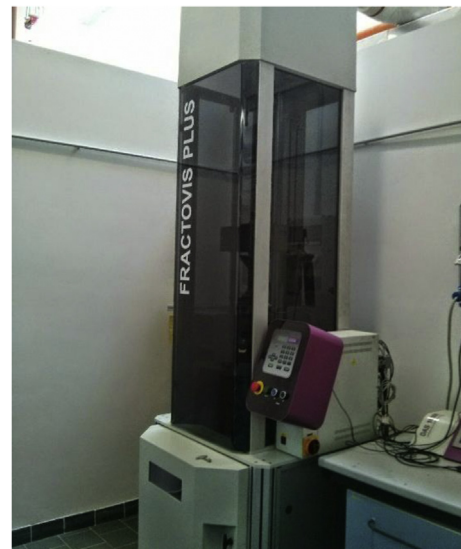
Fig. 6. Mechanical impact test stand.

The investigated samples were impacted by either a falling dart (Fig. 6) and a laser beam (Fig. 7). The mechanical impacts were performed at a velocity below 2 m/s to simulate the typical impact on

Fractovis Plus from CEAST (Pianezza - TO, Italy). The specimens were tested at energies in the range from 1 to 5J. The falling dart mass was constant (1.9265 kg), and the impact energy was changed by changing the impact height. The impact head was hemispherical, 12.7 mm in diameter. Samples damaged with mechanical impacts are coded with an additional 'M' (WA-M, TWA-M, BC3-M, etc.). The laser impact (laser shock) technique is a method that allows to achieve high levels of load inside the materials. It can be used for damage threshold analyses and allows, for example, the simulation of space debris and meteoroids impacts [20], assessment of adhesive bonds quality [21], or fibre/matrix interface study [22]. The laser beam causes the sublimation of the matter on sample surface, and the plasma created induces a reaction force in the form of a pressure shock wave that propagates through the material, thus applying a high tensile loading state (Fig. 8). All the samples were tested at six different laser shock intensities, keeping constant the shock beam diameter (6 mm) and the pulse duration (10.2 ns). Samples tested by the laser are coded with an additional 'L' (WA-L, TWA-L, BC3-L, etc.). Representative samples after each type of impact testing are reported in Fig. 9.

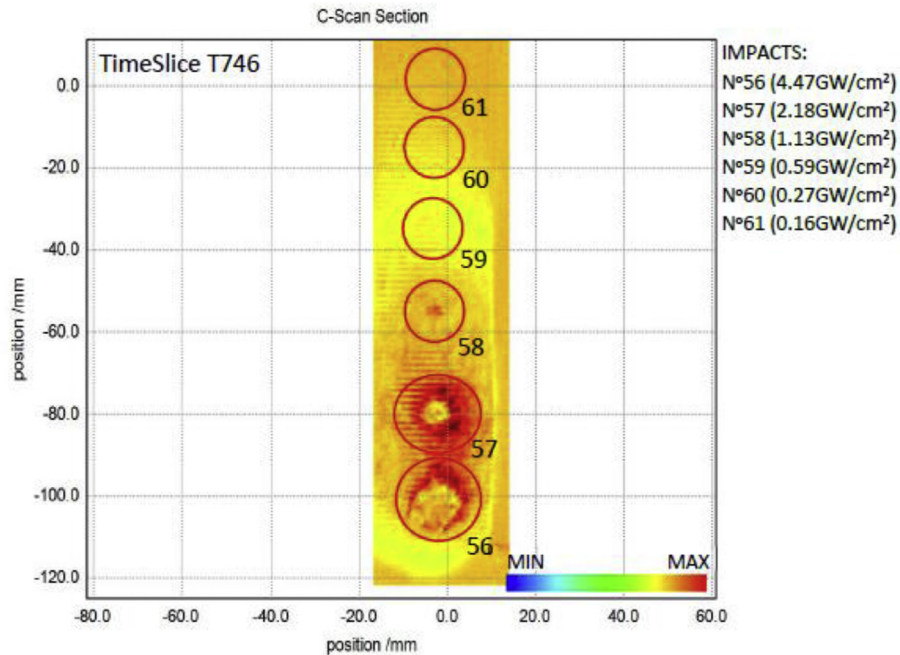
Fig. 13. C-Scan section of BC4-L sample obtained with terahertz spectroscopy.

Terahertz spectroscopy was used because polymer composites made out of electrically not conducting materials can be analysed by using electromagnetic radiations in the terahertz frequency range. Terahertz spectroscopy technique in the time domain (THz-TDS) proved to be a suitable method for the detection of internal defects like delamination in composite materials [23], [24]. According to [25] delaminations and moisture contamination can be visualized using TDS terahertz spectroscopy but the effectiveness depends on depth, matrix material, and size of the defect. The terahertz spectrometer used was TPS Spectra 3000 from Teraview (Cambridge, United Kingdom) with radiation in the 0.1–3 THz range. The spectrometer is equipped with a moving table to apply x-y movements and scan large objects (Fig. 12a). The scanning heads operated in both reflection and transmission modes [23] [24]. The C-scan of a representative sample is depicted in Fig. 13. The sample was impacted with laser at 6 locations, and the most intense damaged locations can clearly be identified (no. 56, 57 and 58).

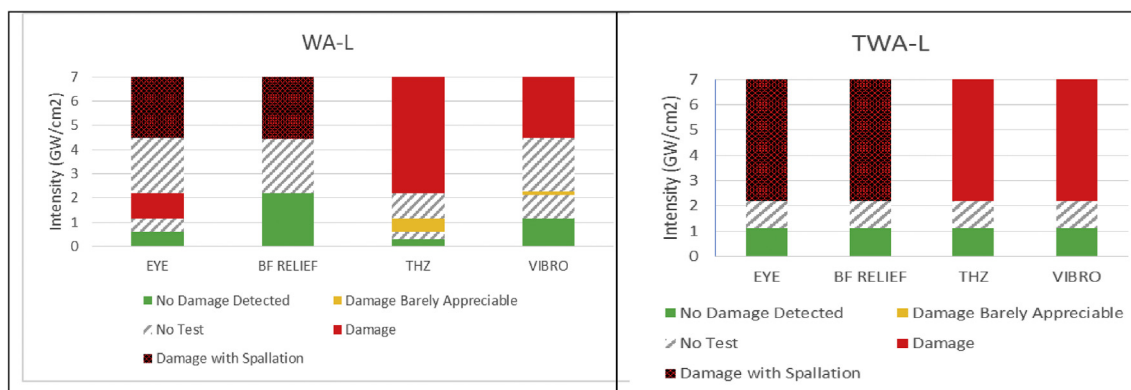
Fig. 18. Damage detection thresholds of WA-L and TWA-L samples.

The results for laser impacts on samples with short fibres are presented in Fig. 18. The initiation of damage was observed already below 1 GW/cm² using the terahertz-based method in WA-L while in the case of TWA-L no damage was observed by any of the analysis methods after the impact at 1 GW/cm².
