Estimating Structure Response and Progressive Failure of a Ship Hull under Side-Bow Collisions

Abstract: This paper presents an analysis of the side hull in marine steel structures under accidental collision phenomena. The type of side collision considered in this work is where the striking ship penetrates the struck ship. First, the configuration of the collision phenomenon is defined, including the ship geometry, mechanical properties of the material, and applied parameters. The collision scenarios are built by applying external dynamic parameters, including target location and striking velocity. Impact locations are determined on three different regions of the struck ship's side hull: the fore-end, middle-hull, and after-end regions. These are discussed, followed by results based on the applied velocity. Second, the tendency of the collision energy is evaluated to observe the structural behaviour on the struck ship's side hull during penetration by the striking ship. Progressive failure is summarised based on the results of two parameters, and the material model is confirmed by comparing the collision energy with pioneering work on ship collision.

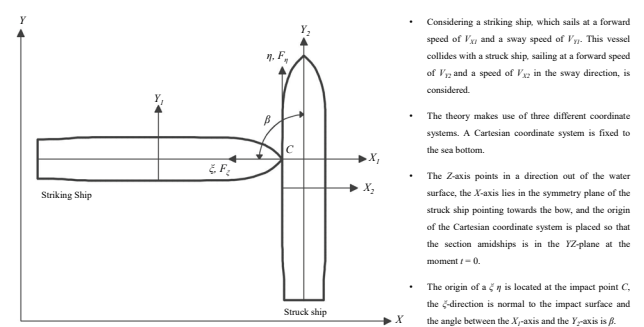
Figure 1 Simplified coordinate system of a ship collision

Ship collision is considered an accidental event in the field of marine engineering. This phenomenon is complex, because various parameters may be involved in a single collision case. In an effort to simplify a collision, the simplified coordinate system (Fig. 1), is presented. As stated in Newton's third law of motion, for every action, there is an equal and opposite reaction. This law indicates that every physical contact to an object involves action and reaction phenomena.

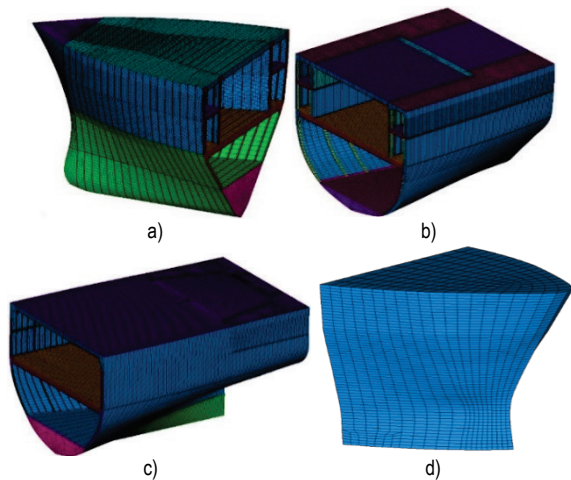
Figure 2 Geometrical model of the involved ships. The deformable struck ship is divided into three regions: (a) fore-end, (b) midsection, (c) after-end. Presented model (d) is the striking ship

A collision incident involving a RoRo and cargo reefer was considered as a reference for the numerical simulation. The RoRo passenger ship was the steel-plated structure of the struck ship. Meanwhile, the cargo reefer acted as a striking bow to penetrate the struck ship. This entity was modelled as a rigid body to focus all the damages that occurred on the struck ship. The principal dimensions for both the struck ship and the striking bow are presented in Tabs. 1 and 2. During the collision analysis, the steel-plated hull of the struck ship was divided into three regions: fore-end, midsection, and after-end (Figs. 2a-c). The geometry of the striking bow is shown in Fig. 2d.

the collision energy's increment as a crashworthiness criterion. As shown in Fig. 2 for the geometrical model of the struck ship, certain regions have different structural arrangements, i.e., the fore-end and midsection have a double-hull structure, whereas the after-end is a single hull. Therefore, it is necessary to conduct overall observation of the struck ship's hull. The after-end region is shown in Fig.5, the midsection is shown in Fig. 6, and the tendency of the fore-end region is shown in Fig. 7.

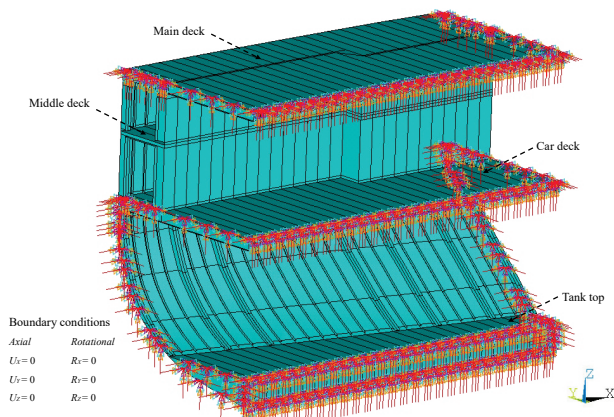
Figure 3 Application of the boundary conditions on the struck ship. Arrows denote location of the boundaries.

The boundary conditions (Fig. 3) were applied on the end of the struck ship's model, according to a recent recommendation of Prabowo, which was set to be fixed on the centreline, and the end of model was clamped [31,32]. The fixation was applied on the transverse frames, and the axial displacement of the longitudinal members was restrained. Based on design research on ships transporting nuclear materials, the crashworthiness of these ships under worst-case conditions was the primary concern. A totally inelastic right-angle collision with the struck ship at rest was considered the worst case. Hence, the majority of currently available models consider only right-angle collisions and assume that the kinetic energy parallel to the struck ship's centerline is negligible. In this study, this concept was applied to the involved ships where the struck ship is standstill in the collision process, while the striking ship penetrates the struck ship while its rotation is assumed to be zero. The most popular of these approaches is the one proposed by Minorsky which is based on several assumptions: the collision is completely inelastic, the system kinetic energy along the struck ship's longitudinal direction is negligible [33] and the rotations of the struck and striking ships are small and can be neglected.

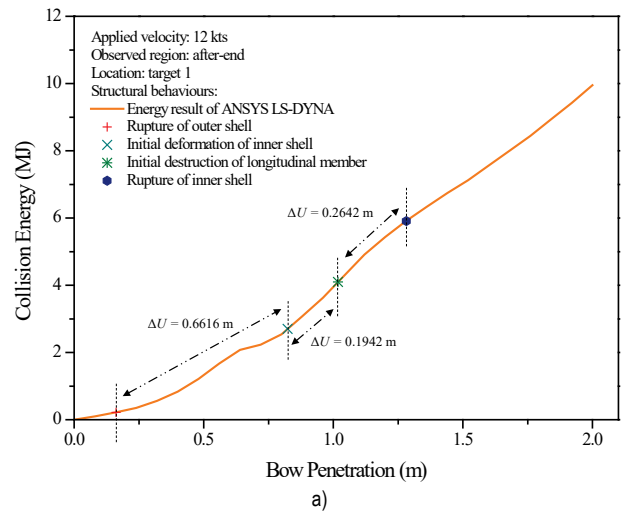
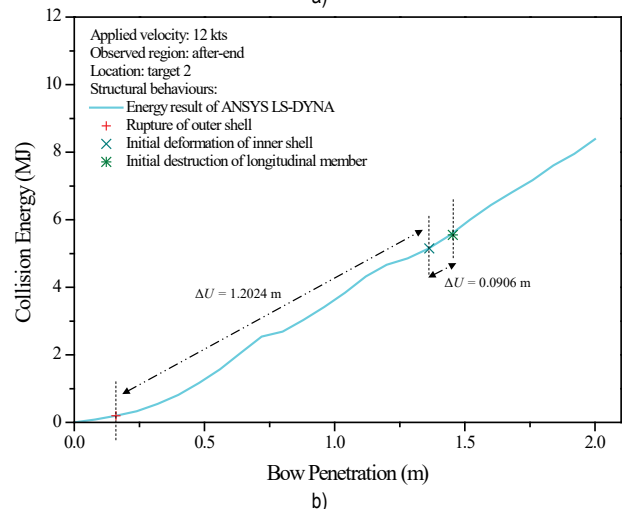
Figure 5 Structural behaviours on the after-end: (a) target 1 and (b) target 2

In the graphs of the collision energy (Figs. 5 to 7), the deformation of the outer shell is not shown, because the deformation began several seconds after the striking bow and struck ship contacted each other or, in other words, it happened shortly after collision started. The middle deck and side stringer dominated the deformation and rupture of the longitudinal members. Only these members were highly involved in the deformation process, because the struck ship was built using transverse framing systems.

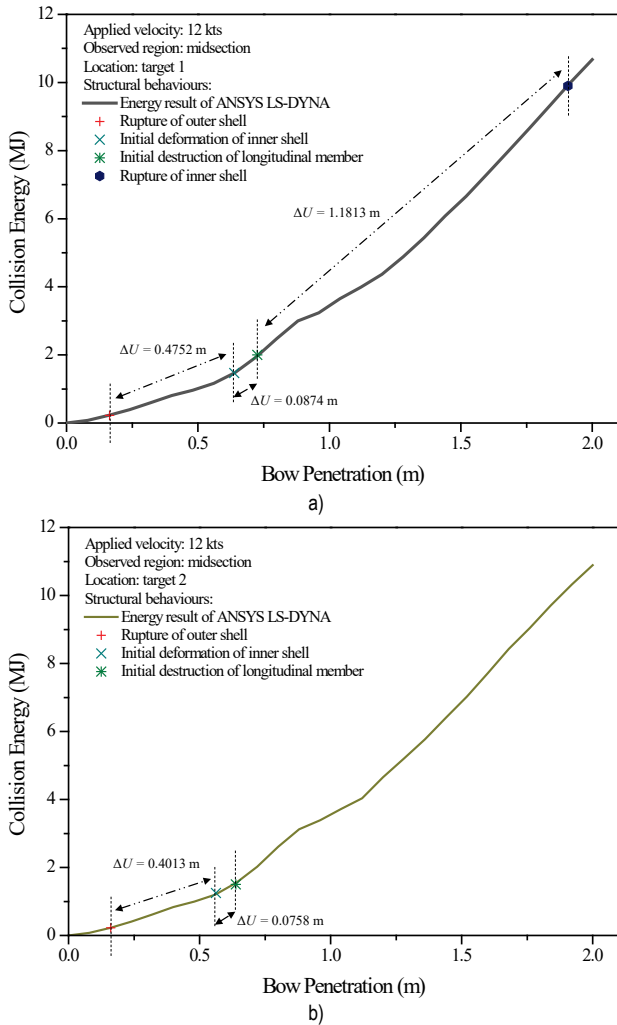
Figure 6 Structural behaviours on the midsection: (a) target 1 and (b) target 2

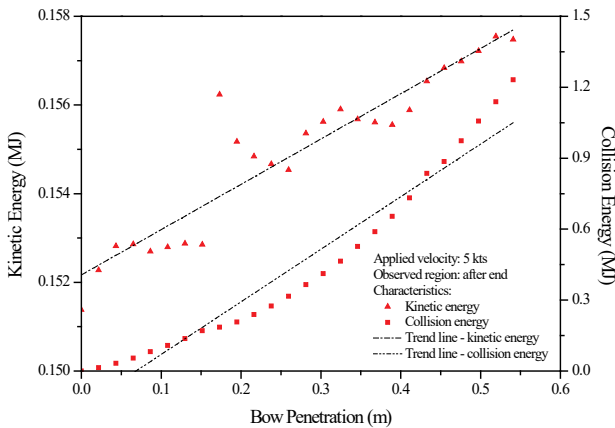
Figure 8 Energy characteristic of the impacted after-end region: the applied velocity 5 kts

In terms of the striking ship's velocity during contact with the struck ship, the results of numerical analysis are presented in Fig. 8 for collision with $V = 5$ kts on the after-end region. The other results are presented in Figs. 9 and 10 for the applied velocities 10 and 15 kts, respectively.

A summary of the energy (trend line of the kinetic and collision energy in Figs. 8 to 10) indicated that the increment of the kinetic energy caused by velocity variations was equally perpendicular with deeper penetration and higher collision energy. Besides reflecting the maximum damage extent on the side structures, the collision energy in the deepest bow penetration provided an indication of the structural strength against marine accidental load.

8 to 10) represented the energy of the striking ship when it was impacting the struck ship. The fluctuation in the results indicated that, after several meters of penetration, the kinetic energy rose and reduced at certain locations. When the energy rose, it implied that the structure on that location needed higher energy to be penetrated or the structure to be more robust than other structures at different locations. The reduction of energy occurred after the penetrated structure experienced rupture. This phenomenon is illustrated in Fig.

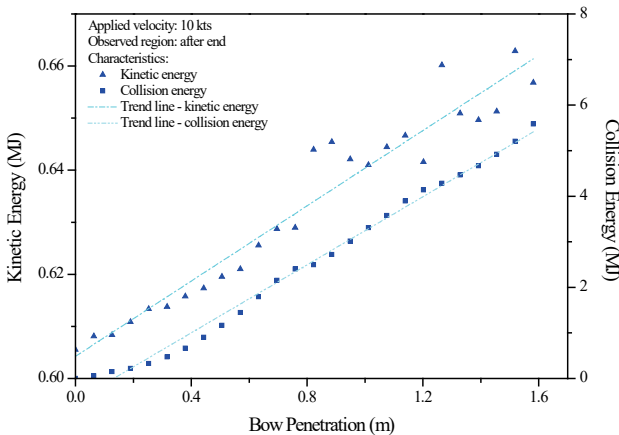
Figure 9 Energy characteristic of the impacted after-end region: the applied velocity 10 kts

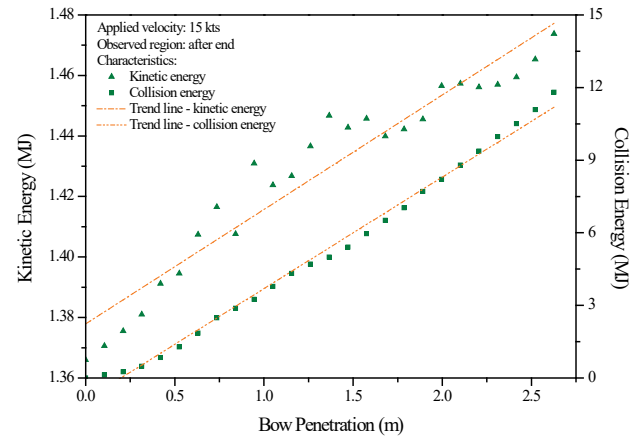
Figure 10 Energy characteristic of the impacted after-end region: the applied velocity 15 kts

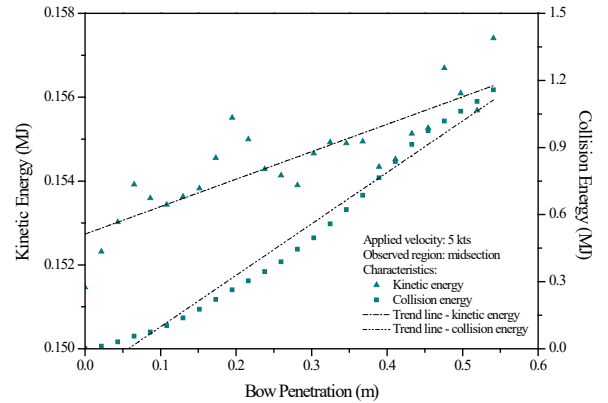
Figure A-1 Energy characteristic of the midsection with striking velocity = 5 kts

More details on the collision energy for each region with different velocities are given in Appendix A.

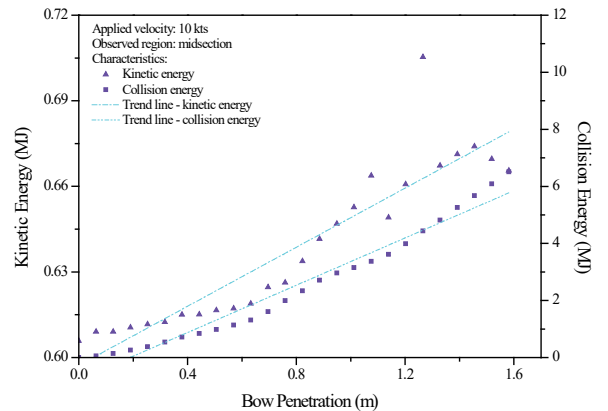
Figure A-2 Energy characteristic of the midsection with striking velocity = 10 kts

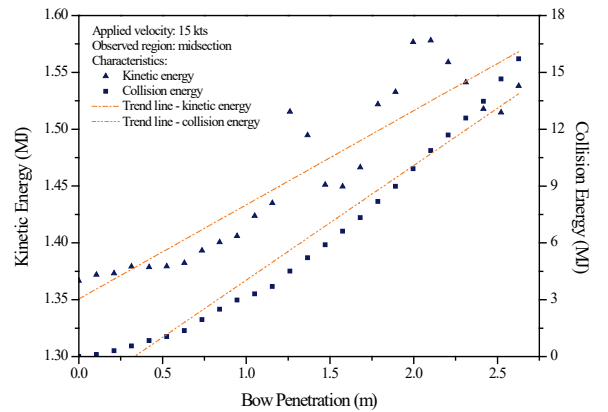
Figure A-3 Energy characteristic of the midsection with striking velocity = 15 kts

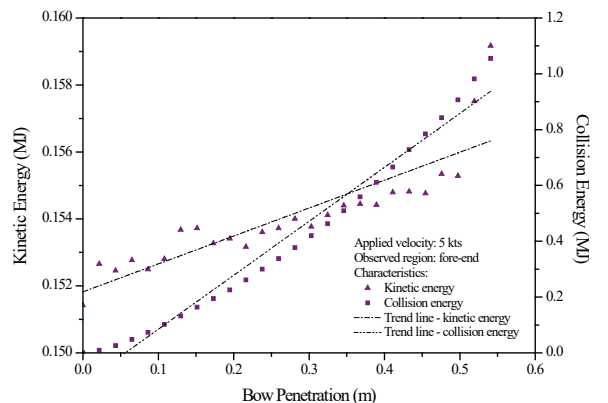
Figure A-4 Energy characteristic of the fore-end with striking velocity = 5 kts

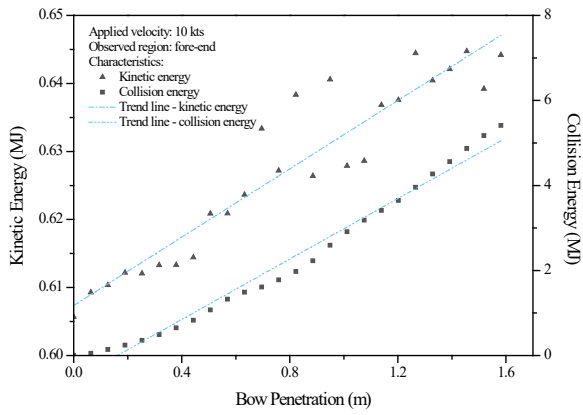
Figure A-5 Energy characteristic of the fore-end with striking velocity = 10 kts

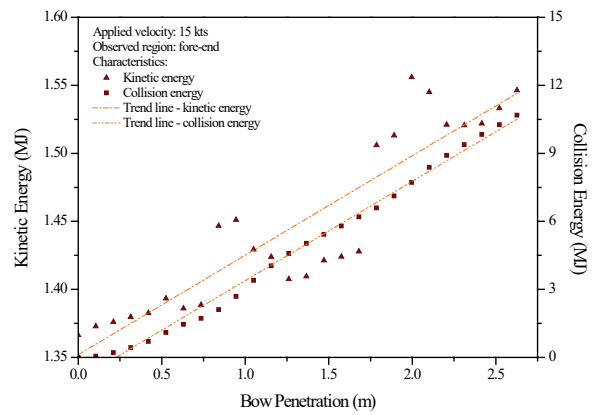
Figure A-6 Energy characteristic of the fore-end with striking velocity = 15 kts
