### Tension and compression behavior of corroded steel beams rehabilitated with BFRP

# **Tension and compression behavior of corroded steel beams rehabilitated with BFRP**

Submitted to the Faculty of Graduate Studies  
through the Department of Civil and Environmental Engineering  
in Partial Fulfillment of the Requirements for  
the Degree of Master of Applied Science  
at the University of Windsor

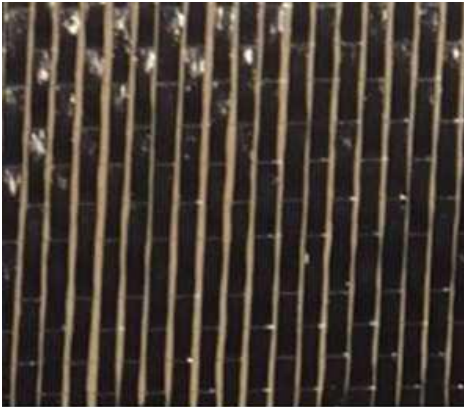
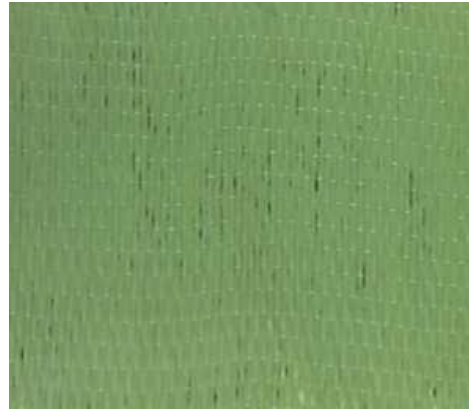
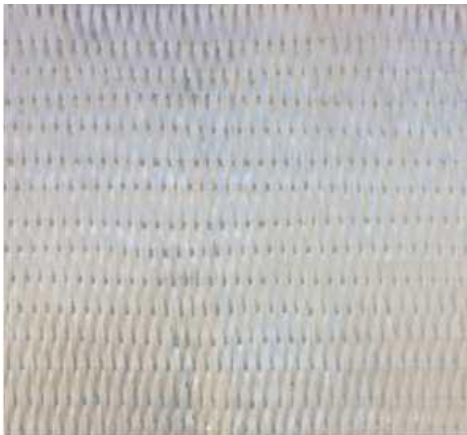
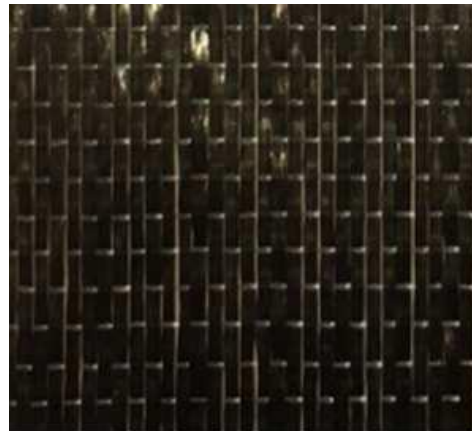
1.1a. Carbon fabrics

1.1b. Aramid fabrics

1.1c. E-glass fabrics

1.1d. Basalt fabrics

Figure 1.1: Different types of fabrics

The FRP consists of two component and these are fabrics and matrix. The fabrics consist of uniaxial or biaxial orientation of fibres. Fabrics are available in either thin sheet consisting of single layers of fibres or prefabricated FRP plates which consist of multiple layers of fabrics with various thicknesses. Figure 1.1 shows the different types of fabrics discussed. The matrix or epoxy is the material through which stresses are transferred between the fibres in the FRP composite. The matrix is also used to bond the fibres sheet to the structure. Matrix or epoxy can be either thermosetting or thermoplastic materials. Thermosetting matrix can be polyester, vinyl ester, and epoxy resin. Thermoplastic materials include polypropylene and polyethylene. Thermosetting materials are cost-effective and

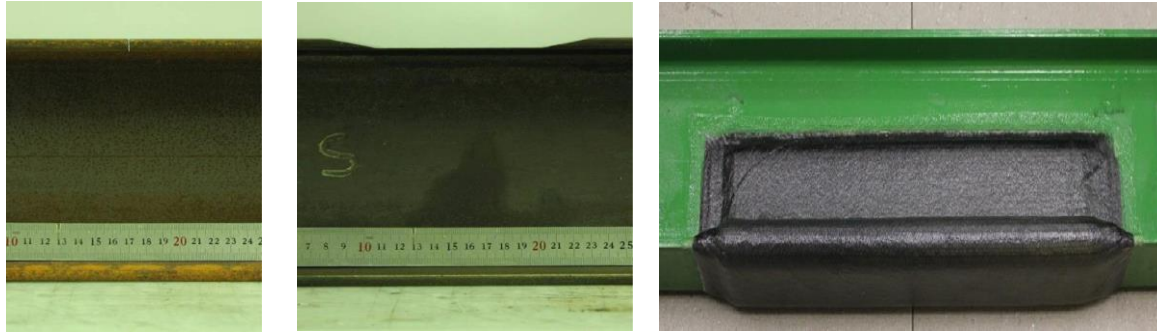
1.2a. Crack defect  
(Malano et al.)

1.2b. 80% Corrosion defect  
(Malano et al.)

1.2c. Repair pattern  
(Malano et al.)

Figure 1.2: Different types of corrosion defects (Malano et al.)

Manalo et al. [20] rehabilitated 3 m long steel I-beams with CFRP fabrics. Damage was introduced in the steel beams in the form of a 1 mm rectangular notch through the span width at the mid-span to simulate crack and 80% of the flange thickness removed to simulate corrosion as shown in Figure 1.2. For rehabilitation firstly, the surface was prepared by introducing surface roughness by grit blasting. This is to ensure good bonding between the steel and CFRP fabrics. The ends were tapered to prevent stress concentration. A layer of glass tissue was inserted between the CFRP and steel layer to prevent galvanic corrosion. Fifteen layers of CFRP fabrics were used for rehabilitating the crack and 11 layers of CFRP fabrics were used for rehabilitation of corrosion defect. Each layer of CFRP fabric measured about 1 mm. The maximum load carrying capacity of the crack beam when rehabilitated increased by 3% as compare to the original (undamaged) beam and the maximum load carrying capacity of the beam with 80% corrosion increased to 8%. There was also a marginal increase in the yield load. The repaired beam also exhibited a 16% increase in the elastic stiffness. It was also suggested to maintain an adequate thickness of the epoxy layer as thicker epoxy layer could increase the chances of debonding failure.

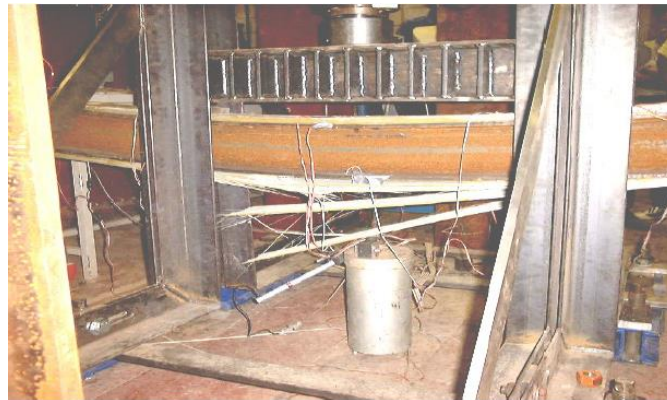
Figure 1.3: Failure mode observed in the rehabilitated beams (El Damatty et al.)

El Damatty et al. [23] strengthened steel I-beams of section W150x37 [22] using 19 mm thick GFRP plates. The GFRP plates were formed by pultrusion process using unidirectional layers of GFRP sheets to provide strength and stiffness in the longitudinal direction. The plates were attached to the steel beams using a methacrylate adhesive system which is a heavy-duty adhesive system. The beams were sandblasted initially to prepare the surface for rehabilitation and ensure good bonding between the plates and the steel. The strengthened beam was cured for 15 days before it was tested in four-point bending as shown in Figure 1.3. It was observed that there was an increase in stiffness of about

15%, the yield load of the strengthened beams showed an increase of about 23% and the ultimate load of the strengthened beam increased to about 78% as compared to the reference (undamaged) steel beam. There was no failure observed at the interface of steel and GFRP indicating very good performance of the adhesive used. The mode of failure observed was a sudden drop in load value due to the tensile failure of the GFRP fabrics. Hence, it can be concluded from the studies that both CFRP and GFRP fabrics as well as plates can be effectively used for rehabilitation or strengthening of steel beams. The advantages of FRP fabrics over plates is fabrics can be applied to a structure of any shape making it possible for rehabilitation. However, FRP plates can only be applied to flat surfaces.

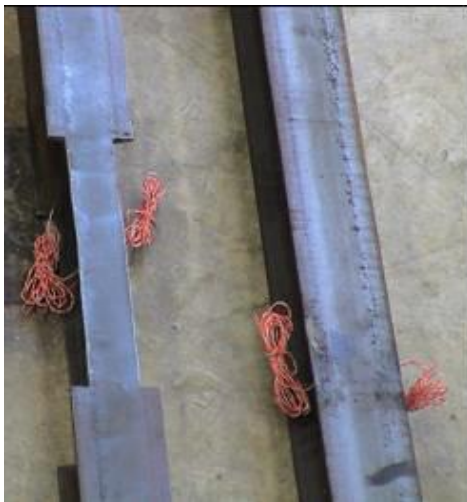
Figure 1.4: Damage pattern in the section  
(Liu et al)

Only a handful number of researches were found which focusses on rehabilitation of steel members in compression. Liu et al. [30] conducted testing on seven steel I-section columns with cross section of S4x9.5 [22] (depth of 101.6 mm and width of 71 mm) and 3.05 m length were tested. Damage was simulated in the columns by removing 15.9 mm from the width of both the flanges for a length of 300 mm along the center of the beam as shown in Figure 1.4. Six specimens were tested. Five of them had the damage and one had no defect. Damaged specimens were rehabilitated with GFRP pipe of different length to compare the effect of GFRP repair on the damaged beams as well as check the effect of development length. The columns were tested in axial loads with four lateral supports to ensure load applied to the center of the section. GFRP pipe or jacket was used for the rehabilitation and expansive concrete was placed in between steel and concrete for better confinement of the GFRP jacket to the steel section. The repair methodology was successful in increasing the axial strength of the members. The failure mode observed in the original (undamaged) specimens were buckling of the specimen at the mid-span. However, the rehabilitated column specimens failed at the jacket termination point as shown in Figure 1.5. With the rehabilitation, the ultimate load capacity of the specimen increased to a maximum 2.33 times to that of the damaged column and about 0.97 times to that of the original (undamaged) column specimen. It was observed that with the increase in the length of the repair the axial strength of the specimen also increased.

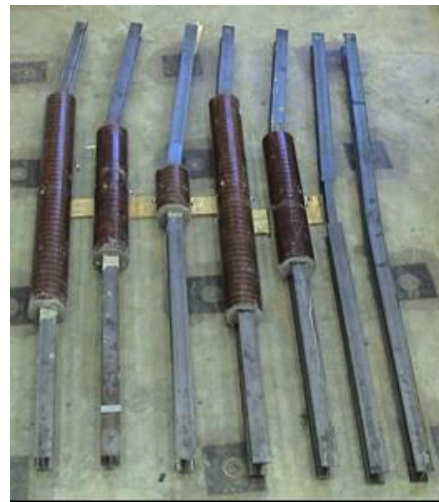
Figure 1.5: Failure type of Specimens  
(Liu et al)

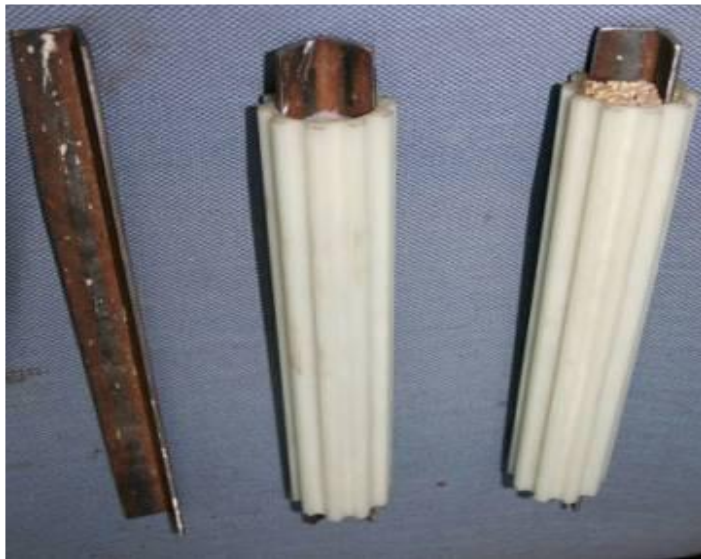
Figure 1.6: Control specimen along with two types of repair (Feng et al.)

fibre and vinyl resin with a petal shaped section of length 250 mm and inner diameter of 35 mm. The strengthened specimens were made with and without filling materials in between the FRP and steel as shown in Figure 1.6. The filling materials used in this study were high strength non-shrinkage grouts and bamboo splits after stewing and drying. It was found that due to use of filling materials the load increased much more than that when no filling materials were used. Fourteen specimens were strengthened and tested with both rigid and pinned boundary conditions. It was concluded that the technique used for strengthening was effective in increasing the axial compressive capacity of the specimens. The failure mode of the strengthened specimens changed from global buckling failure to localized failure which occurred at the end where the GFRP pipe terminates. The maximum load-bearing capacity of the strengthened specimens increased to 2.86 times that of the unstrengthened specimen. There was also an improvement in ductility of the strengthened specimens.

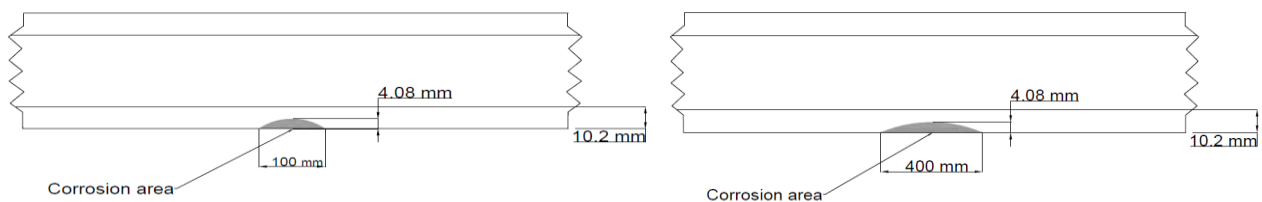
Figure 1.7: Corrosion profile of different shapes

For preparing specimens for rehabilitation, wide flange steel beams (I-shaped) of section W150 X 24 (CSA 2017) [22] were cut to a length of 2000 mm. Corrosion defect was simulated in the beams by removing a maximum of 40% of the flange thickness using a Computer Numerical Control (CNC) machine. Two different aspect ratios of corrosion patch were simulated in the beams, aspect ratio of 1 and aspect ratio of 4 as shown in Figure 1.7.

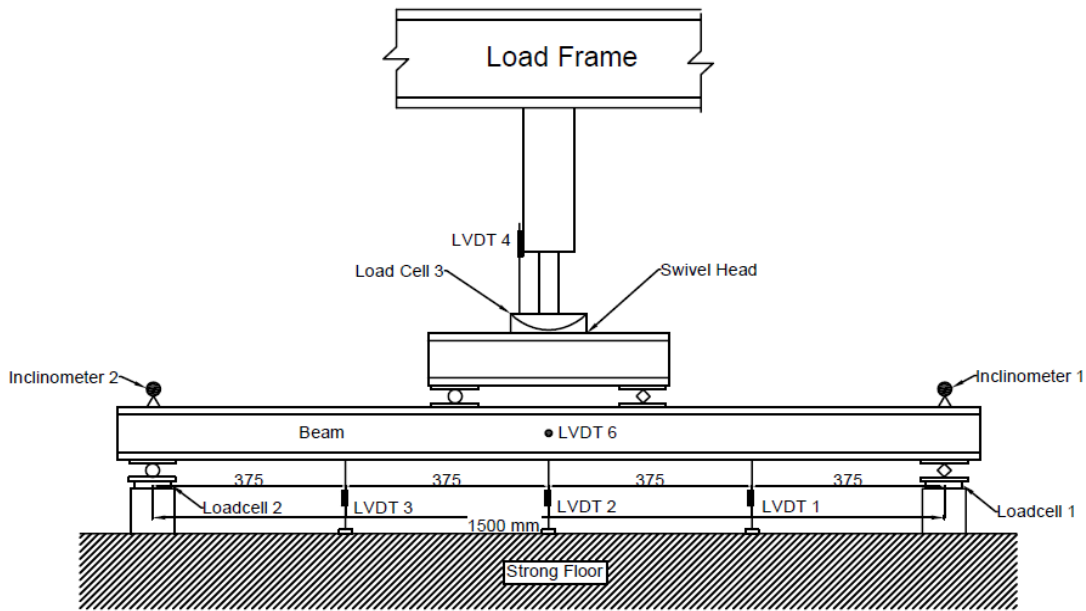
Figure 1.8: Schematic view of the test setup

The beams were tested with a four-point bending loading as shown in Figure 1.8. This setup was used to have a constant moment along the mid-span of the beam section in which corrosion was simulated and rehabilitation was done. The beam specimen as well as the spreader beams had a pin and roller boundary conditions. The spreader beam is a steel beam of length 800 mm with a very high stiffness value. The span length of the beam specimen was 1500 mm. The load was applied through a loading actuator to the spreader beam. The load was then transferred from the spreader beam to the specimen through loading plates which were at a spacing of 500 mm. Five Linear Variable Differential Transformers (LVDTs) were used to obtain the deflections at various locations of the beams. Four of the LVDT's had a maximum stroke of 150 mm, which means the maximum deflection that could be recorded in the LVDT was 150 mm. The out of plane LVDT had a stroke of 75 mm. One LVDT was placed at the center of the beam, two other LVDTs were placed at 375 mm from the mid-span of the beam, one LVDT was used to monitor and record the out-of-plane deflection. One LVDT was part of the loading actuator and also measured the displacement at the mid-span of the specimen as shown in Figure 1.8. These data from the LVDT's were used to obtain and plot the load-deflection as well as moment-curvature relationships of the beams.

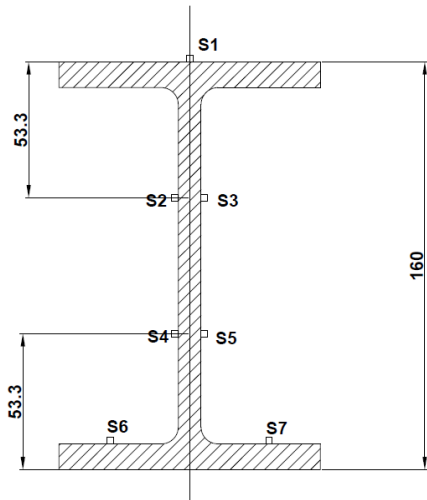
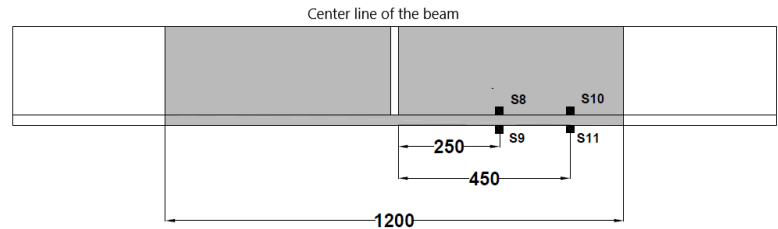
Figure:1.9a. Position of strain gauges at the mid-span of the beam

Figure: 1.9b. Position of strain gauges along the fabric

Figure 1.9: Position of strain gauges

Strain gauges were also attached to the beams. Kyowa strain gages of type KFRP-5-120-C1-1, having a gauge length of 5 mm and resistance of 120 ohms were used for all the experiments. For applying the strain gauge, the area was cleaned by fine grinding and further cleaned with acetone. This was to remove any grease, oil or dirt which might affect the strain reading and ensure good bonding with the steel. Loctite 401 was used as a glue to attach the strain gauges. The leads of the strain gauge were soldered with a wire which was connected to the data acquisition system. Electrical tape was used to cover the leads to avoid any contact with the steel and hence, to prevent electrical conduction. Seven strain gauges were attached to the mid-span of the beam for capturing the neutral axis depth during loading as shown in Figure 1.9a. Four strain gauges were attached at 250 and 450 mm away from the mid-span of the beam, one strain gauge was attached to the steel surface and one strain gauge was attached to the surface of BFRP at each location as shown in Figure 1.9b to check any debonding between BFRP and steel substrate.

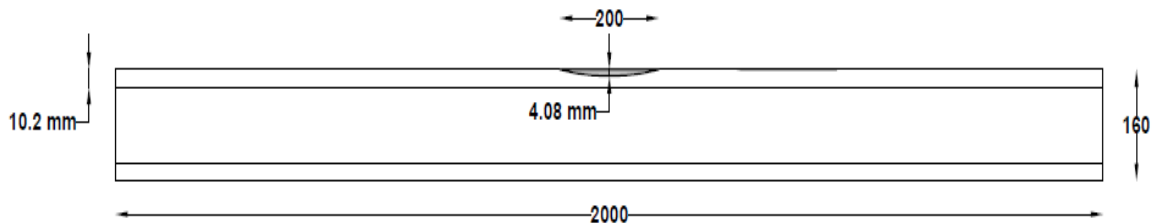
Figure 1.10: Corrosion profile of beam with 40% corrosion

Specimens having the same dimension as shown in section 1.3.1 were also used for this case. The corrosion for this case was also simulated using CNC machine. The corrosion was simulated by removing maximum 20% and 40% of the top flange thickness as shown in Figure 1.10.

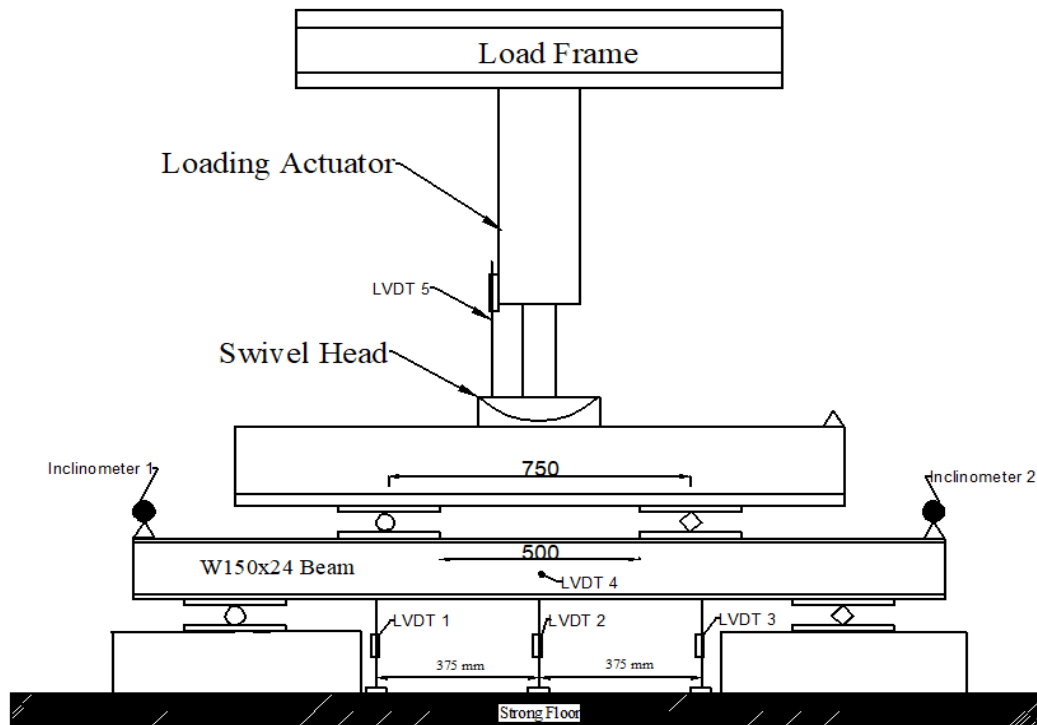
Figure 1.11: Schematic view of the test setup.

The beams were tested with a four-point loading setup as shown in Figure 1.11. This setup is similar to the setup showed in section 1.3.1. The difference, in this case, was to use a longer spreader beam of length 1200 mm and the spacing between the point of application of the load to the specimen was 750 mm. The position of LVDT's was similar to that discussed in section 1.3.1.

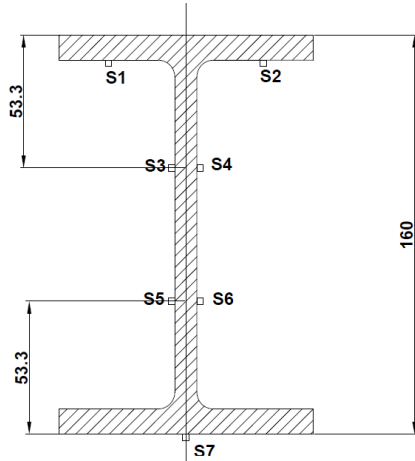
Figure 1.12: Position of strain gauge at the mid-span of the beam

Strain gauges were also used in this setup. The same type of strain gauge was used as described in Section 1.3.1 and attached using the same procedure. However, the point of application of strain gauges is different. Seven strain gauges were attached to the mid-span of the beam for capturing the neutral axis depth during the application of load as shown in Figure 1.12. Two strain gauges were attached at 200 mm from the center of the beam, one strain gauge was attached to the steel substrate and one strain gauge was attached to the BFRP as shown in Figure 1.13. to check any debonding between BFRP and steel.

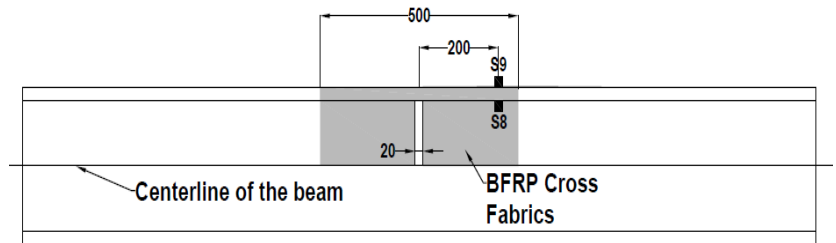
Figure 1.13: Position of Strain gauges along the length of the BFRP fabric

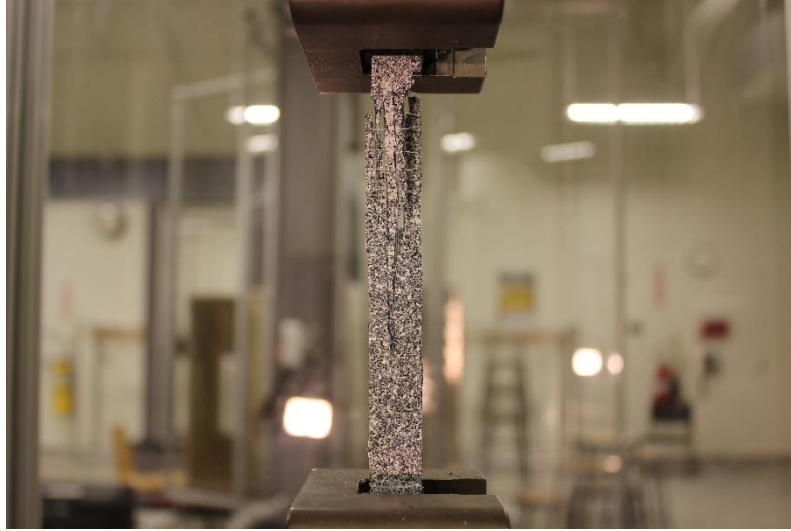
Figure 1.14: Test setup for tension test

The tensile properties of BFRP fabric were determined by conducting tests as per ASTM D3039/D3039M-14 standard (ASTM 2014) [32]. Using the standard specification, the coupons were made to a length of 250 mm, a width of 15 mm, and a gauge length of 138 mm. The thickness of the specimen was dependent on the thickness of BFRP. The BFRP fabrics used in this study had a thickness of 0.45 mm. Tabs were used to tap the ends of the coupon to the grips of the testing machine. Four tabs made of GFRP circuit boards were used for tapping one coupon specimen. The tabs were epoxied to the specimen for smooth transfer of load as per the standard. The fibres were aligned to 0 degrees and 90 degrees with the load application direction, to obtain the tensile properties both along and across the fabric direction. The test setup of the tensile test is shown in Figure 1.14. Digital Image Correlation (DIC) technique was used for the analysis of the data.

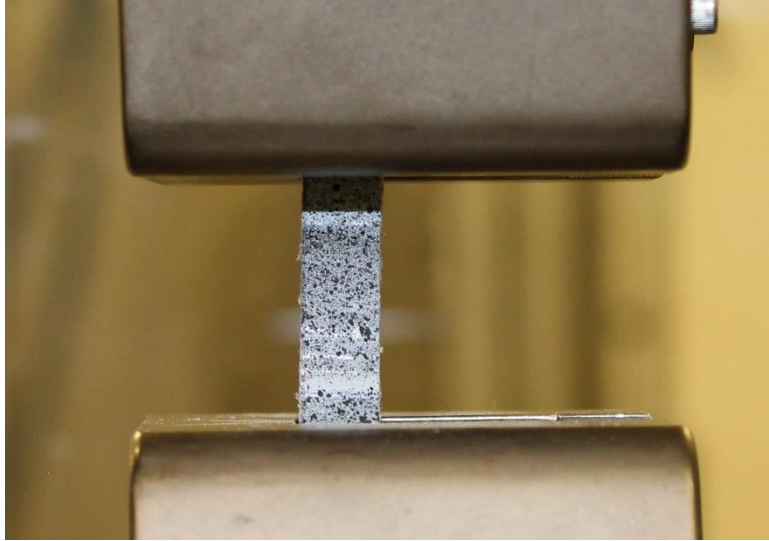
Figure 1.15: Test setup for compression test

The compressive properties of BFRP were determined by conducting tests as per ASTM D3410/D3410M-16 standard (ASTM 2018) [33]. Using the standard specification, the coupons were made to a length of 150 mm, width of 10 mm, and a gauge length of 20 mm for the 0-degree specimens. A width of 25 mm was used for the 90-degree specimens gauge length and total length was same as that of 0-degree specimens. The thickness of the specimen was dependent on the thickness of BFRP. The minimum thickness required for BFRP fabrics was 3.77 mm. Hence, 8 layers of fabrics were used in this study. Tabs were used to tap the ends of the coupon to the grips of the testing machine. Four tabs made of GFRP circuit boards of length 65 mm were used for tapping one coupon specimen. The tabs were epoxied to the specimen for smooth transfer of load as per the standard. The fibres were aligned to 0 degrees and 90 degrees with the load application direction to obtain the compressive properties both along and across the fabric direction. The test setup of the compressive test is shown in Figure 1.15. Digital Image Correlation (DIC) technique was used for the analysis of the data.

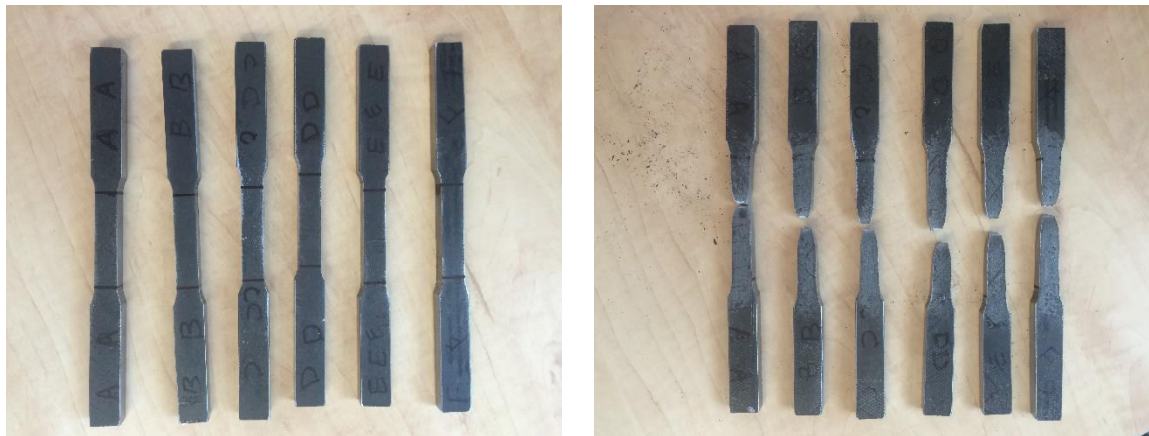
Figure 1.16: Steel specimens before and after testing

The tensile properties of steel specimens were found by conducting tests as per ASTM E8/E8M-15a standard (ASTM 2015) [34]. Using this ASTM standard, the modulus of elasticity, the yield strength, the yield point of elongation, and the tensile strength were determined. The test specimens were machined to a standard shape as per the specification and is shown in Figure 1.16. The rate of loading at the crossheads was set for a strain rate of 0.1 mm/mm/min. Extensometers were used to measure the strain of the specimen.

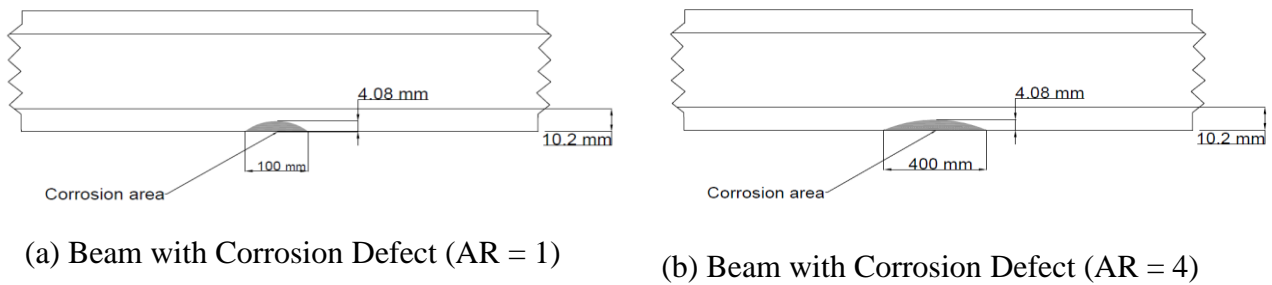
Figure 2.1: Corrosion profile of different shapes

In this study, a wide flange steel beam (I-shaped) with the designation of W150X24 (CSA 2017) [17] was selected for making all the beam specimens. Table 2.1 shows the test matrix used in the experimental program. A total of 10 steel I-beams were tested in this study. Three of these beams were control beams and seven were rehabilitated with BFRP fabric. The control beam that did not have any corrosion defect is called control uncorroded beam specimen or virgin beam specimen and it is identified as “UB” in Table 2.1. The remaining nine beams had corrosion defects. The width of the flange was 100 mm. The beam specimens were corroded through the width of the flange, but two corrosion length were considered. Four beams had a square corrosion shape, measuring 100 mm long x 100 mm wide or aspect ratio (corrosion aspect ratio of 1) and five beams had a rectangular corrosion shape, measuring 400 mm long x 100 mm wide (corrosion aspect ratio of 4). Two of these nine beams had corrosion defect, however, they were not rehabilitated and hence, they are called control corroded specimens (CC). These two beams are identified as “CC100” and “CC400”. In the specimen ID of these beams “CC” indicates control corrosion specimens; and “100” and “400” are the length of the corrosion defect with AR of 1 and 4, respectively. The flange thickness of steel beams was locally reduced to simulate loss of wall thickness due to corrosion as shown in Figure 2.1. The depth of corrosion was kept unchanged at 40% of the flange thickness for all the test specimens.

The specimen IDs of the beams rehabilitated with BFRP fabrics are “R100\_7L”, “R100\_10L”, “R400\_7L”, “R400\_10L”, “R400\_15L” and “R400\_20L”. The specimen ID of the rehabilitated specimens reflects the length of corrosion and the number of BFRP fabric layers used. For example, the specimen “R100\_7L” indicates that this specimen had a corrosion patch of 100 mm x 100 mm (aspect ratio or AR of 1) and the specimen was rehabilitated with seven layers of BFRP fabrics. One beam was rehabilitated with narrow strips of cross BFRP fabrics before the final rehabilitation pattern was determined and this specimen is identified as R100\_7L\_PC. Where, “PC” represents partial cross fabrics. The Specimen R400\_20L was tested to check the effects of applying very thick repair which will be discussed in detail in later sections.

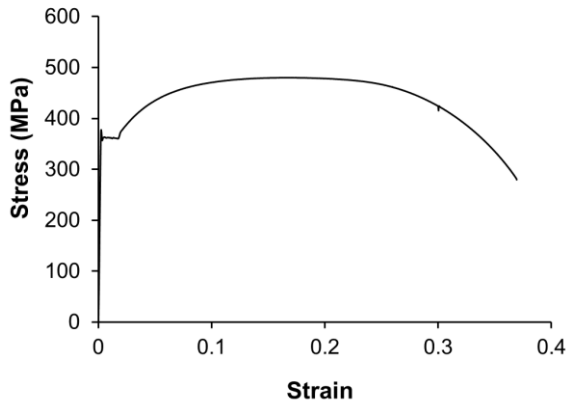
Figure 2.2: Stress-strain behavior of steel

Tension testing of coupon specimens made from these beam specimens was conducted in accordance with ASTM E8/E8M-15a (ASTM 2015) [18] to obtain the material properties of the steel beams. The results are presented in Figure 2.2. BFRP unidirectional fabric was used to rehabilitate the beams with corrosion defect. Tension tests were also conducted on coupons made from BFRP fabric as per ASTM D3039/D3039M-14 (ASTM 2014) [19]. The result obtained is shown in Figure 2.3.

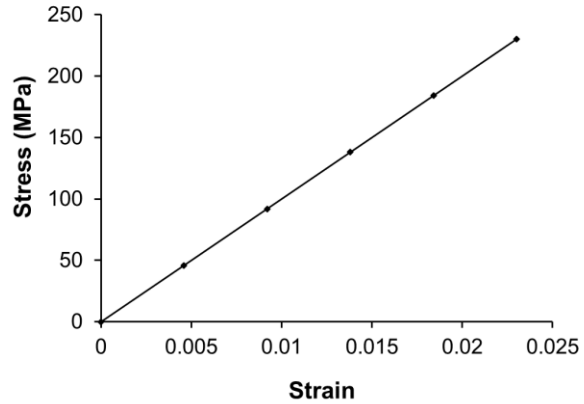
Figure 2.3: Stress-strain behavior of BFRP

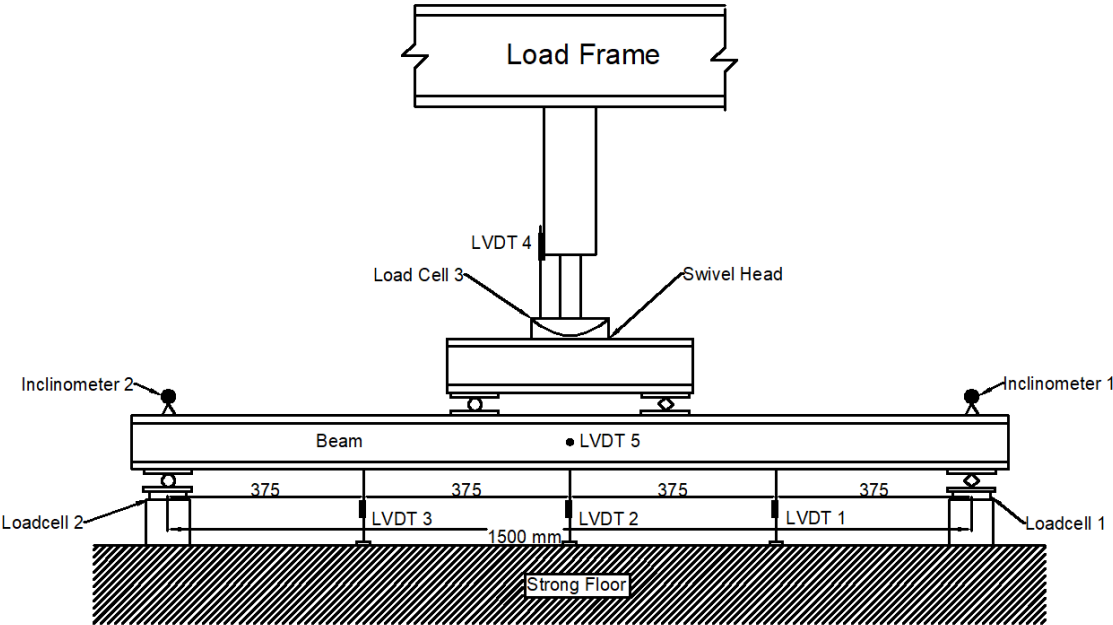
Figure 2.4: Schematic view of the test setup

The four-point bending load was applied to all beam specimens (Figure 2.4). The test setup involved the use of a loading actuator to apply the bending load on the test specimen through a spreader beam. Each beam was 2000 mm long and the span length of each beam was 1500 mm. A total of five Linear Variable Differential Transformer (LVDTs) were used in the setup. LVDTs were used to capture the

deflection values at the mid-span (LVDT 2 in Figure 2.4); at one-third distance from both supports (LVDT 1 and LVDT 3), at the top of loadcell 3 to verify the deflection values at the mid-span (LVDT 4), and to measure the out-of-plane deflection (LVDT 5). The data from LVDTs 1, 2, and 3 were used to obtain the deflection and curvature profile of the beam. Inclinometers were attached at both ends of the beam to check the symmetry of the setup during the application of load using the slope values. The beam specimens were loaded monotonically using the displacement control method. The photo of the experimental setup is shown in Figure 2.5.

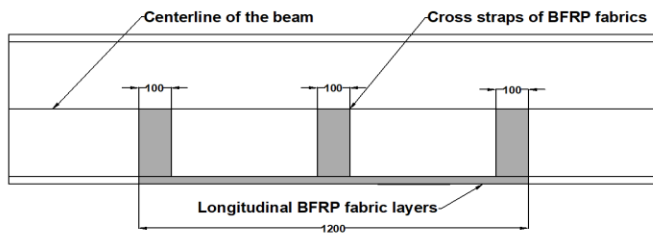
Figure 2.6: Repair pattern

The first objective of the test program was to develop a repair technique for the beams such that debonding or slippage of the fabric can be avoided. Hence, the first corroded beam specimen (R100\_7L\_PC) was repaired with seven longitudinal layers of BFRP and 100 mm wide BFRP cross straps were attached at three regions of the beam: at the mid-span and at two ends as shown in Figure 2.6. However, it was observed that debonding of the fabrics occurred in between two cross straps as shown in Figure 2.7.

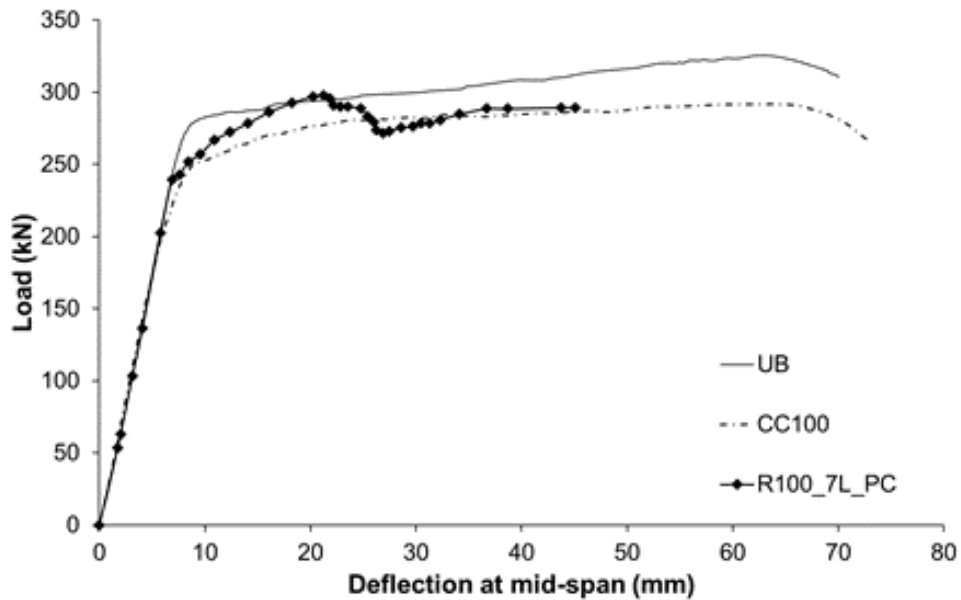
Figure 2.8: Comparison of Load-deflection curve of 40R100\_7L\_PC compare to control beams

The load-deflection curve of the R100\_7L\_PC and its comparison with the uncorroded control beam (UB) and the beam with control corrosion (CC100) is shown in Figure 2.8. The load value was obtained from the loadcell attached to the loading actuator and the deflection was measured from LVDT 2. It was observed that the load capacity of the repaired beam R100\_7L\_PC improved initially. However, at a deflection of about 20 mm, that is soon after yielding of the beam, debonding occurred and the load dropped to that of the control corroded beam specimen, CC100 beam. Hence, this repair scheme was not able to improve the load capacity of the corroded beam at higher deflection values since debonding occurred at an early stage of loading. Consequently, for rehabilitation of subsequent beams, it was decided to apply cross straps for the entire length of the repair to prevent the debonding. In a study conducted by Narmashiri et al [21] in 2012 it was also found that with a longer bond length, the chances of debonding of CFRP fabric failure reduced.

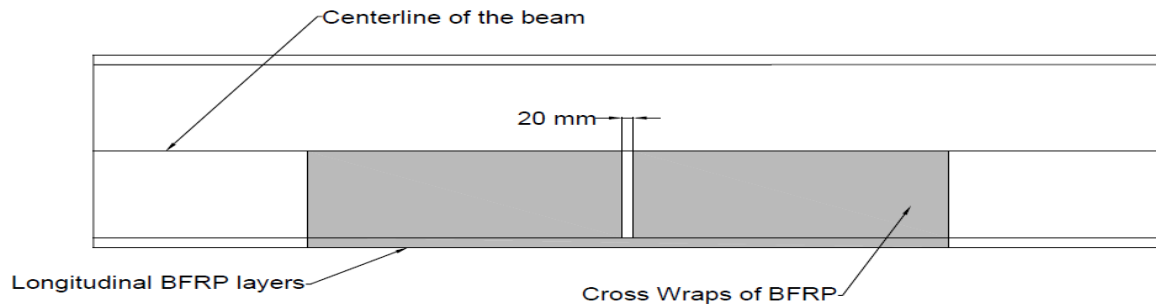
Figure 2.9: Schematic layout of the rehabilitation scheme

A schematic view and a photo of the repair scheme adopted for remaining specimens is shown in Figures 2.9 and 2.10. A 20 mm gap was provided at the mid-span of the beam to facilitate the attachment of strain gauges.

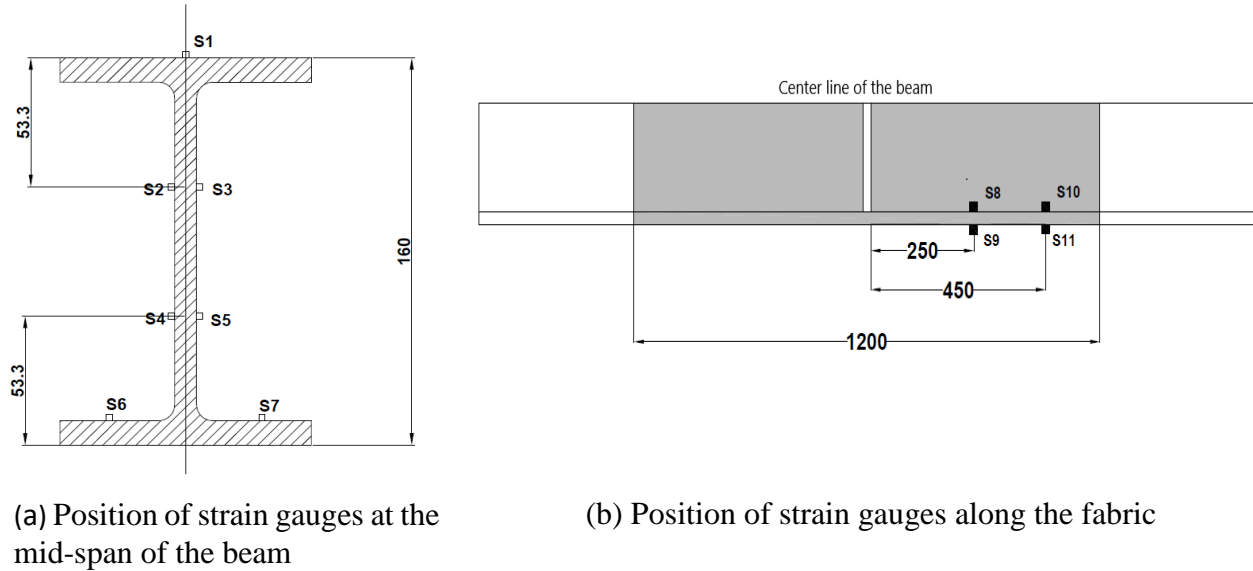
Figure 2.11: Position of strain gauges

Strain gauges were also installed to acquire strain values at various locations of the beam during testing. A total of 11 strain gauges were installed. Seven strain gauges (S1 to S7 in Figure 2.11a) were installed at the mid-span of the steel beam to study the change in neutral axis depth at different deflection values. Remaining four strain gauges (S8 to S11 in Figure 2.11b) were used to monitor any possible debonding or slippage between the BFRP fabrics and the steel substrate. Strain gauges S9 and S11 were installed on the BFRP fabric and strain gauges S8 and S10 were installed on steel substrate. The strain gauges S8 and S9 were located at 250 mm away from the mid-span of the beam whereas, strain gauges S10 and S11 were placed at 450 mm away. All the experiment data was collected using a data acquisition system connected to a computer.

The layout of the strain gauges is shown in Figure 2.11. All the strain values are shown in micro-strain ( $\mu\epsilon$ ). Strain gauges S1 to S7 were used to determine the neutral axis depth and strain gauges S8 to S11 were used for checking any debonding between steel and BFRP fabrics. The strain vs. mid-span deflection for specimen R400\_7L is shown in Figure 2.21. The strain values shown in Figure 2.21 are the strain values at the mid-span of the beam. Strain gauges S1 and S3 showed negative strain values since they were located at the compression zone. Strain gauges S5 and S7 showed positive values or tension. Strain gauges S1 and S7 were located at the extreme vertical faces of the beam or 53.3 mm from the mid-height of the beam. Strain gauges S3 and S5 were located at 26.7 mm from the mid-height of the beam. Hence, the strain values at strain gauges S1 and S7 for both tension and compression were higher than strain gauges S3 and S5.

Figures 2.22 and 2.23 present the strain values of the steel and BFRP at 250 mm and 450 mm from the mid-span of specimen R100\_7L, respectively (see Figure 2.11b for strain gauge locations). It was observed that the strain values of the BFRP (S9 and S11) were slightly higher than the strain values obtained from steel substrate (S8 and S10). This is due to the fact the distances of these strain gauges from the neutral axis were different. Distance of strain gauges S9 and S11 from the mid-height of the beam section was 83.15 mm and distance of strain gauges S8 and S10 was 69.9 mm. Nonetheless, the strain gauges showed similar strain patterns indicating that there was no debonding between the BFRP fabrics and steel substrate. It should be noted that the strain gages S9 and S11 were installed on BFRP fabrics and strain gauges S8 and S10 were installed on steel substrate (see Figure 2.11b).

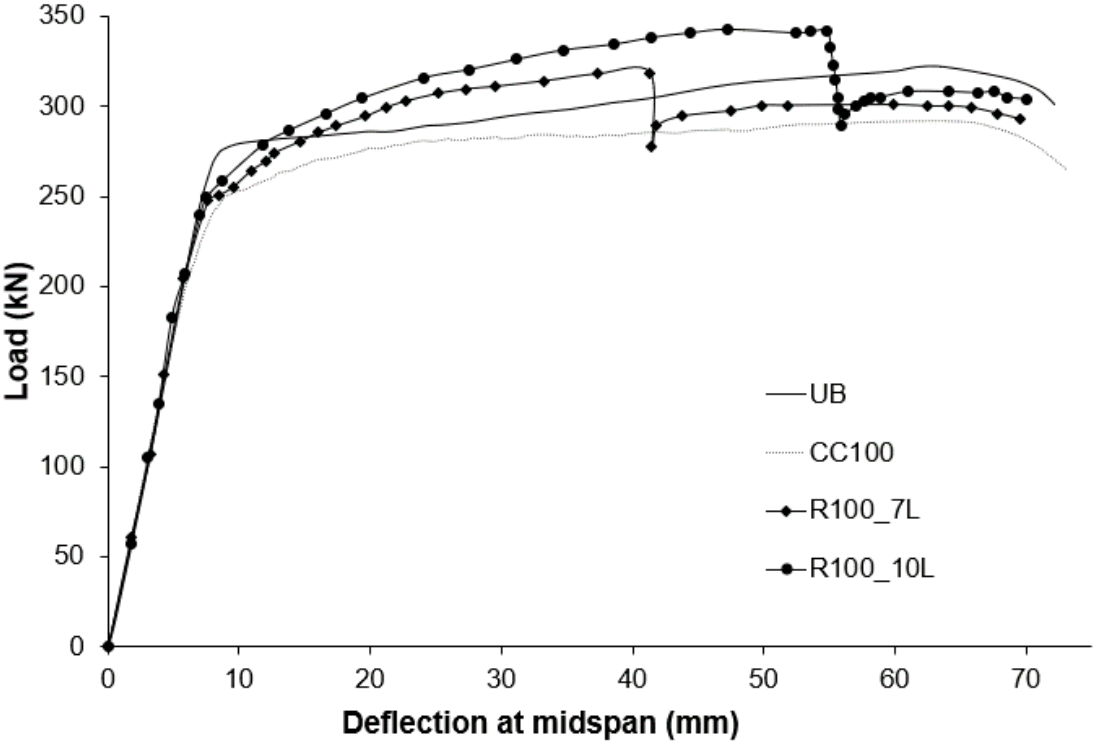
Figure 2.12: Load-deflection curves of beams with corrosion AR of 1

The load-deflection behaviors for each test are plotted. The deflection data was obtained from the LVDT located at the mid-span of the beam (LVDT 2). The load values were obtained from the loadcell attached to the loading actuator. Figures 2.12 and 2.13 show the load-deflection behaviors of the steel beams with 100 mm x 100 mm corrosion shape (AR of 1) and 100 mm x 400 mm corrosion shape (AR of 4), respectively. It was observed that for both corrosion aspect ratios, the load-deformation behaviors were similar. The rehabilitated beam first showed an elastic behavior until yielding occurred, then the non-linear portion started, and the load increased to its ultimate load, followed by a sudden drop in the load due to the rupture of the BFRP fabrics. This was followed by a slight increase in load because of the stress redistribution and the load value beyond the drop was slightly higher than the beams with control corrosion (specimens CC100 in Figure 2.12 and CC400

in Figure 2.13), indicating that the fabrics did not have any significant beneficial strengthening effect once the BFRP fabric ruptured. Similar behavior was also observed by Jayasuriya et al. [16]. Jayasuriya et al. studied the effect of depth of corrosion while rehabilitating the steel beam with BFRP fabric. Figure 2.14 shows the rupture of BFRP fabrics in the beam and Figure 2.15 shows the final deflected shape of the rehabilitated beam as observed in the experimental study.

From Figures 2.12 and 2.13, it can be concluded that the ultimate load capacity of the repaired beams increased as the number of BFRP layers increased. However, the literature review showed that the risk of de-bonding failure increases as the number of FRP layers increases. Sen et al. [5] found that after an optimum number of CFRP layers, the likelihood of de-bonding between CFRP composites and the steel surface begins to increase. In the current study a test was conducted on a corroded beam, with corrosion aspect ratio of four. This beam was repaired with 20 layers of BFRP fabric (specimen R400\_20L). The load-deflection behavior of this specimen is shown in Figure 2.17. This figure shows that the initial load-deflection behavior was similar to that of identical corroded specimen but repaired with 15 layers of BFRP fabric, specimen R400\_15L. However, at the mid-span deflection of about 17.5 mm, de-bonding of the BFRP initiated, which is indicated by the small drop in the load. Debonding of BFRP fabric continued until about 30 mm of mid-span deflection when BFRP fabrics ruptured. At this stage, load dropped significantly, and the beam was never able to regain a load value larger than that of control corrosion specimen, CC400. Hence, the performance of beam R400\_20L was unsatisfactory if compared with the performance of the beam R400\_15L. The debonding pattern of specimen R400\_20L can be found in Figure 2.18. Hence, this study indicates that using a very thick BFRP fabrics for repair of corroded beam needs to be avoided to eliminate

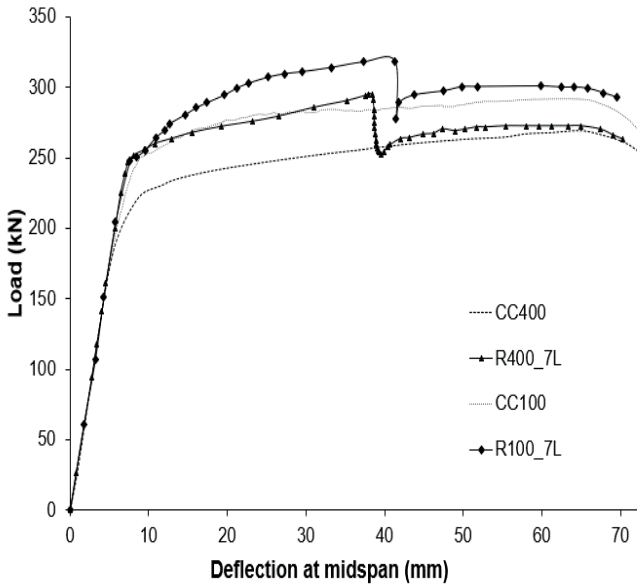
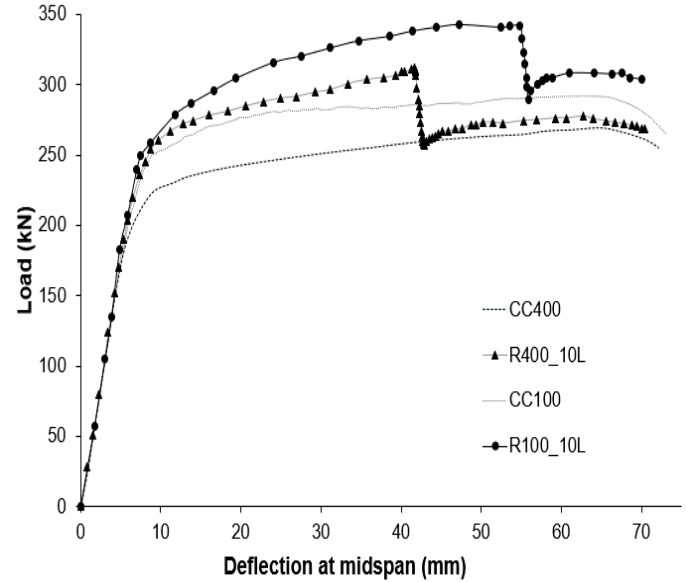
Figure 2.16: Load-deflection behavior for beams with same number of BFRP fabric layers

Figures 2.16a and 2.16b compare load-deflection behaviors of corroded beams with two different aspect ratios but rehabilitated with same number of BFRP fabric layers. Table 2.3 summarises the key information for these plots. It can be found from Table 2.3 that the increase in the ultimate load of the beam with a corrosion aspect ratio of 1 and rehabilitated with seven layers of BFRP fabric (R100\_7L) is 7% higher than the beam with a corrosion aspect ratio of four and rehabilitated with seven layers of BFRP fabric (R400\_7L). The deflection at the ultimate load also increased by 8.7 % when compared with specimen with corrosion aspect ratio of one, indicating a higher ductility for specimen with aspect ratio of one. Similar behavior is observed with beams rehabilitated with ten layers of BFRP fabric. The increase in the ultimate load of Specimen R100\_10L (AR = 1) compared to Specimen 40R400\_10L (AR = 4) is about 14% higher. Deflection at ultimate load also increased by 24% for Specimen R100\_10L. Hence, it can be concluded that for beams with corrosion of lower aspect ratio, the increases in the yield and the ultimate loads are greater than the beams with corrosion of higher aspect ratio if the number of BFRP fabric is kept unchanged. As well the ductility of the beams with a smaller corrosion aspect ratio is more than the ductility of the beams with a larger corrosion aspect ratio when same number of BFRP fabrics is used.

(a) Repair with 7 layers of BFRP for AR of 1 and 4

(b) Repair with 10 layers of BFRP for AR of 1 and 4

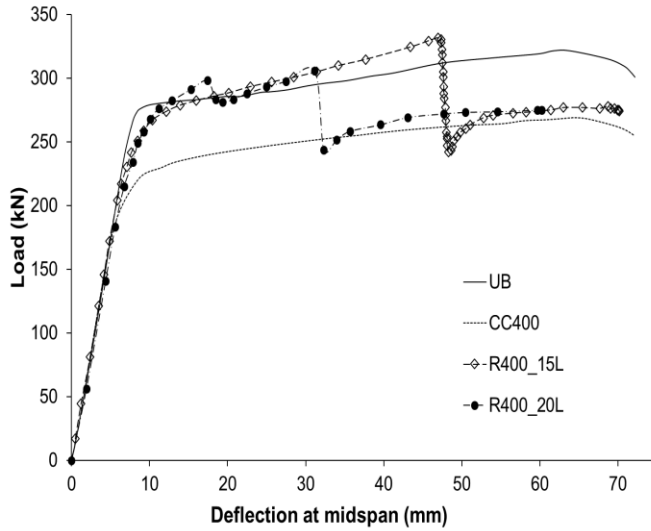
Figure 2.17: Load-deflection behavior of R400\_15L and R400\_20L

unwanted and premature debonding failure. For this study, the maximum number of BFRP layers successfully used for rehabilitation was 15 layers.

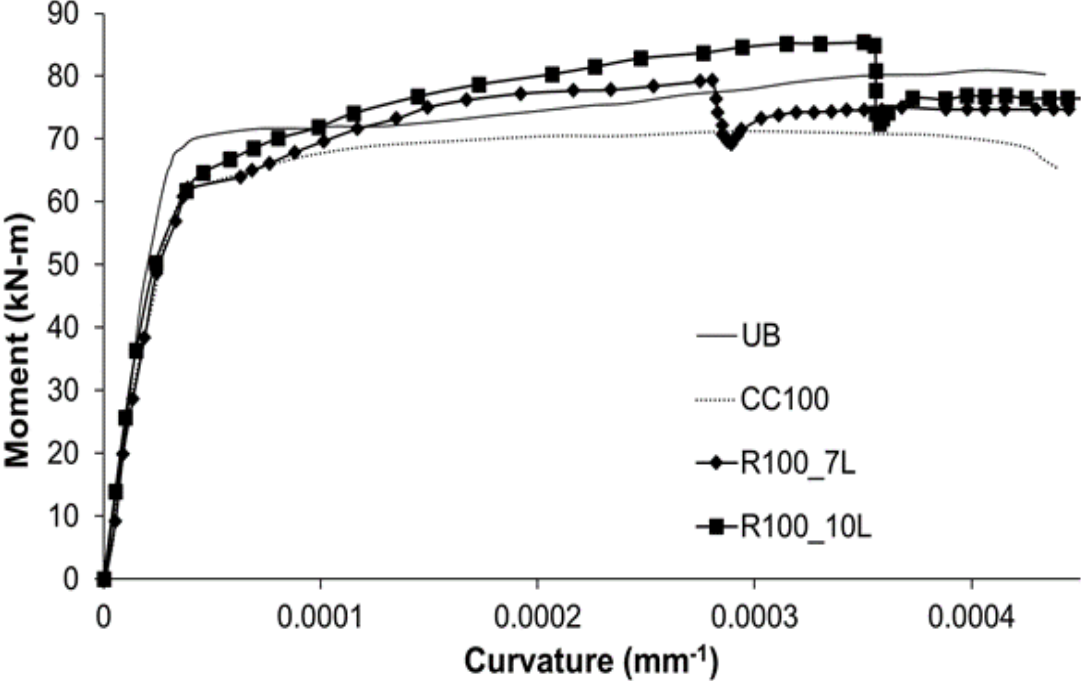
Figure 2.19: Moment-curvature diagrams for beams with corrosion AR of 1

The moment-curvature relationships of the beams with corrosion aspect ratios of 1 and 4 are plotted in Figures 2.19 and 2.20, respectively. The curvature was obtained using the deflection data obtained from LVDTs 1, 2 and 3, while the moment was determined from the data obtained from the loadcell. The moment-curvature plot provides general bending behavior of W150X24 beams with two corrosion aspect ratios irrespective of the loading and boundary condition. The yield moment, ultimate moment, and curvatures are presented in Table 2.4. It can be observed that the ultimate moment carrying capacity of the uncorroded control (virgin) specimen UB is 80.9 kN-m. It reduced to 71.2 kN-m and 67.0 kN-m for control corroded specimens CC100 and CC400, respectively. However, upon rehabilitation using 10 layers of BFRP fabric for CC100 and 15 layers of BFRP fabric for CC400, the ultimate moment capacity increased and exceeded that of the uncorroded control (virgin) beam, UB. The section ductility for each beam is calculated using the curvature values. Section ductility is defined as the curvature at the ultimate moment ( $\phi_u$ ) divided by curvature at yield moment ( $\phi_y$ ) as shown in Equation 2.1.

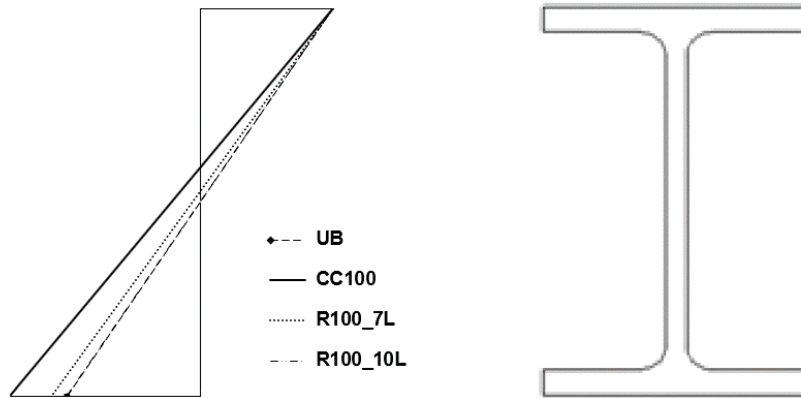
Figure 2.24a: Neutral axis depth for beams with corrosion AR of 1

Another indicator for the improvement in behavior of the rehabilitated beams is the location of the neutral axis. The neutral axis of the un-corroded control (virgin) beam is expected to be located at the mid-height (~80 mm) of the beam section. At the mid-span of the beam, the location of the neutral axis moves up due to corrosion defect in the bottom flange. As the beam is rehabilitated, it is expected that the neutral axis should move downward to its original location (location of the uncorroded control or virgin beam). The neutral axis depths at 30 mm deflection and at the mid-span of the beam

specimen for all the beams are presented in Table 2.5. The deflection of 30 mm is used because at that deflection all the specimens past the yielding load, however, BFRP fabrics did not rupture. Figures 2.24a and 2.24b show the variation of neutral axis depth for specimens with corrosion aspect ratios of 1 and 4, respectively. It can be observed that the neutral axis depth moves upward for control corroded specimens (CC100 and CC400) with respect to the uncorroded beam. However, with the application of BFRP, the neutral axis depth improves (moves downward) and restores to near mid-height of the beam. Hence, it can be concluded that with the application of BFRP in corroded beams of both aspect ratios, the neutral axis depth can be successfully restored to its uncorroded control (virgin) beam level.

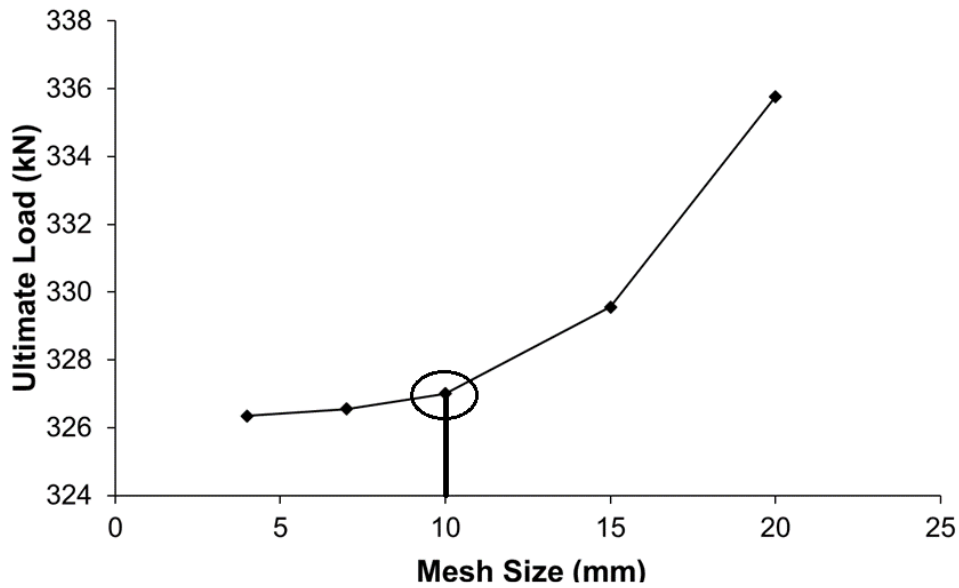
Figure 2.25: Mesh Convergence study for specimen UB

Twenty-node quadratic brick or solid element with reduced integration (C3D20R) with a mesh size of 10 mm was used to model the steel beam and 8-node quadrilateral continuum shell element with reduced integration (SC8R) of mesh size 10 mm was used to model the BFRP fabric. The optimum mesh size for the steel beam and BFRP fabric was determined through a mesh convergence study. The mesh convergence study for steel is shown in Figure 2.25. The geometry of the shell element was modeled as a solid, however, its kinematic and constitutive behaviors were assigned similar to that of a conventional shell element. The material properties of steel were obtained from tension testing of coupons made from each material as per ASTM standards, as shown in Figure 2.1.
