### Tension and compression behavior of corroded steel beams rehabilitated with BFRP

# **Tension and compression behavior of corroded steel beams rehabilitated with BFRP**

Submitted to the Faculty of Graduate Studies  
through the Department of Civil and Environmental Engineering  
in Partial Fulfillment of the Requirements for  
the Degree of Master of Applied Science  
at the University of Windsor

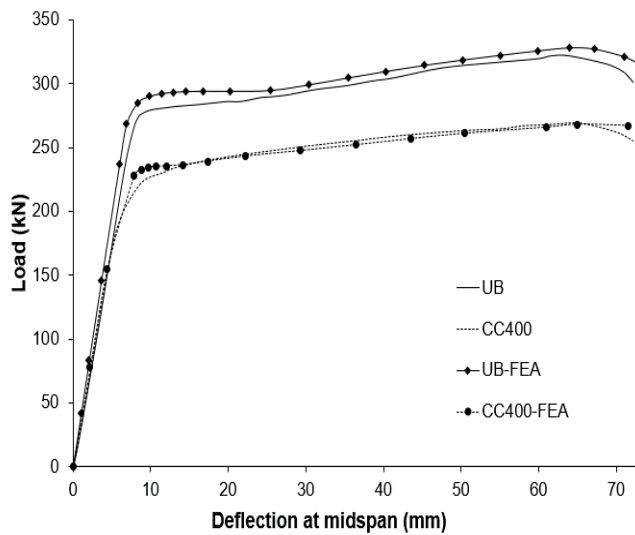
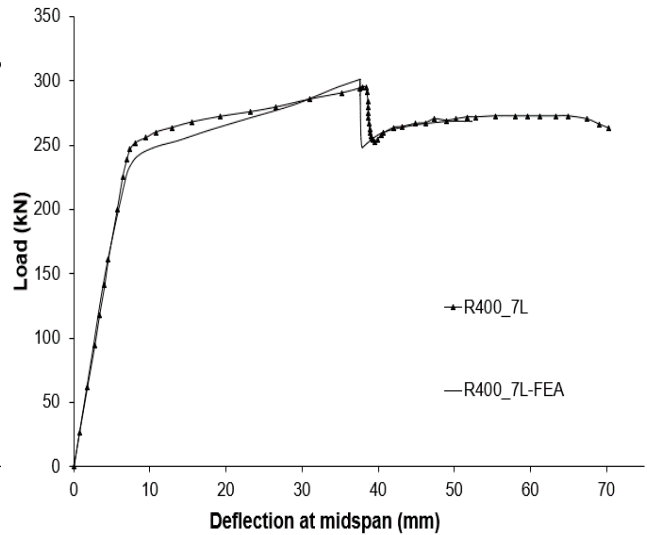
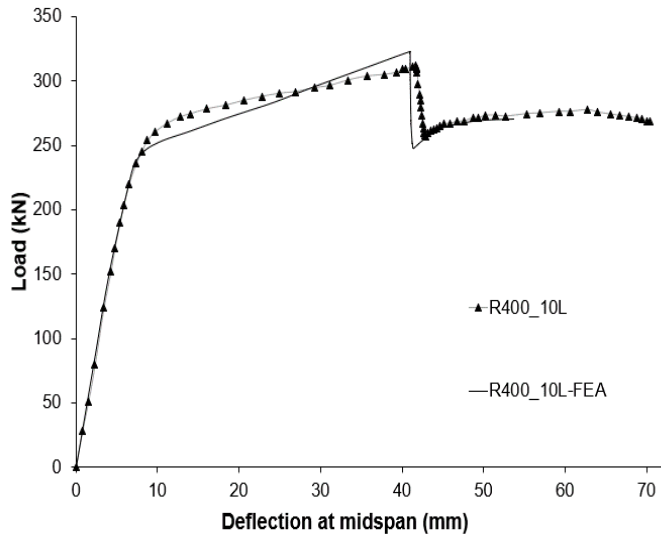
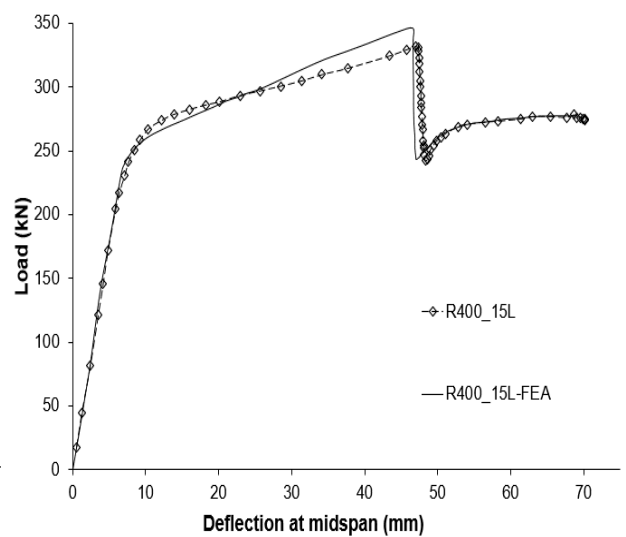
Figure 2.26: Validation of FEM model data for corrosion aspect ratio of 4

In the FE models, the BFRP fabric was modeled as a single layer of equivalent thickness which is the total thickness of BFRP fabrics applied for the rehabilitation. Surface to surface tie constraint was used to attach the BFRP fabric to the steel beam substrate. Surface to surface tie constraint was used in the model because no de-bonding or slippage was observed in any test specimens (Table 2.1). Figure 2.26 shows the comparison of load-deflection data obtained from the tests with the data obtained from FE models for beams with corrosion aspect ratio of 4, while Figure 2.27 compares the load-deflection data obtained from the experiments and finite element models for beams with a corrosion aspect ratio of 1. The comparison of the results obtained from experiments and the FE models are also presented in Table 2.7. It is observed that there is a good agreement between the load-deflection data obtained from the tests and the FE models. The maximum percentage error obtained for ultimate load is 4.41 % and it was for beam R400\_15L.

Figure 2.26a: Control specimens UB and CC400

Figure 2.26b: Rehabilitated specimen R400\_7L

Figure 2.26c: Rehabilitated specimen R400\_10L    Figure 2.26d: Rehabilitated specimen R400\_15L

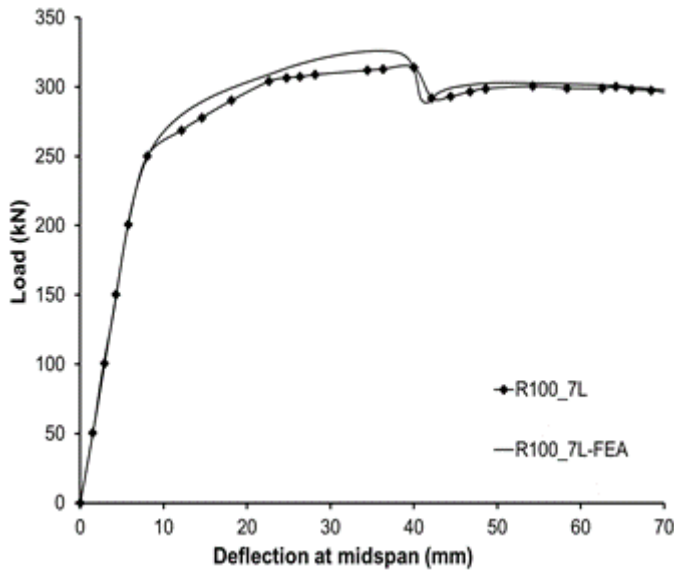
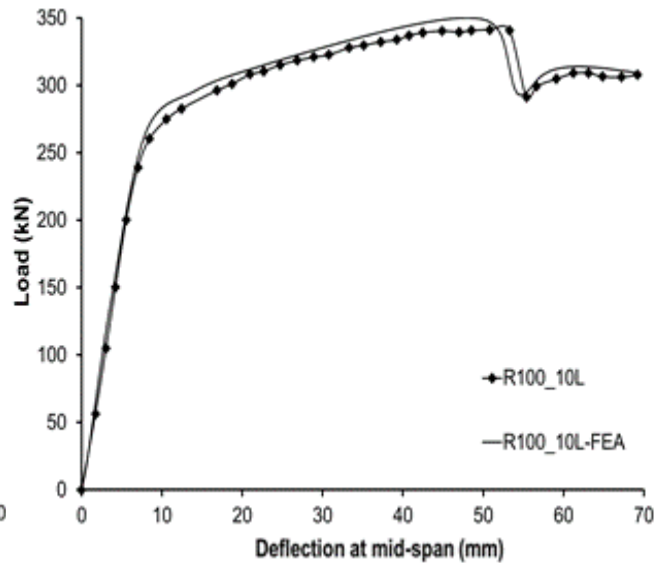
Figure 2.27: Validation of FEM model data for corrosion AR of 1

Figure 2.27a: Rehabilitated specimen R100\_7L    Figure 2.27b: Rehabilitated specimen R100\_10L

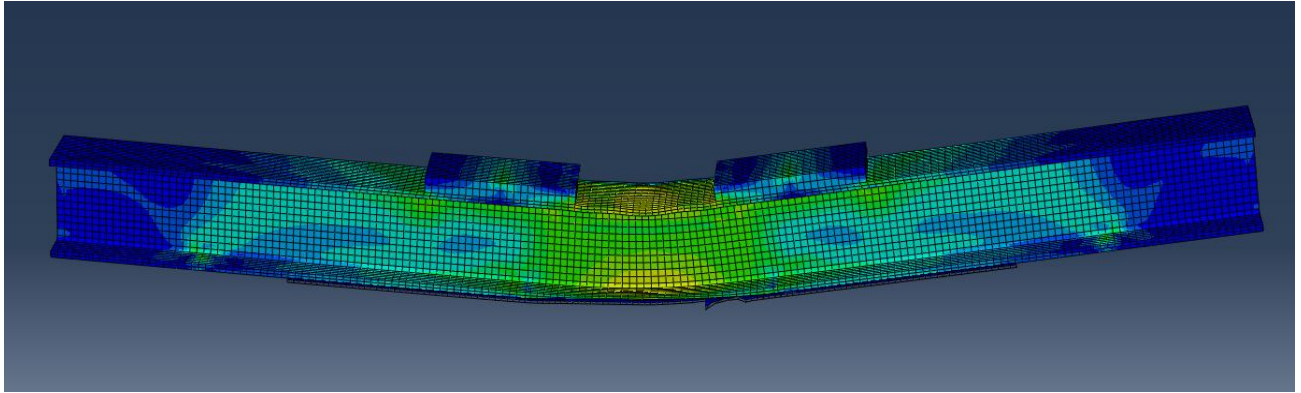
Figure 2.28: Final Deflected shape in the FEM model

The deflected shape for specimen R100\_10L obtained from the FE analysis is shown in Figure 2.28. The shape of the BFRP composite after its rupture is shown in Figure 2.29. The other rehabilitated specimens also showed similar behavior (See Appendix A Figures A.1 -A.8). The validated FE models were then used to conduct a parametric study where corrosion aspect ratio was varied from 1 to 6 while keeping the corrosion depth unchanged at 40% of flange thickness. The plot of the optimum number of layers with different corrosion depth is shown in Figure 2.30. The optimum number of layers is the minimum number of BFRP fabric layer required to be applied to the corroded beam to restore the ultimate strength of the corroded steel beams to the level of uncorroded (virgin) beam.

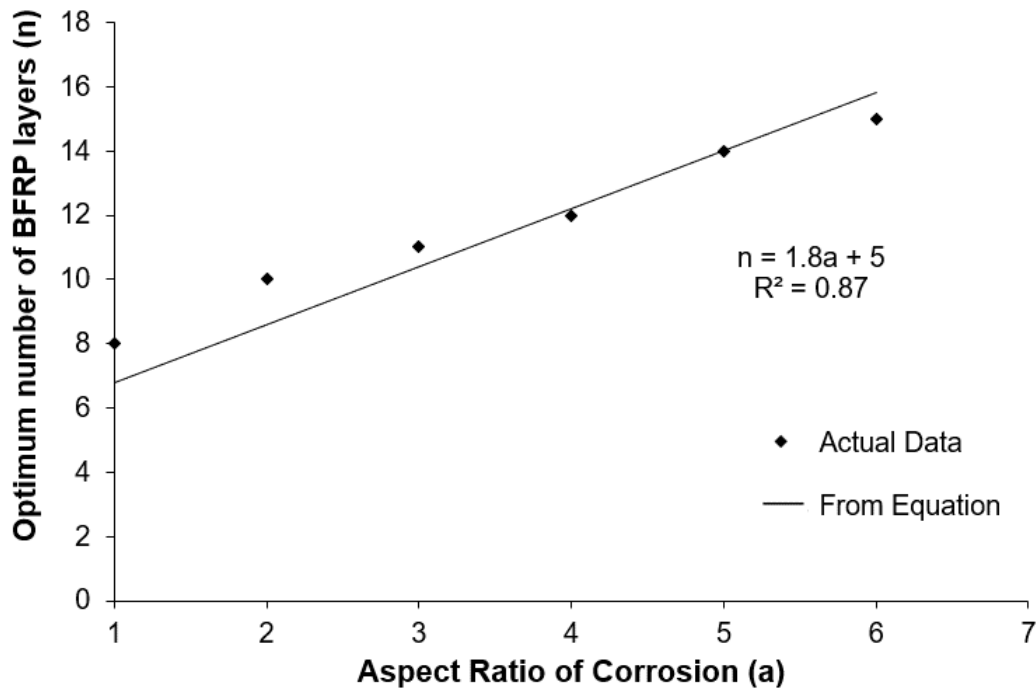
Figure 2.30: Relation between aspect ratio of corrosion and optimum BFRP layers

In the above equation,  $n$  is the optimum number of BFRP layers and  $a$  is the aspect ratio of the corrosion patch. The coefficient of determination,  $R^2$  value, of this equation is 0.87, which indicates that it is a good fit for the current set of data. It can be observed from Figure 2.30 that the number of layers of BFRP fabrics needed for repair increases with the increase in the aspect ratio of the corrosion patch.

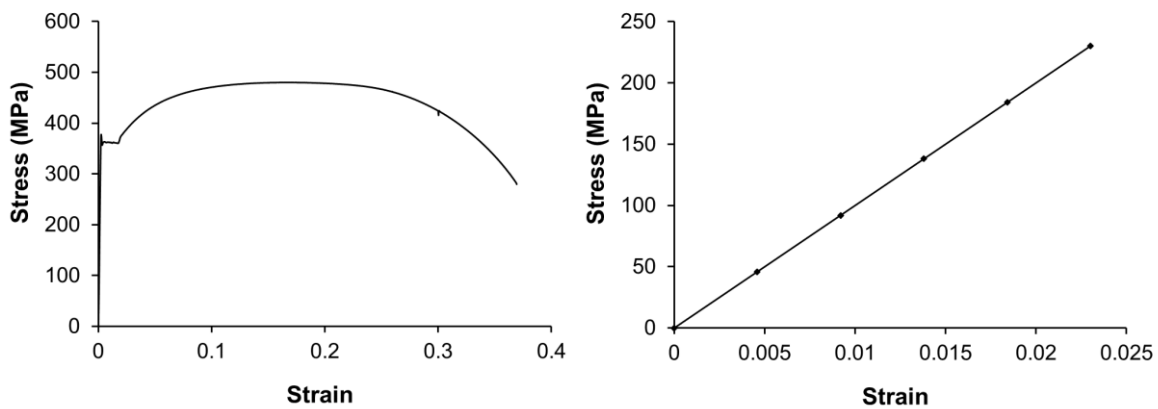
Figure 3.1: Stress-strain behaviors

484 MPa, respectively. The modulus of elasticity (E) was found to be 205 GPa. The stress-strain curve obtained from this data is presented in Figure 3.1a.

For the rehabilitation process, unidirectional BFRP fabric sheets were used. The fabrics were attached to the steel substrate using two-part epoxy resin. Unidirectional compression tests were conducted from the coupons made from these fabrics as per ASTM D3410/D3410M – 16 standard (ASTM 2018) [18]. The stress-strain curve of the BFRP fabrics, obtained from this test, is shown in Figure 3.1b.

Figure 3.1a: Stress-strain behavior of steel      Figure 3.1b: Stress-strain behavior of BFRP

The steel beam was modelled using twenty-node quadratic brick (solid) element with reduced integration (C3D20R), and the BFRP fabrics was modelled using 8-node quadrilateral continuum shell element with reduced integration (SC8R). The shell element has the geometry of a brick element; however, the kinematic and constitutive behaviors are that of a conventional shell element. A mesh convergence study was conducted to determine the optimum mesh size for the models. The optimum mesh size for C3D20R elements was found to be 12 mm. The mesh convergence study for steel beam is shown in Figure 3.19. For the SC8R elements a mesh size of 10 mm was used. The material properties of steel used in the model are the modulus of elasticity, the Poisson's ratio, and the plastic stress-strain values obtained from the true stress-strain curve, as shown in Figure 3.1a.

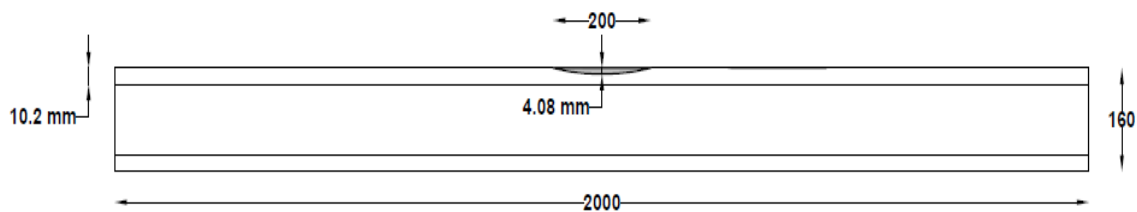
Figure 3.2: Corrosion profile of beam with 40% corrosion

The corrosion defect was simulated in the beams by removing a circular-shaped area from top flange, as shown in Figure 3.2. The percentage of corrosion is the maximum depth of the portion removed from the top flange of the beam. For example, for 40% corrosion, the maximum depth (4.08 mm) of the steel removed from the beam was 40% of the top flange thickness. The flange thickness of the beam is 10.2 mm. Table 3.1 shows the test matrix used in the experimental study. Three of the specimens were control beam specimens and four were rehabilitated beam specimens. The control specimen which did not have any defect or thickness loss due to corrosion is referred to as uncorroded beam or “UB”. Remaining two control specimens had thickness loss due to corrosion of 20% (2.04 mm) and 40% (4.08 mm) of their flange thickness. These beams are referred to as control corroded beams and identified as “20CC” and “40CC”, respectively. In the specimen ID of these beams, “40” and “20” are the maximum depth of corrosion in percentages of the flange thickness, and “CC” indicates control corrosion specimens which were not rehabilitated.

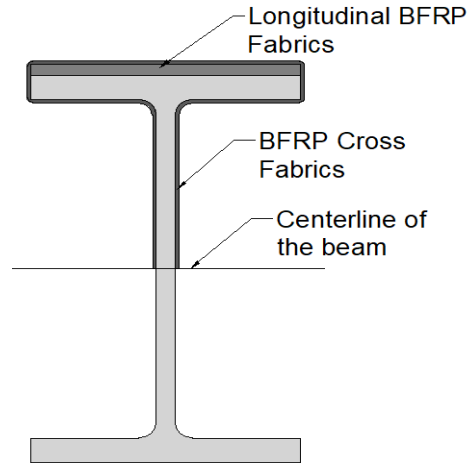
Figure 3.3a: Cross sectional view of the rehabilitation scheme

Cross fabrics are layers of BFRP fabric that were attached perpendicularly on top of the main reinforcing layers of BFRP fabric and connected to the web of the beam up to the mid-height of the beam (Figure 3.3a). Cross-wrapping helps in holding the longitudinal layers of BFRP fabrics and prevents debonding of these fabrics. Jayasuriya et al. [19] and Bastani et al. [14] found that for the rehabilitation of steel beams with corrosion defect in the tension zone and shear zone, cross fabrics played an important role in the prevention of debonding failure. Hence, similar cross fabrics were used in the current study to prevent debonding failure.

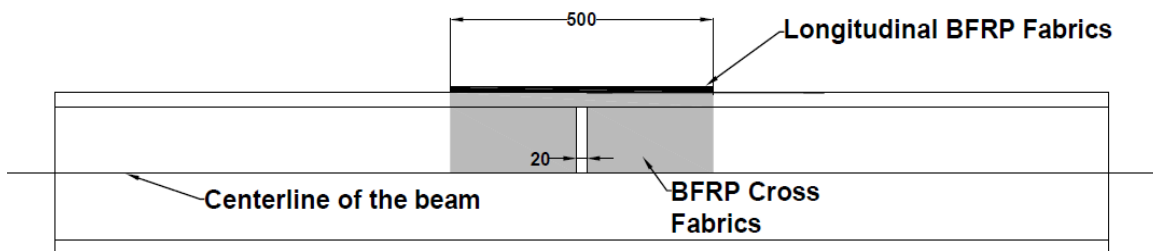
Figure 3.3b: Side view of the rehabilitation scheme

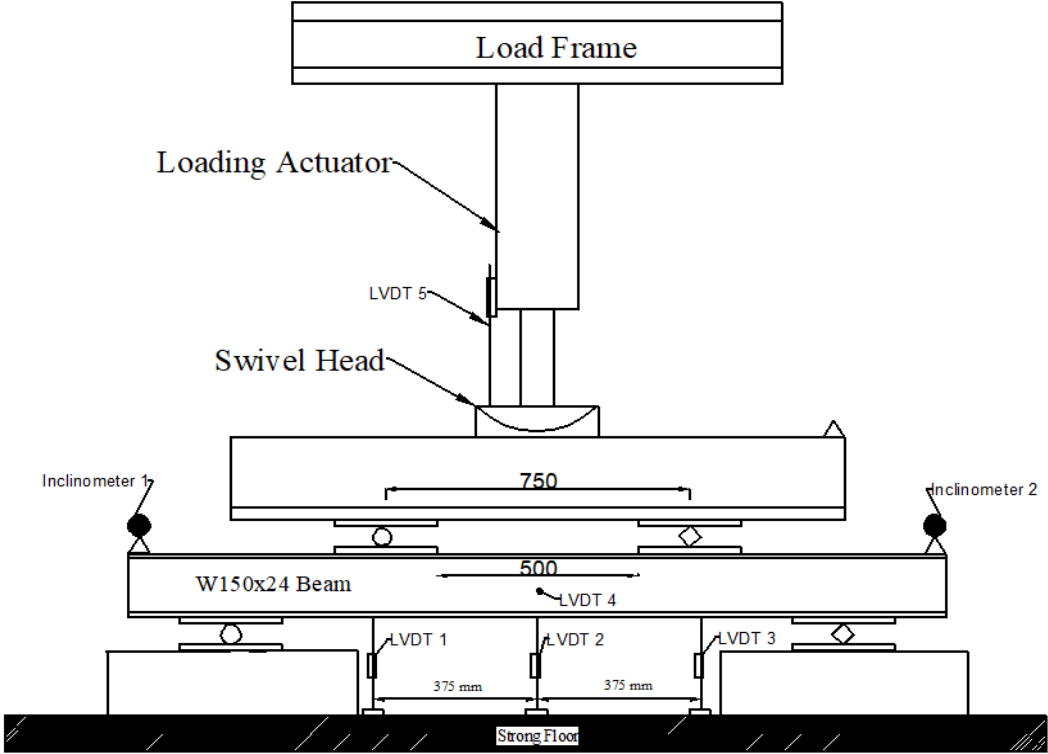
Figure 3.4: Schematic view of the test setup

Four-point bending load was applied in the experimental testing as shown in Figures 3.4 and 3.5. The load was applied to the beam specimen using a loading actuator, through a 1000 mm long spreader beam. Both the beam specimen and the spreader beam had a pin and roller boundary condition. The beam specimen had a span length of 1500 mm and the moment span of the setup was 750 mm. Five Linear Variable Differential Transformers (LVDTs) were used as shown in Figure 3.4 to measure deflections at those points. LVDT 2 was placed at the mid-span of the beam. LVDT 1 and LVDT 3 were placed at 375 mm from the mid-span of the beam. LVDT 4 was placed horizontally at mid-height to obtain the out of plane deflection, if any. LVDT 5 was part of the loading actuator and hence, it measured the deflection at the mid-span of the specimen. Symmetry of the specimen was checked during the test using slope values obtained from inclinometers placed at both ends of the beam. Loadcells were used to acquire the value of the applied load. Data from LVDT 2 and the loadcell attached to the loading actuator was used to plot the load-deflection curves. Data from

LVDTs 1, 2 and 3 along with the data from the loadcell attached to the loading actuator was used to plot the moment-curvature curves.

The moment-curvature relationships are shown in Figures 3.14 and 3.15. The curvature values were calculated using the deflection data obtained from LVDTs 1, 2, and 3 (Figure 3.4). The deflection data for each load point was fitted to a fourth order polynomial equation to obtain the equation for vertical displacement with is the displacement along the direction of application of load. The value of second derivate of the vertical displacement equation at the center of the beam was considered as the curvature. The moment was calculated by multiplying the reaction force at the support with the moment arm of the reaction force. The moment-curvature relationship provides a more general behavior of the steel section than the load-deflection relationship as it is not dependent on the loading and boundary conditions of the setup. Table 3.3 shows the yield moment, ultimate moment, and the respective curvatures for all the specimens tested. The ultimate moment-carrying capacity of the uncorroded control beam (UB) was found to be 74.0 kN-m. For the control corrosion specimens (40CC and 20CC), the moment-carrying capacities were 57.6 kN-m and 63.2 kN-m, respectively. However, when the beam 40CC which had 40% corrosion defect was rehabilitated with 15 layers of BFRP fabric (specimen R40-15L-3C), the ultimate moment capacity was 74 kN-m which is equal to that of uncorroded (virgin) specimen, UB.

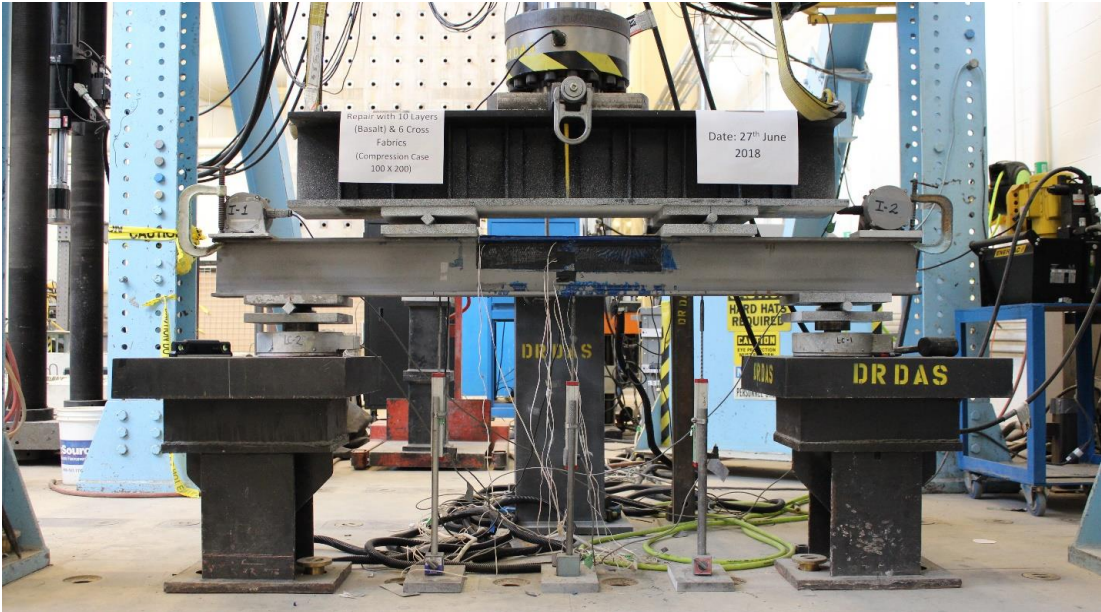
Figure 3.5: Photo showing the test setup

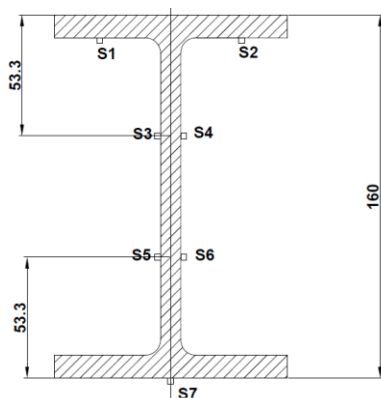
Figure 3.6: Position of strain gauges at the mid-span of the beam

Strain gauges were also installed at various locations of the beam to acquire the strain values at these locations. A total of nine strain gauges were installed on each specimen. Seven strain gauges (S1 to S7) were installed at the mid-span of the beam as shown in Figure 3.6. The strain data obtained from these strain gauges were used to obtain the neutral axis depth of the beam at various mid-span deflections (LVDT2). Two strain gauges (S8 and S9) were installed at 200 mm away from the mid-span. Strain gauge, S9 was attached to the BFRP fabric and strain gauge, S8 was installed on the steel surface as shown in Figure 3.7. Data from these two strain gauges was used to monitor any slippage or debonding between the steel substrate and the BFRP fabric layers as the testing continued.

The layout of strain gauges is shown in Figures 3.6 and 3.7. Strain gauges 1 to 7 were attached to the mid-span of the beam at various depths. The data obtained from these strain gauges was used to determine the neutral axis depth of the beam as the loading process continued. Figure 3.16 shows the strain values of various strain gauges with respect to the mid-span deflection for specimen R40-15L-3C. It was observed that the magnitude of the strain in the compression zone (S2 and S4) was almost equal to the magnitude of the strain in the tension zone (S6 and S7). This indicated that the compression zone of the rehabilitated specimen had almost equal strength as the tension zone and thus, it can be concluded that the rehabilitation with 15 layers of BFRP fabric was effective. The distance of S2 and S7 from the mid-height of the beam section was 53.3 mm and distance of S4 and S6 was 26.7 mm. Hence, the magnitude of strain values at S2 and S7 were higher than the values of S4 and S6.

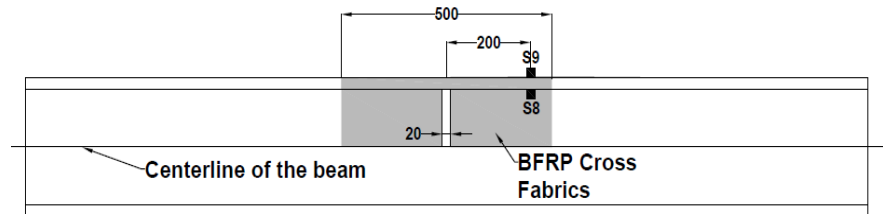
Figure 3.7: Position of strain gauges along the length of the BFRP fabric

Figure 3.17 shows the strain values of the steel (S8 in Figure 3.7) and of the BFRP fabrics (S9 in Figure 3.7) at 200 mm from the mid-span of the beam for the same specimen, R40-15L-3C. It was observed that both strain values followed the same pattern, however, the strain value of the BFRP (S9) was found to be slightly higher than the strain value of steel substrate (S8). This is because the BFRP fabrics were located slightly away from the mid-height of the beam than the steel substrate. The distance of strain gauge S8 was 69.9 mm and distance of S9 was 86.75 mm from the mid-height of the beam. Hence, it can be concluded that there was no debonding between the steel and the BFRP fabrics.

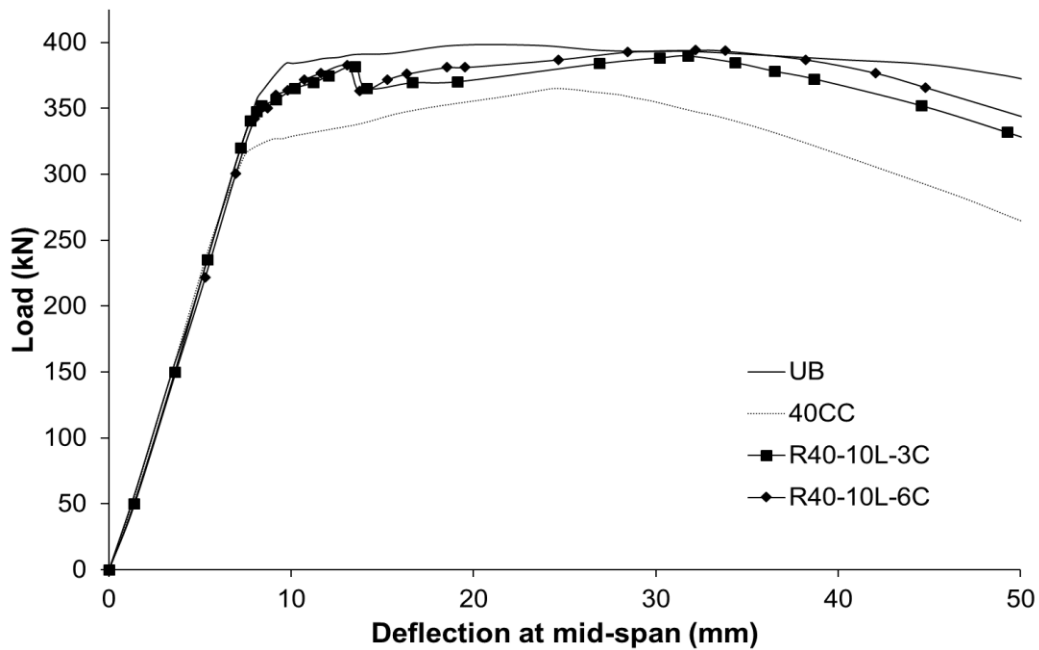
Figure 3.8: Load-deflection curves for beams with 3 and 6 layers of cross fabrics

The effect of cross fabrics in preventing debonding was investigated by rehabilitating two specimens with three layers (R40-10L-3C) and six layers (R40-10L-6C) of cross fabrics, respectively. However, the number of longitudinal fabrics layers used was same for both specimens (10). The load-deflection

behaviors of specimens R40-10L-3C and R40-10L-6C were obtained and compared with the control specimens (UB and 40CC) and shown in Figure 3.8. This figure shows that both rehabilitated beams exhibited very similar behavior and both beam specimens were successful in eliminating debonding failure. Hence, the remaining specimens were rehabilitated with three layers of cross fabrics. For the control corroded specimen 40CC, there was a substantial decrease in load resistance at a mid-span deflection of 50 mm and it was found unsafe to continue the test beyond this deflection. Hence, for all the specimens, the tests were terminated at a mid-span deflection of about 50 mm.

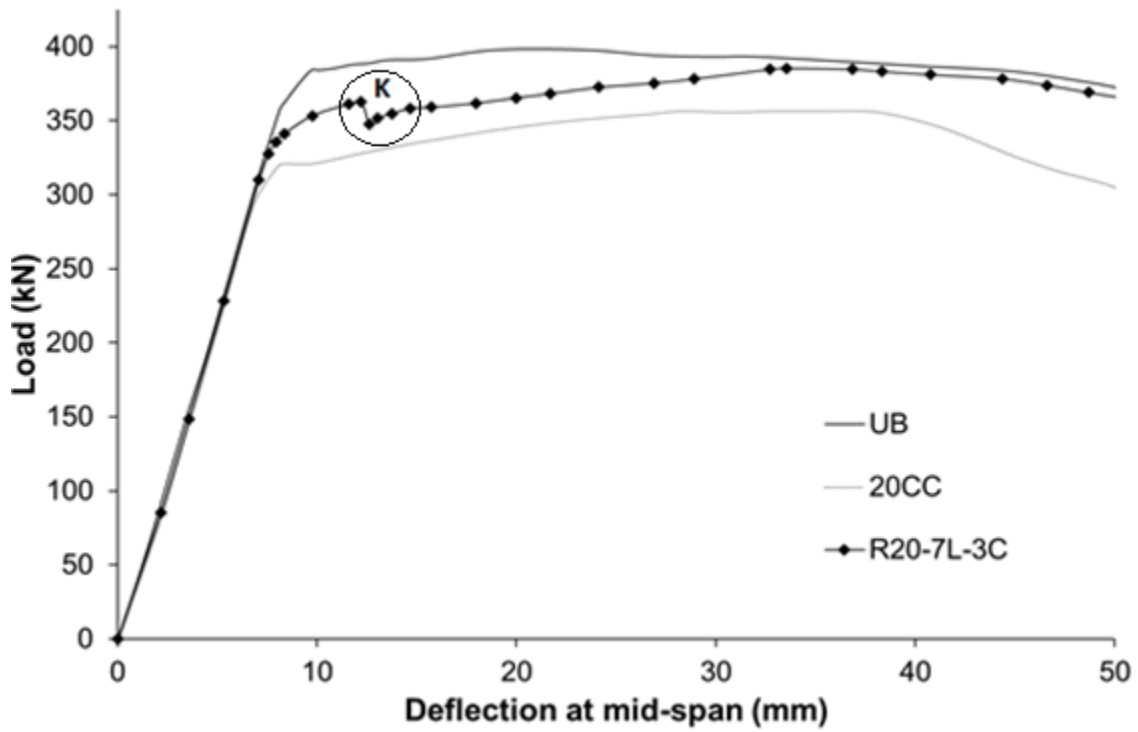
Figure 3.9: Load-deflection curves of beams with 20% corrosion

The load-deflection behaviors of rehabilitated specimen R20-7L-3C along with control specimens UB, 20CC are shown in Figure 3.9. The load-deflection behaviors for rehabilitated specimens R40-10L-3C, R40-15L-3C and the control specimens UB and 40CC are shown in Figure 3.10. It can be observed that for rehabilitated specimens with both 20% and 40% corrosion defects (specimens R20-7L-3C, R40-10L-3C, R40-10L-6C, and R40-15L-3C), there is an improvement in load carrying capacity of all the beams. Figure 3.10 shows that with the increase in the number of BFRP layers, the ultimate load of the rehabilitated beams improved.

The final failure mode observed in the rehabilitated beams was local buckling of the top flange and followed by a lateral torsional buckling of the beam. The first failure was observed in the attached BFRP fabrics due to kinking along the stress concentration line formed due to the corrosion defect (see Figure 3.11). It caused the first load drop in the experiment as indicated by K (see Figures 3.9 and 3.10).

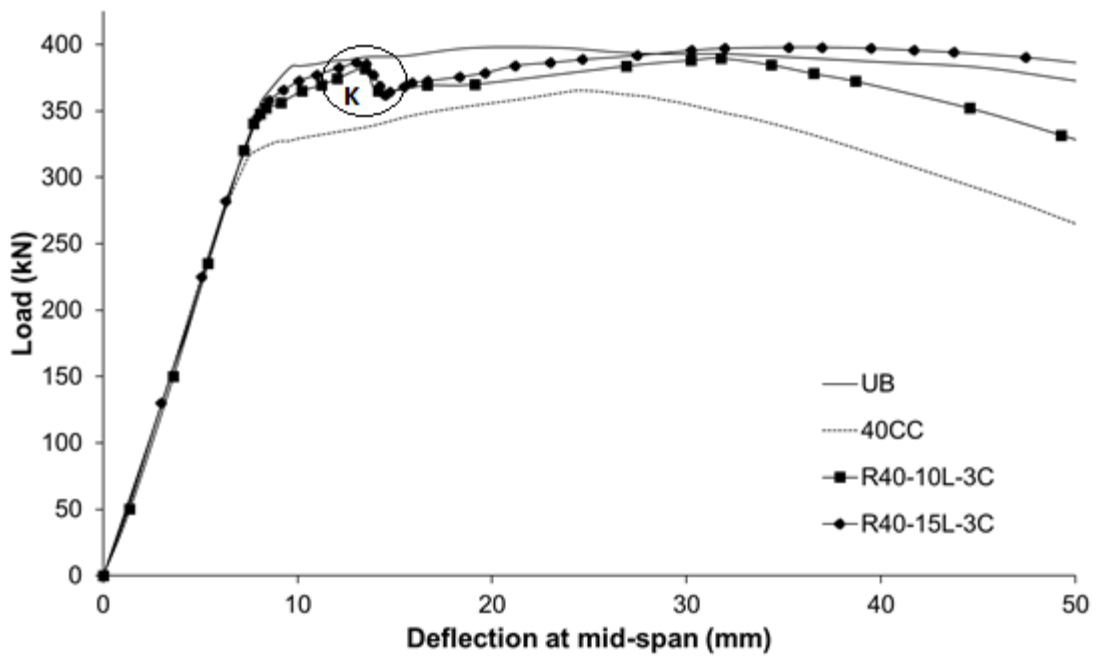
Figure 3.10: Load-deflection curves of beams with 40% corrosion

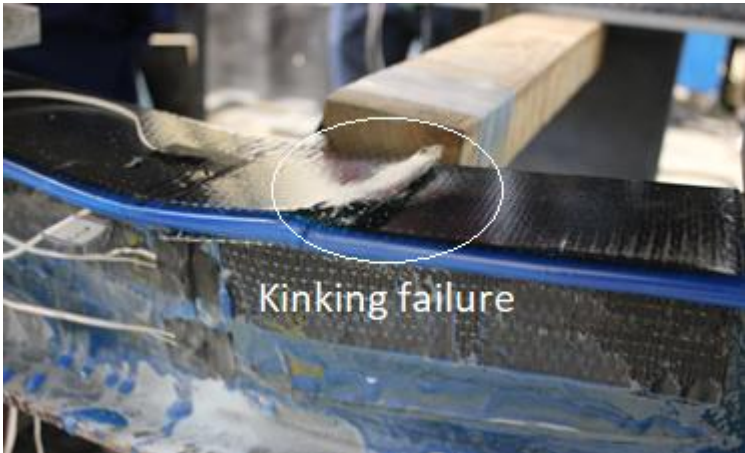
Figure 3.11: Kinking along the stress concentration line

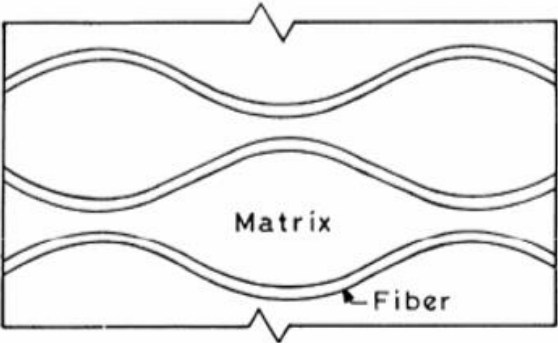
Figure 3.12a : Extensional microbuckling [20]

Literature review shows that the failure of the BFRP fabrics when subjected to axial compression can be either due to extensional microbuckling which is out of phase buckling of the fibers within the matrix (Figure 3.12a), shear microbuckling which is in phase buckling of the fibers within the matrix (Figure 3.12b), kinking which is highly localized fiber buckling occurring after the development of microbuckling (Figure 3.12c) or transverse tensile rupture due to Poisson stress [20].

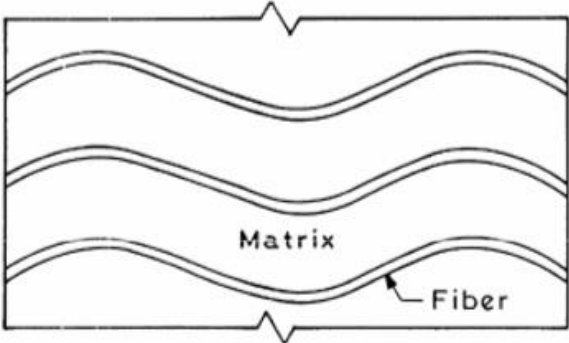
Figure 3.12b : Shear Microbuckling [20]

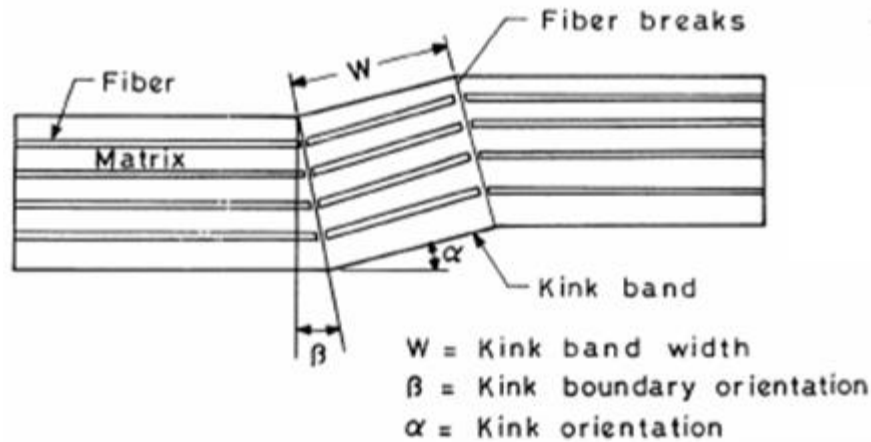
Figure 3.12c: Kinking [20]

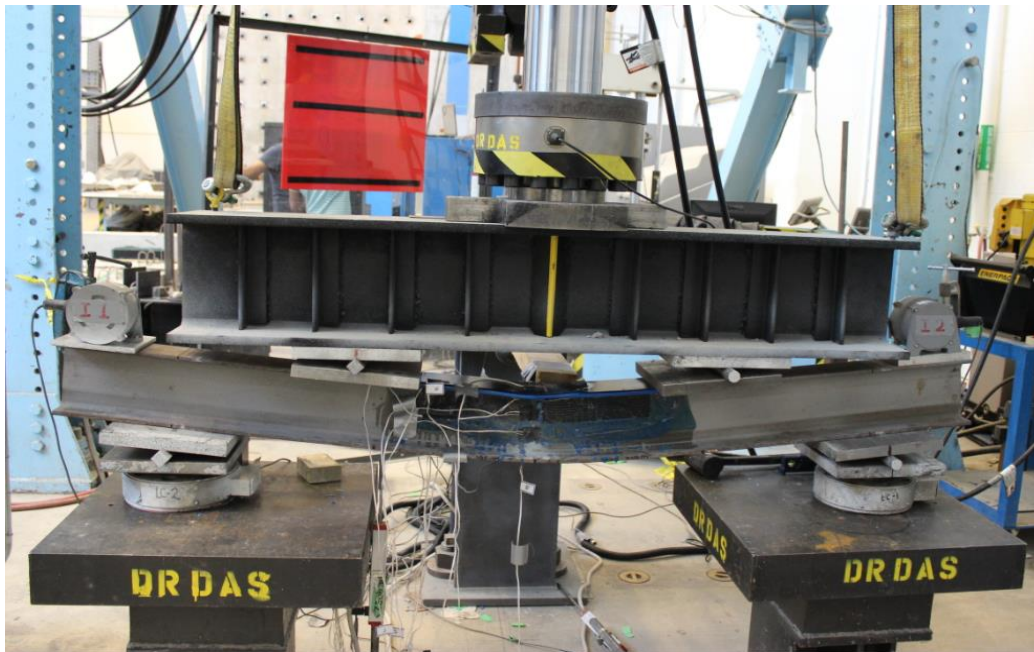
Figure 3.13: Final deflected shape of the rehabilitated beam

Table 3.2 details the yield and ultimate load values for all the specimens. It was observed that for all the rehabilitated beams, there was a moderate increase in the yield load and a relatively large increase in the ultimate load as compared to the control corroded beams (20CC and 40CC). With the application of adequate number of layers of BFRP fabrics the ultimate strength of the rehabilitated beam was restored to that of the uncorroded virgin beam, UB. For specimen R40-15L-3C which was rehabilitated with 15 layers of BFRP fabric (total thickness of 6.75 mm), the yield load increased to 357 kN when compared with the yield load of control corroded specimen 40CC (319kN). The ultimate load increased from 365 kN for the specimen 40CC to 398 kN for specimen R40-15L-3C. Hence, increases in both yield load and ultimate load were observed in the rehabilitated specimen as compared to the control corroded specimens. The specimen R40-15L-3C was also able to restore the ultimate load to the level of uncorroded virgin (reference) specimen UB (398 kN). Hence, this study found that 15 layers of BFRP fabrics was adequate for restoring the ultimate strength of a beam with corrosion defect of 40% of the flange wall thickness. However, the yield strength could only be restored partially. For specimen R20-7L-3C, the yield load increased from 339 kN for specimen 20CC to 358 kN, and the ultimate load increased from 374 kN to 394 kN. Increases in yield and ultimate loads were observed in the rehabilitated specimen as compared to the control corroded specimens. The yield load and the ultimate loads values did not reach to that of the uncorroded beam, UB. However, the difference in ultimate load values obtained from specimens R20-7L-3C and UB was only about 1%. Figure 3.13 shows the final deflected shape of a typical rehabilitated beam.

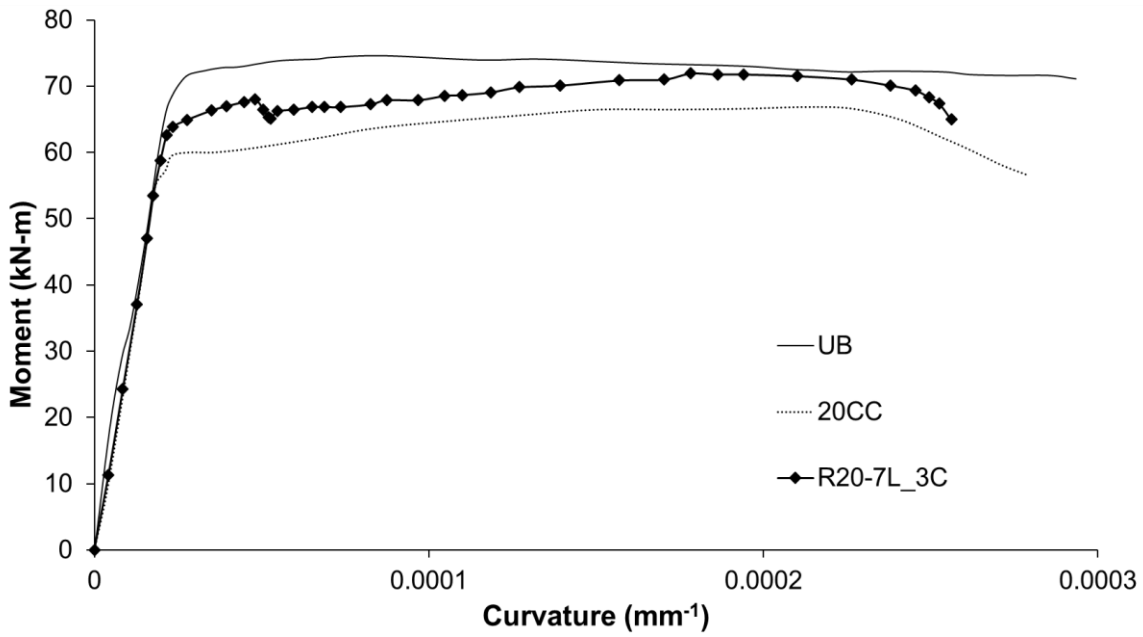
Figure 3.14: Moment-curvature relationships for beams with 20% corrosion

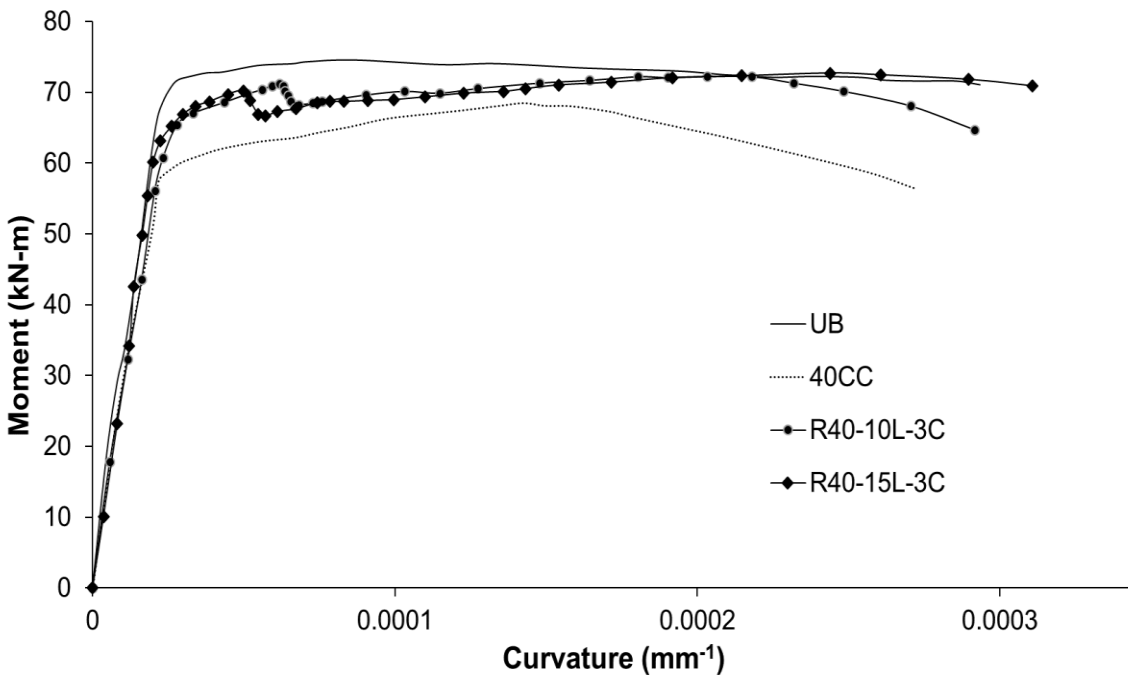
Figure 3.15: Moment-curvature relationships for beams with 40% corrosion

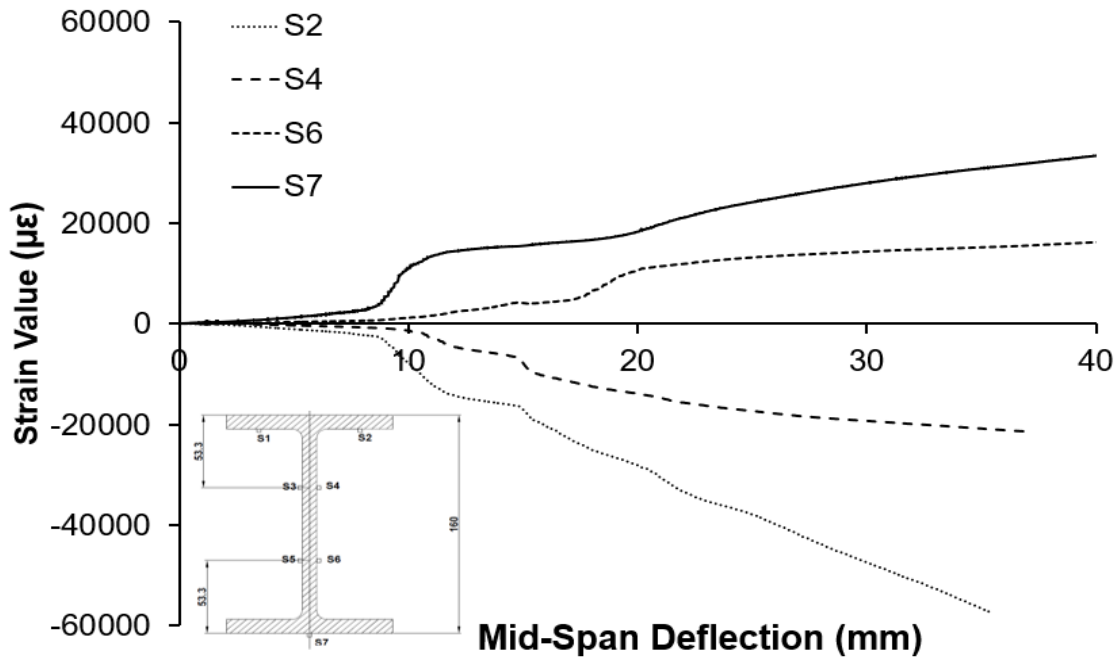
Figure 3.16: Strain vs. deflection at mid-span for R40-15L-3C

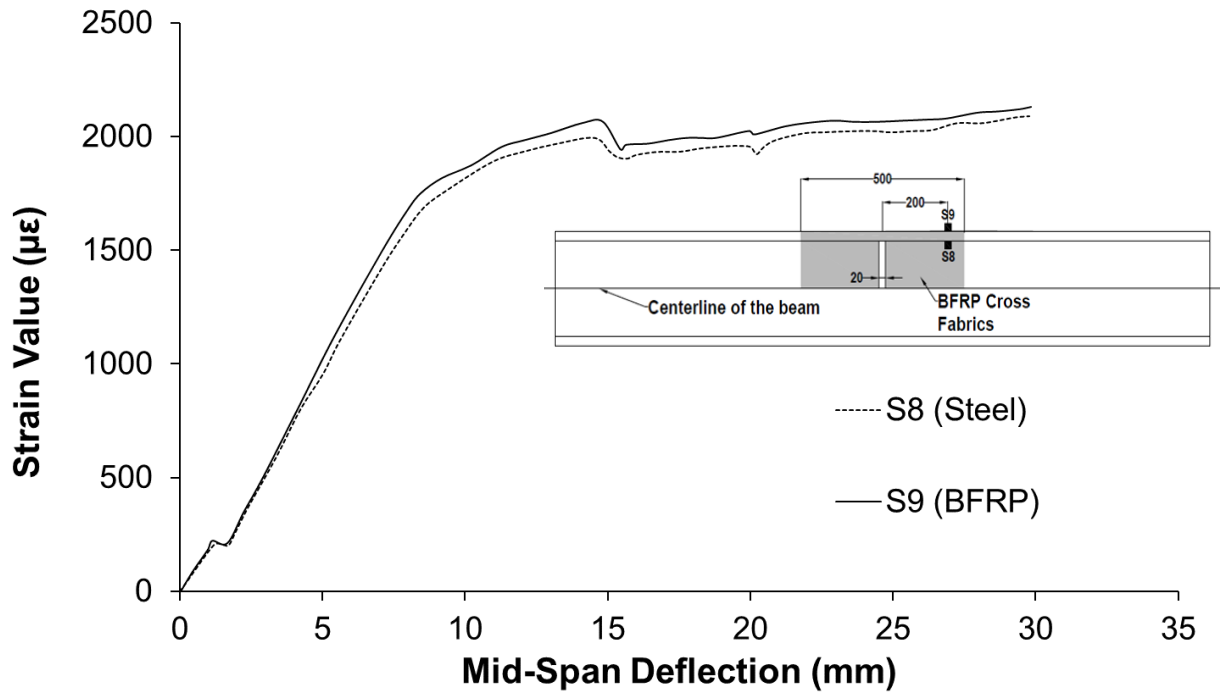
Figure 3.17: Comparison of strain value of steel and BFRP at 200 mm from center for R40-15L-3C

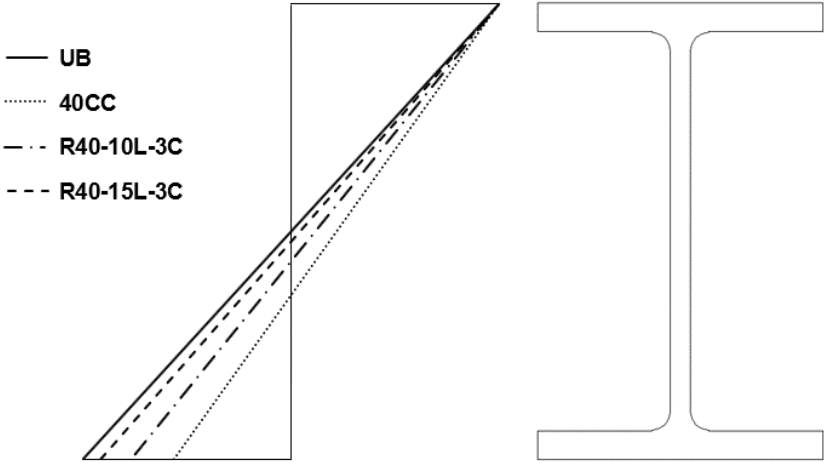
Figure 3.18a: Neutral axis depth for beams with 40% depth of corrosion

The location of the neutral axis (NA) was also used as an indicator for checking the improvement of the rehabilitated beams. The NA depth at any deflection value was determined by interpolation of the strain data obtained from the strain gauges attached at various locations of the mid-span section of the beam (Figure 3.7). The neutral axis depth at 20 mm mid-span deflection for all the specimens is shown in Table 3.4. Figures 3.18a and 3.18b show the change in neutral axis depth for the control corroded specimens with 40% (40CC) and 20% (20CC) corrosion depths, respectively. It was observed that the location of neutral axis moves downward for the control corrosion specimens 40CC and 20CC with respect to uncorroded control (virgin) specimen UB. However, with the application of BFRP fabrics, the location of the neutral axis moves upward. As the number of BFRP fabrics layers increases, the neutral axis of the rehabilitated beams moves back closer to that of specimen UB. Hence, it can be concluded that with rehabilitation of the corroded specimens with BFRP fabrics, the neutral axis depth of the corroded specimens (40CC and 20CC) can be restored to that of the uncorroded specimen (UB) if required number of BFRP fabric layers is added. For this study, 15 layers of BFRP fabric was sufficient for restoring the neutral axis depth of 40CC specimen.

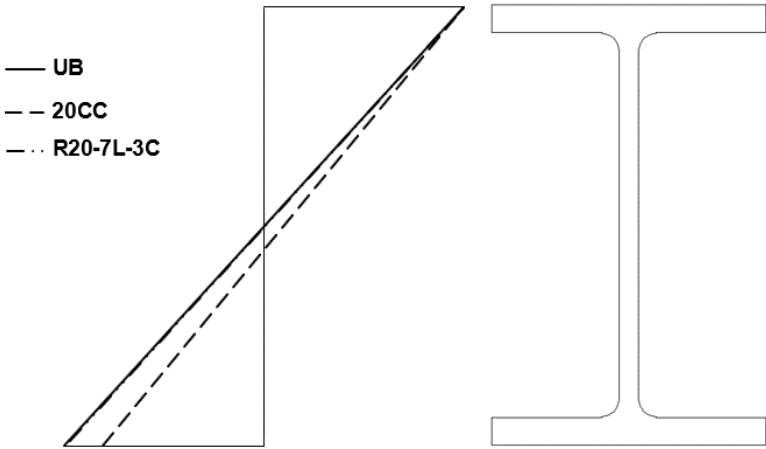
Figure 3.18b: Neutral axis depth for beams with 20% depth of corrosion

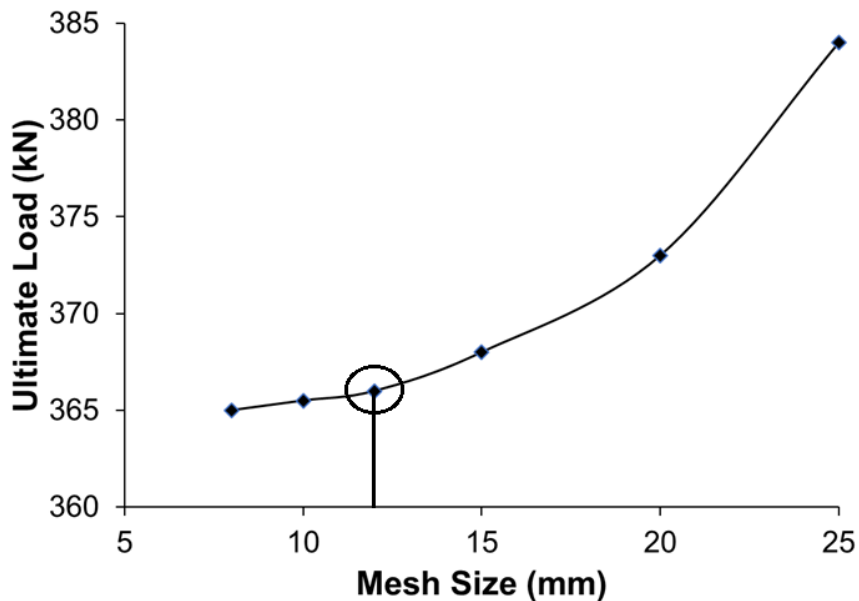
Figure 3.19: Mesh Convergence study for steel

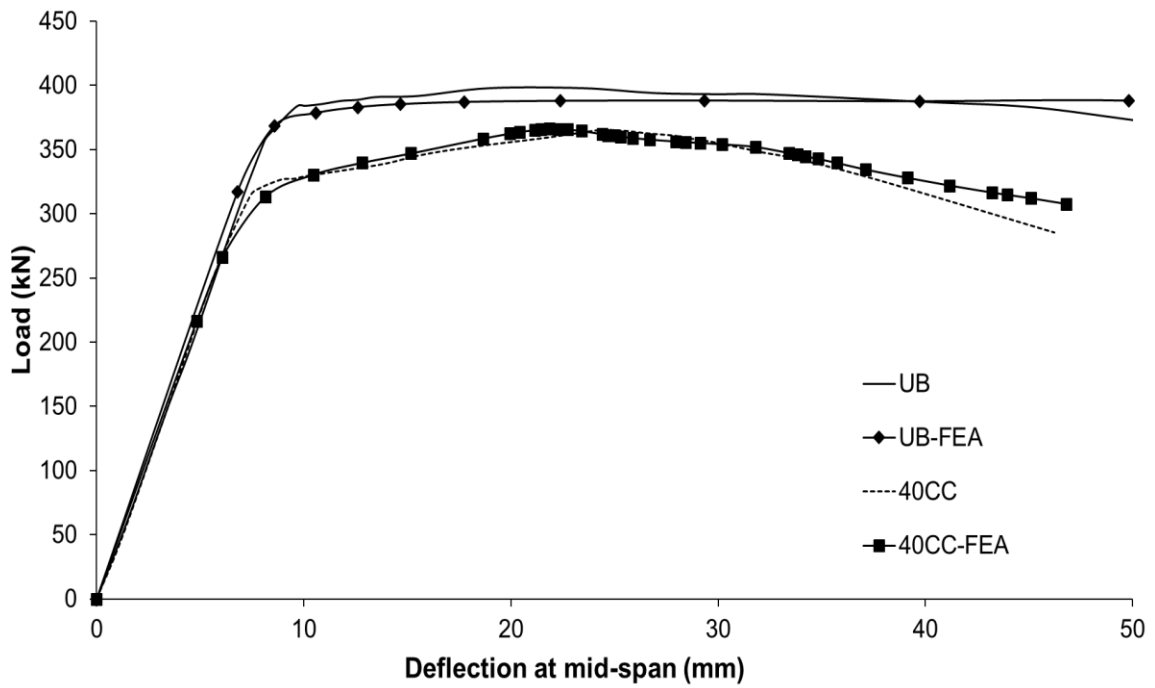
Figure 3.20: Validation of FEM models for the UB and 40CC beam

In the FE models, the BFRP fabrics was modeled as a single layer of thickness equal to the total thickness of the BFRP fabrics used for the rehabilitation. A surface-to-surface tie constraint was used to attach the BFRP fabrics layer to the steel beam since no de-bonding or slippage was observed in the experimental study. As narrow strips of BFRP fabrics were used to fill up the void created by the corrosion, another layer of BFRP fabrics was created to simulate the small strips. This layer was also attached to the steel beam and the main BFRP fabrics using a surface-to-surface tie constraint. Figure 3.20 shows the comparison of the load-deflection data obtained from the test specimens and the FE models for the specimens UB and 40CC. A good correlation between test specimens and FE models is found.

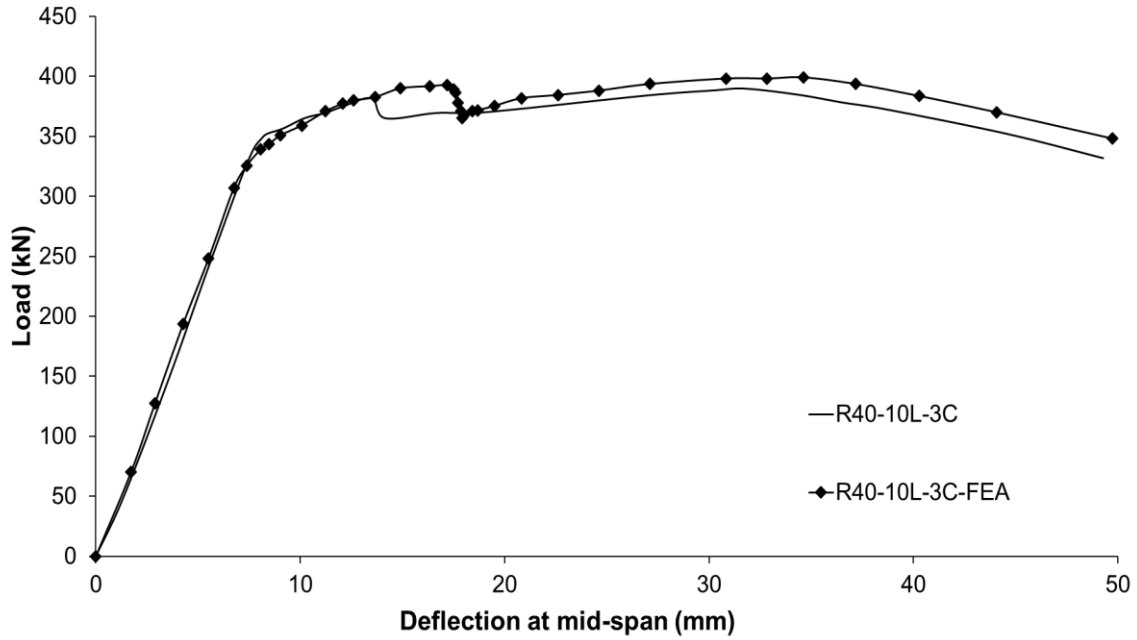
Figure 3.21: Validation of FEM models for R40-10L-3C beam

Figures 3.21 and 3.22 show the comparison of the load-deflection behaviors of the beam with 40% corrosion defect when rehabilitated with 10 layers and 15 layers of BFRP fabric, respectively obtained from the tests and the FE models. Again, a good correlation between the test specimens and FE models can be observed.

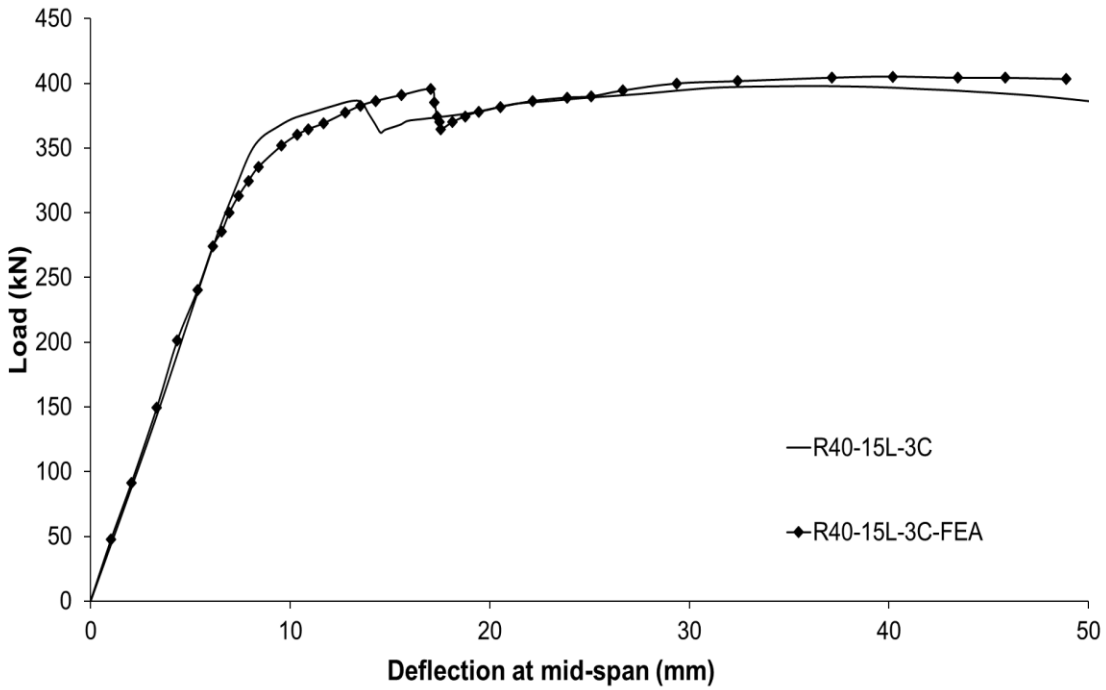
Figure 3.22: Validation of FEM models for R40-15L-3C beam
